Landing gear failures involving a Gippsland Aeronautics GA8 Airvan, VH-BFS

Fraser Island, Queensland, 24 August 2019 and 31 October 2019

ATSB Transport Safety Report

AO-2019-045

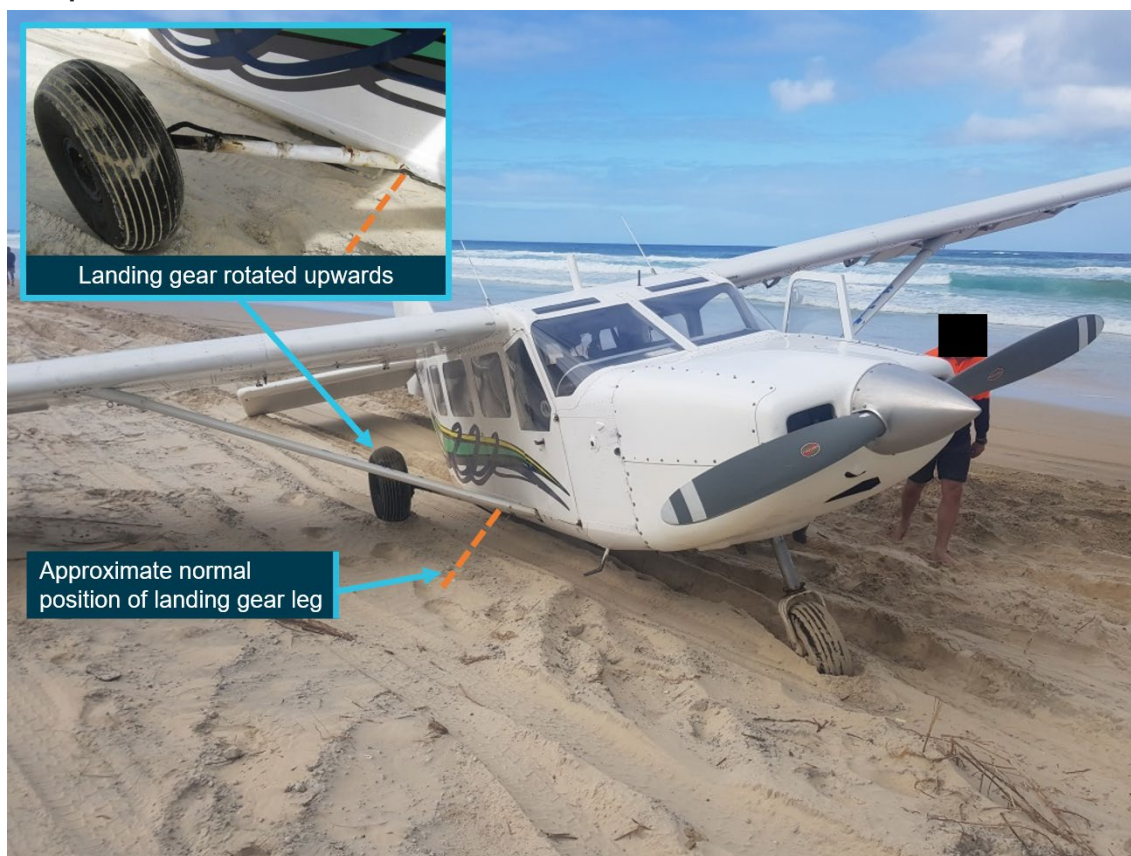
The operator's licenced aircraft maintenance engineer (LAME) reported that the right main landing gear was no longer secured at its mount fitting by eight mount bolts, allowing it to rotate aft and upwards to a position where it could no longer support the aircraft (Figure 1). The aircraft was repaired and returned to service.

Figure 1: VH-BFS where it came to rest on 24 August, showing the right landing gear collapsed

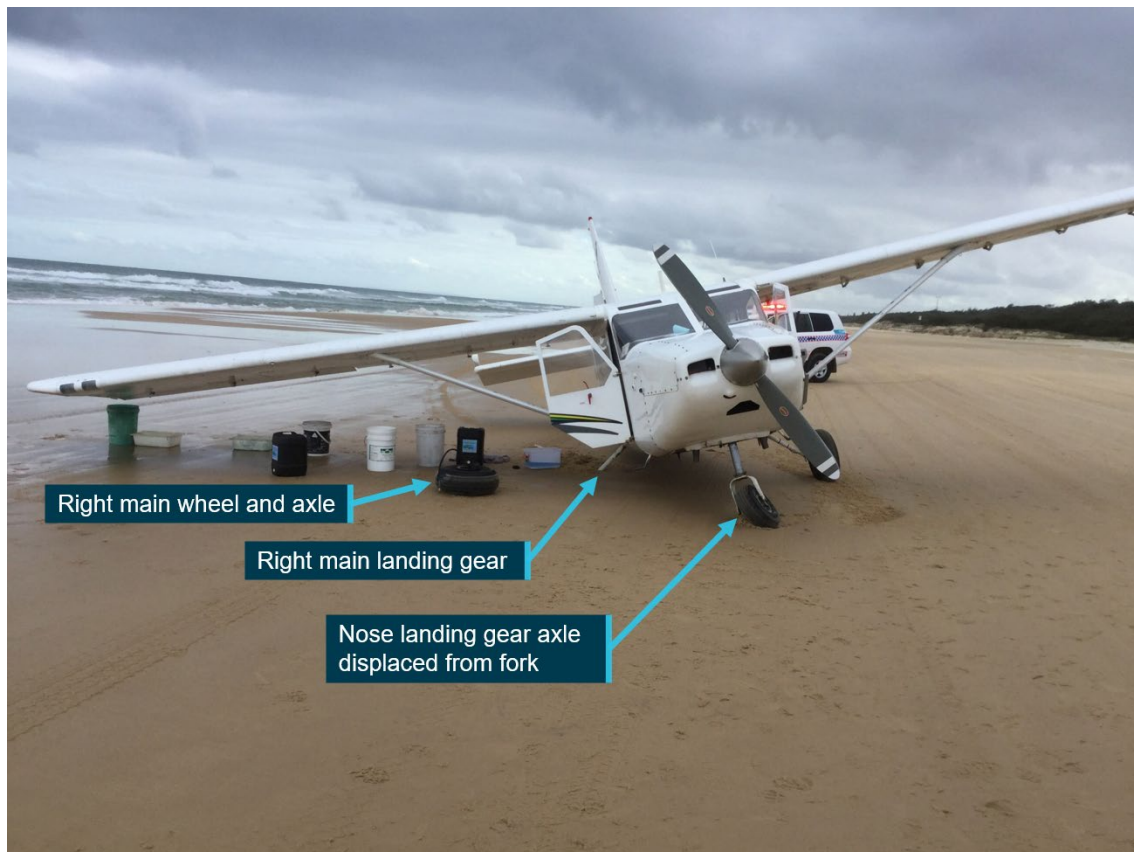
The pilot reported that the landing was normal with no excessive loads. During the landing roll on the beach ALA, the right main landing gear wheel separated from the aircraft. There were no reported injuries. Following the flight, fuel was observed to be leaking from the right wing. Queensland Parks and Wildlife Service personnel were in attendance and attempted to manage the spill (Figure 2).

Figure 2: VH-BFS where it came to rest on 31 October, showing the right main wheel separated from the aircraft

The operator's LAME established that the right main landing gear had fractured at the axle, which is the attachment point for the main wheel to the landing gear. Another main landing gear assembly from the operator's other GA8³ was fitted to VH-BFS, and the nose wheel axle bolt was replaced. The aircraft was subsequently returned to service.

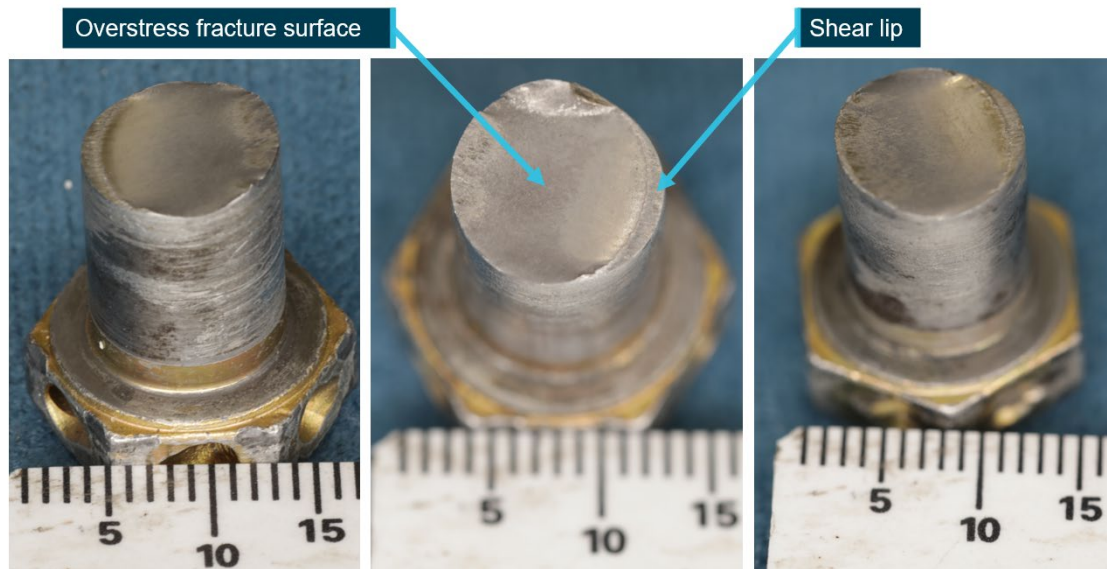
- Manufacturing stamps and measurements indicated the bolts were the right type and fit for purpose.
- There were no pre-existing defects with the bolts.
- There was no evidence of cracking, and there were shear lips present on all three bolts. Their fracture surfaces were consistent with shear overstress⁶ from a single event.

Dimensional examination of the bolt remnants showed it was likely that all three bolts were correctly tightened, and that the fractures occurred at the interface between the landing gear leg and its mount fitting.

Figure 6: The three recovered main landing gear mount bolt heads with partial shanks

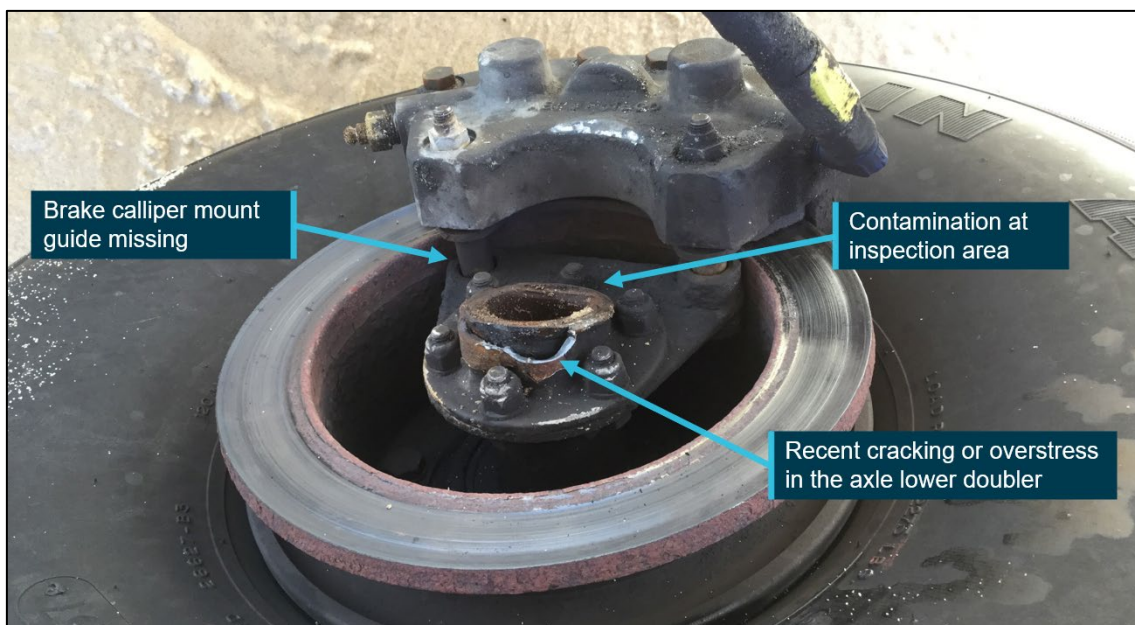
Examination of photographs taken immediately after the main landing gear axle fracture occurrence on 31 October 2019 showed that significant amounts of pre-existing contamination existed at the axle inspection area, and that one of the mount guides on the brake calliper torque plate had broken off at an unknown time prior to the occurrence (Figure 7).

Figure 7: VH-BFS right main wheel, brake and axle taken just after 31 October 2019 occurrence

Additionally, there was significant amount of pre-existing contamination at the axle inspection area. This indicated that required cleaning of the inspection area had not been conducted for an extended period, which reduced the likelihood of identifying cracks in the inspection area.

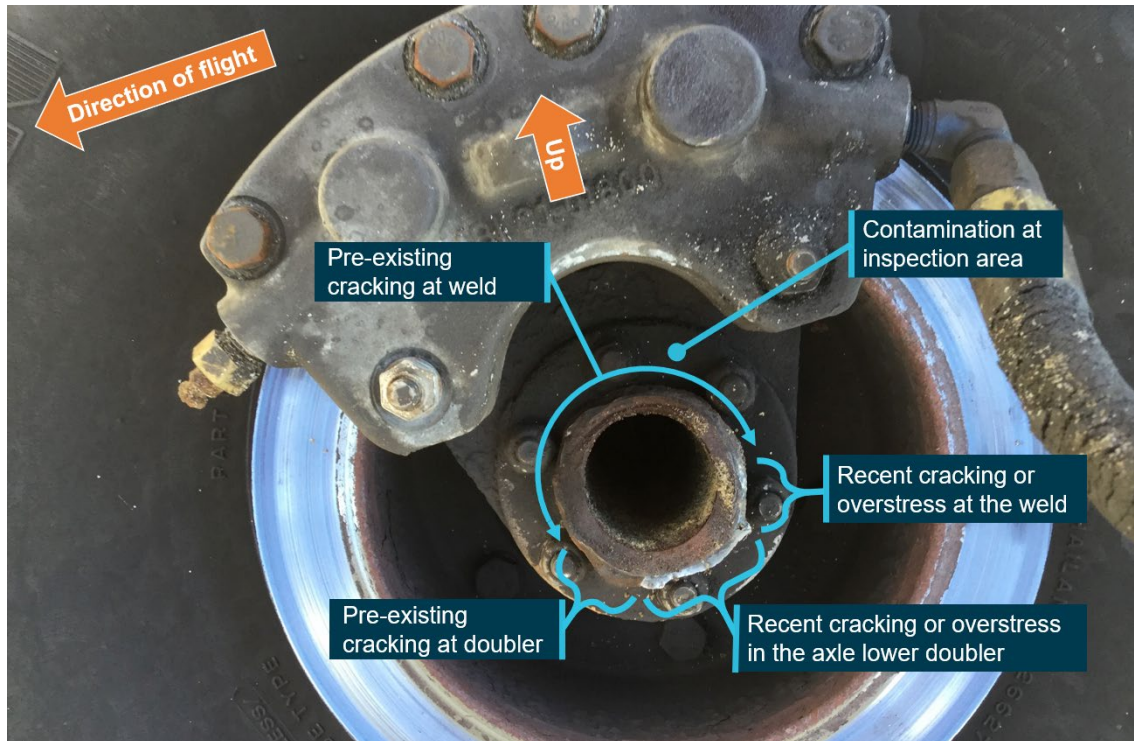
Figure 8 shows dark and light areas across the axle fracture surface. Analysis of the photograph by materials failure specialists assessed the darkened areas as being pre-existing areas of fracture and the brighter areas, such as the area labelled as the 'axle lower doubler', were

overstress in nature. Based on that evidence, the axle weld was cracked around about two thirds of the circumference. The remaining structure failed in overstress during the landing occurrence.

Figure 8: VH-BFS right main landing gear axle failure taken just after 31 October 2019 occurrence

Technical analysis of axle fracture surfaces showed that a fatigue crack formed and propagated undetected around two thirds of the axle circumference along the weld and eventually failed in a weakened state during a normal beach landing. Examination of the weld points on the axle indicated that there was a low weld penetration at the axle attach sleeve. A combination of low weld penetration, operations on uneven beach ALAs and high landing cycles in a highly-corrosive environment may have increased the crack initiation and propagation rate. Corrosion pitting inside the fracture surfaces indicated that the crack had been present for a significant period of time.

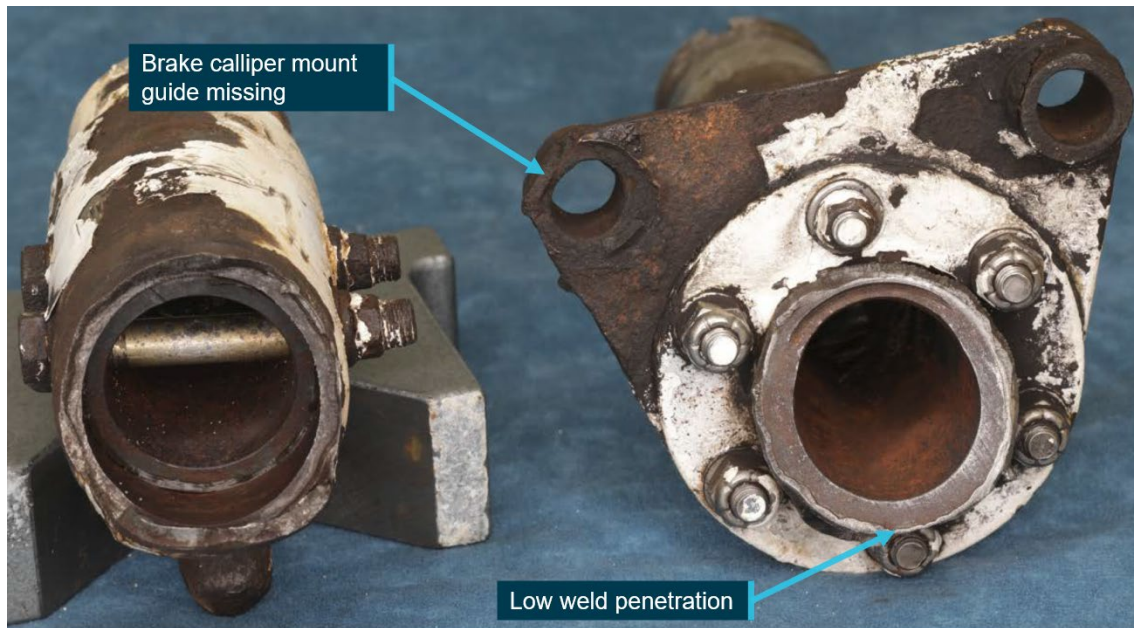
- There was low weld penetration (less than 1 mm) in some areas.
- The axle assembly was fractured in the area known to crack as described in SB-GA8-2016-169. However, smearing⁷ and corrosion at the fracture surface prevented a determination on the degree of fatigue present prior to the occurrence.
- The axle assembly lower doubler had failed in overstress.
- There was paint missing on the leg and axle assembly with darker corrosion visible, likely present prior to the occurrence.
- Corrosion pitting was present on the fracture surface opposite the doubler, suggesting pre-existing damage.
- A secondary crack was found opposite the doubler, near the region of corrosion pitting.

Figure 9: VH-BFS right main landing gear axle after cleaning

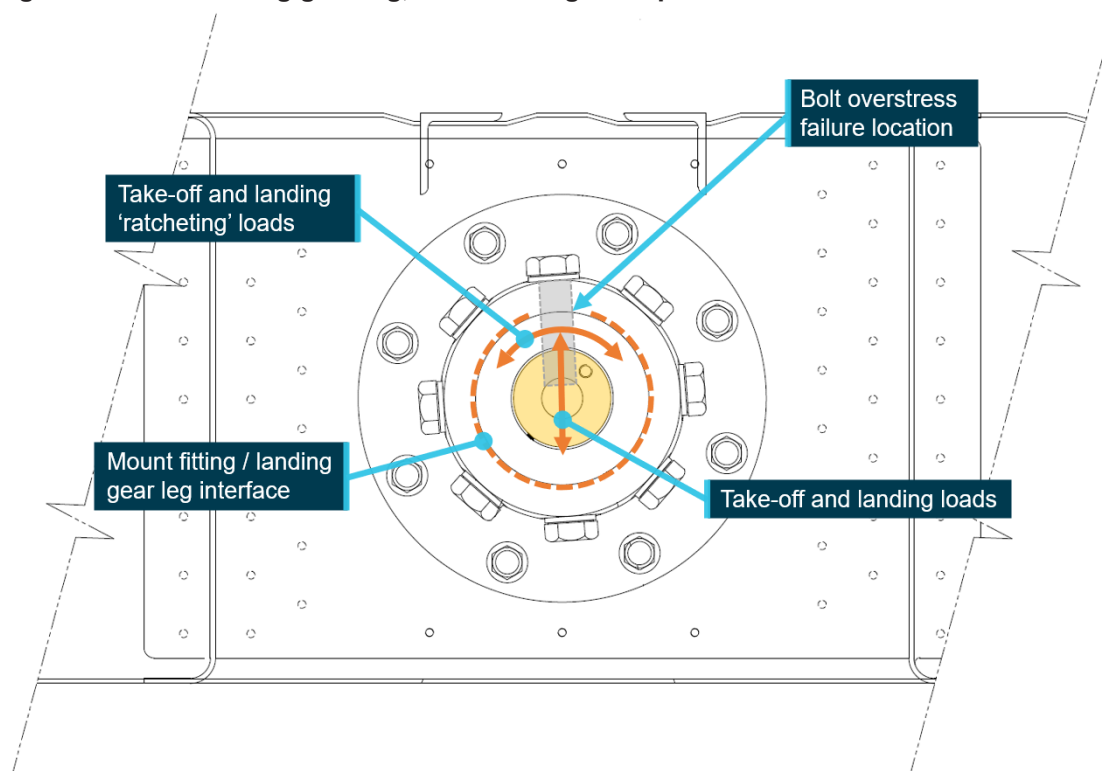
Figure 10 shows an illustration of the eight mount bolts that are designed to secure the landing gear to the airframe structure. The bolts pass through the airframe fitting, into the landing gear leg and then they are retained by a special nut with eight threaded holes. The illustration also indicates the point of intersecting forces or loads applied by the airframe against forces applied by the landing gear. These forces are in shear and the point of intersection is the location where the three provided bolts sheared in overstress.

Figure 10: Main landing gear leg, mount fitting and special nut
