Safety Advisory Notice

To R44 helicopter operators

Number: AO-2020-064-SAN-014

R44 helicopter drive train failure

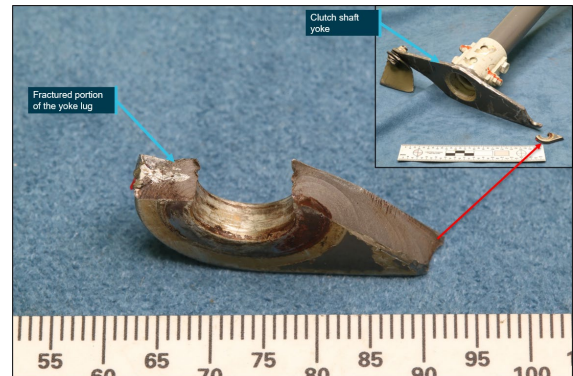
Fractured clutch shaft yoke (Source: ATSB)

The ATSB's preliminary metallurgical examination of the drive train components identified that the clutch shaft forward yoke had fractured. The fracture occurred at a bolt hole on the yoke lug that connected with the forward flex plate (Figure 1) and was due to the development of fatigue cracking that progressed almost entirely through the yoke cross-section.

The fracture resulted in the loss of engine drive to the main rotor system. Corrosion product and fretting damage were identified in the vicinity of the bolt hole adjacent to the fatigue fracture surfaces.

AO-2020-064-SAN-014: The ATSB advises operators of R44 helicopters to note the preliminary finding of this accident and to look for the presence of corrosion, fretting or cracking, which may not be visually obvious, during all inspections of the clutch shaft yoke. Any identified defects should be notified to both the ATSB and the Civil Aviation Safety Authority.
