New investigation: **201807226** - 9V-OJE B787 - Engine Failure - Perth WA - 11 Oct 2018

Engine failure involving Boeing 787 , 9V-OJE, Perth WA, 11 October 2018

AO-2018-069  
 Engine failure involving Boeing 787 , 9V-OJE, Perth WA, 11 October 2018

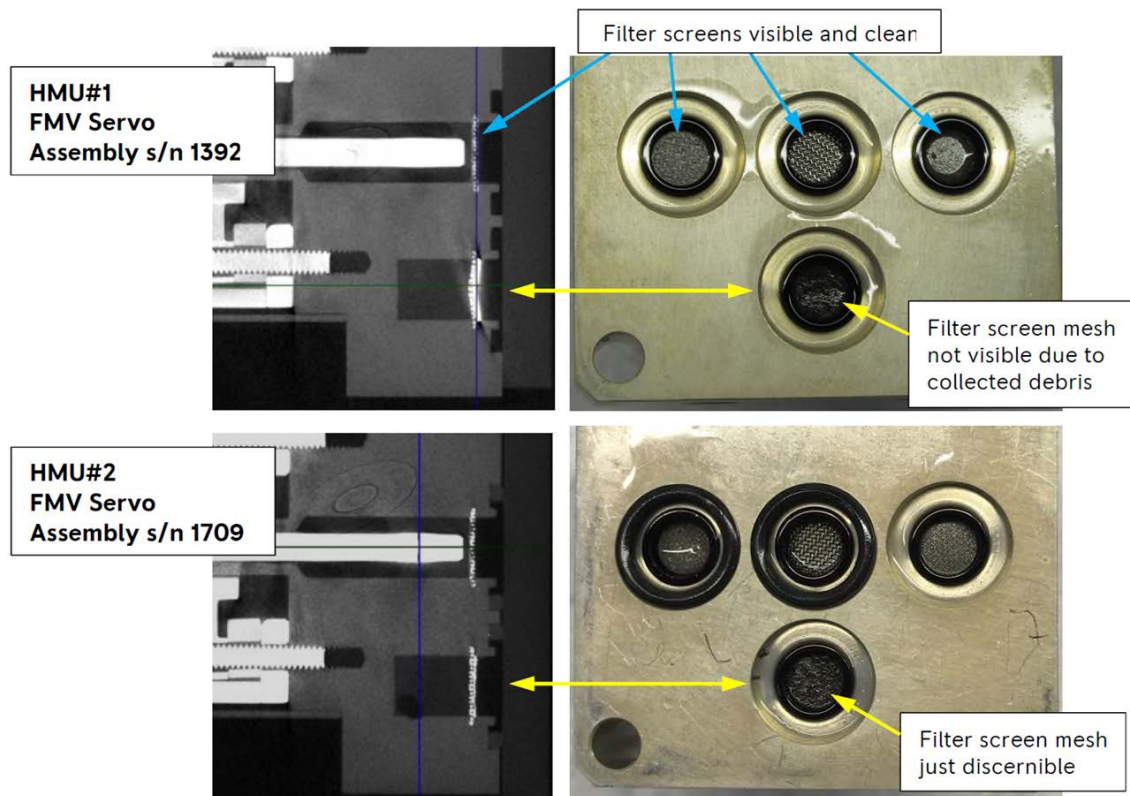
**Figure 1: Blocked inlet filters on both FMV servo assemblies**

Rolls-Royce examined the HMU from the occurrence flight (HMU 1) as well as the one from the subsequent flight (HMU 2). In both units, a build-up of metallic debris was found in various locations, although more debris was found in HMU 1. The inlet filter to the FMV servo assembly was at least partially blocked with debris in both units.

*The build-up of metallic debris was greater on HMU #1. Some deformation can also be observed in the #1 inlet filter x-ray image. Rolls-Royce determined that this was likely due to the high-pressure differential caused by the blockage.*  
 Source: Rolls-Royce

The engine manufacturer, Rolls-Royce, concluded that the engine shutdown was the result of a blocked inlet filter on the fuel metering valve (FMV) servo assembly. This blockage restricted the electronic engine controller's (EEC) ability to adjust fuel pressures within the servo. As a result, the EEC had limited control over the FMV position, and consequently the amount of fuel flowing to the burners. When the EEC commanded the FMV to increase fuel flow from sub-idle to idle levels, it did not respond in time, and the engine shut down. The blockage was due to debris from worn journal bearings in the secondary HP fuel pump driven gear.

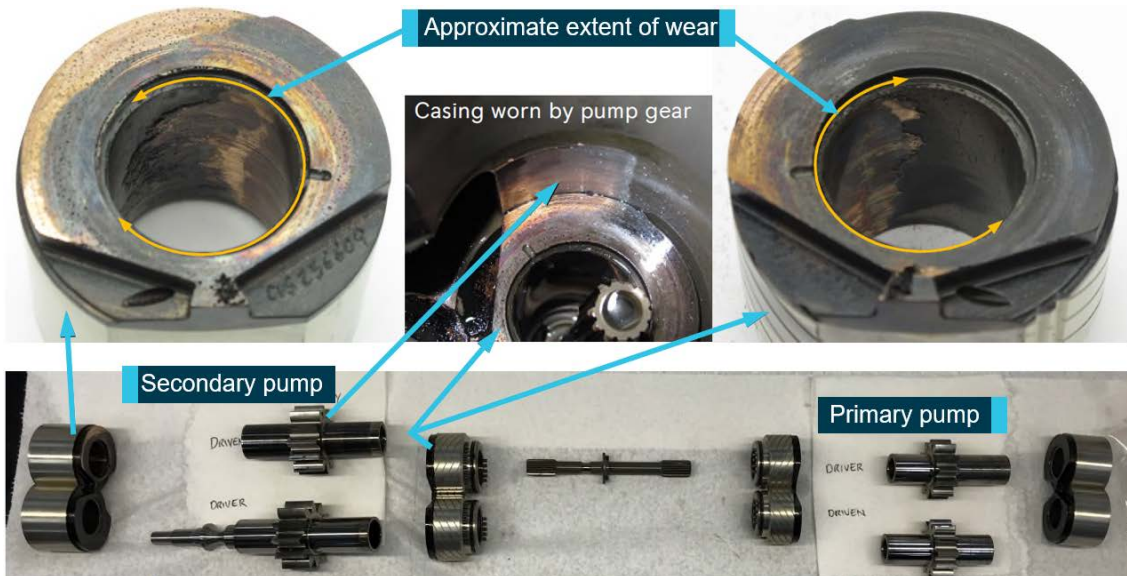
**Figure 2: Worn journal bearings and casing for the secondary HP pump driven gear**

Analysis of the metallic debris revealed that it consisted of material from the fuel pump bearings and the casing. All three stages of the pump (the LP pump, and the two HP pumps) were disassembled and examined by Rolls-Royce in the presence of the United Kingdom Air Accidents Investigation Branch.

The examination found that the debris originated from the secondary HP pump. The bearings for the secondary HP pump driven gear were heavily worn, with evidence of scoring and missing material (Figure 2). Rolls-Royce found that the casing for the driven gear had more wear than would be expected during normal operation, likely due to shaft movement resulting from the damaged journal bearings. No damage was found on other bearings within the secondary HP pump or the other two fuel pumps.

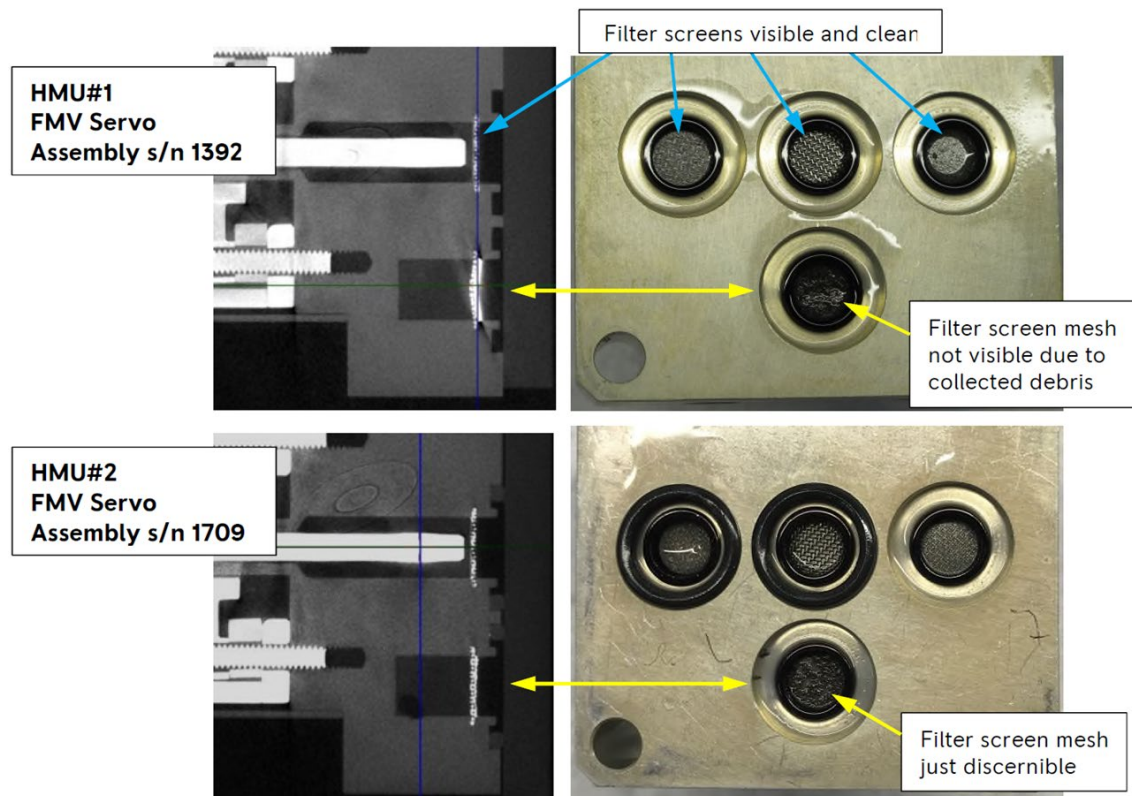
**Figure 1: Blocked inlet filters on both FMV servo assemblies**

Rolls-Royce examined the HMU from the occurrence flight (HMU 1) as well as the one from the subsequent flight (HMU 2). In both units, a build-up of metallic debris was found in various locations, although more debris was found in HMU 1. The inlet filter to the FMV servo assembly was at least partially blocked with debris in both units.

The build-up of metallic debris was greater on HMU #1. Some deformation can also be observed in the #1 inlet filter x-ray image. Rolls-Royce determined that this was likely due to the high-pressure differential caused by the blockage. Source: Rolls-Royce

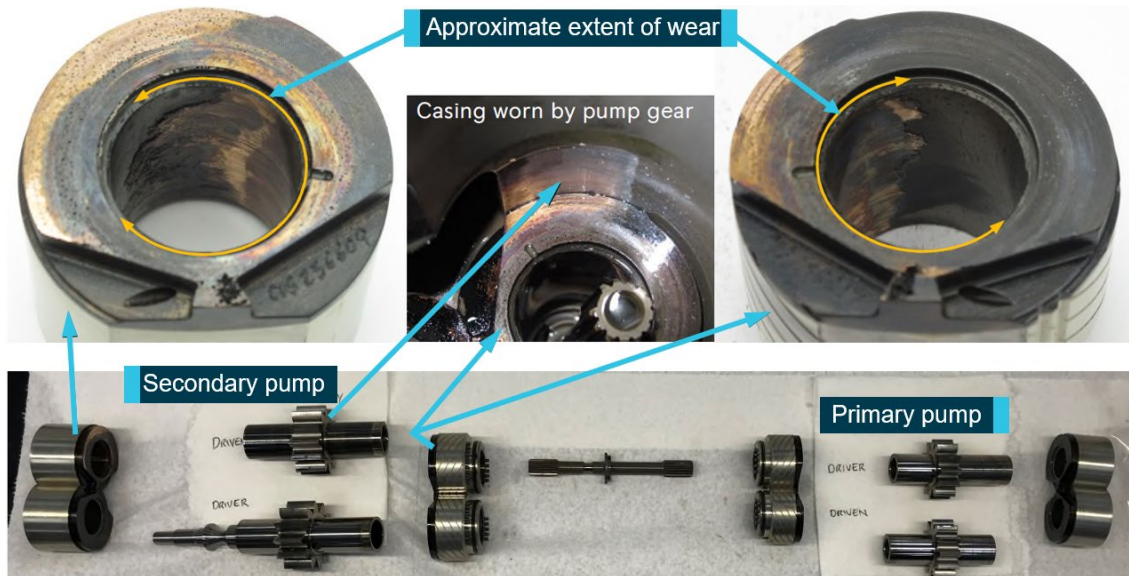
**Figure 2: Worn journal bearings and casing for the secondary HP pump driven gear**

Analysis of the metallic debris revealed that it consisted of material from the fuel pump bearings and the casing. All three stages of the pump (the LP pump, and the two HP pumps) were disassembled and examined by Rolls-Royce in the presence of the United Kingdom Air Accidents Investigation Branch.

The examination found that the debris originated from the secondary HP pump. The bearings for the secondary HP pump driven gear were heavily worn, with evidence of scoring and missing material (Figure 2). Rolls-Royce found that the casing for the driven gear had more wear than would be expected during normal operation, likely due to shaft movement resulting from the damaged journal bearings. No damage was found on other bearings within the secondary HP pump or the other two fuel pumps.

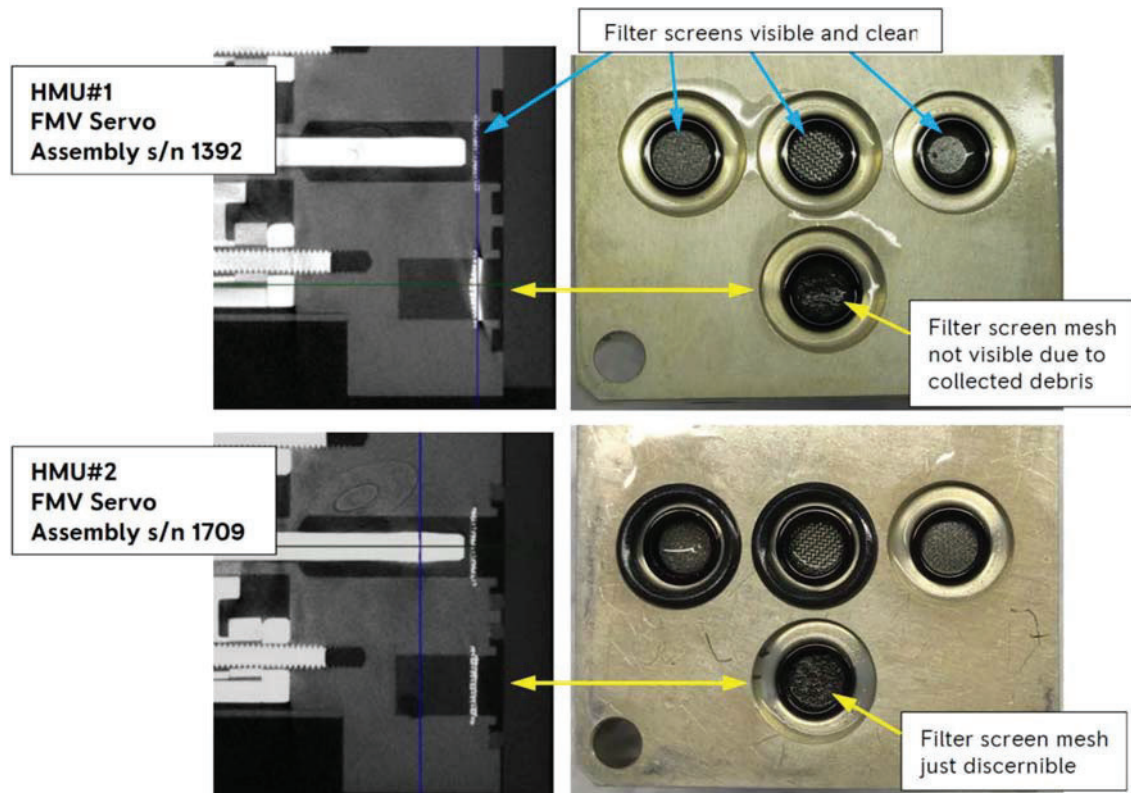
**Figure 1: Blocked inlet filters on both FMV servo assemblies**

The build-up of metallic debris was greater on HMU #1. Some deformation can also be observed in the #1 inlet filter x-ray image. Rolls-Royce determined that this was likely due to the high-pressure differential caused by the blockage. Source: Rolls-Royce

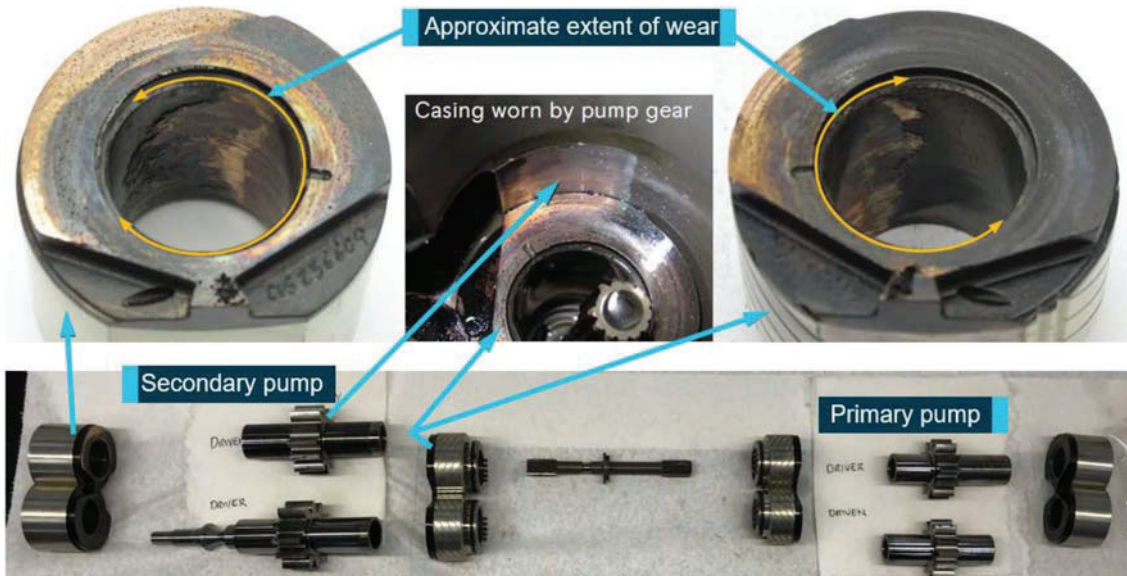
**Figure 2: Worn journal bearings and casing for the secondary HP pump driven gear**

Analysis of the metallic debris revealed that it consisted of material from the fuel pump bearings and the casing. All three stages of the pump (the LP pump, and the two HP pumps) were disassembled and examined by Rolls-Royce in the presence of the United Kingdom Air Accidents Investigation Branch.

The examination found that the debris originated from the secondary HP pump. The bearings for the secondary HP pump driven gear were heavily worn, with evidence of scoring and missing material (Figure 2). Rolls-Royce found that the casing for the driven gear had more wear than would be expected during normal operation, likely due to shaft movement resulting from the damaged journal bearings. No damage was found on other bearings within the secondary HP pump or the other two fuel pumps.
