Door failure and depressurisation involving a Cessna 441, VH-LBY

near Broome, Western Australia, on 22 July 2020

ATSB Transport Safety Report
Aviation Occurrence Investigation
AO-2020-036
[Final – 30/06/2021]

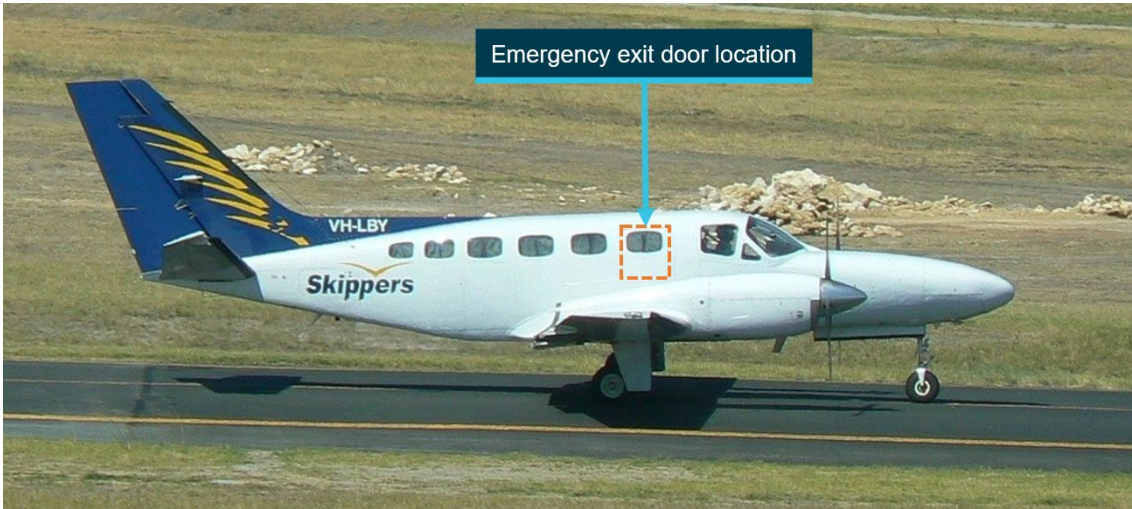
Figure 2: VH-LBY and the location of the emergency exit door

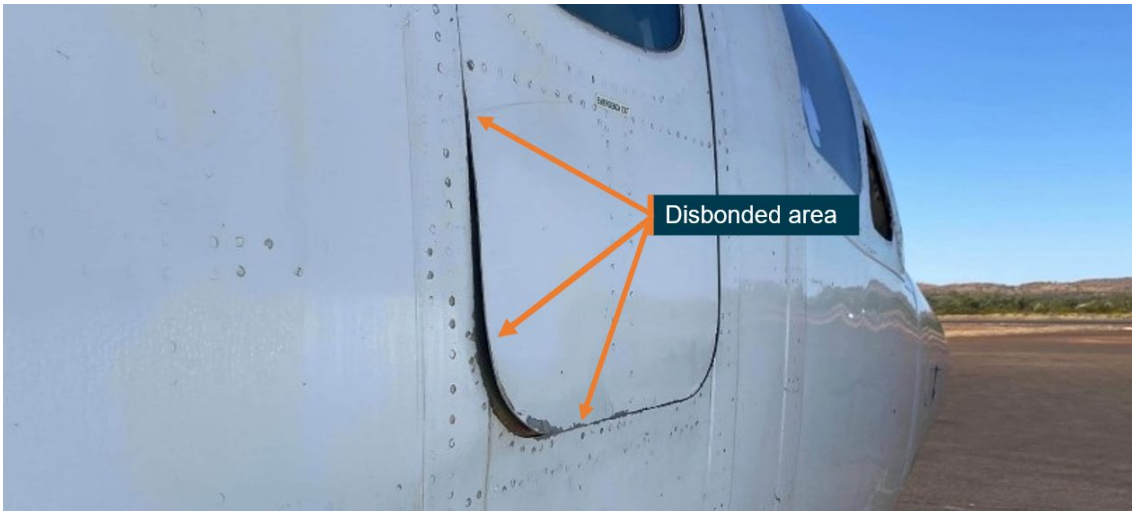
Figure 3: Separation of the emergency exit door outer skin

On arrival at Halls Creek, the SBP inspected the emergency exit door and noted there was a 10 mm gap at the bottom of the door and that the door had disbonded, which they had not seen before. They photographed the door and sent them to the maintenance shift supervisor for further discussions.

- The depressurisation was the result of a failure of the emergency exit door skin, which appeared to have been caused by propagation of a disbond between the inner and outer skin layers. The final position of the distorted skin corner was about 16 mm proud from the original bond surface.

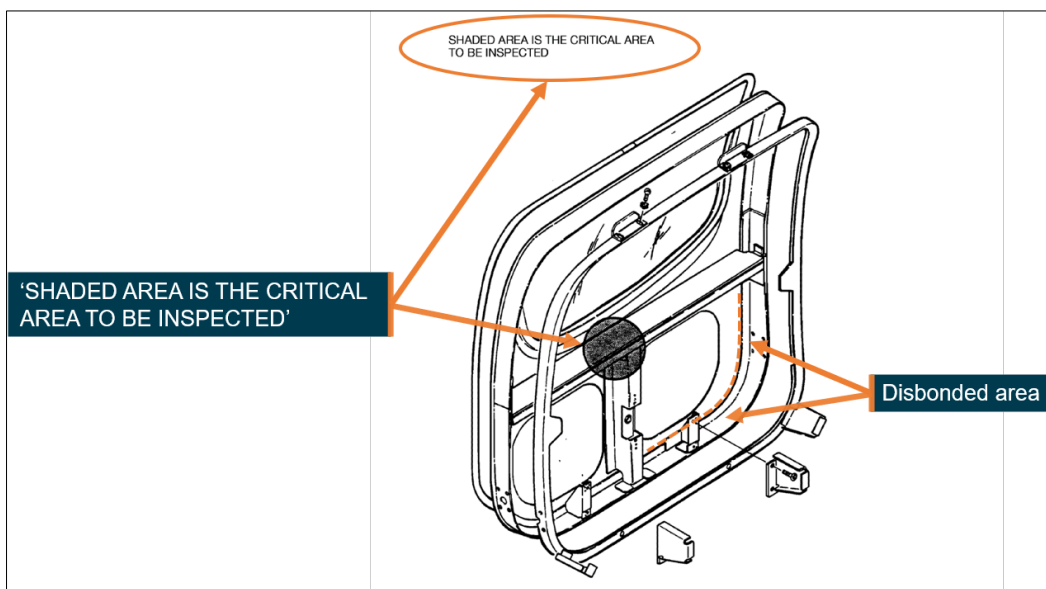
The MMS made no changes to the Cessna maintenance manual requirements for 52-20-01, nor were there any additional requirements related to the ongoing airworthiness of the emergency exit door. Inspection 52-20-01 was last certified as completed for the incident aircraft on 1 March 2020, with nil defects found. At interview, the maintenance shift supervisor noted that a visual inspection alone might not be adequate to detect the pre-failure condition of the bondline. The shift supervisor stated the ‘current diagram might draw attention to a specific area [shaded area] ...very easy to overlook...need a bond check with NDT [non-destructive testing] or a tap test’.

Figure 4: Maintenance manual figure for the inspection of the emergency exit door

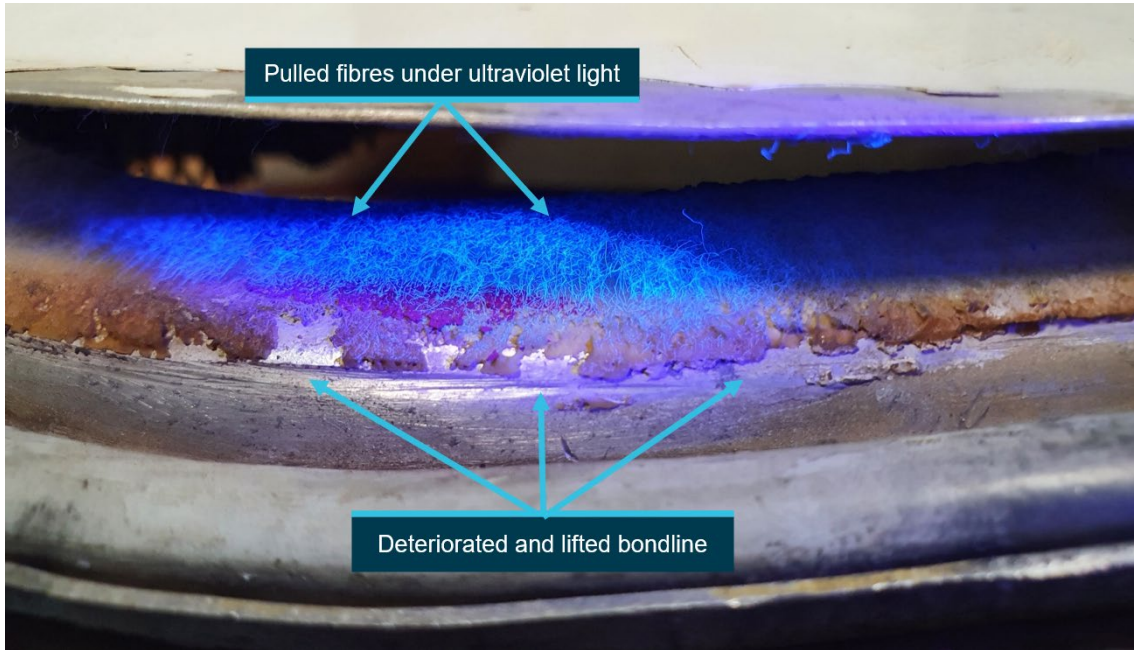
- A large disbond area resulted from moisture and corrosion, progressing from the inside edge of the door. There were no rivets in the bond in this area to interrupt a progressive disbond (peeling action).

- The basic design, with an overhanging edge and lack of any edge sealing, allowed for eventual bondline contamination, disbonding, and failure. This was exacerbated by corrosion and dents accumulated at the edge.

Figure 5 depicts the deteriorated bondline and pulled fibres visible under ultraviolet light, indicating final cohesive failure of the normal bond.

Figure 5: Deteriorated and failed bondline of the emergency exit door

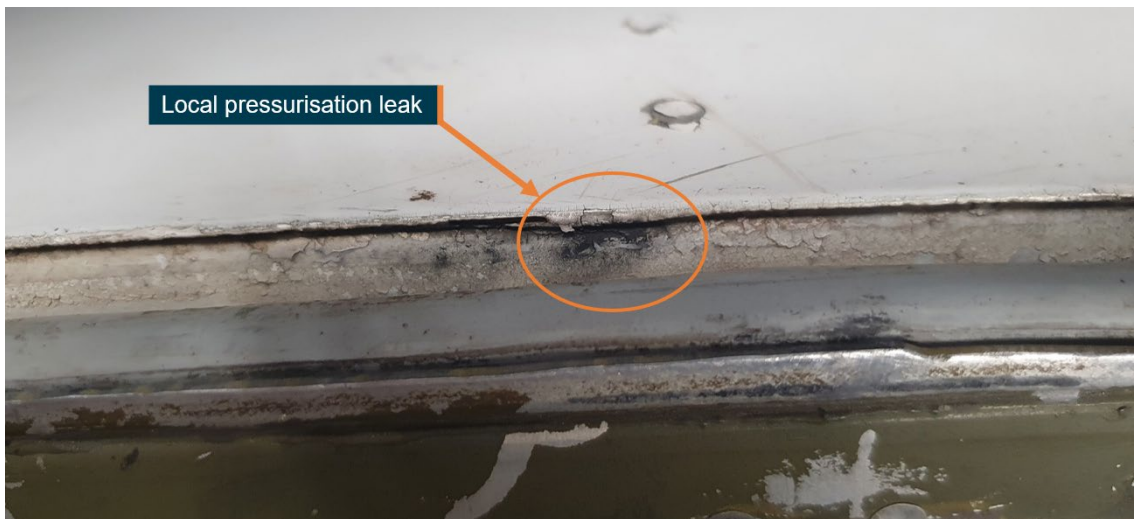
- there were numerous other smaller starting points for bondline failures
- a smaller, similar disbond was found on the lower forward corner and failure at this location was probably also imminent
- lifting of the adhesive carrier cloth was noticed in many places
- a small smudge may have been an indicator of an early local pressurisation leak, however, this would not have been detectable unless the door was removed from the aircraft (Figure 6).

Figure 6: Indication of a local pressurisation leak
