# Runway incursion involving Sling 2, VH-ZSD

Moorabbin Airport, Victoria, on 23 July 2020

**ATSB Transport Safety Report**

AO-2020-037

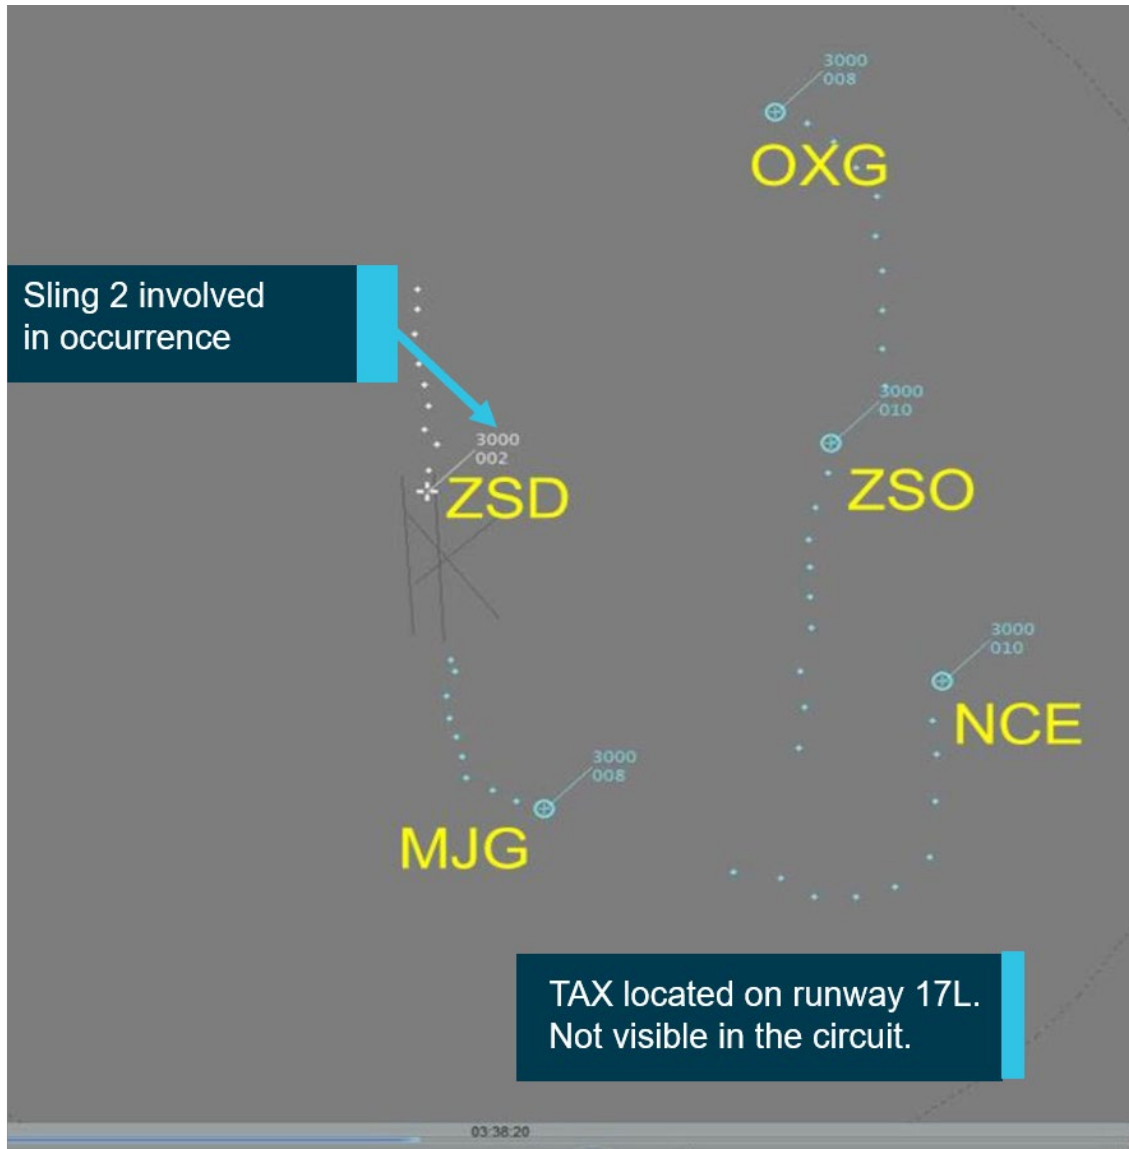
**Figure 1: Runway 17L circuit traffic situation display screen shortly before the occurrence**

At about 1334 Eastern Standard Time<sup>1</sup> on 23 July 2020, five aircraft were operating in the runway 17 left (17L) circuit at Moorabbin Airport, Victoria (Figure 1). They included a Sling 2, registered VH-ZSD (ZSD), operated by the Royal Victorian Aero Club (RVAC) with a student pilot on a second, solo flight. The pilot conducted a touch and go landing on runway 17L a few minutes earlier.

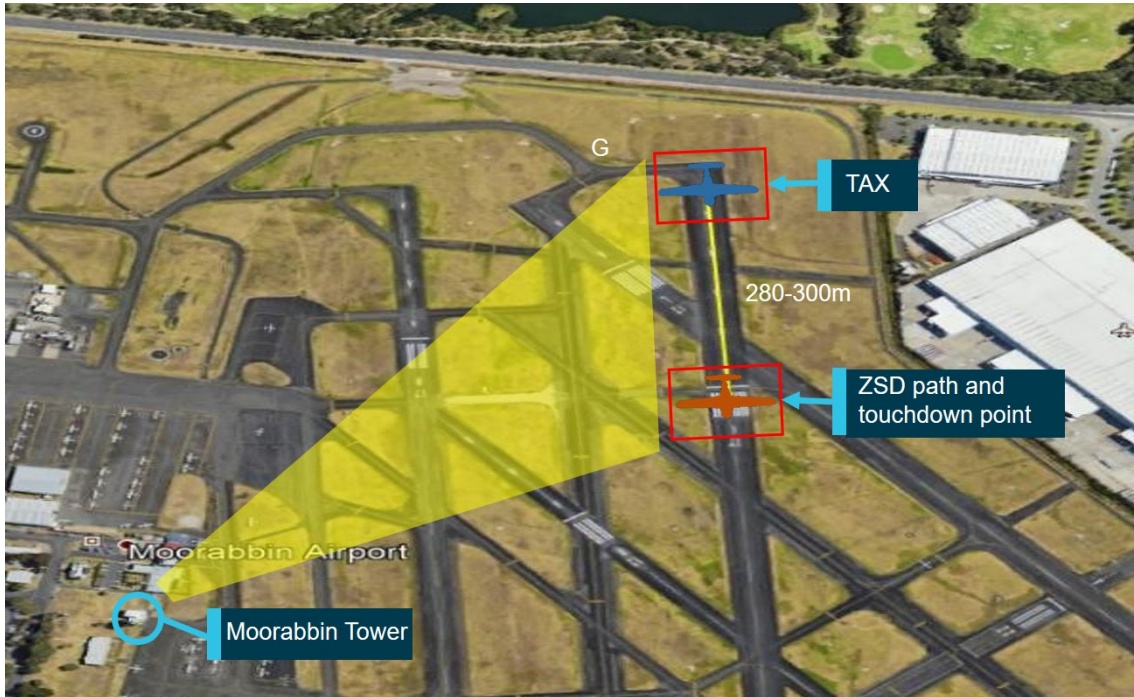
**Figure 2: Overview of Moorabbin Airport showing key locations**

*The shaded yellow area indicates the tower perspective of the part of the runway when ZSD overflew the lined-up TAX.  
Source: Airservices Australia, annotated by ATSB*

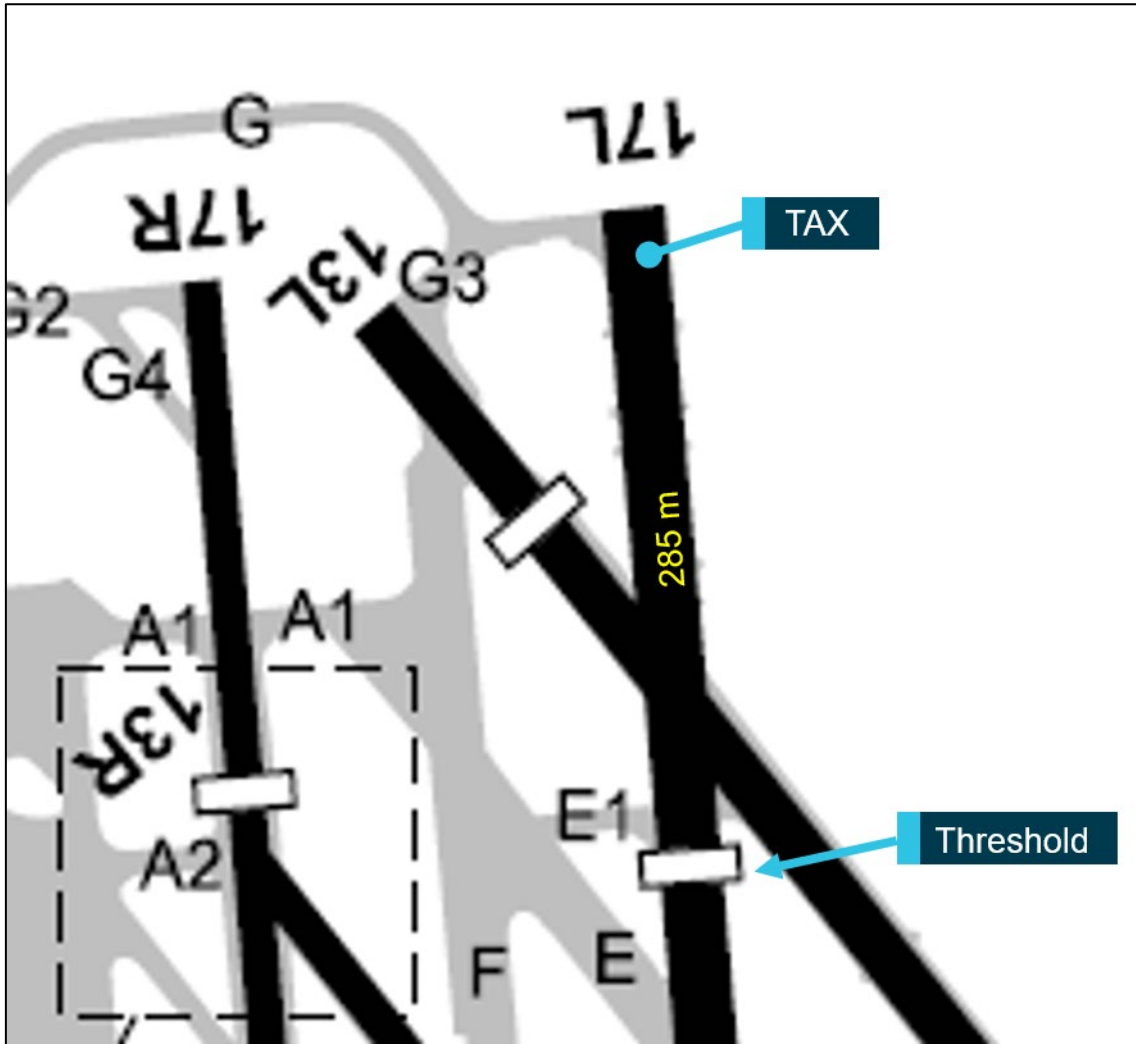
Figure 4: Runway 17L section showing the position of TAX behind the displaced threshold

At 1336:49, the controller instructed the pilot of TAX to line up on runway 17L. One minute later, TAX was still waiting in the lined-up position about 280 m behind the displaced threshold. The pilot of ZSD sighted TAX on the runway during the approach for landing. Just as the instructor was about to contact the tower to ask about the take-off clearance, ZSD passed above TAX and conducted a touch and go landing.<sup>3</sup>

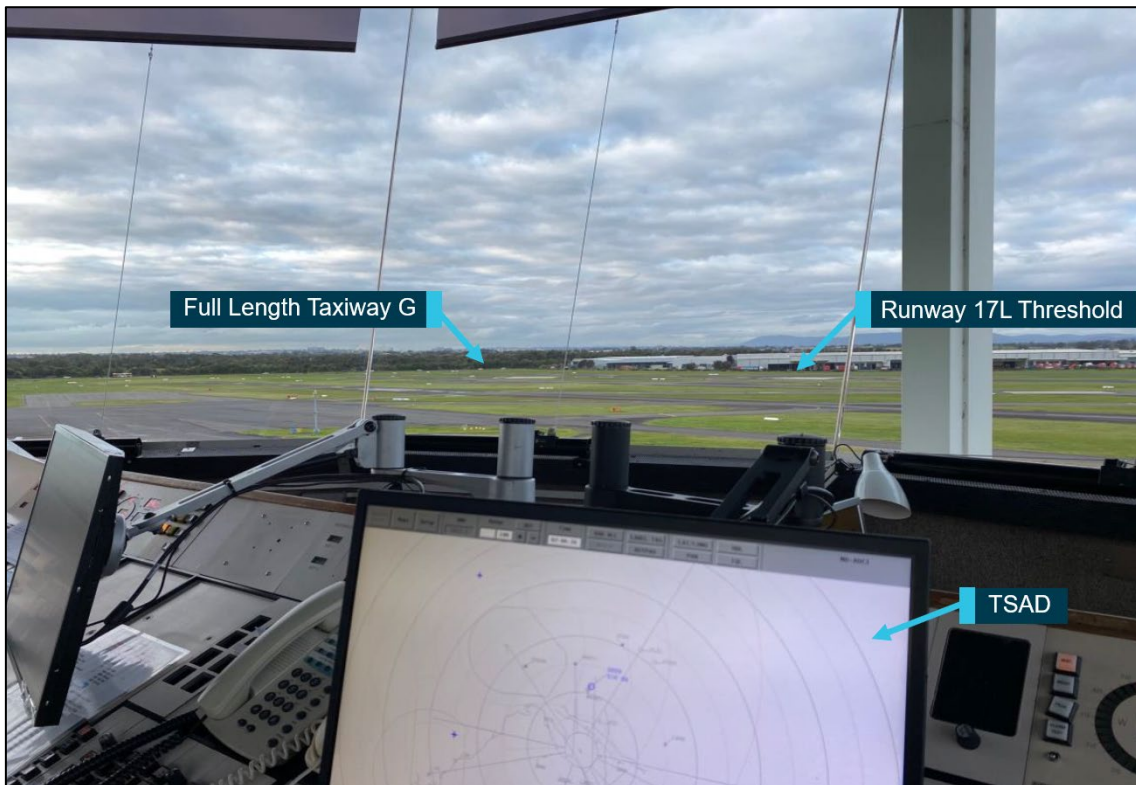
**Figure 5: View and perspective from controller position towards runway 17L**

Moorabbin Tower also utilises a support tool called the Traffic Situation Air Display (Figure 5). This display provides awareness of aircraft higher than about 200 ft, which is higher than ZSD was operating at the time of the incident.
