VFR into IMC involving Piper Aircraft PA-28, VH-FPS

near Warrnambool, Victoria, on 25 February 2021

ATSB Transport Safety Report

AO-2021-009

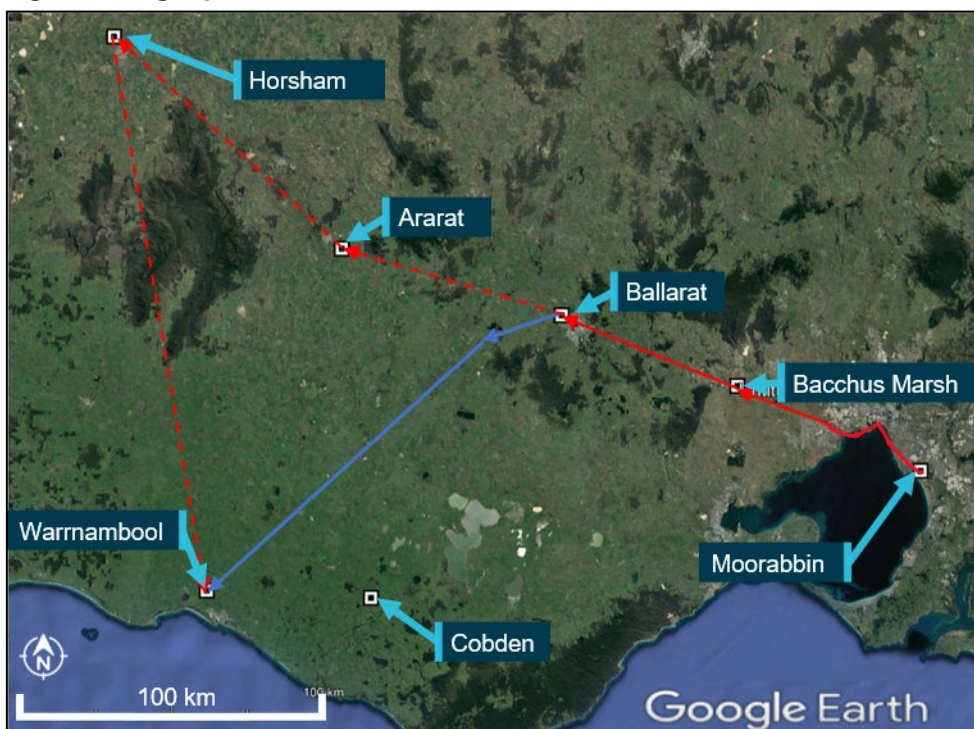
Figure 1: Flight planned track and diversion

The red full line shows the flight track, which was planned and flown, the red broken line shows the intended flight planned track and the blue line shows the track flown after the diversion from Lake Goldsmith, near Ballarat, to Warrnambool.
Source: Google earth, annotated by the ATSB

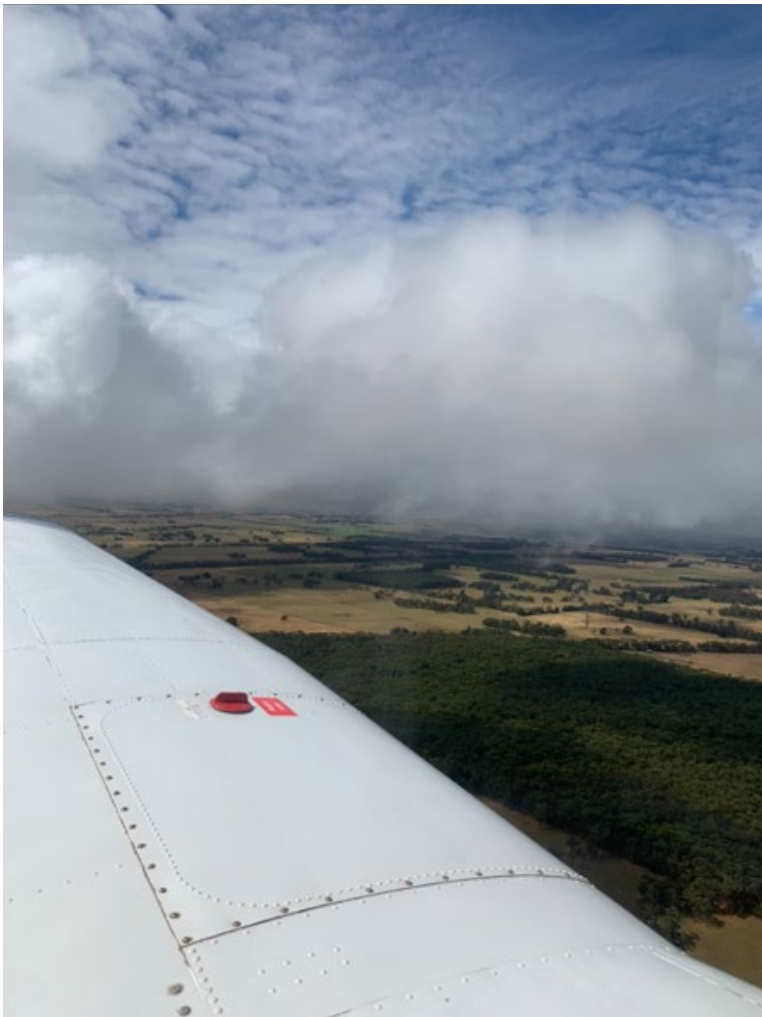
Figure 2: Photograph taken en route to Cobden Airport

Due to the deteriorating weather, the instructor decided to divert to Cobden Airport to land and wait until the weather cleared. As the aircraft approached Lake Elingamite, about 5 km south-west of Cobden (see Figure 1), the visibility reduced significantly in rain. As a result, the instructor, in the right seat, took control of the aircraft. They stated they could no longer see Cobden Airport and a decision was made to return to Warrnambool.

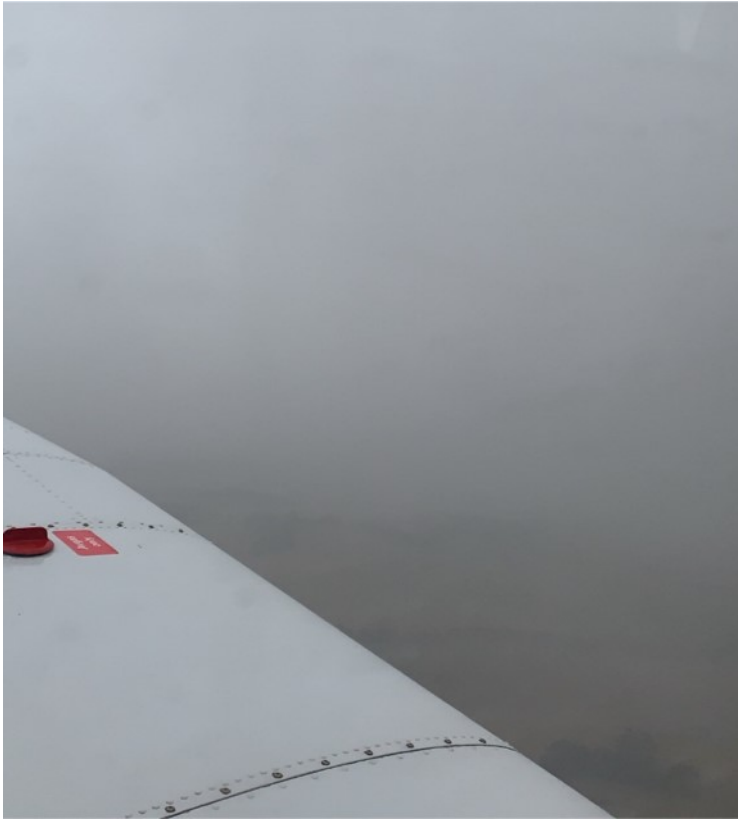
Figure 3: Photograph taken at 1613 during the return to Warrnambool Airport

The flight crew reported that during the initial stages of the return, the visibility was good. As they got closer to Warrnambool however, the visibility reduced, and they had to descend as the cloud base again began to lower. The instructor advised they were continuously listening to the AWIS during the return. At about 1615, while approaching Warrnambool township, at approximately 450 ft AGL, the instructor slowed the aircraft and extended two stages of flap. The visibility reduced significantly and the instructor, not wanting to descend further, made the decision to climb into cloud.

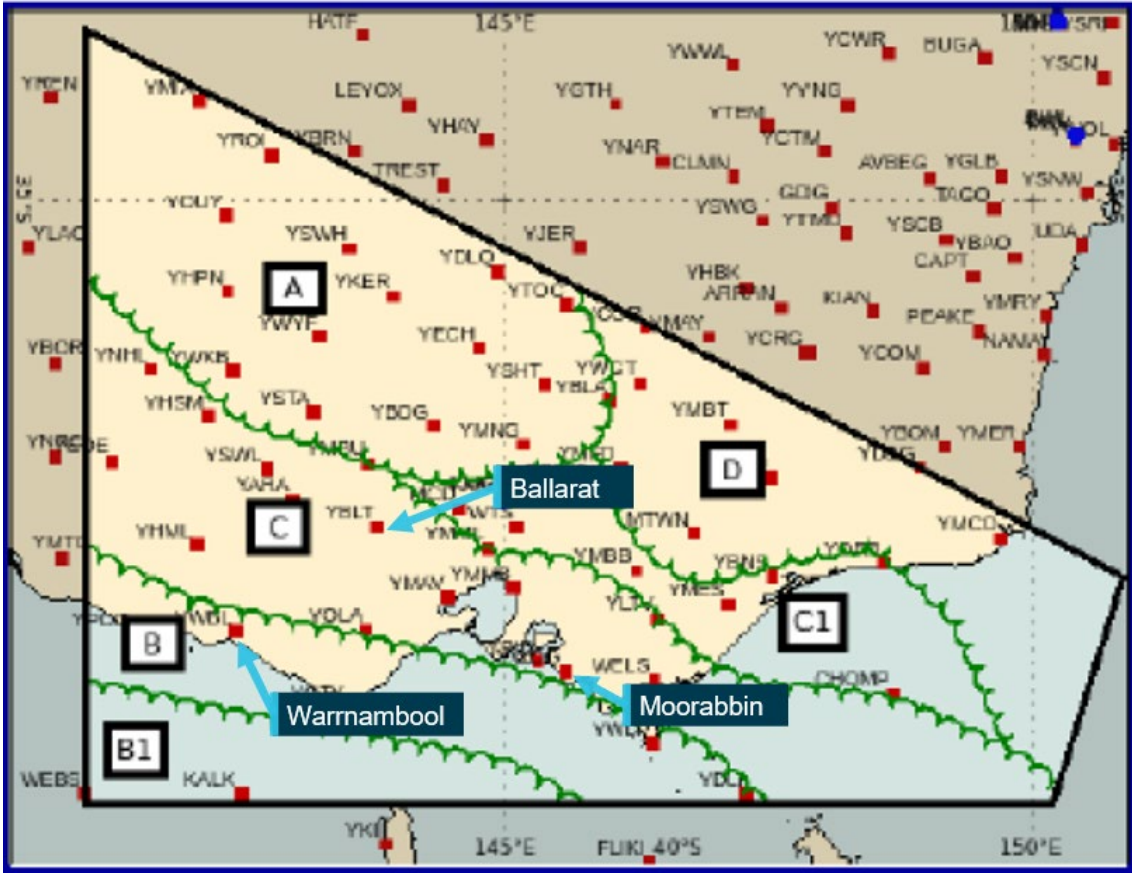
Figure 5: Graphical area forecast valid for flight

The student received the graphical area forecast (GAF)¹⁴ at 0910. It was valid until 1600. The GAF was split into six different areas on the day (Figure 5). The flight was planned to traverse two of these areas: B and C.

The initial section of the flight from Moorabbin Airport was planned in area C. This area was forecast to have greater than 10 km visibility and scattered cloud between 1,600 and 3,000 ft AMSL. From 1500, cloud was forecast to increase to broken between 3,000 and 8,000 ft AMSL.

The flight was then planned to enter area B, which included Warrnambool. From 1400, the visibility in this area was forecast to reduce to 3,000 m in scattered rain with broken stratus¹⁵ cloud between 500 and 2,000 ft AMSL and broken stratocumulus¹⁶ clouds between 2,000 and 9,000 ft AMSL.
