# Collision between out of gauge freight train 3WB3 and passenger train C181

Loftus, New South Wales, on 21 July 2020

**ATSB Transport Safety Report**

RO-2020-012

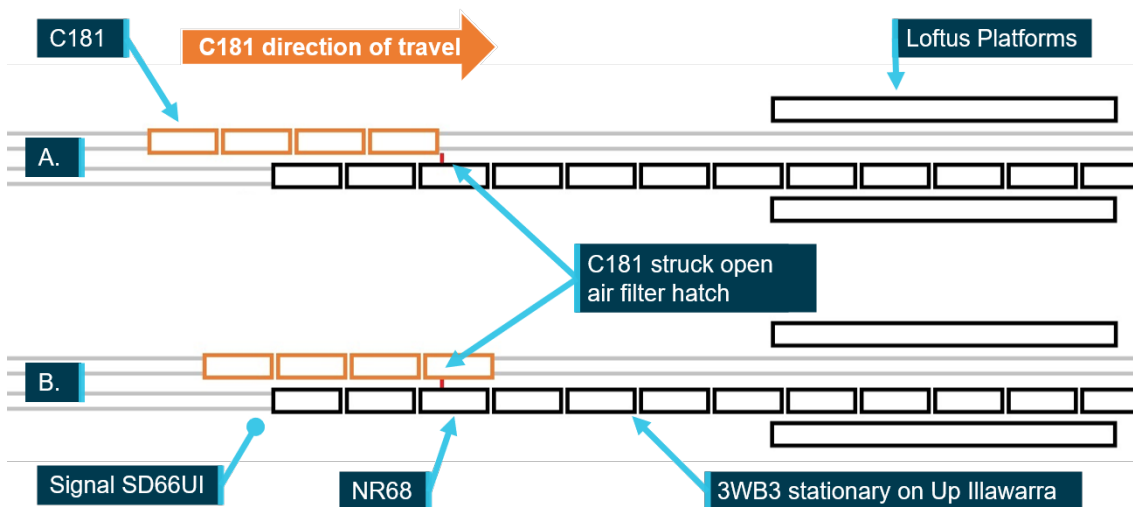
**Figure 1: Location and collision details**

Passenger train C181 consisting of four carriages was travelling towards Kiama in the Down<sup>2</sup> direction and was not scheduled to stop at Loftus. At 1918, train C181 began to pass train 3WB3 near Loftus. The lead carriage 6984 of C181 struck an open air filter hatch on the third locomotive damaging the front and side of the carriage (Figure 1 and Figure 2). The driver of C181 stopped the train at Loftus station after hearing a loud noise and came to a stand at 1918:48.

The image shows a simplified diagram for the track configuration at Loftus with the positioning of trains 3WB3 (shown in black) and C181 (shown in orange). The two diagrams A and B show the progression of C181 towards Loftus past the stationary air filter hatch (shown in red).  
Source: OTSI

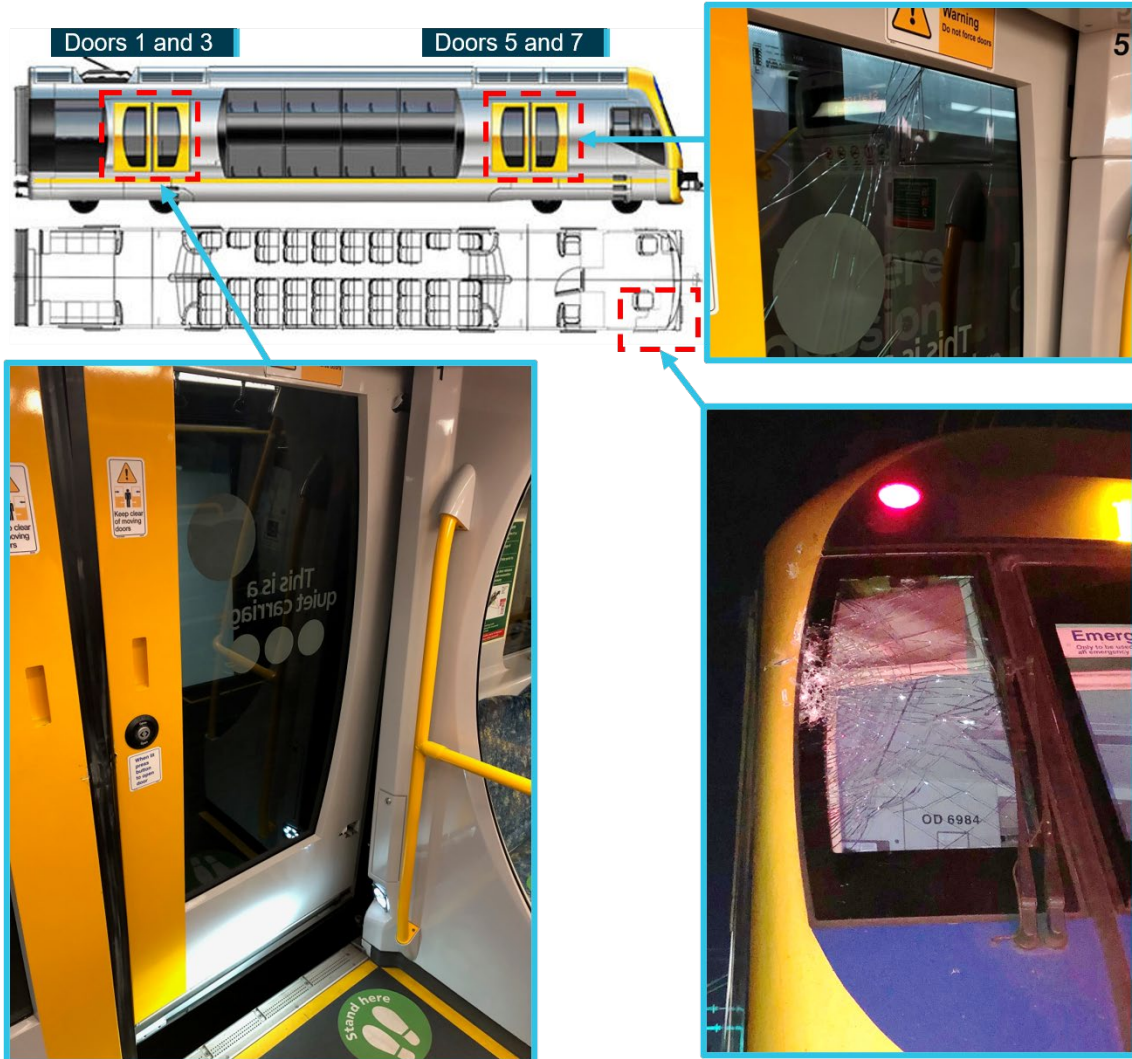
**Figure 2: Collision damage to carriage 6984**

The collision with the air filter hatch broke the guard side windscreen and the passenger door glass on door 5, and partially dislodged passenger doors 1 and 3 (Figure 2) on carriage 6984 of C181. The air filter hatch broke free from NR68 and fell to the track after the collision with 6984. There were between 30 and 40 passengers on board C181 at the time with no reported injuries.

The diagram and photos show the location of the damage on carriage 6984. The bottom of passenger doors 1 and 3 were pulled outwards by the air filter hatch.

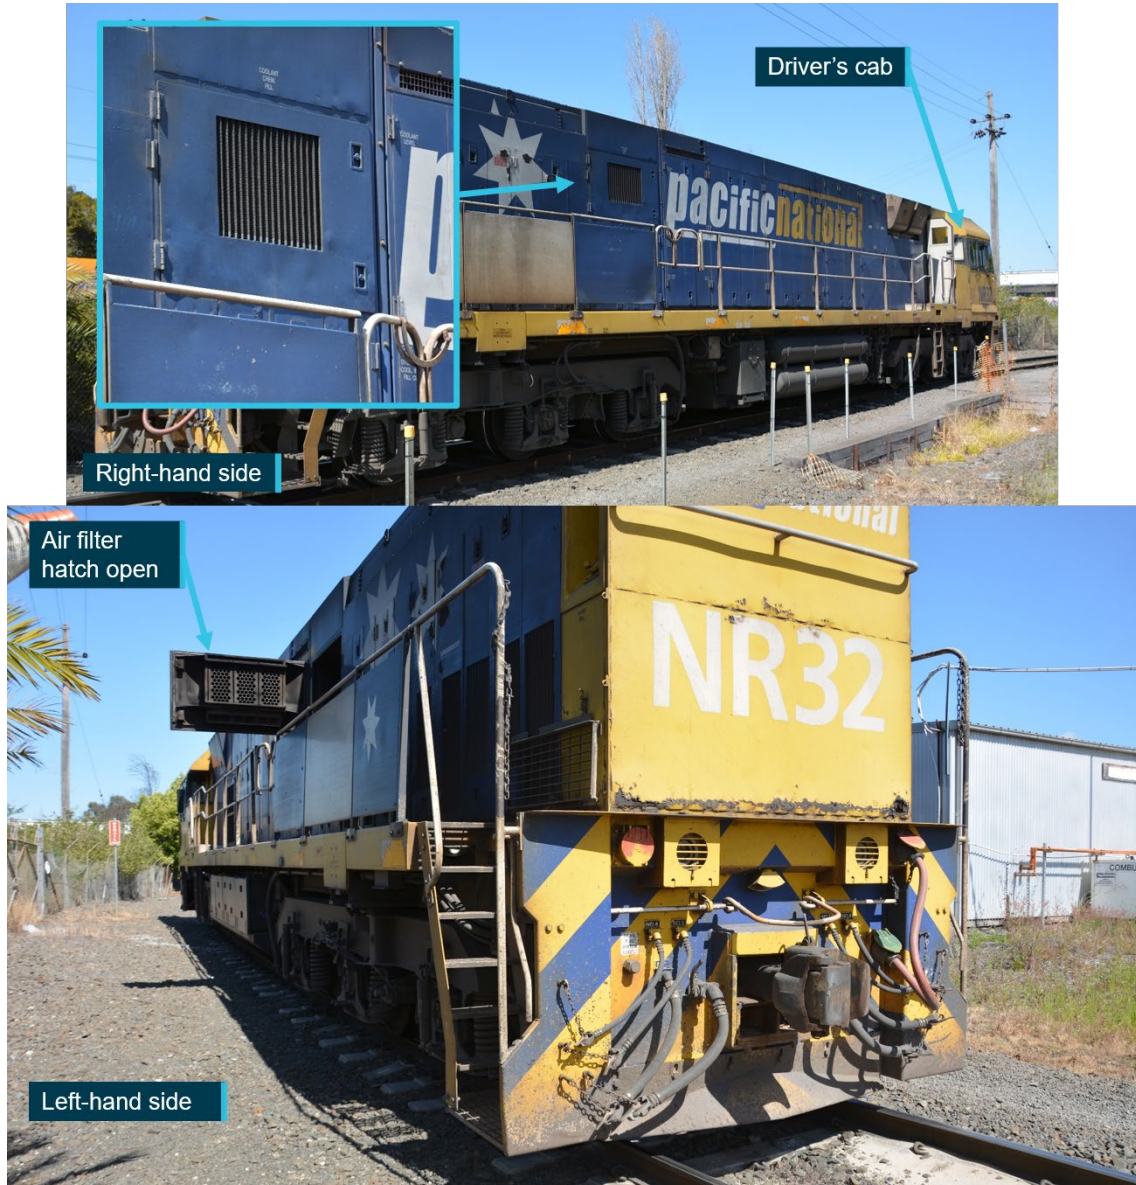
**Figure 3: NR locomotive air filter hatch configuration**

In this case, NR68 was operating in a trailing direction (drivers cab at the rear) and the air filter hatch on the left-hand side opened as shown below (Figure 3). The air filter hatch when opened protruded 935 mm past the body of the locomotive and exceeded the kinematic outline.<sup>3</sup>

*The right-hand and left-hand sides of an NR locomotive are shown. The left-hand side of the locomotive is shown with the air filter hatch open and protruding past the body of the locomotive (rolling stock outline).  
Source: OTSI*

The locking and hinge arrangement of the air filter hatch allowed the hatch to exceed the kinematic outline and presented a risk to people, structures and passing trains if the locks failed or the hatch was incorrectly secured. While the hatch was not required to be designed in accordance with AS 7507:2017, the inclusion of some of these features specified in the standard would likely have prevented this occurrence.

- Developed a design change to install a secondary latch to the air filter and CA10 hatches under Field Modification Instruction (FMI-1752 – Secondary Latch Install on NR Locos).

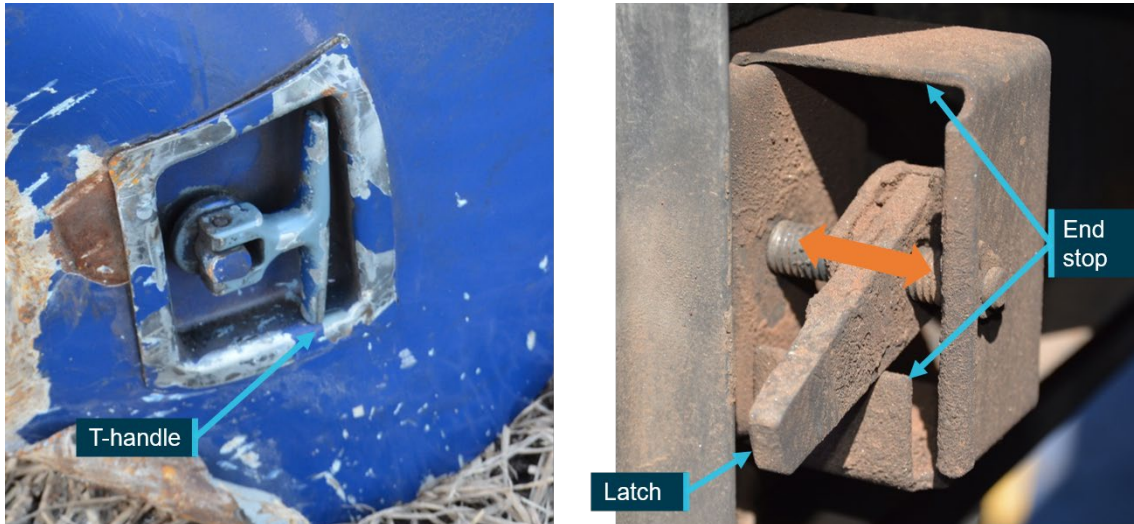
**Figure 4: Air filter hatch latch**

The air filter hatch was fitted with two T-handle screw latches to secure the hatch (Figure 4).

- The T-handle wound a screw that operated a latch that could rotate through about 95 degrees between two end stops. On contacting an end stop, the latch would slide forward or backwards in relation to the screw rotation.
- To secure (clockwise rotation) - the latch would rotate to a horizontal position and clamp (may require a number of revolutions) against a bracket on the locomotive.

- To open (anti-clockwise rotation) - once the clamping force was lost against the bracket, the latch could rotate upwards to a vertical position allowing the hatch to open.
- The T-handle could be folded flat against the hatch when the latch was in the locked or unlocked position.

Post collision the air filter hatch was found to be missing one (lower) of the two latches, probably the result of the collision although the missing latch was not recovered. The remaining latch (upper) was inspected and functioned as expected. Both hinges failed during the collision sequence as the hatch detached from NR68.

The design of the air filter hatch and locks meant that the hatch could appear visibly closed and locked without it being secured correctly. The inspections following maintenance and the roll-by
