Loss of control and collision with terrain involving de Havilland DH82A Tiger Moth, VH-UZB

Pimpama Airfield, Queensland, 28 December 2015

ATSB Transport Safety Report
Aviation Occurrence Investigation
AO-2015-150
Final – 1 March 2019

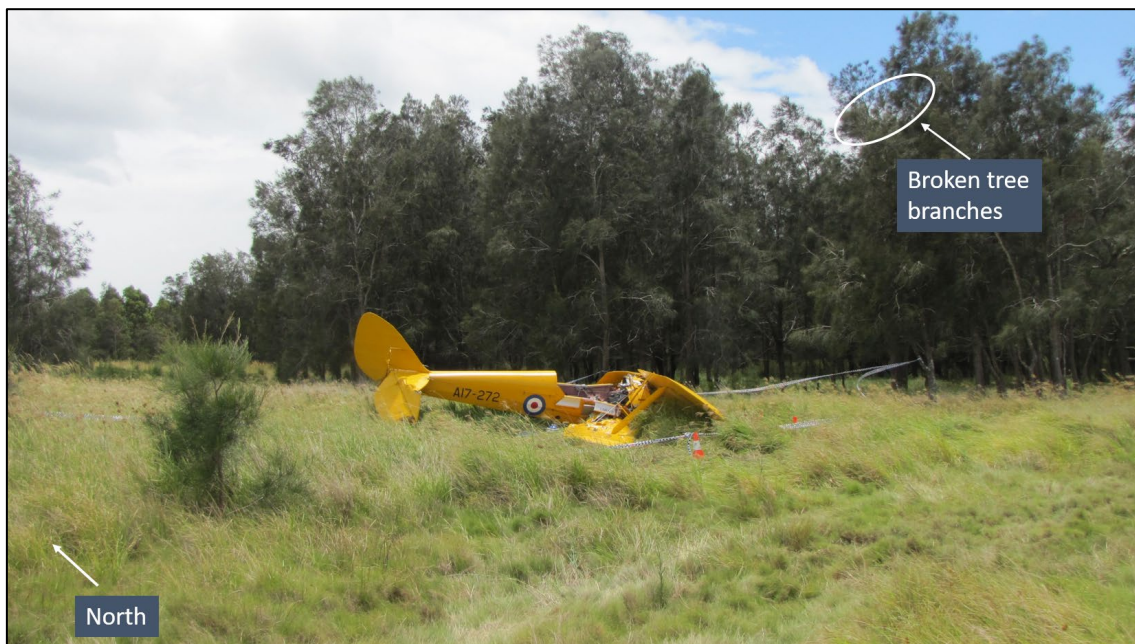
Figure 3: Accident site

Impact marks were identified on the underside of the upper left wing (Figure 4) and significant tree debris were located in the vicinity of the left wing. There was evidence of freshly broken branches in the trees to the east of the accident site. There was minimal damage to the right wing.

- all parts of the aircraft were present at the accident site
- there were no observable pre-accident defects to the airframe
- propeller slash marks and the damage to the propellers indicative of the engine driving the propeller at the time of impact (Figure 5)
- the aircraft impacted the ground in a steep nose-down attitude with little forward velocity
- the damage to aircraft, the trees and location of the aircraft wreckage was consistent with a collision with terrain while spinning to the left.

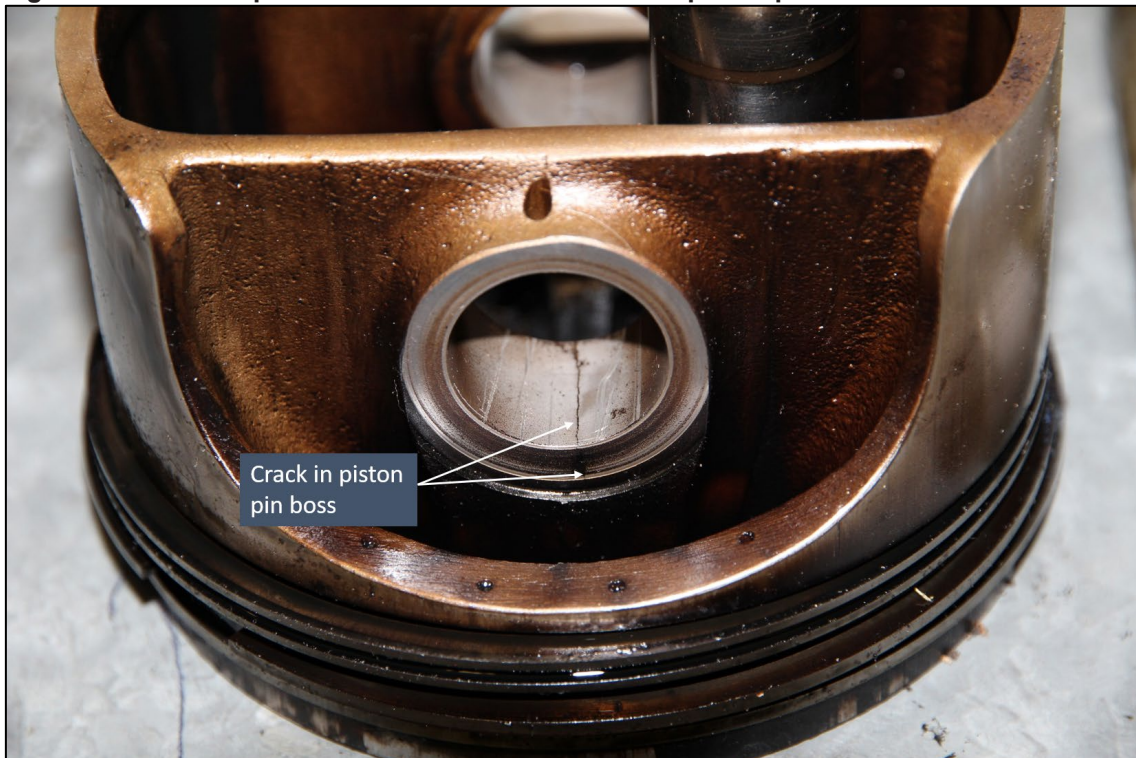
- impact damage to the rocker covers and exhaust system
- the number 1 cylinder exhaust valve was bent and stuck, most likely due to impact damage
- the engine rotated freely by hand with all cylinders (apart from number 1) having correct compression
- the number 4 piston had a full thickness crack through the piston pin boss (Figure 6). The crack may have been pre-existing or a result of the impact. As the crack had not propagated to the point of failure, it did not lead to the power loss.
- the spark plugs appeared normal
- the engine carburettor in line filter was clean
- the valve guide clearances were within the documented tolerance. The cylinder number 4 exhaust valve was stiff in comparison to the other valves, although still free to move.

There were no mechanical defects identified that would have led to a sudden reduction in engine power.

Figure 6: Number 4 piston with full thickness crack in piston pin boss.

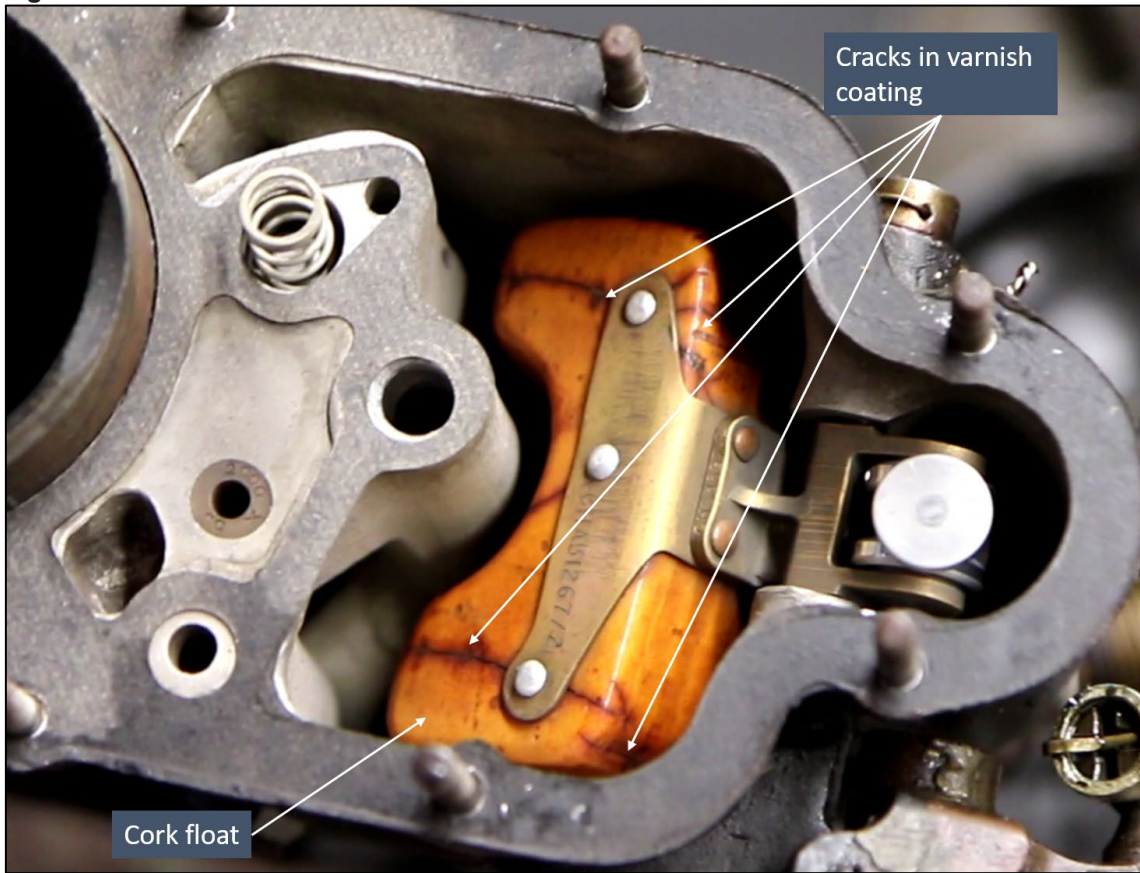
The carburettor was disassembled and inspected. The float chamber was refilled with fuel and the fuel level was measured and found to be within limits. The freedom of movement of the mechanism was also checked and found to be serviceable. Some cracks in the varnish of the cork float were identified (Figure 7). Such cracking can allow the ingress of fuel into the float and affect both the dimensions and buoyancy of the float within the carburettor. Fuel-affected cork floats have been found to be a contributing factor in a number of other engine malfunctions involving Gipsy Major engines.

Figure 7: Carburettor float chamber and cracked cork float

Observed cracking of the carburettor cork float varnish raised the possibility of the float being impregnated with fuel to the extent that the performance of the carburettor may have been affected. Testing of the carburettor mechanism and additional submersion testing of the float conducted during the investigation indicated that this was possible, however the likelihood was difficult to assess.

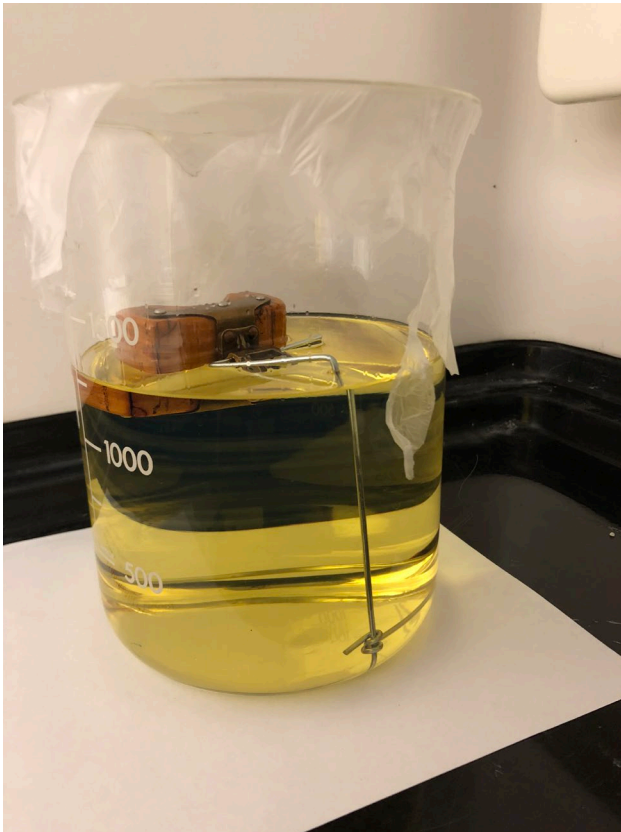
Figure 8: Carburettor cork float testing

Consequently, the ATSB conducted testing of the float to determine if the cracks allowed fuel to penetrate the float. The cork float dimensions and weight were measured and recorded. The float was then immersed in unleaded petrol for a total of 26 hours. There were minor changes in the float dimensions and a minor increase in weight, however, these changes were not considered significant enough to have resulted in the observed power loss.

The ATSB found that over a period of 101 days the float increased in weight by about 0.89 grams (from 39.41 to 40.30 grams), a 2.4 per cent increase in weight. When the cork float was re-weighed approximately 16 months after the beginning of the test it weighed about 40.55 grams (a 2.91 per cent increase in weight). This final weight could not be verified, as a portion of the fuel had evaporated, and the cork had not been submerged for a period of time.

The aircraft type certificate holder and the ATSB assessed that the increase in weight, while low, had the potential to affect the buoyancy of the float. However, the degree of any resultant effect on carburettor operation could not be determined.
