# Safeworking irregularity involving train 9261

Sellheim Station, Mount Isa Line, Queensland, on 28 July 2020

RO-2020-014

Final – 25 August 2021

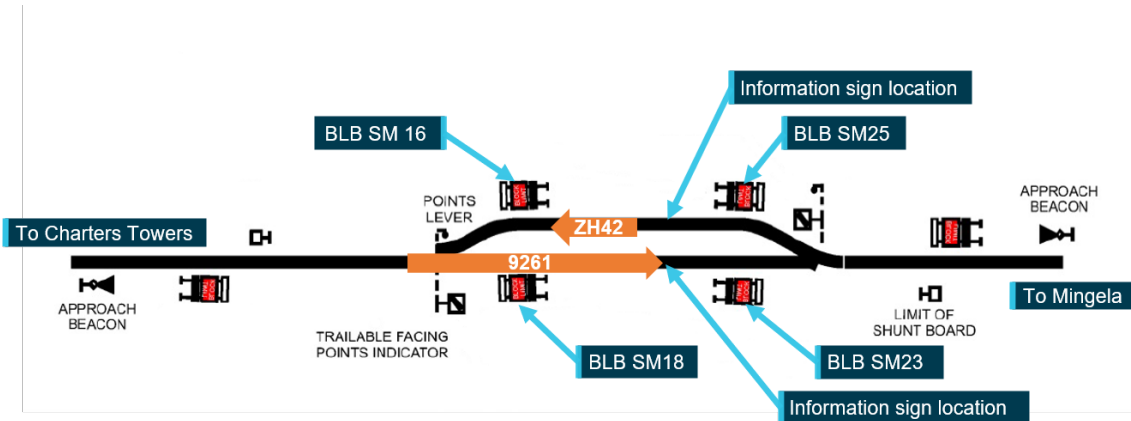
**Figure 2: Sellheim Station and location of 9261 and ZH42**

The driver recalled that, as the lead locomotive of 9261 passed BLB SM18 and entered the down track<sup>2</sup> at Sellheim, they triggered the counter in the cab to measure the distance the locomotive then travelled. The driver stopped 9261 at a point next to an information sign erected adjacent to the down track.

At about 0936, the driver of 9261 provided the NCO with a release code for the section block between Charters Towers and Sellheim Station (to the rear of 9261). After receiving the release code, the NCO responded by communicating an understanding that the train was intact and in-clear<sup>4</sup> at BLB SM18 in the down road at Sellheim (Figure 2). The driver of 9261 confirmed the NCO’s understanding and inquired about how long it would be before the cross with ZH42 could occur.

*Location of BLBs and signs is indicative only (not drawn to scale).  
Source: Queensland Rail, annotated by the ATSB*

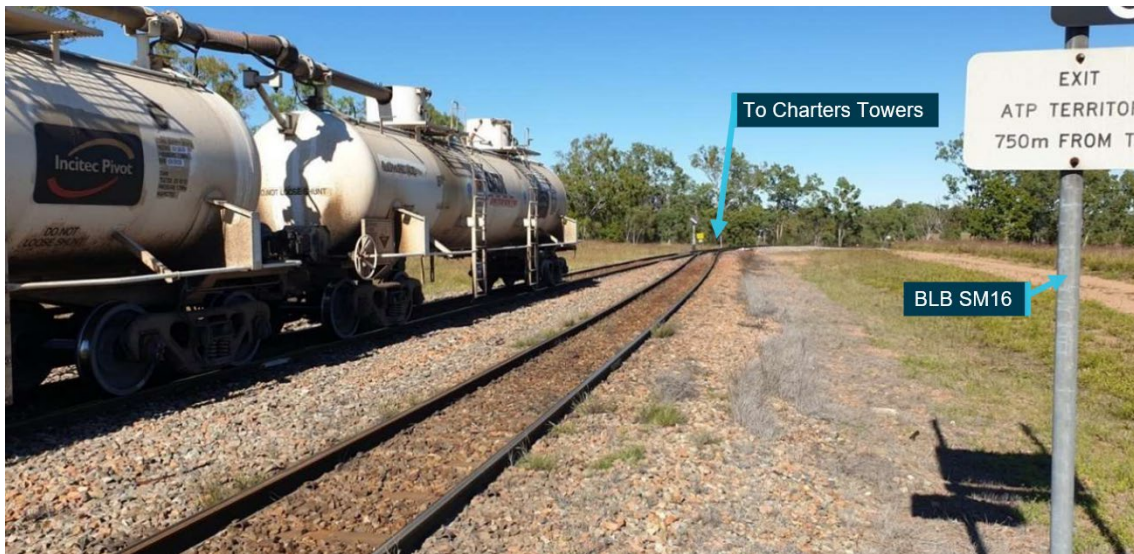
**Figure 3: Rear wagons of train 9261**

At about 0949, the crew of 9261 contacted the NCO asking when their next authority would be available. Shortly after, the NCO again contacted the driver of ZH42 to request a release code for the Mingela to Sellheim section. The driver of ZH42 advised the release code was available but that they were stationary at BLB SM16 as the rear of train 9261 was not in-clear. The driver of ZH42 estimated that two and a half wagon lengths (at the rear of 9261) were occupying the block section ahead (Figure 3).

*Image taken after train 9261 moved approximately one wagon length. Rear wagons of 9261 were still foul of BLB SM18.  
Source: Queensland Rail, annotated by the ATSB*

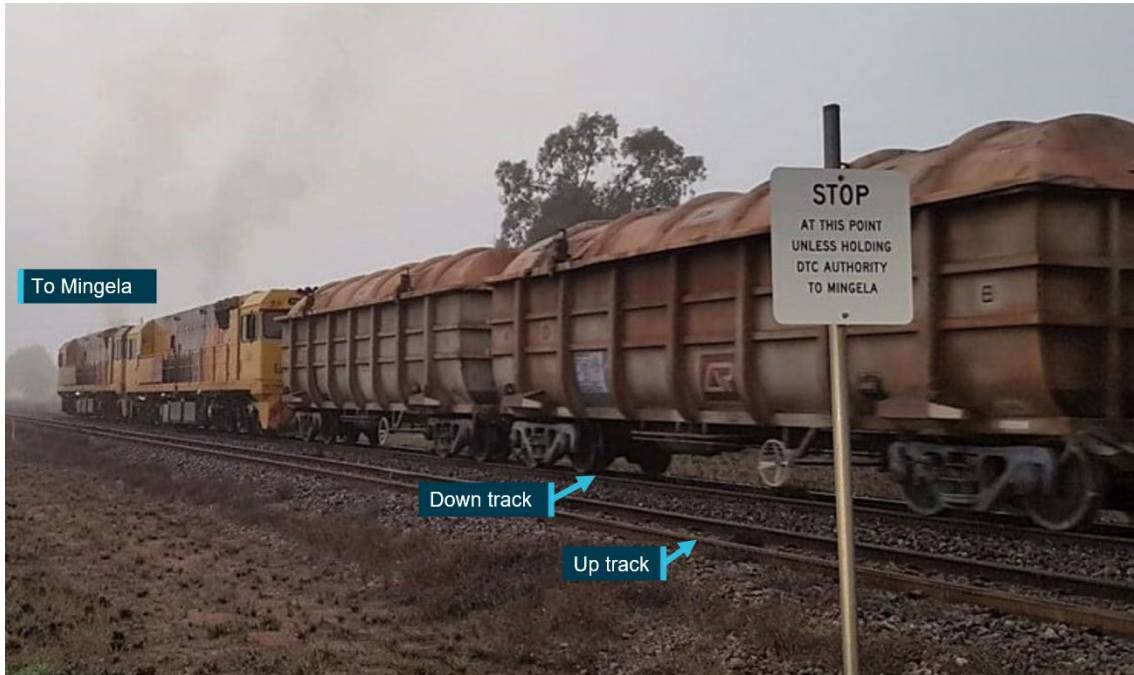
**Figure 4: Information sign at Sellheim Station**

To address noise complaints from residents (see *Infrastructure change management* processes), on 30 November 2015<sup>13</sup> QR installed information signs on the up and down track at the 110.243 km point, away from the limit of authority at block limit boards (BLBs) SM23 and SM25 (Figure 2). The signage displayed the text ‘Stop at this point unless holding DTC Authority to Mingela’ on a white background (Figure 4). The format of the sign (white background) conveyed to drivers that the text was for information or advice. Although the sign displayed the word ‘stop’, it was not meant to be interpreted by rail traffic crews as a stop board.

The actual track length available between the up and down starting BLBs<sup>14</sup> at Sellheim Station was 1,240 m. When rail traffic crew stopped the locomotive of their train at the nominated point, the track length between the information sign and BLB SM16 or SM18 to the rear reduced to approximately 940 m, effectively shortening the track length on which a train could be stopped and be clear of the section to the rear.

When the signs were installed, train notice TN15-09327 was issued. The notice advised of the kilometre mark where the signs were installed and the wording of the sign, and it also stated that the signage was ‘...erected to stop all trains at nominated point clear of local residence unless RTC have DTC authority to Mingela’. It did not specify the distance between the signs and the BLBs 16/18.

Queensland Rail (QR) undertook a risk assessment of the information signs at Sellheim Station and subsequently moved the signs to the 110.109 km point, approximately 134 m east of the first location. The revised location provided about 1,060 m between BLBs and the associated information signs. QR also started a program of works to find locations on the Mount Isa Line and other lines where inconsistencies existed between the trackside infrastructure and the information contained in route maps, signalling arrangement diagrams and the DTC software.
