Engine power loss and low-speed rejected take-off, involving Airbus A320-232, registered VH-VFF

Brisbane Airport, Queensland, on 23 October 2020

ATSB Transport Safety Report

AO-2020-058

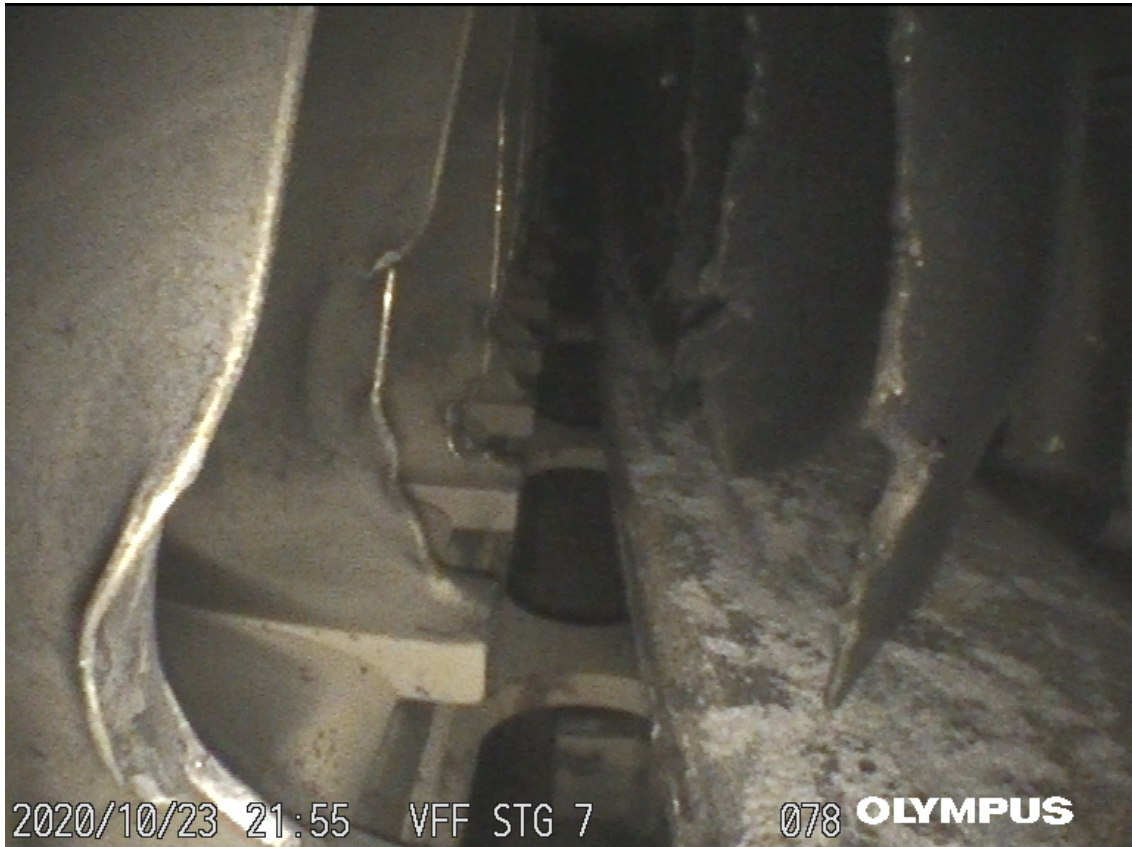
Figure 3: Borescope image of stage 7 HPC and stage 8 stator vanes

A borescope inspection of the right engine found there was damage to HPC stages 3, 5, 6, 7, 8 and 9 (Figure 3) consistent with foreign object damage (FOD).⁶ As the damage was outside maintenance manual limits, the engine was removed from the aircraft and sent for a teardown inspection.

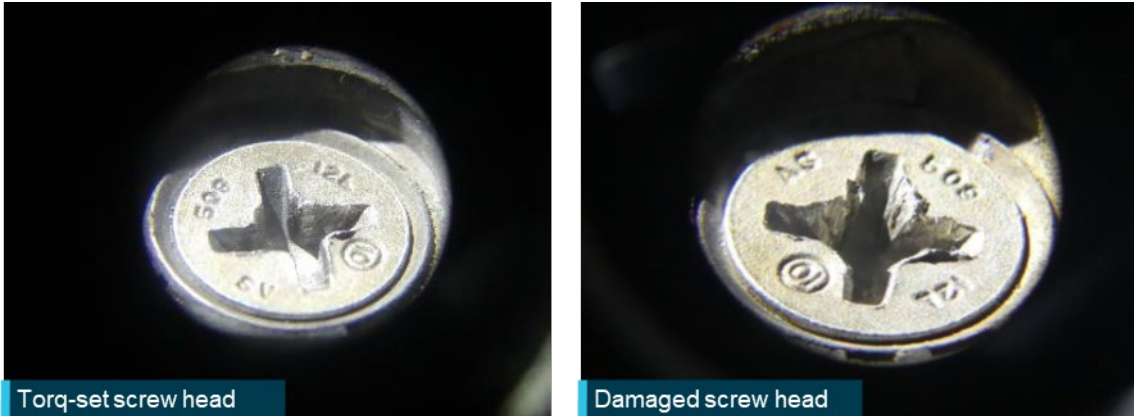
Figure 4: Interstage screw heads

- The fan blades and LPC contained no visible damage.
- The rear fairing to the LPC bleed valve mechanism was in place but had one Torq-set screw with a damaged head. Although of an incompatible shape, testing showed that due to the damage, the head would also accept a Phillips screwdriver tip (Figure 4).

The damage to the HPC section and the screwdriver tip found in the cooling cavity were consistent with the screwdriver tip falling into the LPC bleed duct, passing through the interstage duct and into the HPC. The lack of damage to the LPC indicated the tip was not FOD from the runway. The damage to the rear fairing screw meant it was likely the screwdriver tip had been left in the screw or had fallen into the bleed duct during maintenance. At the next engine start-up, it then travelled through the HPC section striking various components, in some cases leaving witness marks, before being held captive adjacent to the combustion chamber.

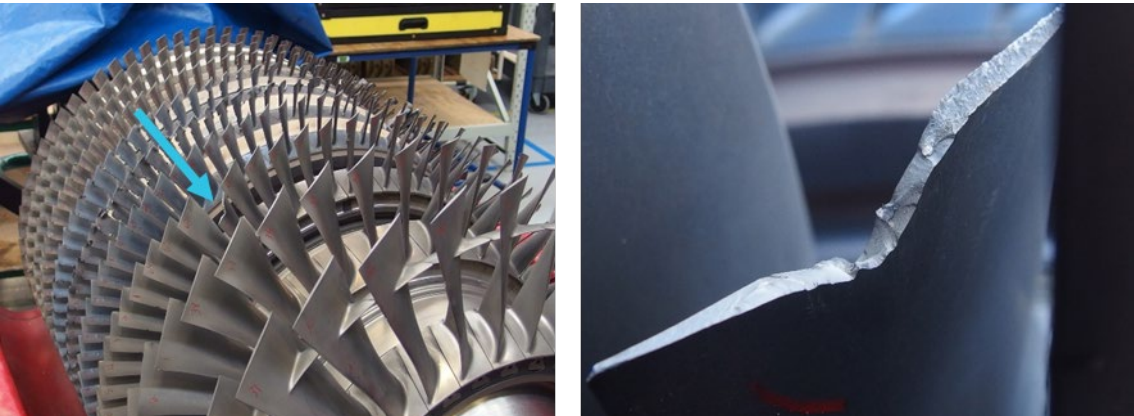
Figure 5: Stage 5 blade fatigue failure

- In the HPC section, rotor blades (blades) and stators (vanes) in stages 3 and 4 contained dents and minor tears.
- Approximately half of one stage 5 blade (Figure 5) and a whole stage 6 vane (Figure 6) were missing and had failed due to cyclic fatigue. Some of the remaining stage 5 blades exhibited tip curl,⁷ dents and/or missing material.

A failure analysis was conducted by an engine maintenance facility. The fractured stage 5 blade showed minor leading edge mechanical damage at approximately half span, which initiated a fatigue crack that propagated through approximately two-thirds of the chord. The remaining third of the chord failed in material overstress.

Both fatigue fracture surfaces displayed fine striations consistent with a high frequency load spectrum, likely from aerodynamic vibrations. While no fatigue growth rate analysis was conducted, based on similar occurrences, it was estimated the components took tens of flight cycles to fail.

There was evidence that fatigue cracks initiated from the impact damage in a stage 5 blade and stage 6 vane. These cracks propagated until one reached a critical size due to aerodynamic forces and vibrations, and additionally for the blade, centripetal forces. As the engine surge event occurred during the application of take-off power and acceleration of the engine internal componentry, it is more likely the blade failed first due to the increase in centripetal acceleration.

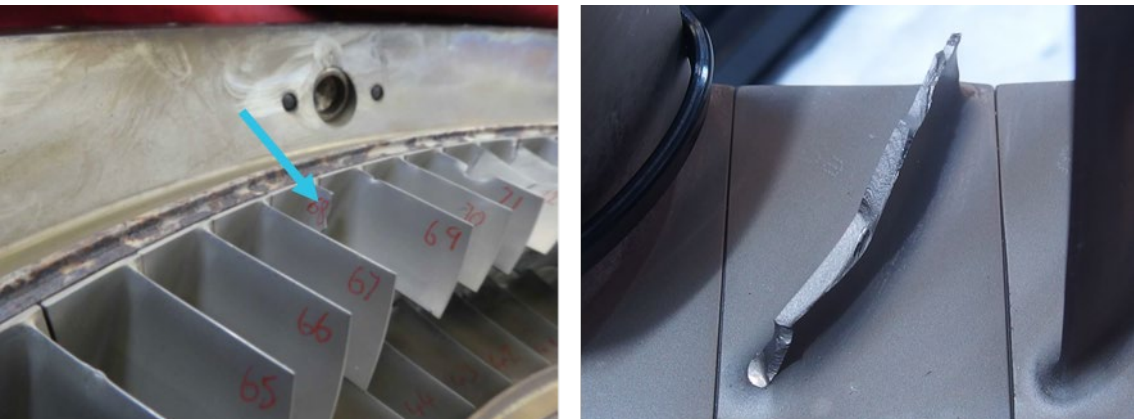
Figure 6: Stage 6 vane fatigue failure

The fractured stage 6 vane sustained a tear near the aerofoil root to a depth of approximately 10 per cent chord. This initiated a fatigue crack that ended 2 mm from the trailing edge with the remaining material exhibiting a material overstress signature.
