Australian Transport Safety Bureau

Helicopter winching incident involving Eurocopter AS365, VH-WPX

Near Swanbourne, Western Australia, on 29 September 2020

AO-2020-053

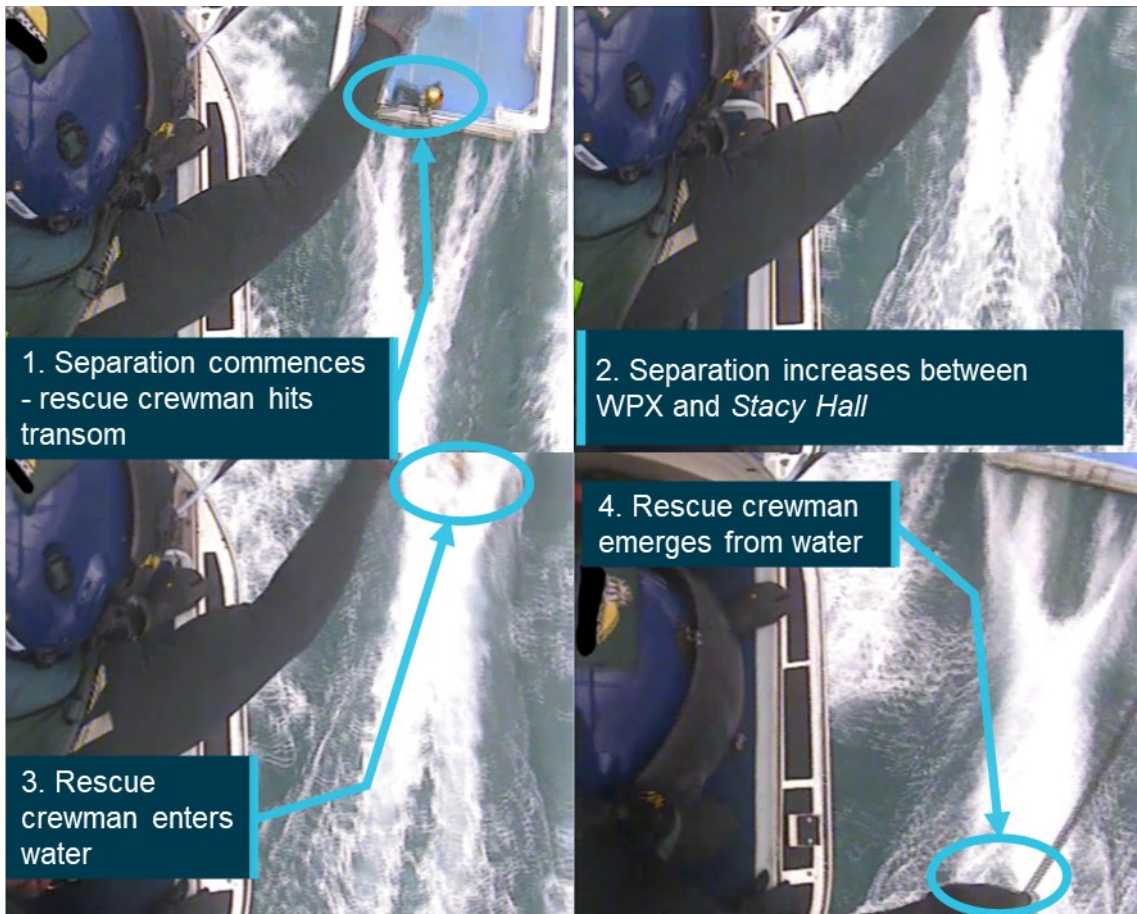
Figure 1: Rescue crewman overboard

backwards onto their back as the vessel's aft deck rose on the swell. The winch operator reported 'crewman has fallen' and immediately payed out cable to prevent it from becoming taut.

Despite those instructions from the winch operator, the separation between the helicopter and vessel increased. As a result, the winch cable became taut and the rescue crewman was dragged aft along the deck, into the transom and overboard into the water (Figure 1). The following then occurred in quick succession:

A series of still images captured from on-board video highlighting the commencement of separation and rescue crewman going overboard.

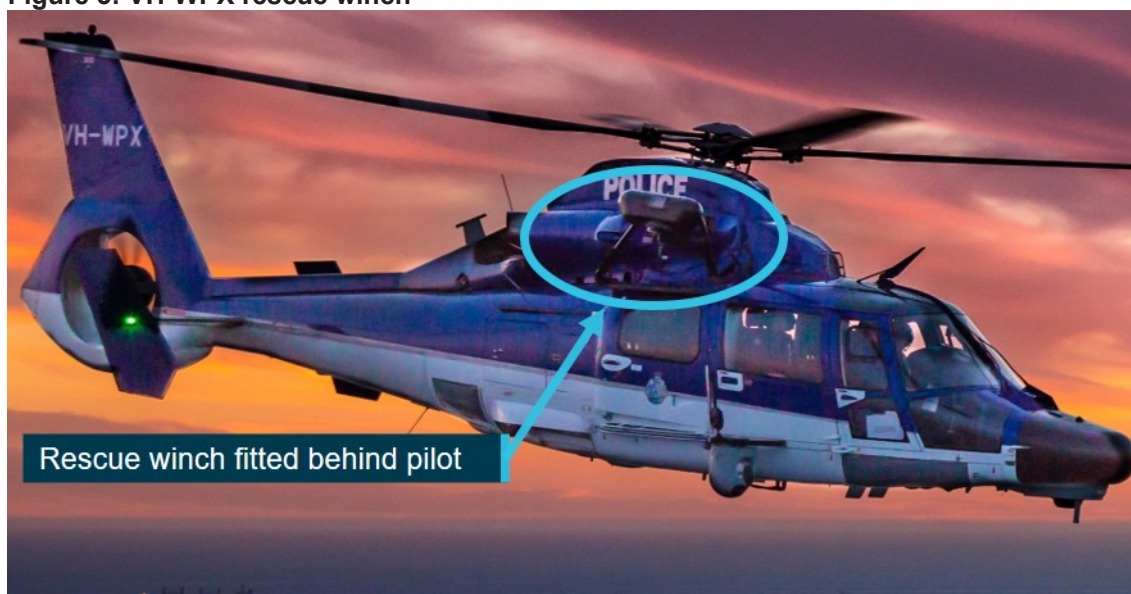
Figure 3: VH-WPX rescue winch

After the incident, aircrew viewed onboard winch boom video imagery and identified potential cable shock loading during the recovery of the rescue crewman. WA Police Technical Log records showed that on 1 October 2021, a full cable inspection was conducted in accordance with the Goodrich Rescue Hoist Component Maintenance Manual, with no defects identified.
