Fuel data occurrence involving Bombardier Dash-8-315, VH-TQE

Tamworth Regional Airport, New South Wales, on 15 January 2021

ATSB Transport Safety Report

AO-2021-002

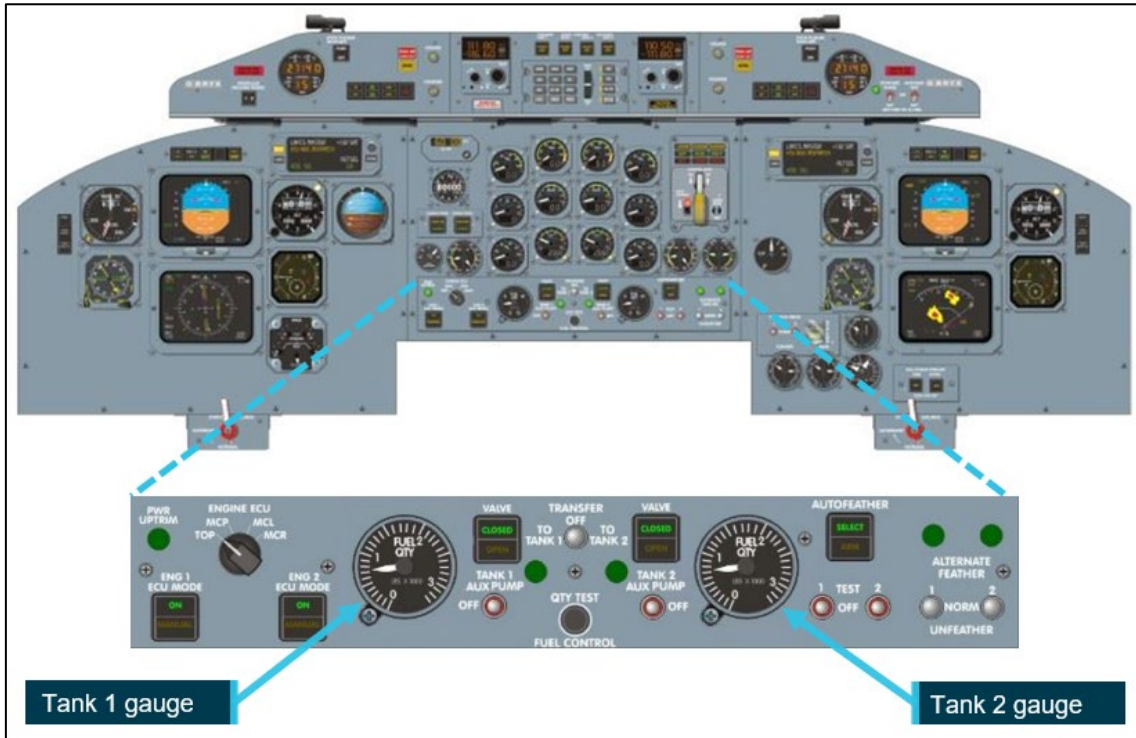
Figure 2: Q300 fuel gauge layout

The Q300 aircraft has two analogue fuel quantity gauges located on the lower part of the engine instrument panel (Figure 2). The gauges fitted to VH-TQE indicated the quantity of usable fuel in each of the two main tanks in pounds. The flight crew needed to add these quantities to determine the total fuel on board.

Both the captain and FO described experiencing a physiological response to the Tamworth arrival, which persisted throughout the pre-flight preparations for departure. This physiological distraction probably degraded their attentional focus and resulted in the initial misinterpretation of the fuel gauges. Additionally, the captain had limited experience on the Q300 aircraft in which the flight crew was required to mentally calculate the total fuel on board. This additional cognitive step

probably increased the chance of the error and made it more difficult to identify the error once it had occurred.

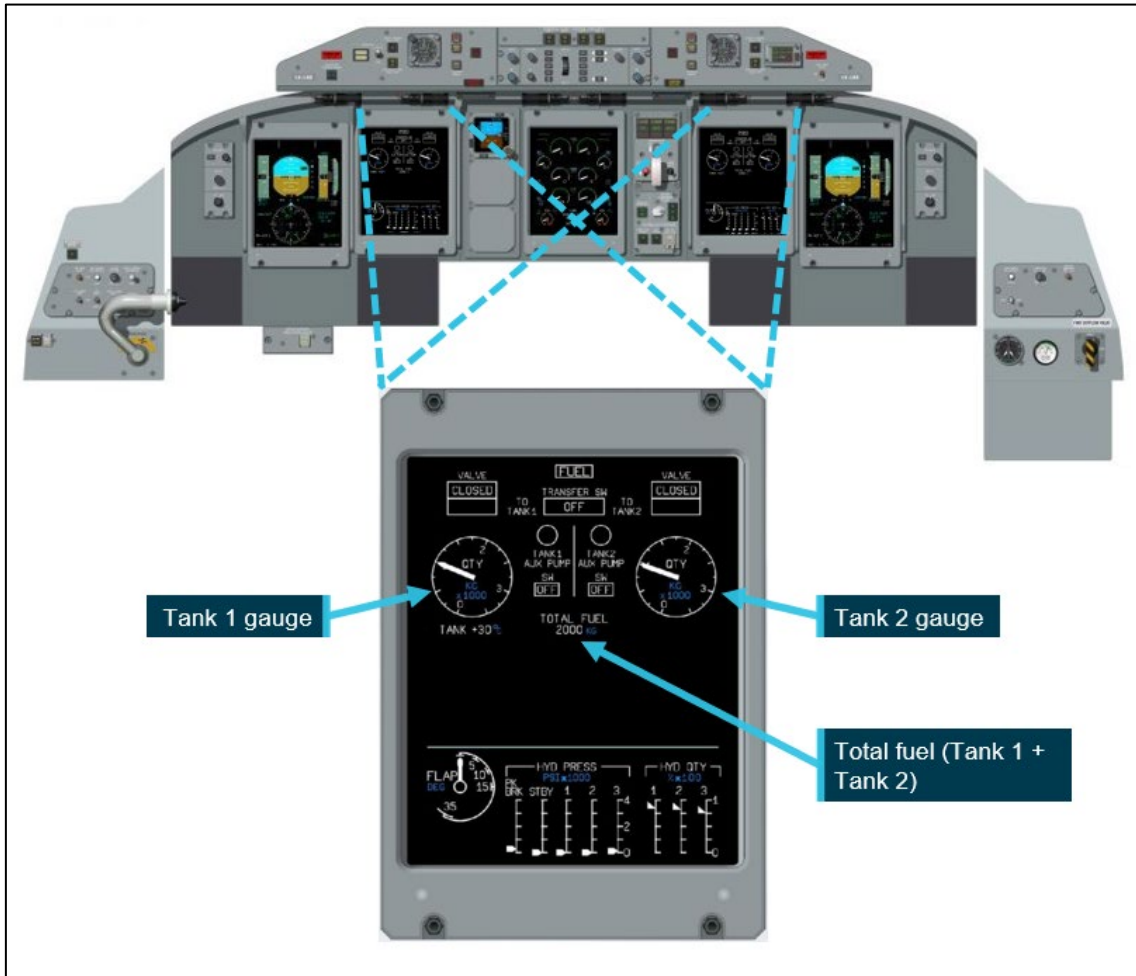
Figure 3: Q400 fuel gauge layout

The captain had only recently commenced operating the Q300 and had significantly more experience on the Q400 aircraft. In the Q400, the fuel quantity is presented on the aircraft's multi-function display and includes a digital readout of the total fuel quantity, removing the need for any calculation (Figure 3).
