# Engine power loss and collision with terrain, Bell 206B3 helicopter, VH-FHW

107 km south-west of Jabiru, Northern Territory, on 21 May 2019

**ATSB Transport Safety Report**  
Aviation Occurrence Investigation (Defined)  
AO-2019-025  
Final – 26 February 2021

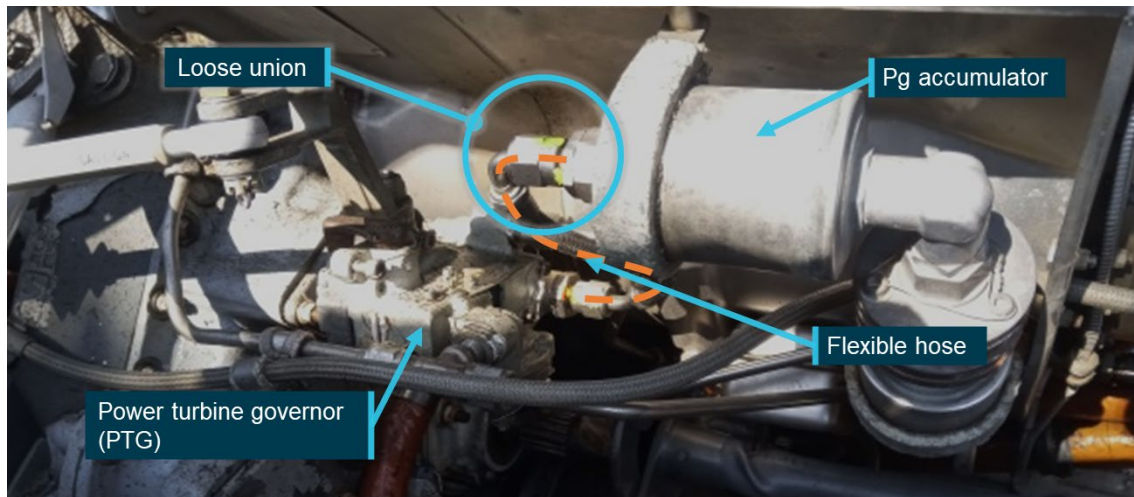
**Figure 4: Loose reference air union**

During the inspection of the wreckage it was found that an engine reference air line<sup>2</sup> union between the power turbine governor and the accumulator was loose (Figure 4). No other pre-existing problems with the helicopter were reported to be found during the wreckage examination.

<sup>2</sup> Reference air line: This line provides compressor discharge pressure to the fuel control unit (FCU). If this line leaks, the air pressure signal to the FCU is reduced or lost, resulting in the engine idling, or flaming out.

Based on the available evidence, the direct initiator of the engine power loss was the loose reference air line connected to the accumulator downstream from the power turbine governor (PTG). The reference air union was found loose at the accident site, and it was considered very unlikely that this would have loosened during the impact sequence.

In addition, a loose reference air union is consistent with the descriptions of the engine power loss. It would have vented air pressure from between the PTG and the fuel control unit, which the fuel control unit recognised as a signal to reduce fuel flow to idle. Reducing fuel flow to idle would have decreased the power generated by the engine.

In summary, the ATSB concluded that the loose union on the engine reference air line unscrewed in flight, creating a leak, and this leak resulted in a loss of engine power.

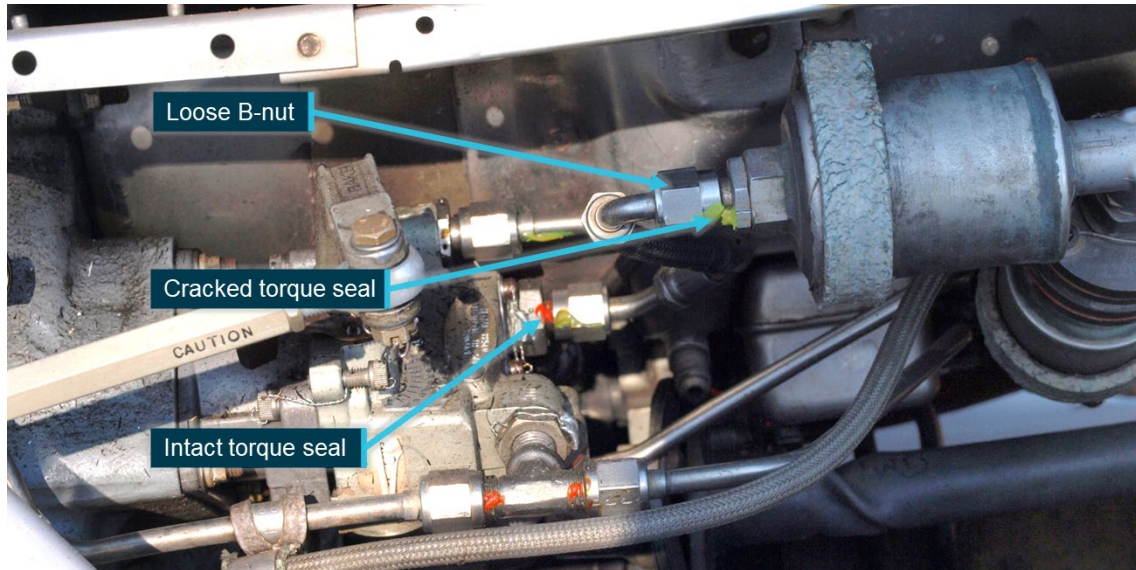
**Figure 6: Torque seal on air line unions as found on VH-FHW**

Orange torque seal had been applied to the several areas around the PTG, and these areas corresponded to the parts the engineer stated were manipulated when installing the PTG ( Figure 6). There was yellow torque seal applied where the loose reference air line was located and it was observed to be cracked following the accident (Figure 6). Yellow torque seal was also present on some other parts that were not manipulated during the last maintenance.

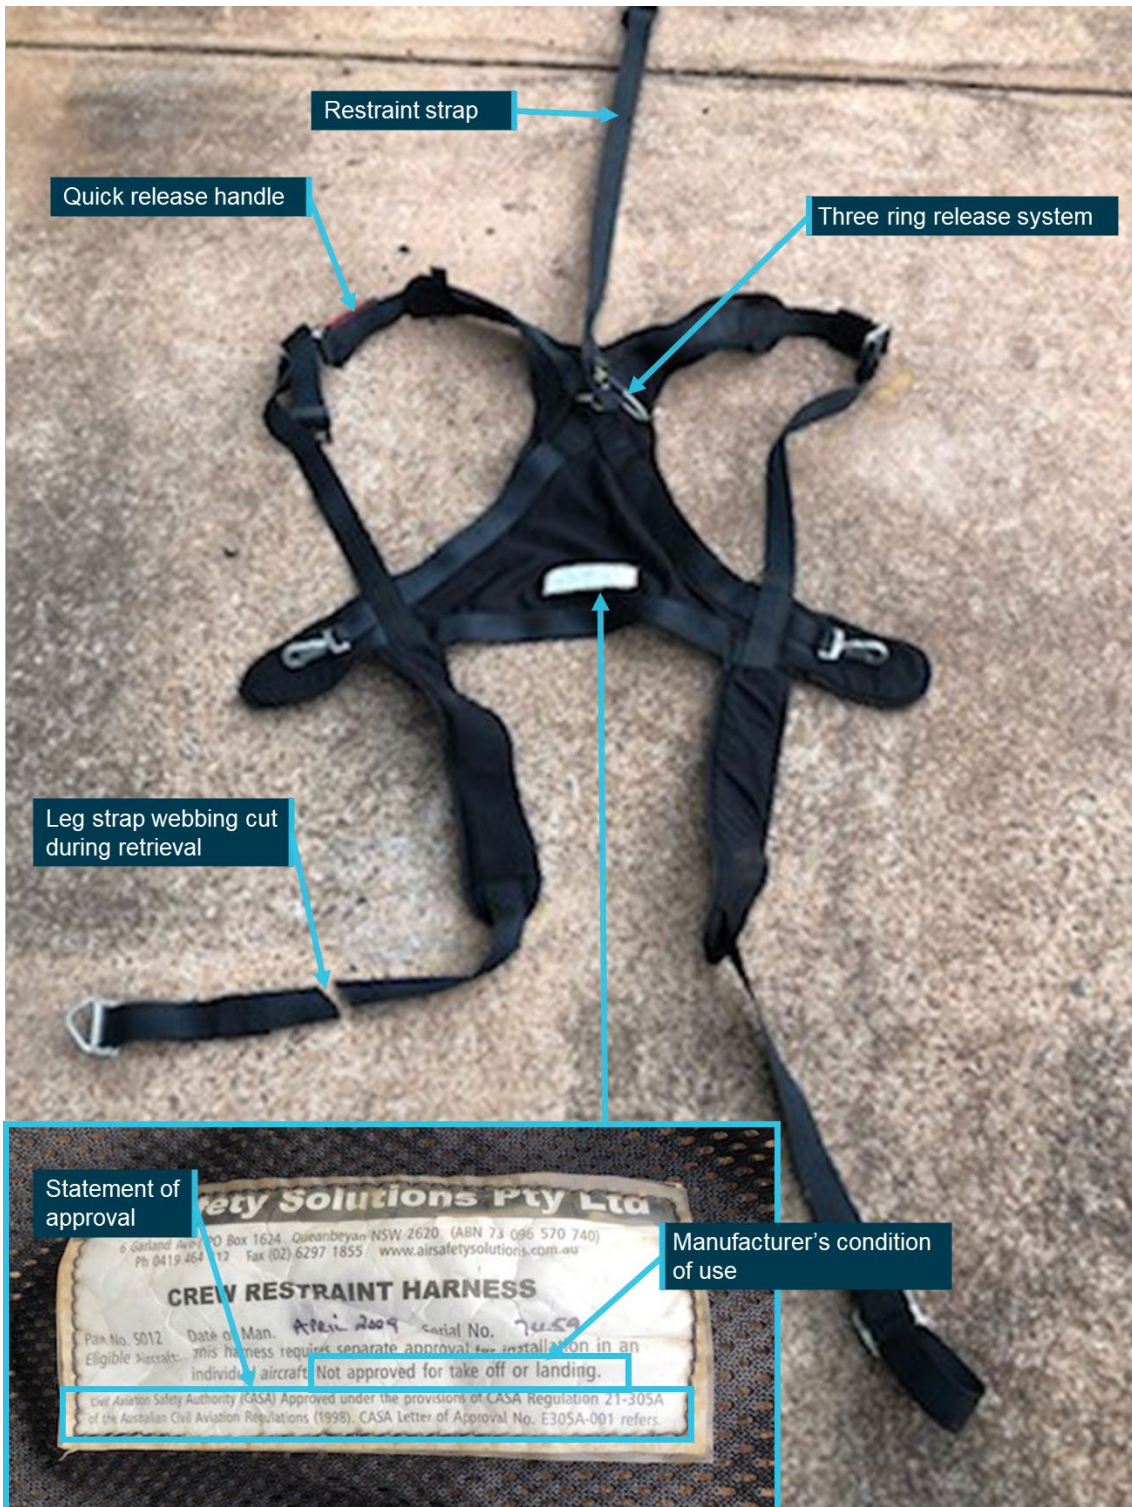
Figure 7: Shooter's harness, rear view

The harness used by the shooter did not fail in the accident sequence, though it was noted after the accident to be past its 10-year retirement date by 3 weeks (Figure 7). The operator took immediate steps to prevent third parties using expired equipment aboard their aircraft after discovering this post-accident.
