Rescue hoist cable failure involving AS 350 B3, VH-UAH

1 km south-west of Bulga New South Wales, 5 February 2020

ATSB Transport Safety Report

AO-2020-013

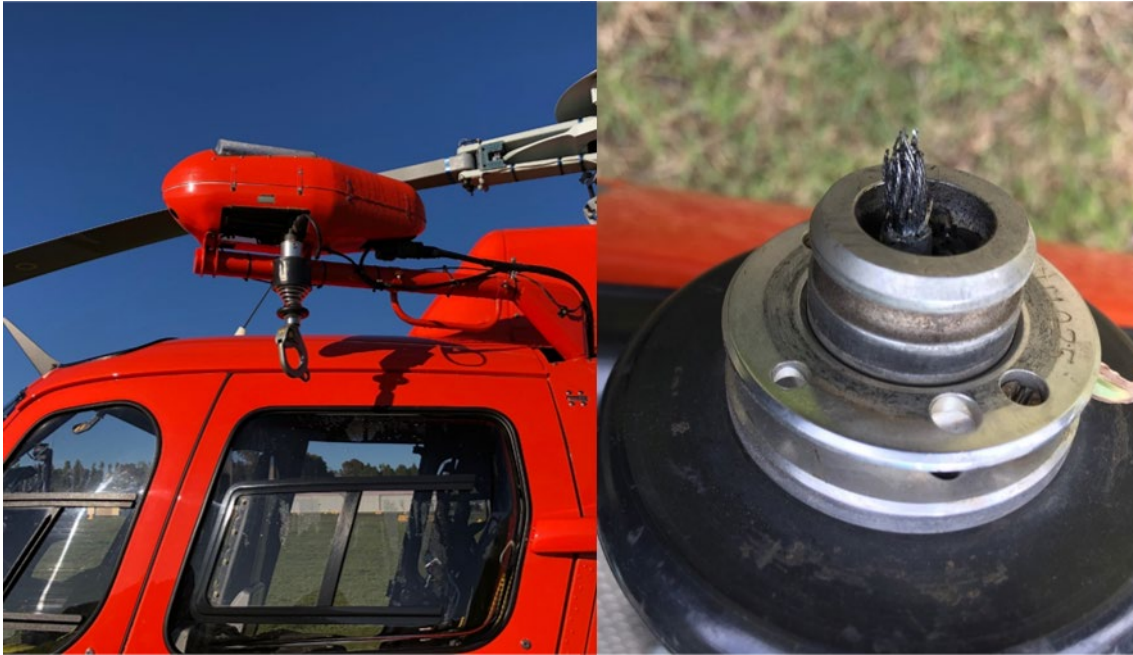
Figure 1: A NPWS ParkAir AS350 helicopter (left) displaying general fitment of the rescue hoist, and a close-up of the fractured cable (right)

*The fractured cable was found protruding from the swivel hook assembly.
Source: National Parks and Wildlife Service*

The load cable fractured approximately 10 mm from the swaged ball end fitting that terminated into the swivel hook assembly (Figure 3). The diameter of the remnant cable stub had drawn down with 'necking' of the cable cross-section evident. Measurements also identified that the inner core had retracted between 50 to 60 mm from the outer layer. Those outer strands had splayed which was typical of an overload cable failure, while the inner core remained tightly gathered. A faint serial number was etched on the shank of the swaged fitting that was confirmed by Breeze-Eastern to match their own records for the hoist and that the cable had been an original fitment from 2011.

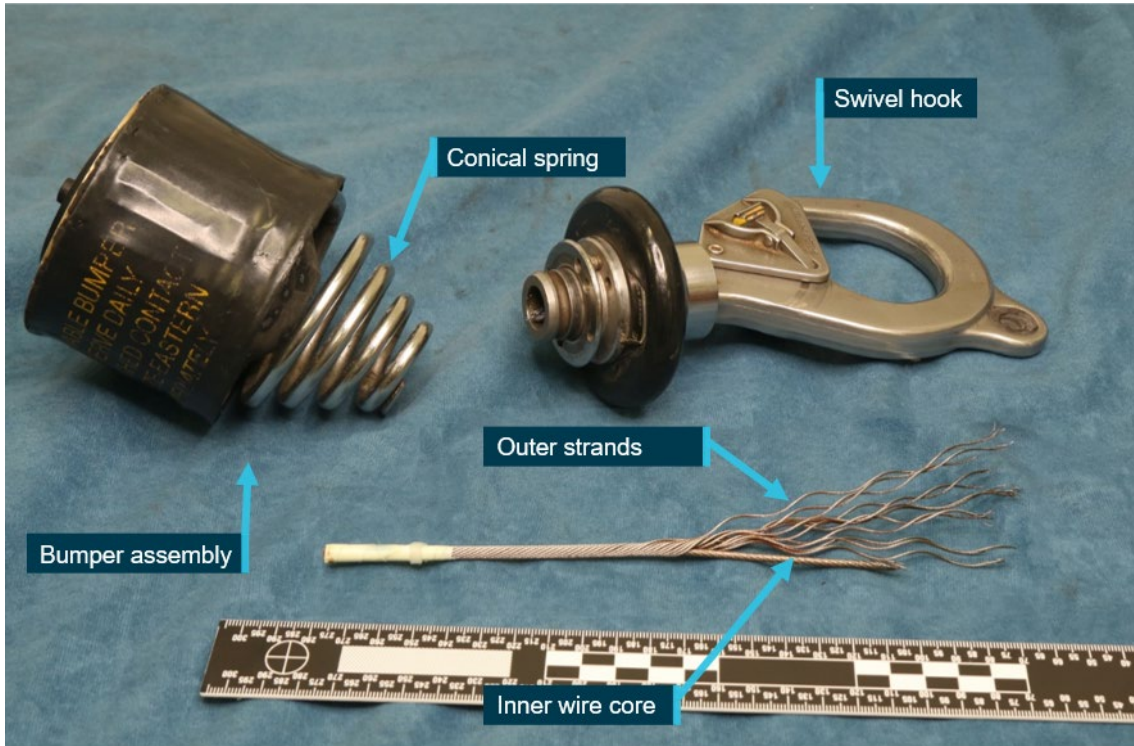
Figure 3: Swivel hook and bumper assembly

The wire strands comprising the inner core of the cable had retracted approximately 50 mm to 60 mm from the outer strands.
Source: ATSB

The ATSB's technical examination identified that severe wear damage had developed within the wire strands of the load cable. Additionally, the cable internal core had retracted from the externally wound strands indicating that the inner portion had probably fractured prior to the commencement of the conditioning operation. The failure occurred when the cable was loaded with a 160 kg weighted bag which was significantly less than the ultimate tensile load limit of the cable. In normal circumstances the cable should have withstood the imposed load. There was no evidence of corrosion, kinking, shock loading or any other such damage on the cable that might have otherwise contributed to the failure. Remnant lubricant was identified between the wire strands.

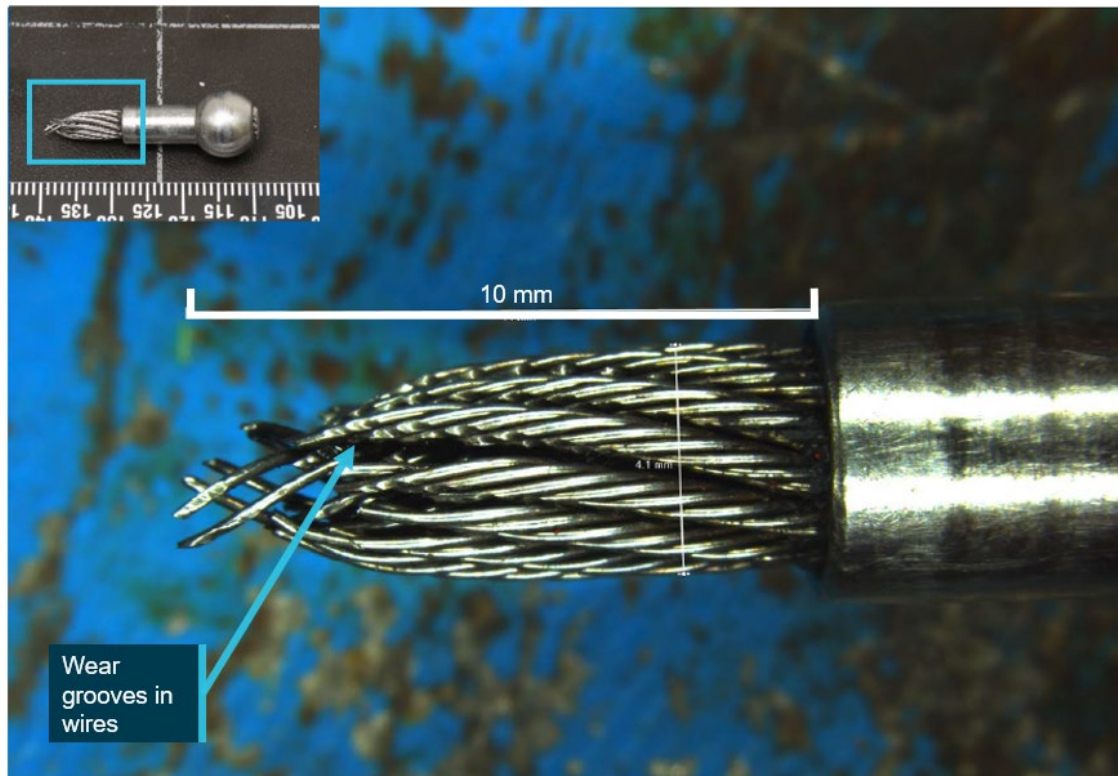
Figure 4: Close-up of the remnant cable portion near the swaged ball end fitting showed narrowing or 'necking' and grooves in many of the wires from severe wear damage

Close visual examination of the cable at the point of fracture in the 'necked' region identified that many of the wires were grooved and scalloped (Figure 4). There was no evidence of foreign debris, external abrasion, corrosion, kinking or nicks that might otherwise explain the failure. Remnant lubricant was identified between the wires and on the swaged ball end fitting.

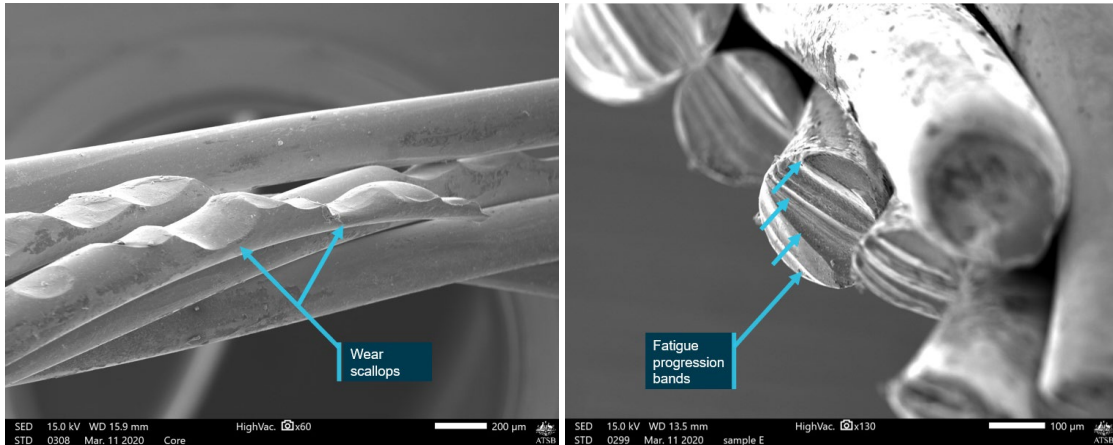
Figure 5: SEM images of the fractured cable identified severely worn wires (left) and fatigue crack progression bands from bending fatigue (right)

A scanning electron microscope (SEM) was utilised to further analyse the failed cable at much higher magnifications. The SEM examination confirmed that the severe scalloping was due to a wear mechanism of the cable near the point of fracture. The wear had progressed to an extreme level with many of the wires having lost almost the entirety of their cross-section.

A mixed fracture mode was also identified with evidence that some wires had sustained fatigue cracking prior to failure (Figure 5). The general shape of the fatigue cracking was indicative that the cable had been exposed to cyclic bending loads. A portion of the wires had also failed in ductile overstress and these were likely what provided the remnant cable strength during the final conditioning operation.

The identified wear led to a significant reduction in cross-sectional area and eventual overstress of the load cable. Some of the worn wires also showed indicators of progressive fracture consistent with the development of fatigue cracking, with the remainder displaying ductile overstress fracture.

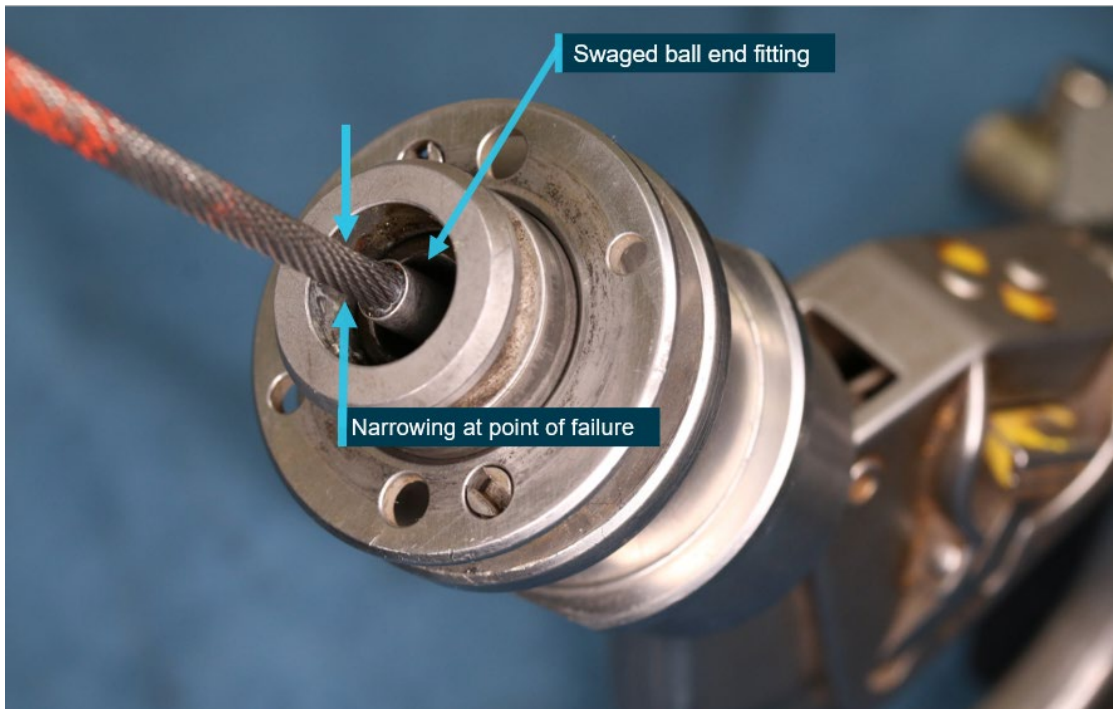
Figure 6: Another ParkAir rescue hoist removed from service after the occurrence displayed narrowing of the cable at the ball end fitting.

An additional hoist cable was also supplied by ParkAir for comparative examination. That cable had been removed from another Breeze-Eastern BL-29700 rescue hoist as an immediate organisational response to the failure. The secondary hoist cable had accrued 535 hoist cycles. External inspection before destructive sectioning of that cable showed local 'necking' had also occurred in the same area as the failed cable approximately 10 mm from the swaged ball end fitting.

The 'necking' provided an indicator of the onset toward a serious defect, such as worn or broken internal wires and strands. The subtle changes in diameter associated with the 'necking' could also be felt when handling the cable during physical inspection. Magnified examination of the 'necked' region identified that wear grooves and scallops had occurred to the wires comprising the cable. The damage was similar in appearance to that from the failed cable off VH-UAH, though all strands remained intact. Figures 6 and 7 provide further detail on the severity of wear damage associated with 'necking' of the intact hoist cable.

The narrowing, or 'necking', could be detected during physical handling and close visual examination. The cable had accrued 535 hoist cycles throughout its service life.
Source: ATSB

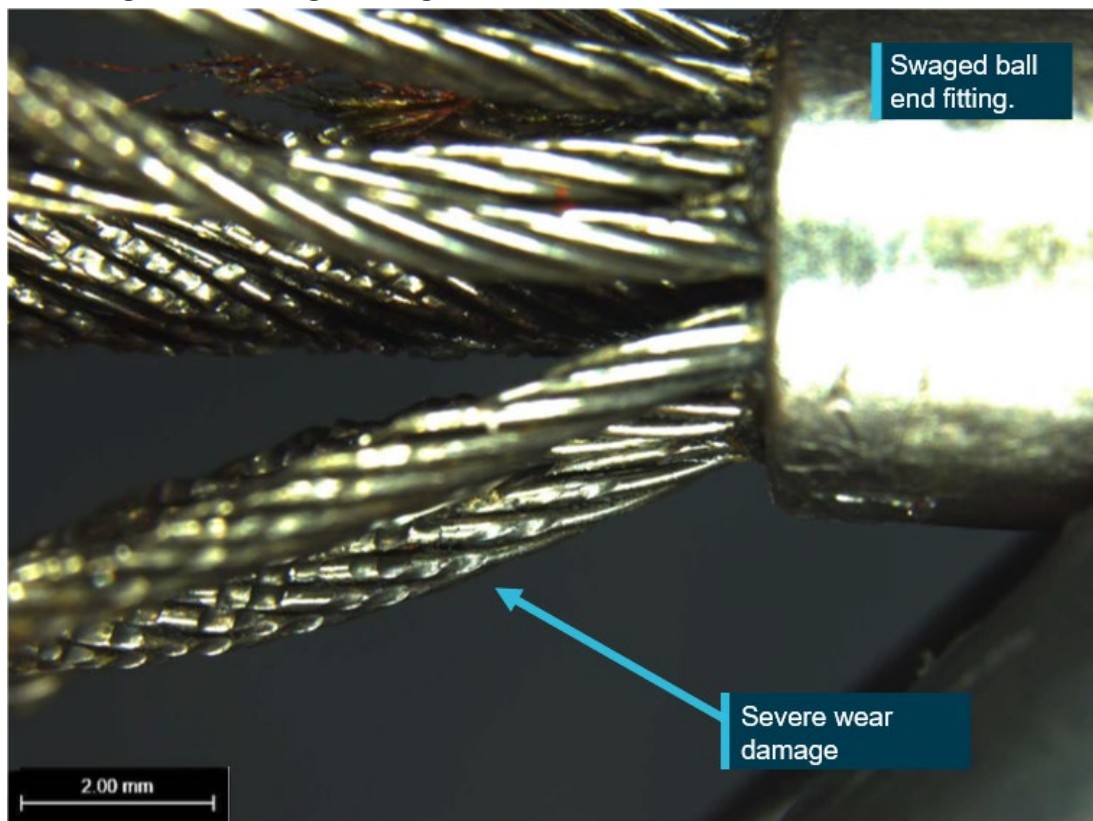
Figure 7: Severe wear to the wires was evident from the intact cable at the point of narrowing near the swaged fitting

The cable strands in the 'necked' region were spread apart in order to identify the extent of wear damage.
Source: ATSB
