# Signal SST535 passed at danger involving passenger train 8239 and near collision with another passenger train

Docklands, Melbourne, on 23 November 2020

Rail Occurrence Investigation (Defined)

RO-2020-019

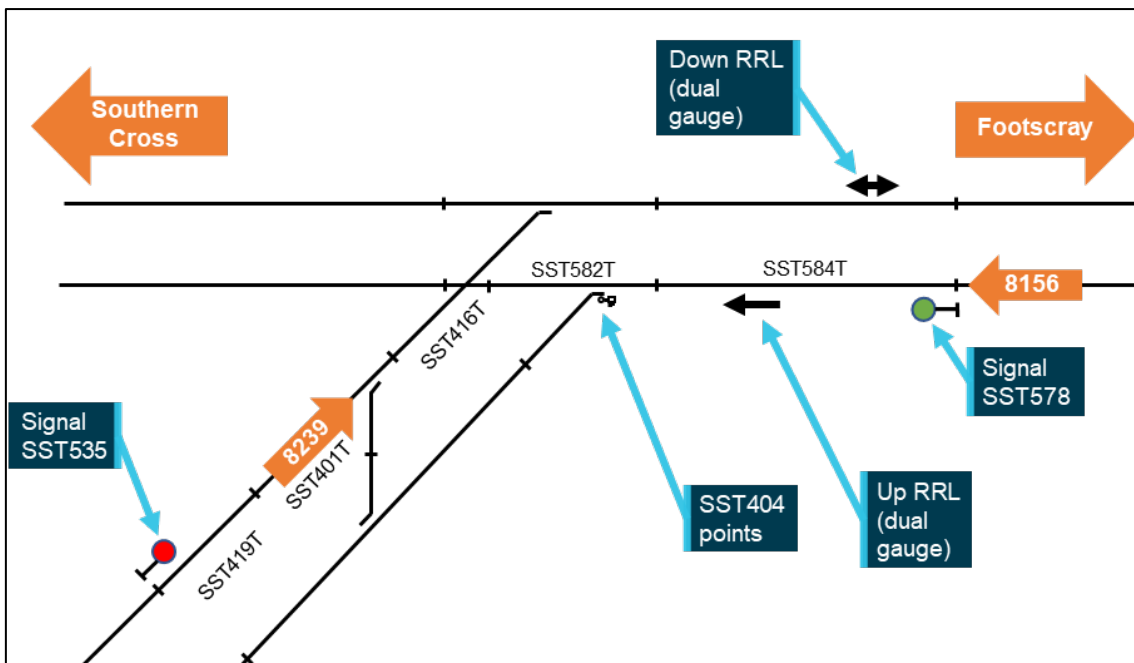
**Figure 2: Simplified layout of the relevant tracks and signals at Docklands (not to scale)**

display<sup>6</sup> showed that the train was routed via the 'Up Regional Rail Link (RRL) dual gauge'<sup>7</sup> track (Figure 2).

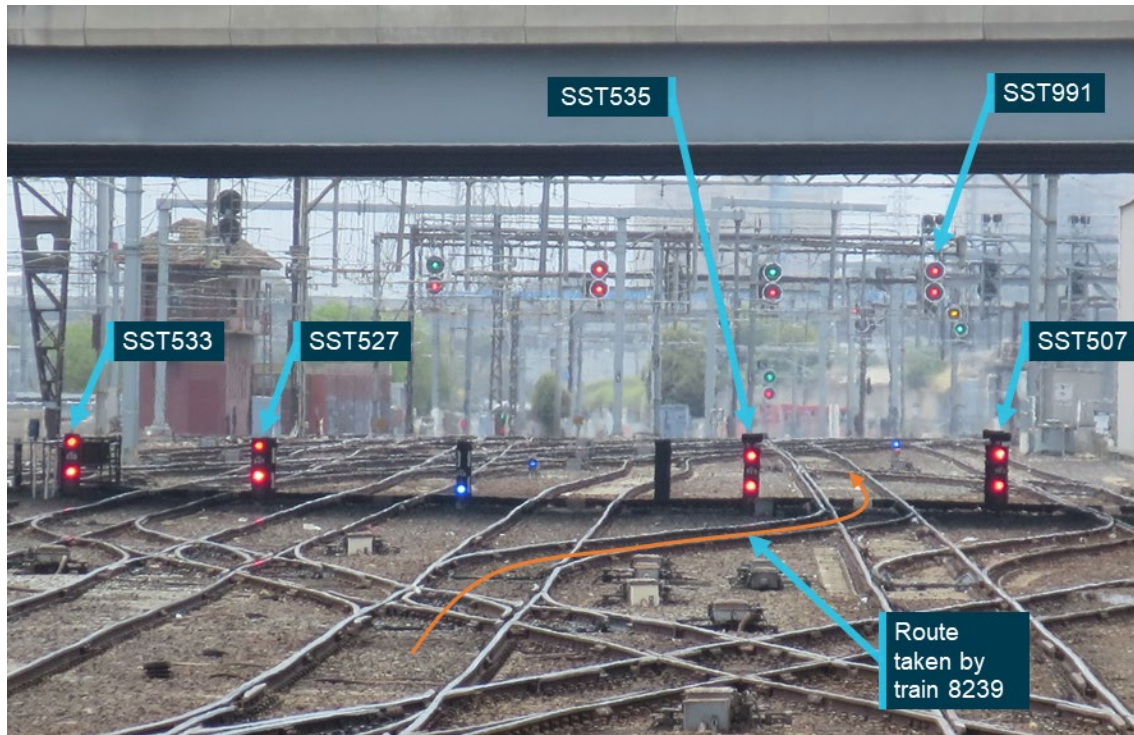
**Figure 3: Signals SST535 and SST991 at stop**

The driver reported thinking about the passenger they had left behind when passing signal SST537 on the departure from Southern Cross Station. This signal displayed a red indication over a yellow indication, which advised the driver to be ready to stop at the next signal. The driver reported seeing signal SST537 and acknowledging it by repeating the aspect to themselves. While the driver reported acknowledging this warning signal, they also advised that they did not at that time think about the next signal, SST535, which was 351 m ahead of signal SST537. The driver reported they looked past ground-mounted signal SST535 at LaTrobe St bridge and saw gantry-mounted signal SST991 at Dudley St showing a red indication (Figure 3). The driver

reported they erroneously matched stop signal SST991 to the warning (to be ready to stop at the next signal) provided by SST537.

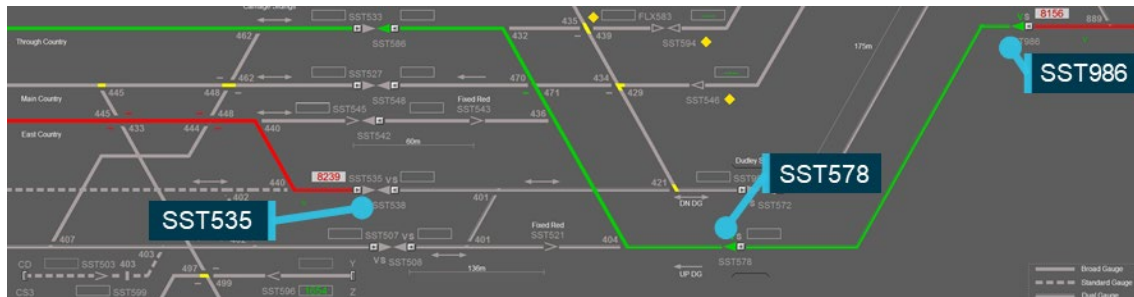
Figure 4: TCS playback showing train 8239 approaching SST535 at stop

The status of signals and the movement of trains were captured by the Southern Cross train control system (TCS) event logger. Figure 4 shows the position of trains, the status of signals and points, and routes set at 16:35:31 (9 seconds prior to the SPAD event), as were shown on the signaller’s train control system display. Red indicated the presence of a train on a section of track and green indicated the track was clear and the route was set. Train 8239 approached signal SST535 at stop. A route had been set for train 8156 to pass in front of train 8239 and onto the ‘Through Country’ track, with signals SST986 and SST578 both at proceed.

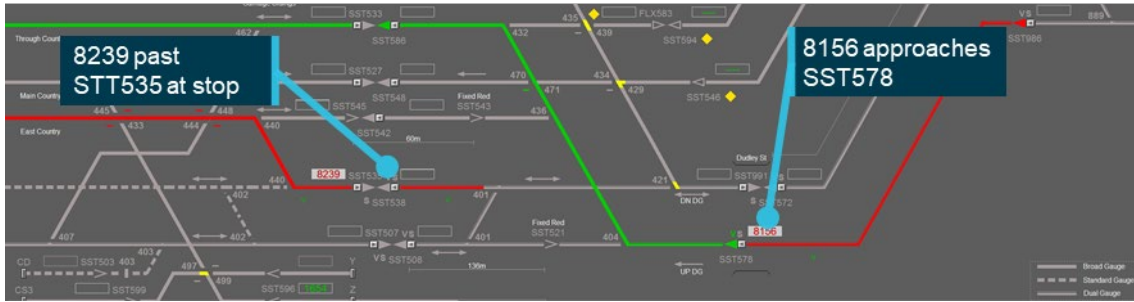
**Figure 5: TCS playback showing train 8239 having passed SST535 at stop**

Figure 5 shows that at 16:35:47, train 8239 had passed signal SST535 at stop, and train 8156 was approaching signal SST578 at proceed. It is estimated that train 8156 was between 50 m and 80 m from signal SST578 when train 8239 passed signal SST535 at stop.

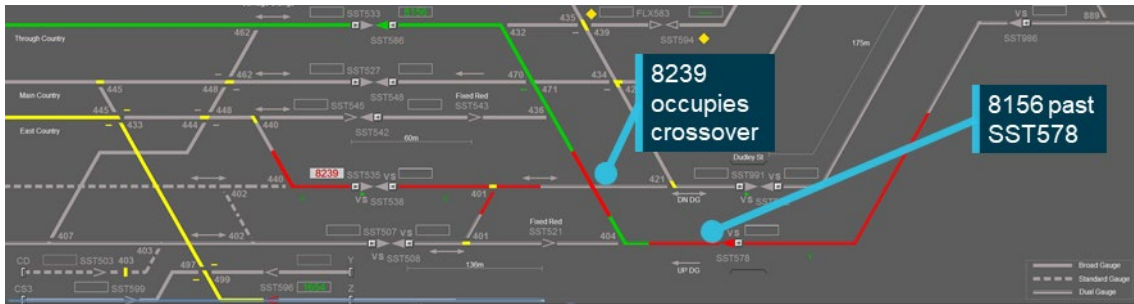
**Figure 6: TCS playback showing train 8156 having passed SST578 showing proceed**

Figure 6 shows that at 16:36:03 train 8239 was continuing to travel towards the route set for train 8156. The system playback shows train 8156 had passed SST578 when it showed a proceed indication, and this signal had subsequently restored to danger once the train had moved onto the track circuit past the signal. Both trains had come to rest by 16:36:13.

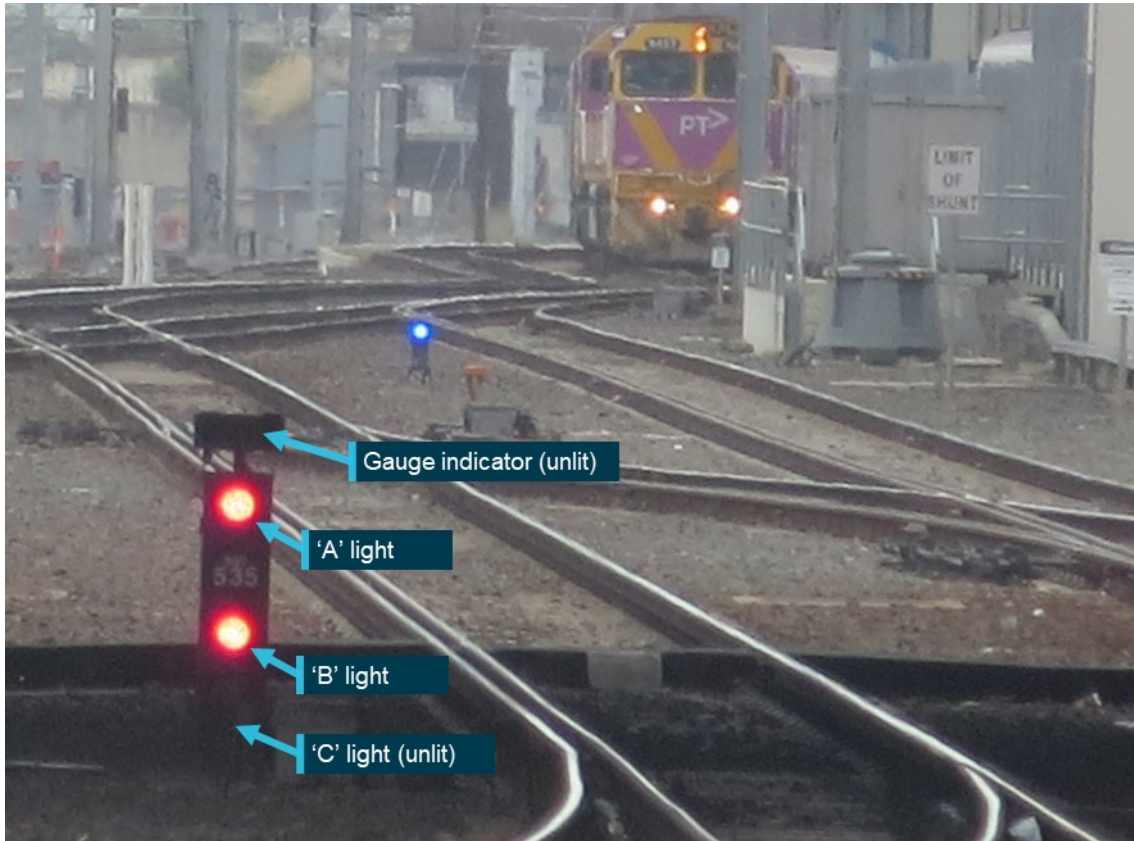
**Figure 7: Signal SST535 at stop**

Signal SST535 (Figure 7) was commissioned in 2014 as part of the RRL project as a ground mounted mainline three-position home signal. The main signal aspects were displayed as light-emitting diode (LED) colour light combinations on the “A” and “B” lights. The “C” light could display a yellow low speed aspect when both A and B lights were red. As the signal was located on a dual gauge line, it was provided with “V” and “S” indicators. A “V” indicator displayed in conjunction with another proceed aspect authorised a broad-gauge train to pass the signal, and an “S” indicator displayed in conjunction with another proceed aspect authorised a standard gauge train to pass the signal. The signal was not equipped with Train Protection and Warning System (TPWS)<sup>12</sup> or other train protection equipment.

Post-incident observations from the driver's cab showed that signal SST535 was visible to the driver for approximately 60 seconds when approached in compliance at the allowable track speed from platforms 1 to 5 at Southern Cross Station.

The SRRT was made up of three elements: an initial collision potential assessment, an accident vulnerability ranking, and a final risk ranking score. For signal SST535, the analysis of the SRRT considered a potential collision type of *Plain line rear-on or buffer*.

V/Line Corporation has advised that a funding submission to fit TPWS to signal SST535 and other similar signals in the Southern Cross area was approved in July 2021. Plans are underway to complete this installation during 2022.

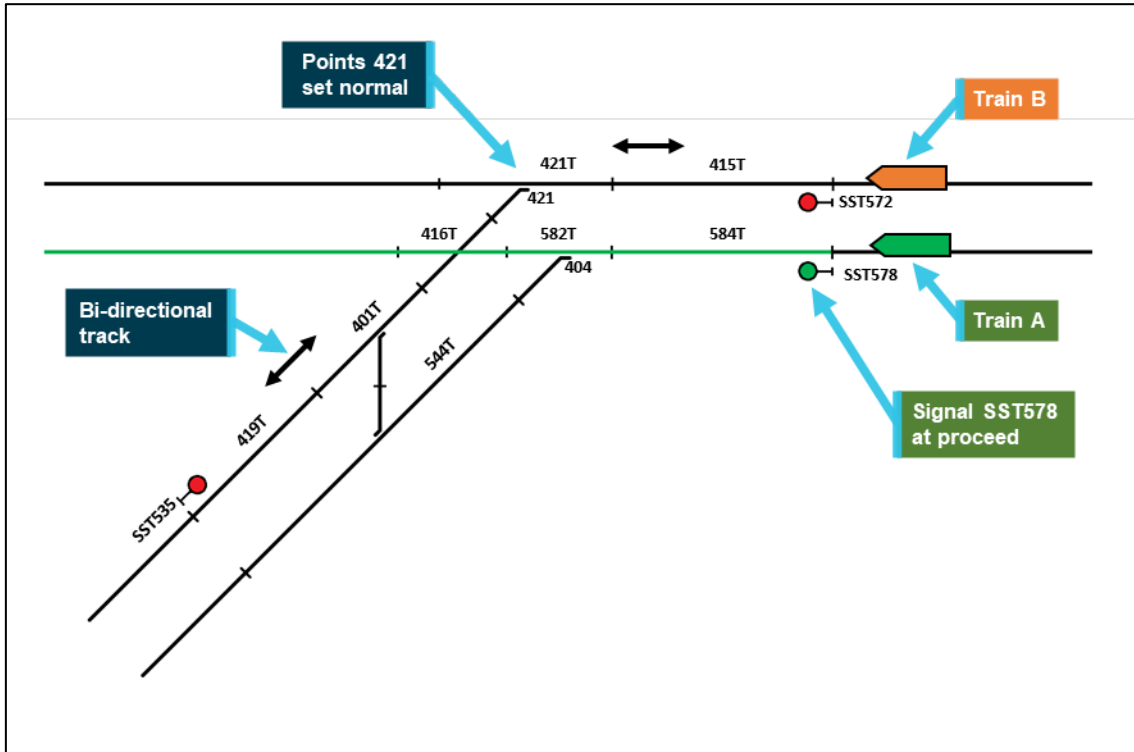
**Figure 8: Simplified track layout for the relevant tracks at Docklands**

Flank protection is often provided through the setting of signals and points. In Figure 8: for example, a route from signal SST578 is at proceed for train A. Points 421 are set to the normal (straight through) position so that if train B proceeds past signal SST572, it is not routed into the side of train A. That is, the flank of train A is protected by points 421 set normal and routing train B straight ahead rather than towards the junction.

However, for the SPAD that occurred on 23 November 2020, similar protection was not available for an unauthorised movement past signal SST535 since there were no facing points to route the movement of train 8239 away from the junction.

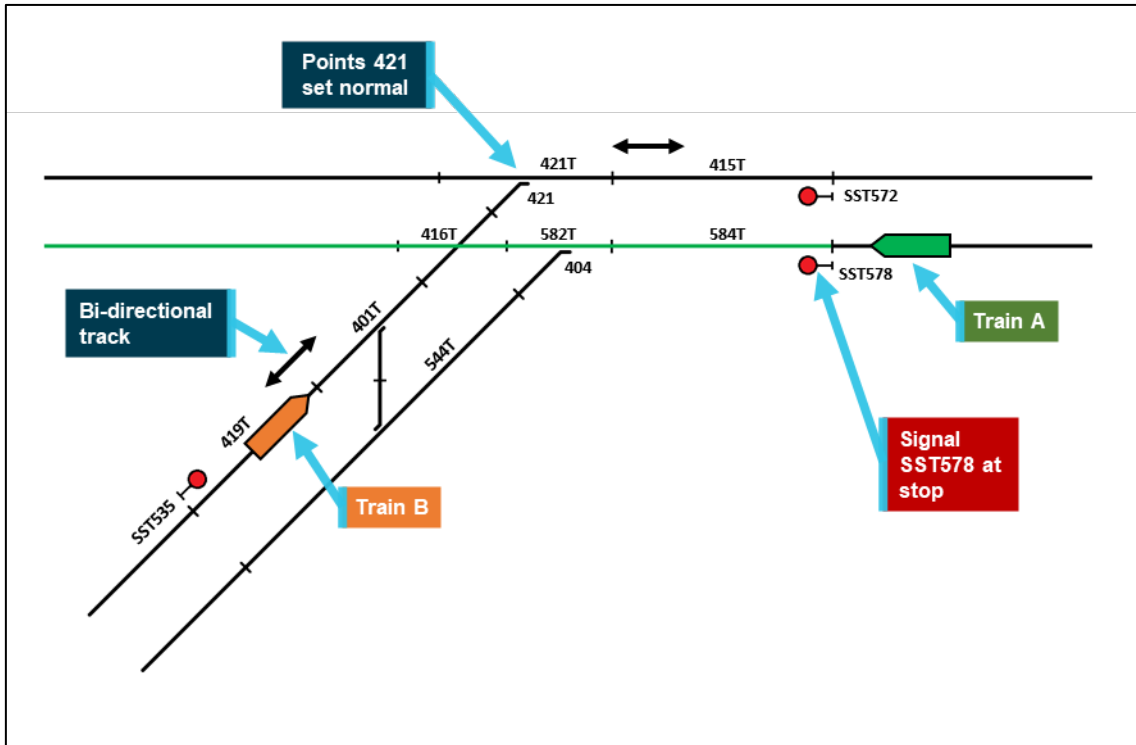
Figure 9: Simplified track layout for the relevant tracks at Docklands

Figure 9 provides an example of a route called from signal SST578 for train A. However, if train B passes signal SST535 at stop (SPAD) and occupies a track circuit between the signal and the junction (tracks 419T and/or 401T), a potential conflict with train A would be imminent. If flank-track protection was provided, any unauthorised occupancy of track circuits 419T or 401T would revert signal SST578 to a stop aspect. This would provide the opportunity for the driver of train A to react and stop prior to the junction and the potential conflict with train B (braking distances permitting and assuming train A had not already passed signal SST578).

However, the risk control of flank-track protection was not provided for the section of track where the SPAD occurred on 23 November 2020.

The Rail Industry Safety and Standards Board (RISSB) advised that flank - track protection has been recorded for inclusion when the signalling principles standard AS 7711 is next under review.
