Engine power loss and forced landing involving Robinson R22 Beta, VH-HCX

4 km south-west of Geraldton Airport, Western Australia on 20 February 2021

ATSB Transport Safety Report

AO-2021-008

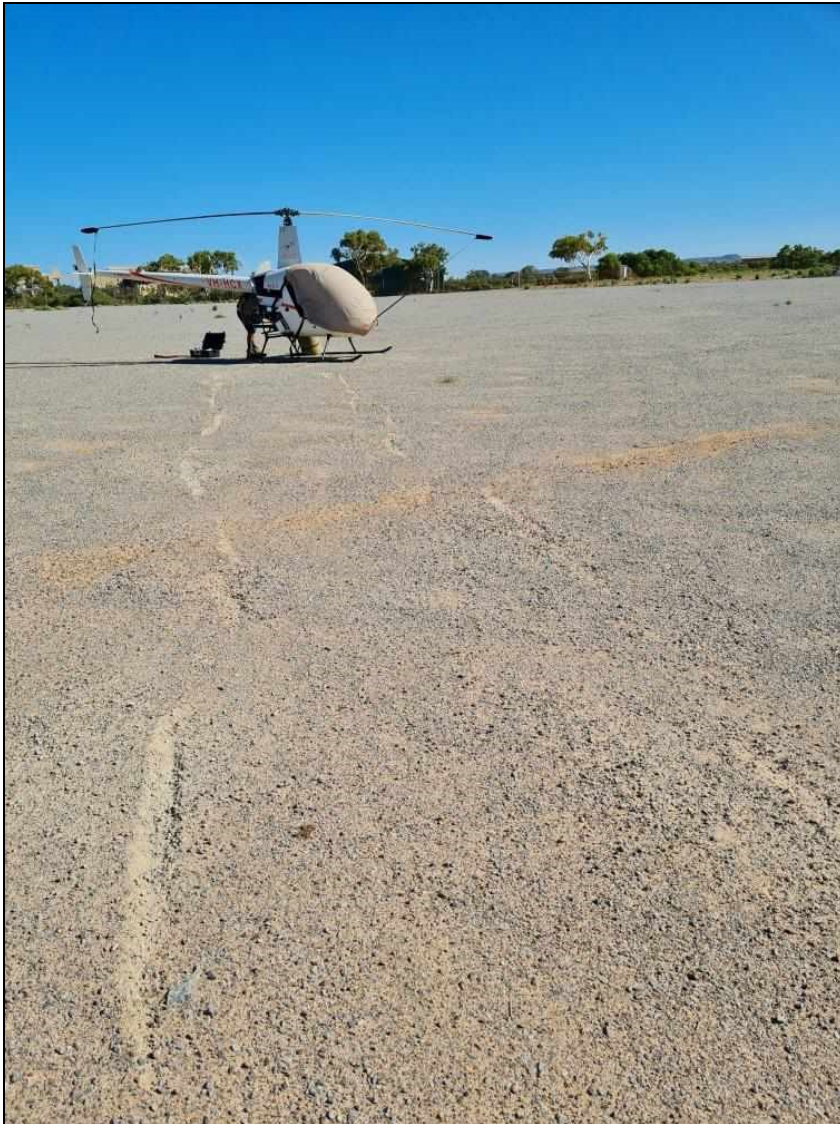
Figure 1: VH-HCX at the landing site

Aware that a forced landing was imminent, the pilot prepared to conduct a running landing onto a yard adjacent the departure point. The helicopter landed heavily, in a slightly nose high attitude, resulting in the skids rocking in a heel-toe manner several times along the gravel surface before coming to a stop in line with the helicopter’s flight path (Figure 1).

Several heel-toe skid marks were created during the landing. The helicopter subsequently yawed right after the pilot attempted to reposition the helicopter.
 Source: Fortescue Helicopters

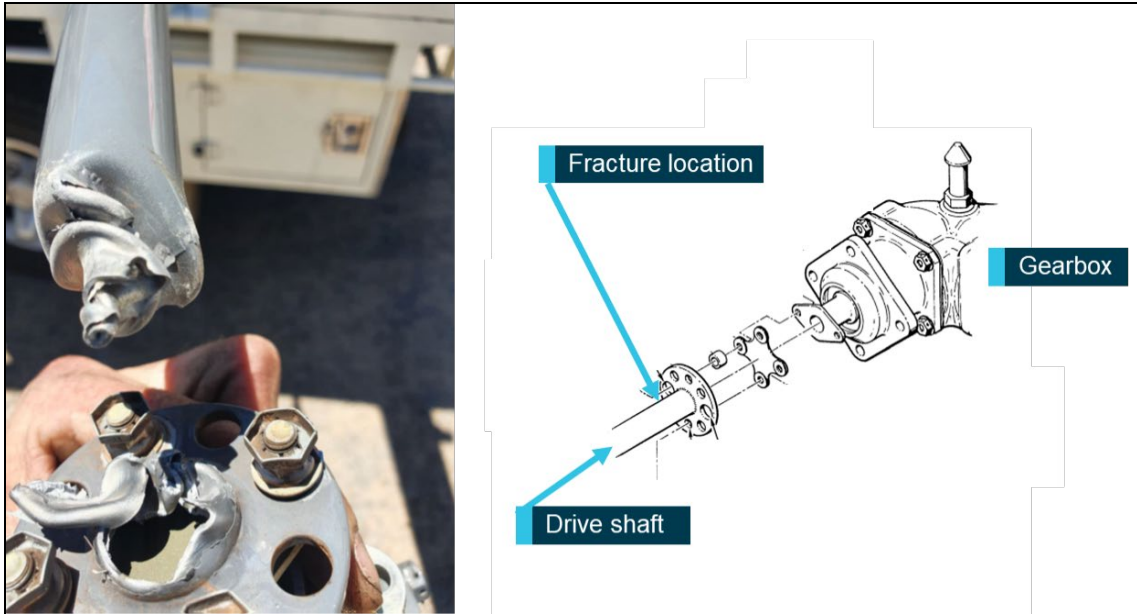
Figure 2: Tail rotor drive shaft fracture and schematic of the general area of the fracture

The pilot examined the helicopter after landing and identified that the tail rotor drive shaft had fractured at its connection to the tail rotor gearbox (Figure 2). The helicopter was grounded, and the operator contracted a maintenance organisation that specialised in Robinson helicopters to complete an engineering examination and damage assessment.

In their report, the maintenance organisation noted that the tail rotor gearbox was correctly installed and free to rotate with no internal damage. All hardware that attached the tail rotor drive shaft, rear flex plate, and tail rotor gearbox input coupling was in place and in the manufacturer’s specified assembly order. The tail rotor blades were inspected and found serviceable with no evidence of foreign object damage to their surfaces. There were no indications that the tail section had contacted the ground. Although assessed as non-contributory to the shaft fracture, the maintenance organisation also reported that the friction from a bolt within the tail rotor drive shaft damper assembly was found to be less than manufacturer’s specification. Excluding the fractured shaft, no significant defects were identified with the tail rotor drive line components.

The ATSB examination identified that the drive shaft fractured in overstress from torsional loading that led to total separation of the shaft from its connection to the rear flex plate and tail rotor gearbox. It was while attempting to reposition the helicopter following the forced landing that the pilot was unable to maintain directional control of the helicopter due to the complete loss of anti-torque thrust from the tail rotor system. The ground contact marks created by the helicopter skids during the forced landing were relatively straight, which indicated that the drive shaft was probably intact at the time of ground contact.

The ATSB was unable to conclusively determine the reasons for the driveshaft fracture, which probably occurred during the running landing. The surfaces around the drive shaft fracture contained no evidence of pre-existing damage, mechanical rubbing or rotational contact damage. There was no evidence that the engine was operated at a resonant speed nor was there damage identified to the tail rotor blades from contact with a foreign object that could have overstressed the shaft. The previous damage to one of the rotor blades was considered unlikely to have been contributory as the shaft had been inspected following that occurrence and found to be serviceable.

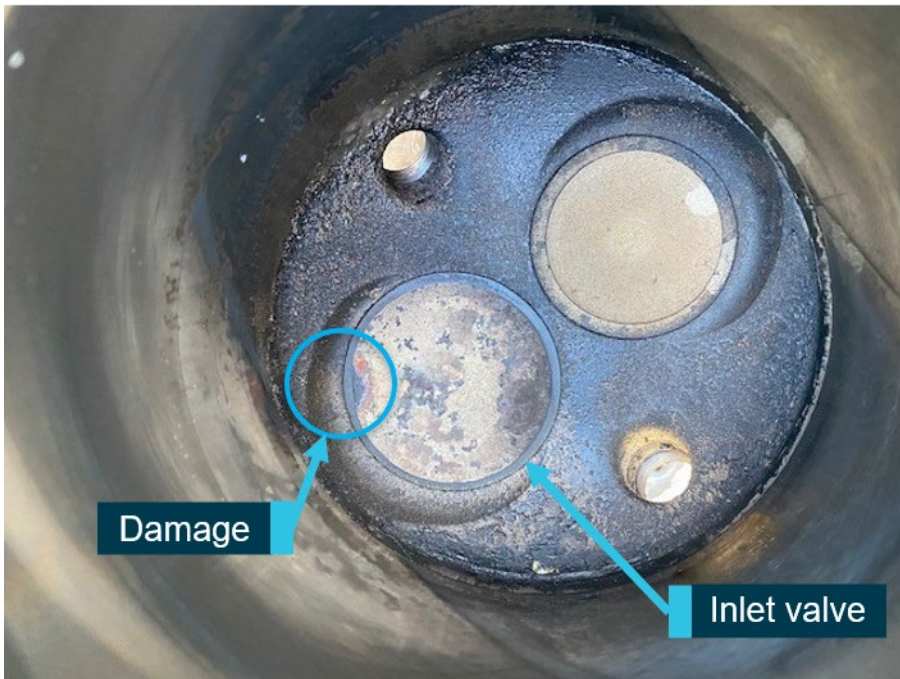
Figure 3: Internal view showing localised heat damage to the inlet valve from the number-four cylinder of the engine

During the post-occurrence inspection of the engine, maintenance engineers identified that the number-four cylinder was unable to hold pressure when subjected to a compression check. That cylinder was removed and, on further inspection, localised thermal damage to the inlet valve was identified (Figure 3). Reduced cylinder compression and valve damage can lead to engine power reduction, induction backfires, and aircraft yawing. No further defects were identified with the helicopter.

Shortly after the Robinson R22 departed from the Geraldton storage depot, the helicopter sustained an engine power loss that required the pilot to conduct a forced landing. The investigation of this occurrence identified that the power loss was due to thermal damage to an inlet valve from the number-four engine cylinder.

The clearance created by in-service thermal damage to the valve head reduced the inlet valve sealing capacity. This, in turn, likely permitted combustion gases to bypass the valve seat and extend back through the intake of the engine producing the reported backfire, power loss and associated airframe yaw. The previous instances of yawing and reduced engine performance while the helicopter was operated in the Geraldton region provided an indicator of the developing inlet valve damage.

Additionally, when a loss of engine power or abnormal operation is encountered, an appropriately licensed maintenance engineer should complete an engine cylinder inspection in accordance with the helicopter and engine manufacturer's most recent service instructions before further flight. Maintenance organisations should note that when completing a differential compression test of the engine cylinders, an accompanying borescope inspection of the cylinders and valves will provide an effective method to visually assess the condition of these components.

The LAME should listen for the sound of leakage at each intake valve while performing a differential compression test in accordance with the latest revision of Lycoming SI No. 1191. A cylinder borescope inspection should also be performed.

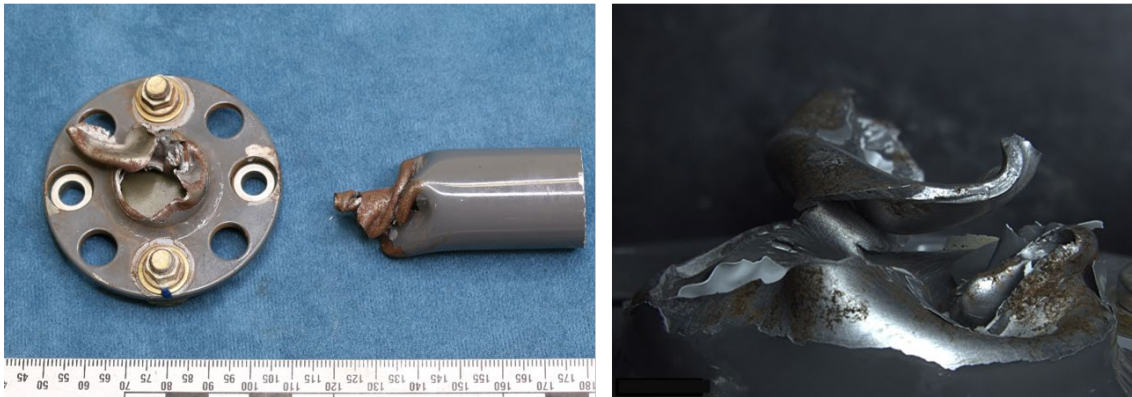
Figure 4: Gross ductile twisting and overstress fracture of the drive shaft

The fracture surfaces of the drive shaft were examined at high magnifications using both an optical and scanning electron microscope (SEM). The optical examination confirmed that the shaft fracture was located close to the welded flange with the entire section of shaft twisted and its cross-section inwardly necked in a ductile manner (Figure 4). The SEM examination confirmed the presence of gross ductile overstress features. There were no pre-existing defects identified from manufacture, or operational damage such as surface scoring, fatigue cracking, denting or corrosion that might have otherwise weakened the shaft and predisposed it to fracture.

The helicopter manufacturer advised that the VH-HCX tail rotor drive shaft fracture was highly consistent with a slowing (extreme drag) or sudden stoppage of the tail rotor blades and that in certain instances, contact with a foreign object such as water, tall grass, plastic bags or small birds may not result in visible damage to the blades.
