Defective axle bearing leading to fire on passenger train SN68

Yerrinbool, New South Wales, on 13 October 2020

ATSB Transport Safety Report
Rail Occurrence Investigation (Defined)
RO-2020-017
Final – 20 January 2022

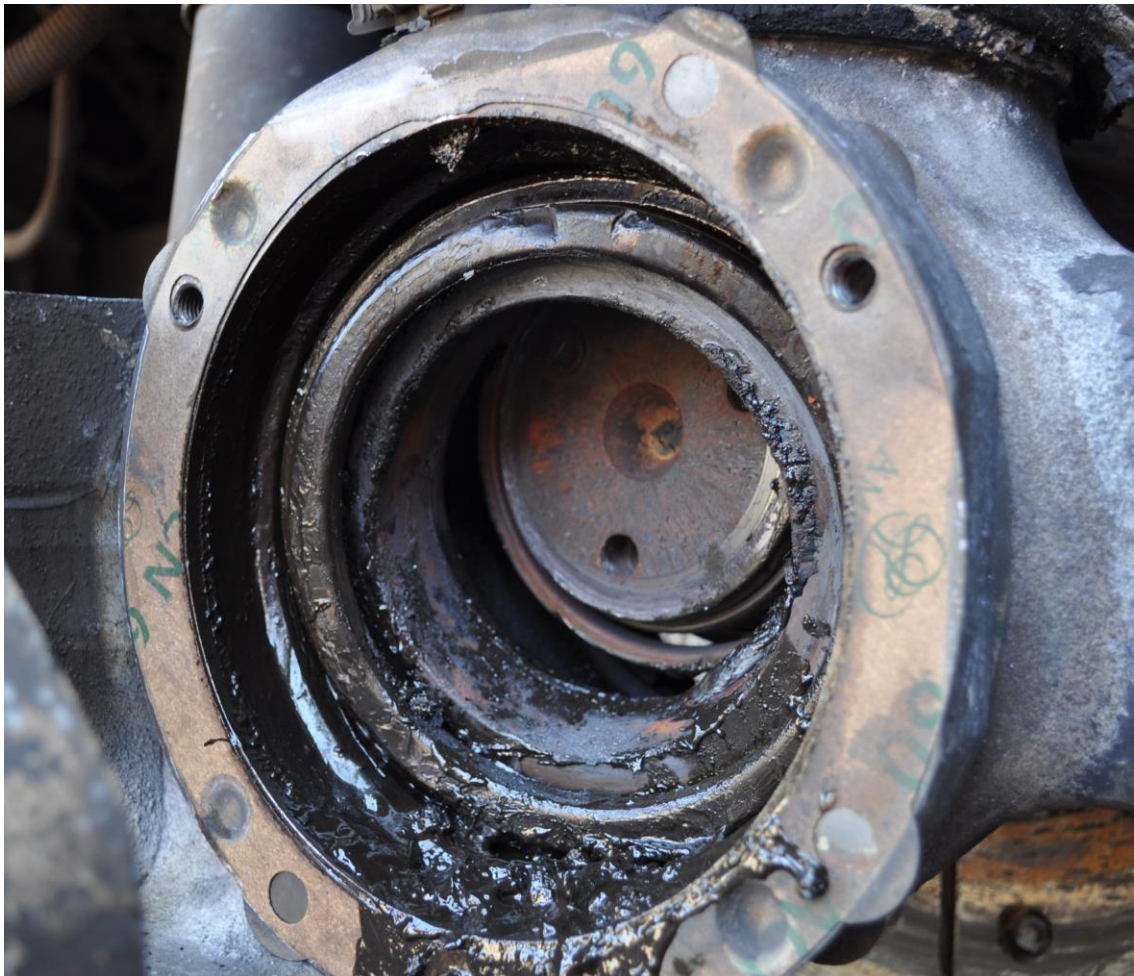
Cover photo: Collapsed axle bearing with end cap removed on swing arm assembly
Source: Office of Transport Safety Investigations (OTSI)

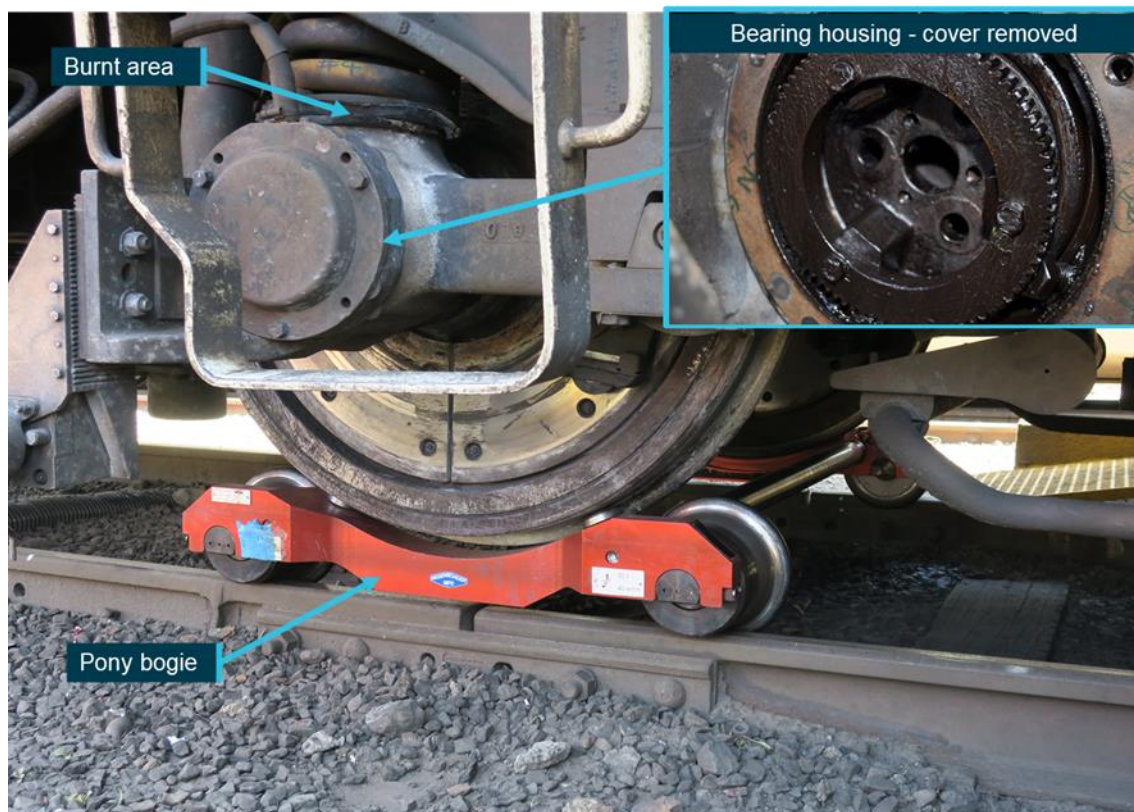
Figure 2: Heat affected area and pony bogie fitted under NJA31

The inset image shows the axle cover removed. Two bolts were found to be missing from the end cap and one bolt was broken. All three bolts remained within the axle housing.

The damage was contained to this localised area around the trailing axle of the rear bogie. Parts of the axle box were heat affected and the speed sensor and rubber suspension components were significantly damaged.

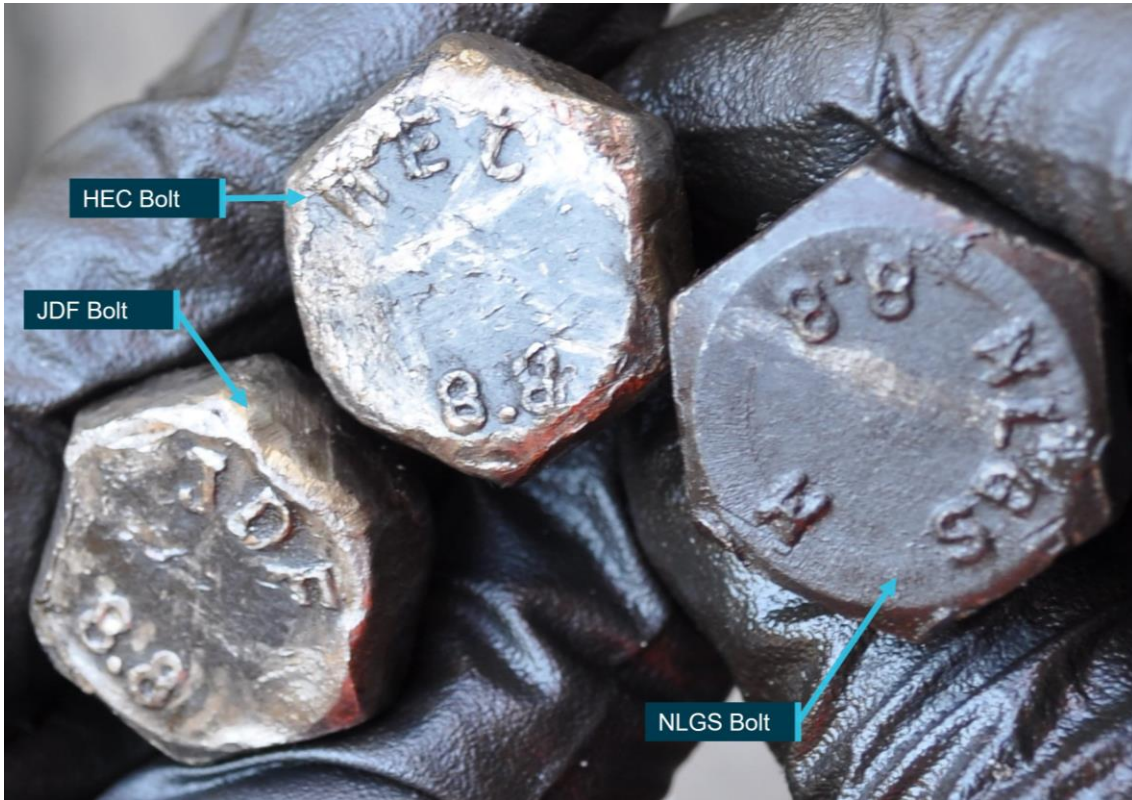
Figure 5: Three types of axle end cap bolts removed from hub following incident

The metallurgical examination showed that the bolts had no material or surface defects and complied with the requirements of the Australian Standard.⁷ The use of differing bolt brands was initially identified as a concern but was later ruled out as an issue as all brands complied with the requirements of the standard. The metallurgical examination also showed the locking plate to be without issue. Other results from the metallurgical examination were:

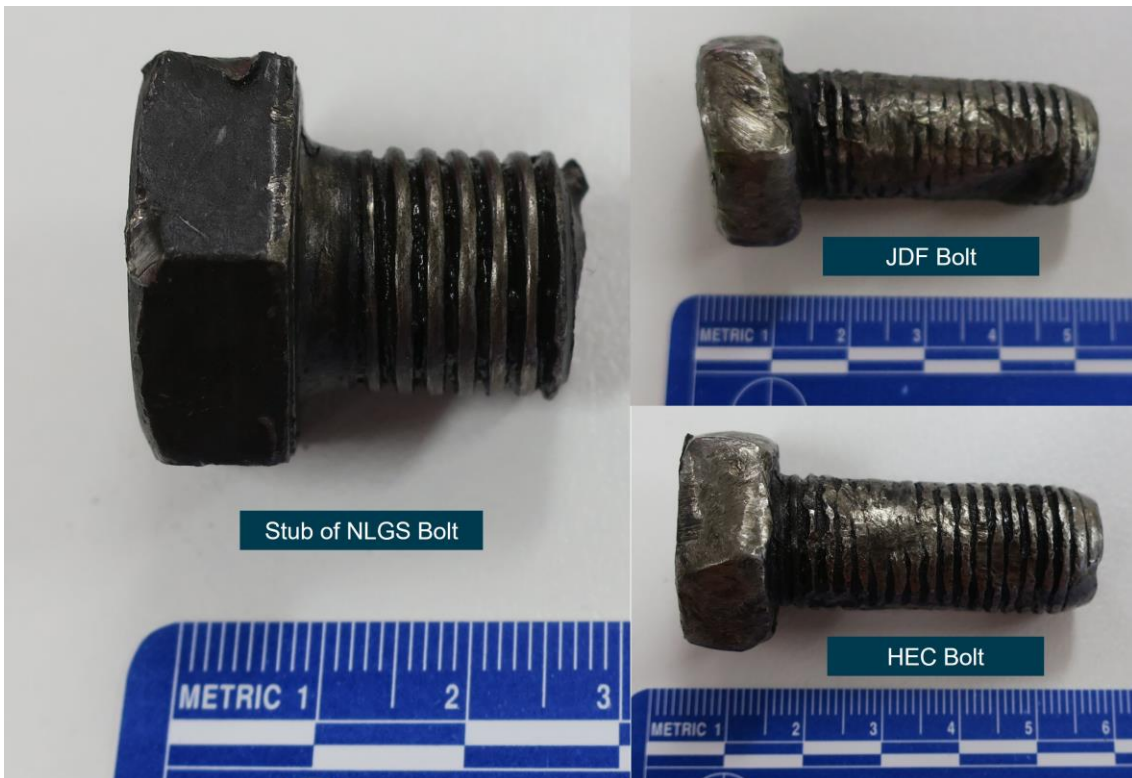
Figure 6: Side view of three axle end cap bolts, including broken NLGS bolt

- Damage was most severe on the first two bolts which loosened and fell out. These bolts were damaged after being tumbled around inside the case.
- The third bolt had the least damage as it had fractured after the first two bolt had fallen out.
- The third bolt had partially unscrewed about 4-5 mm before failure.
- The third bolt failure occurred progressively over a period of approximately one to two hours.
- The locking plates were made of low hardness steel which provided less resistance to loosening if the stresses in the system were sufficient to unscrew the bolts.
- The locking plate showed heavy damage and bent arms at the hole where the third bolt fractured.

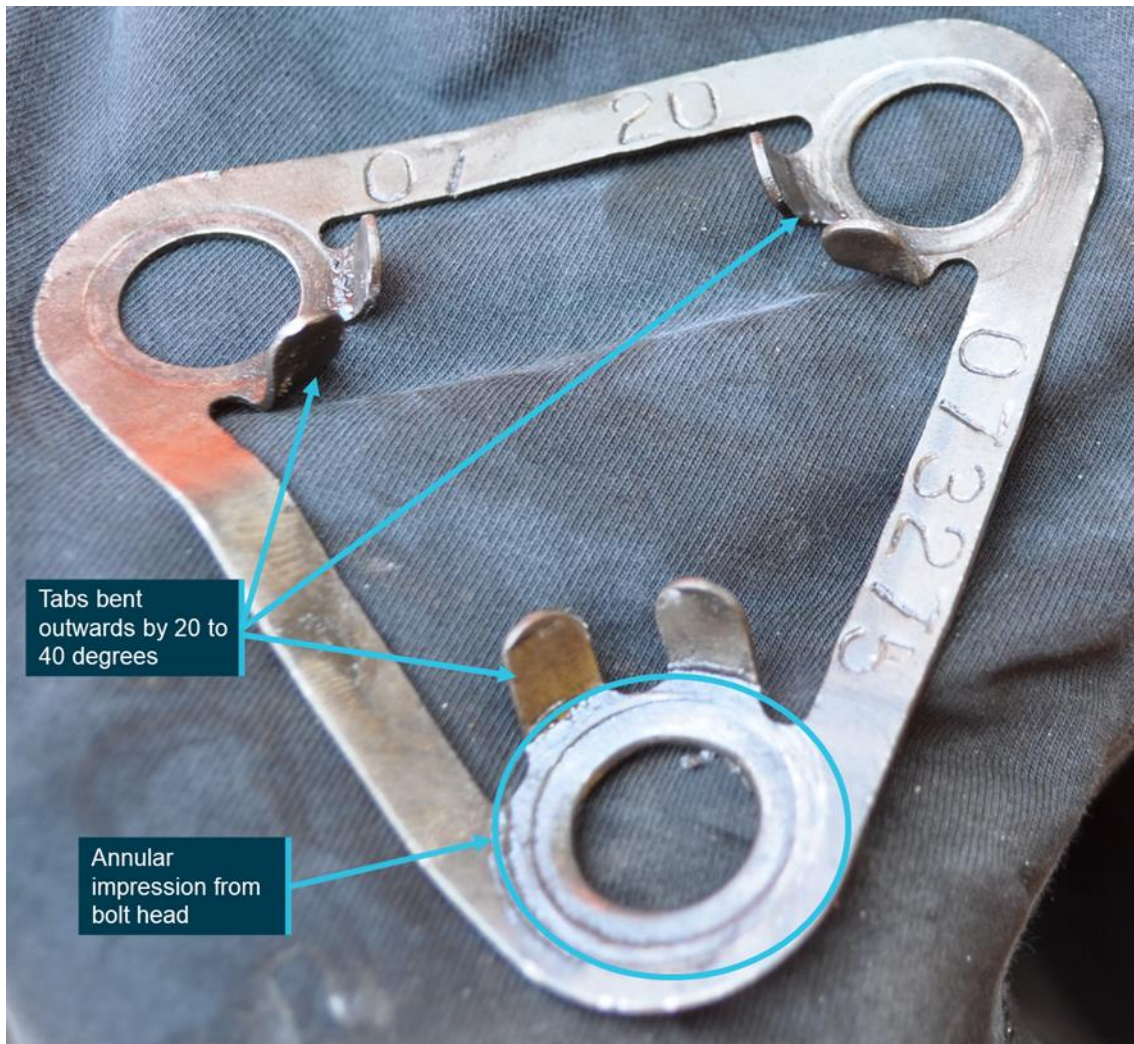
Figure 7: Locking plate

The locking plate was a Timken brand K-422091 R.S 120-130. Stamped on the plate was the axle number (073275) and installation date (07 20 – July 2020) (Figure 7).

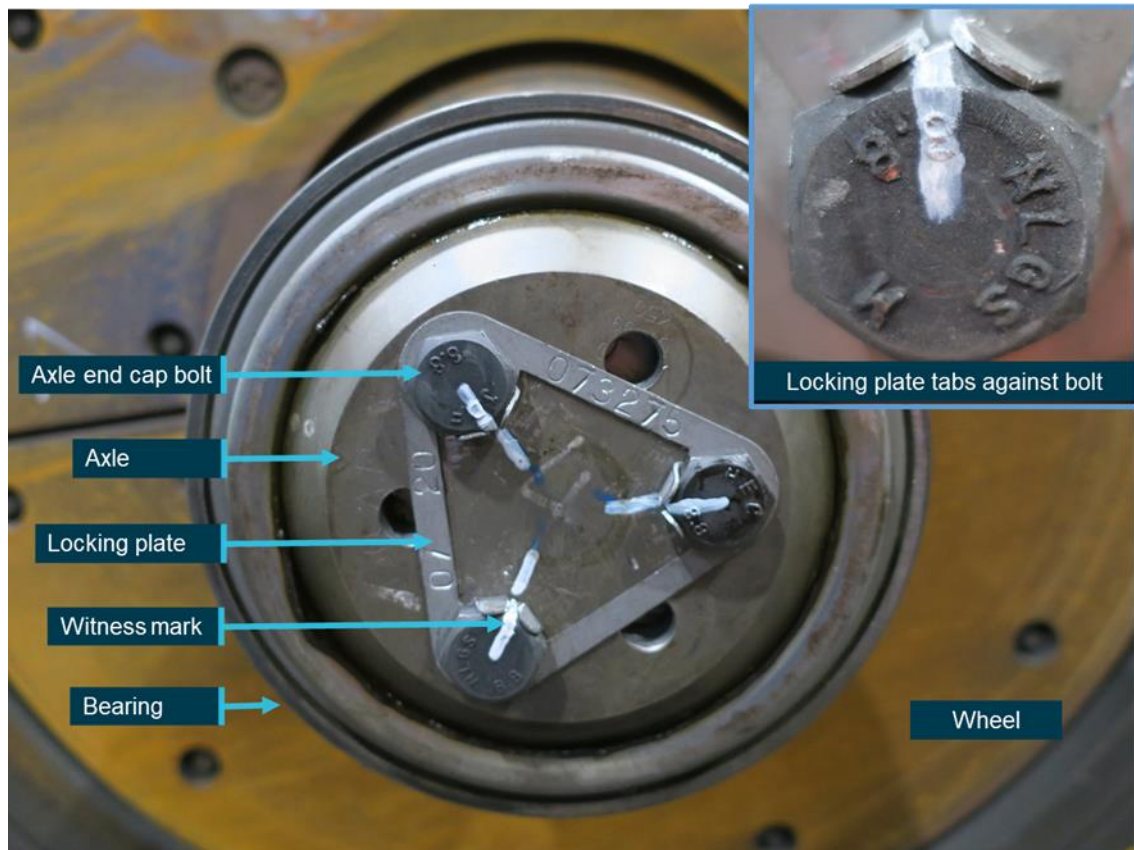
Figure 8: Correct bolt and locking tab installation bolt

Inset image shows a close of the locking tabs correctly bent up and in contact with the head of the bolt as well as the witness mark (white paint pen).

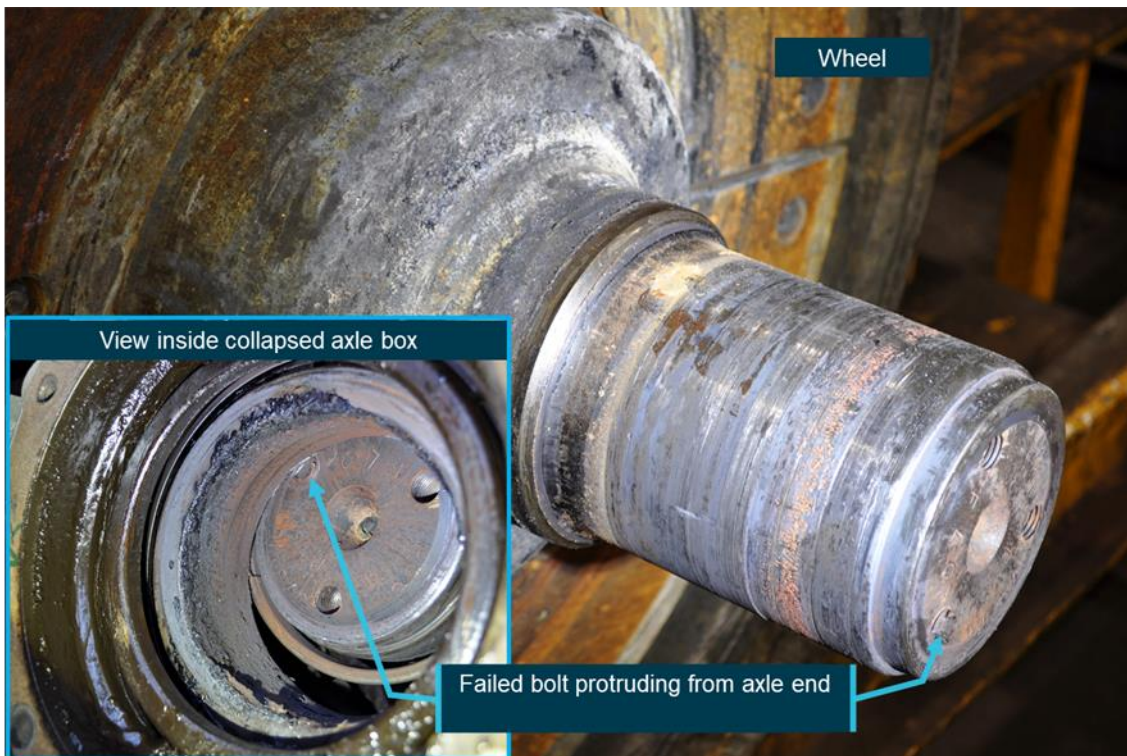
Figure 11: Axle end with protruding failed bolt

The likely precipitating events to the bearing collapse was the loosening of two of the three axle end cap bolts which placed higher loading on the remaining bolt which then started to fracture. During every cycle of the bearing there are micro movements within the system. The locking plate tabs, if positioned correctly against the face of the bolts, assist in retaining the bolts in position. The two bolts, inadequately restrained by the locking plate, continued to loosen and fell out and the remaining bolt then fractured completely (Figure 11). With the end cap unsecured the outer cone of the bearing was able to move on the axle. Wayside data indicated that once the bolt fractured it took approximately 15-20 minutes for the failure to be identified.

Insert image showing the inside collapsed axle box and failed bolt protruding.
Source: OTSI

ULGU also updated their end cap installation process to replace any end cap screw that, when torqued between 80 and 100 Nm, does not align with the lock tabs to allow the tabs to be bent up correctly. This process sometimes requires half a dozen end cap screws to be rejected before one aligns correctly to allow the lock tabs to be bent up.
