Runway incursion involving Beech Aircraft Corp. 58, VH-NSK

Bankstown Airport, New South Wales, on 26 October 2021

ATSB Transport Safety Report

AO-2021-046

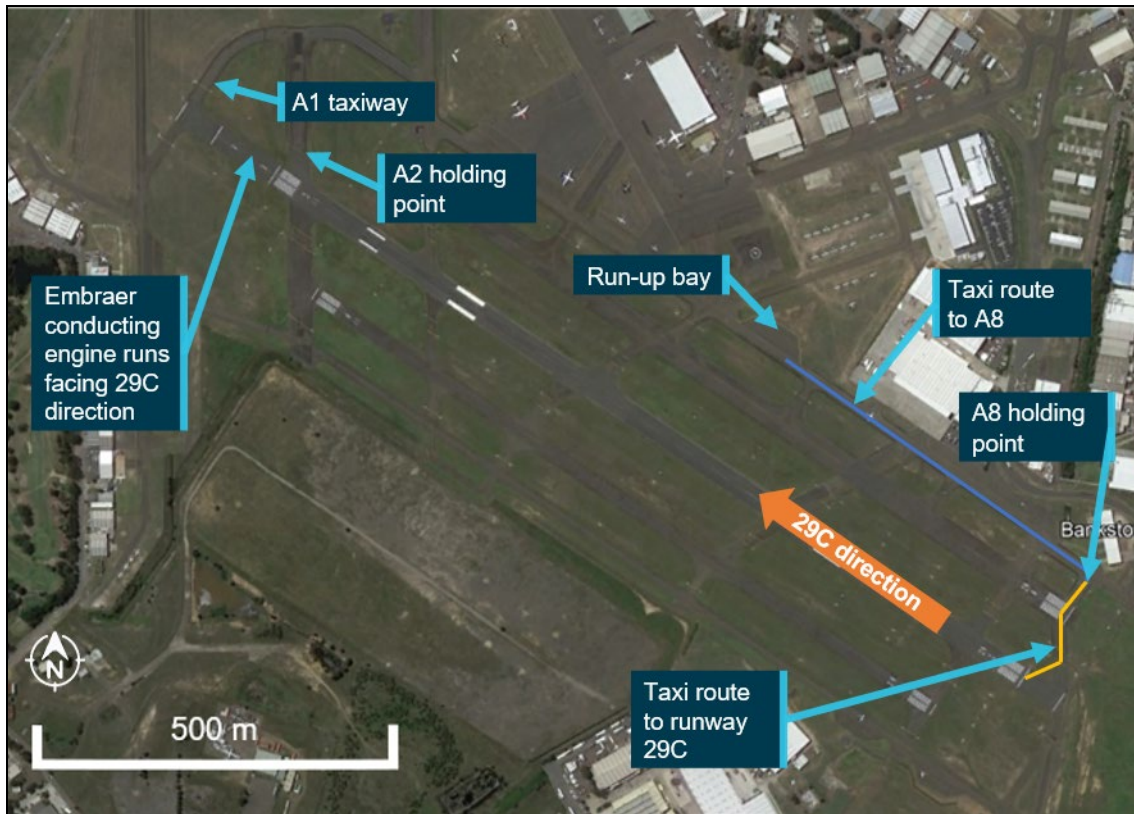
Figure 2: Bankstown Airport showing the route NSK took to the holding point

The next morning, the pilot conducted their normal pre-flight checks and started the engines. As the pilot taxied across the apron, they contacted the Bankstown surface movement controller (SMC), to obtain their taxi clearance. The SMC instructed them to taxi to holding point A8 for runway 29R¹ (Figure 2). This clearance automatically included an approval for the aircraft to enter a run-up bay to conduct the pre-flight engine checks and then taxi to the runway holding point. The pilot was not aware of this and advised the SMC that they needed to taxi to the run-up bay, which the SMC advised they were cleared to do. During this exchange, the pilot advised the SMC that they had not been to the Bankstown training area for over 40 years.

As the pilot was conducting their engine checks in the run-up bay, the crew of an Embraer 190 (Embraer) requested, and received, clearance to taxi to holding point A2 (Figure 2), the upwind end of runway 29C, to conduct high power engine runs for maintenance purposes.

The Embraer completed their engine runs and exited the runway onto taxiway A1, taxiing around runway 29R (Figure 2).

- Despite correctly acknowledging the clearance to enter and line up on runway 29R, the pilot crossed runway 29R and entered runway 29C without a clearance, probably due to expectation bias associated with previous operation only from 29C.
