AIRCRAFT ACCIDENT REPORT

Controlled Flight into Terrain

Ilyushin IL-76 TD, RDPL-34141
Baucau, Timor-Leste
31 January, 2003

Australian Transport Safety Bureau

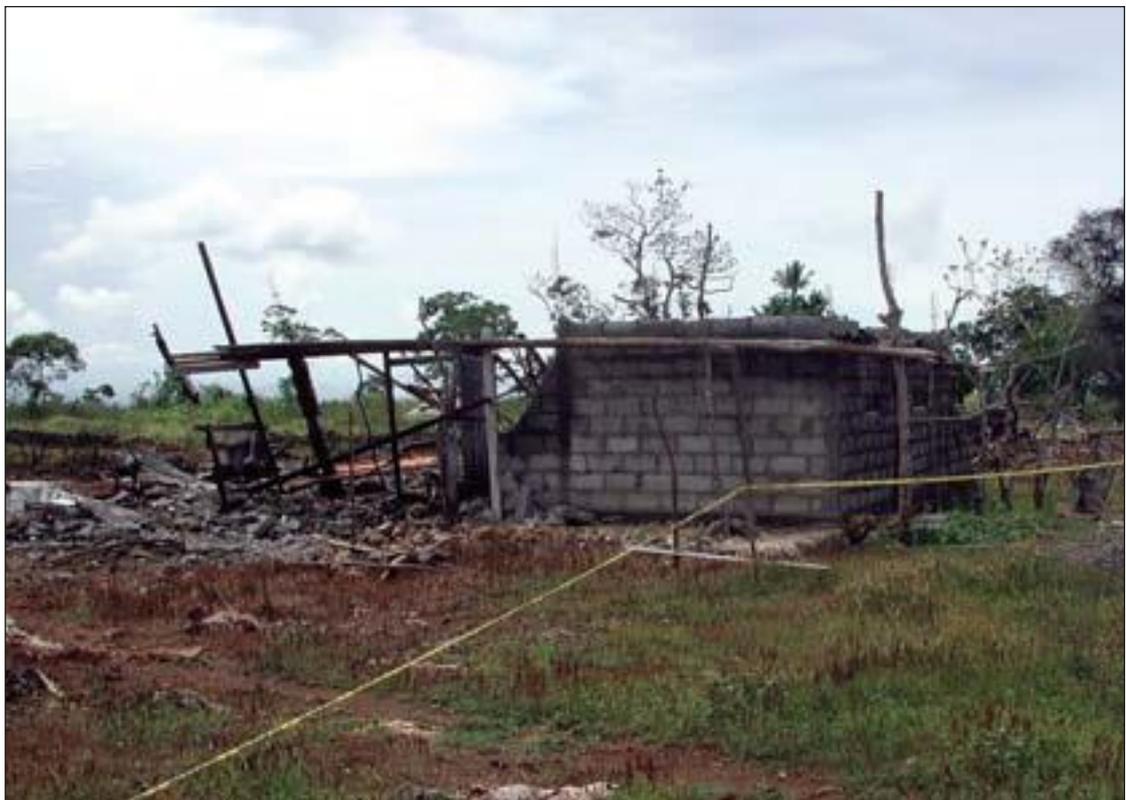
FIGURE 6:
Partially constructed house struck by the aircraft during the impact sequence

During the impact sequence, the right wingtip of the aircraft struck a partially constructed house to the left of the centreline of the wreckage trail, about 190 m from the first impact point (see Figure 6). The house, which was occupied at the time by its owner, was severely damaged. The owner of the house was physically uninjured by the impact.

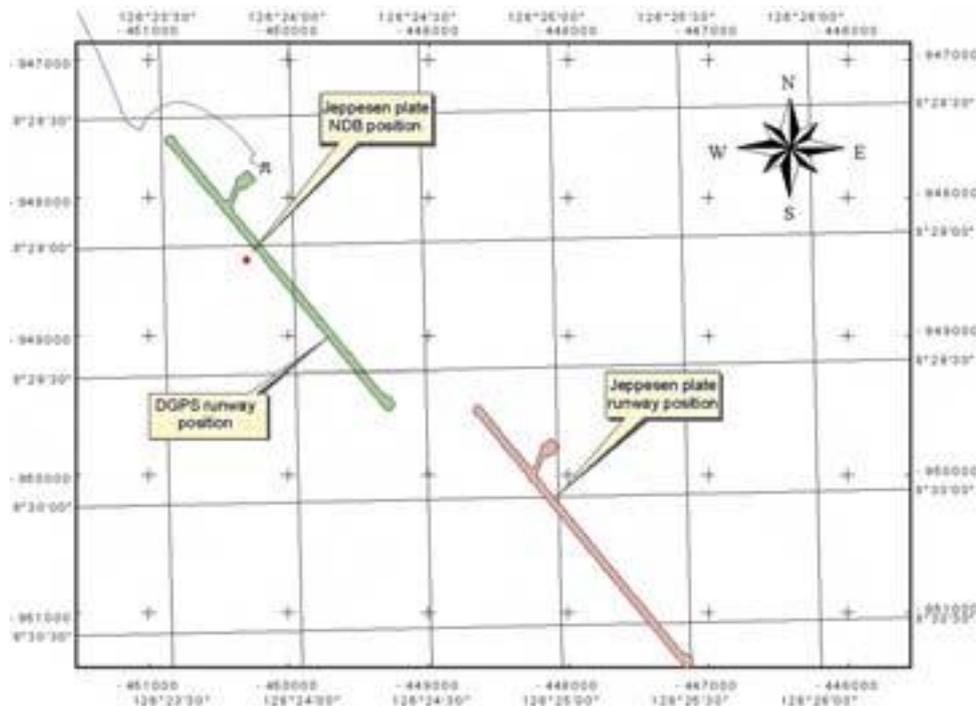
FIGURE 12:
Actual vs. depicted runway position

The Jeppesen aerodrome chart depicted the threshold of runway 14 as being about 0.9 NM (1,700 m) southeast of the NDB. The Jeppesen runway 14 and 32 NDB approach charts also depicted the runway in that position, relative to the NDB. During the investigation the actual threshold of runway 14 was found to be about 1.35 NM (2,500 m) northwest of where it was depicted on those charts. The runway heading for runway 14 at Baucau was depicted as 135 degrees magnetic on the Jeppesen aerodrome chart. CAD did not publish an aerodrome chart for Baucau, and the runway heading was not included on CAD Baucau NDB approach charts. Following the occurrence, runway 14 was surveyed and the actual runway heading was determined to be 139 degrees magnetic.

The Australian accredited representative and his team were unable to locate the aerodrome reference point (ARP) in the position where it was depicted on any of the Jeppesen aerodrome chart. Using the DSTO GPS, the threshold elevation of runway 14 was determined to be 519 m (1,703 ft) AMSL. Subsequent to the accident, the UN commissioned another survey of Baucau, which revealed that the threshold elevation of runway 14 was 516 m (1,694 ft) AMSL.

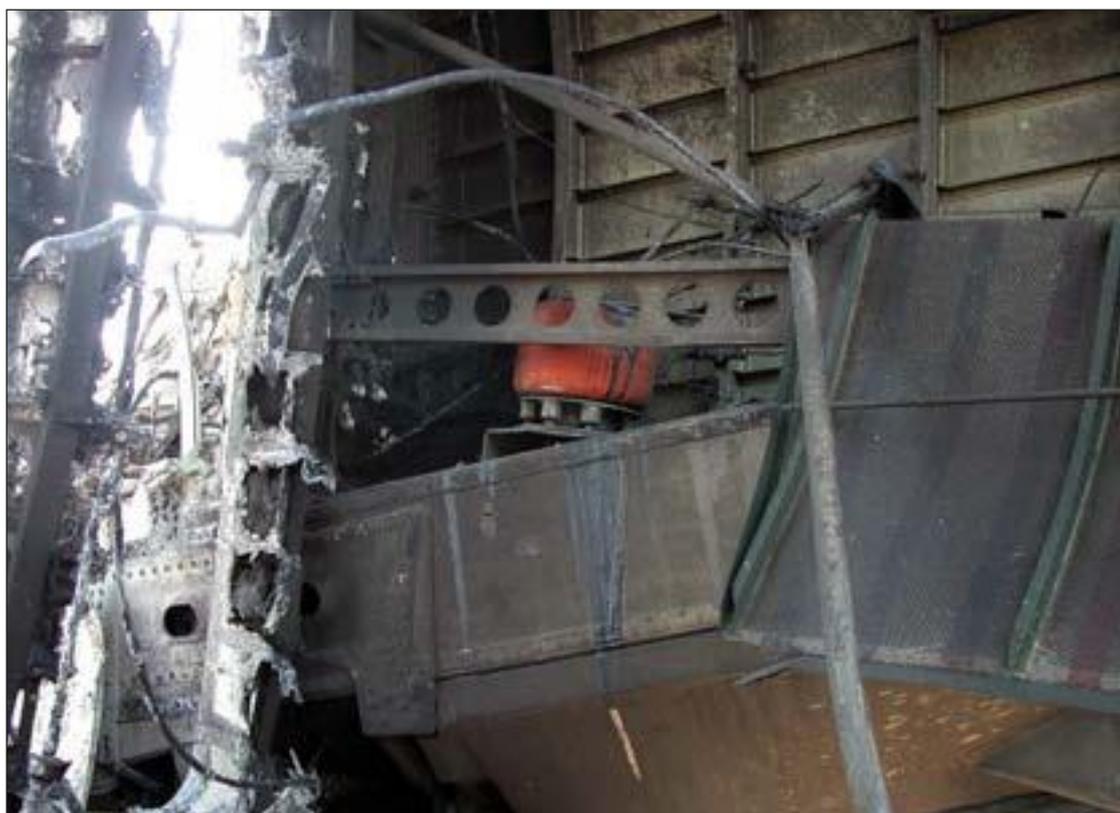
FIGURE 13:
Flight data recorder before recovery from the aircraft wreckage

The casing of the FDR storage unit was sooted from the post-impact fire, but revealed no evidence of heat or structural damage (see Figure 13). Examination of the recorded data revealed that the FDR had operated normally until impact.

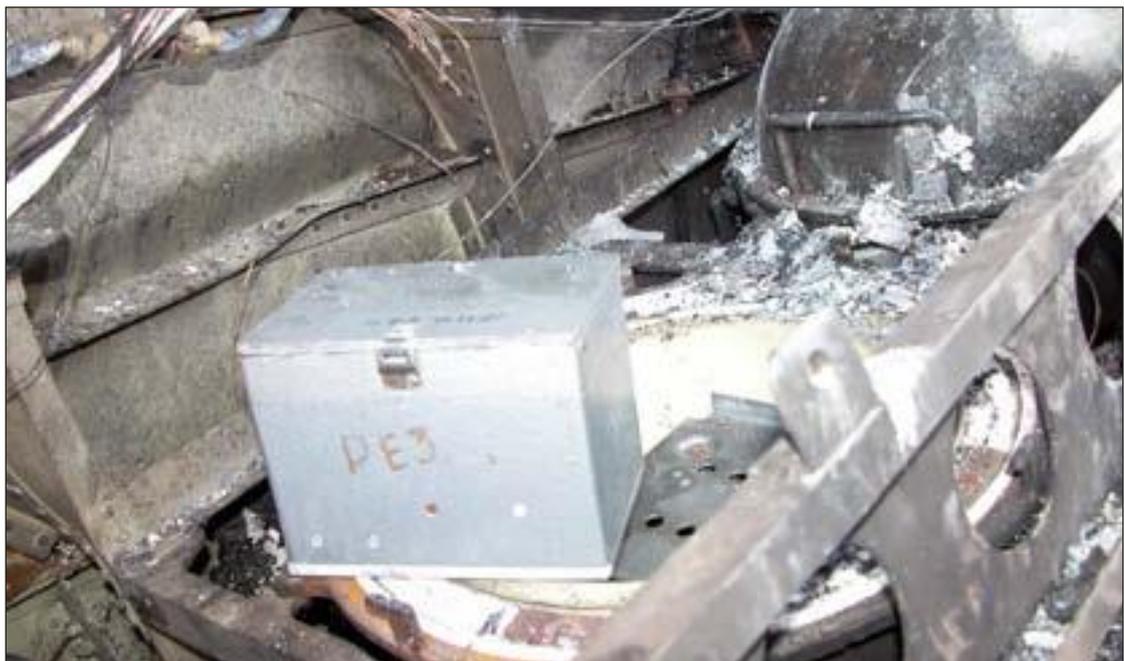
FIGURE 15:
Cockpit voice recorders during recovery from the aircraft wreckage

The cases of both CVRs were also sooted from the post-impact fire, but they revealed no evidence of structural damage (see Figure 15).

The interior of both CVRs showed no evidence of interior heat or impact damage. The wire-recording medium in one of the CVRs was dislodged from the recorder spools in that unit, and provided no useful data. The other cockpit voice recorder provided good quality audio information for the descent and approaches to Baucau.

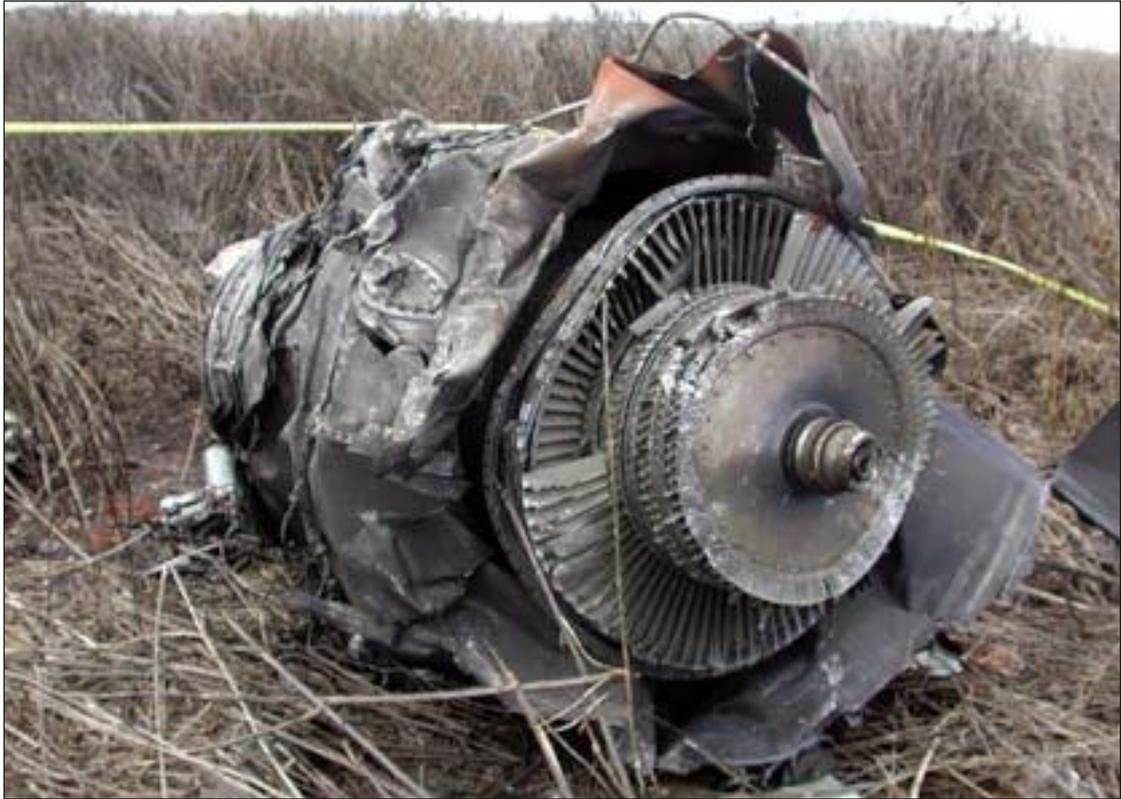
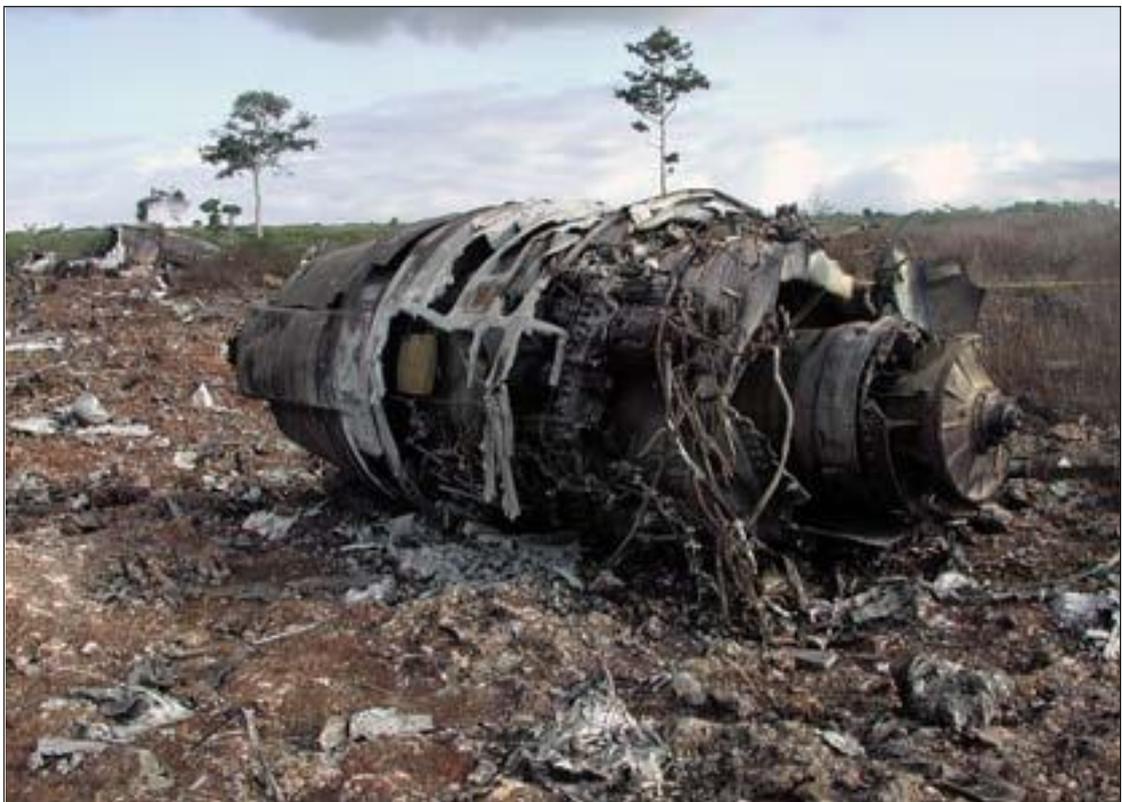
The post-occurrence technical examination of the engine fan blades found in the wreckage did not display any evidence of bird strike or blending repairs.³⁰ It was not possible to determine whether the engines had sustained any foreign object damage before impact because of the significant damage resulting during from the impact sequence. The FDR EGT and N2 plots are depicted at Figures A.8 and A.9 in Appendix A. The plots revealed no apparent aircraft engine anomalies during the descent into Baucau or during the approach sequences. The extent of the typical resultant engine damage is depicted at Figures 17 and 18.

FIGURE 17:
Typical engine damage

FIGURE 18:
Another damaged engine

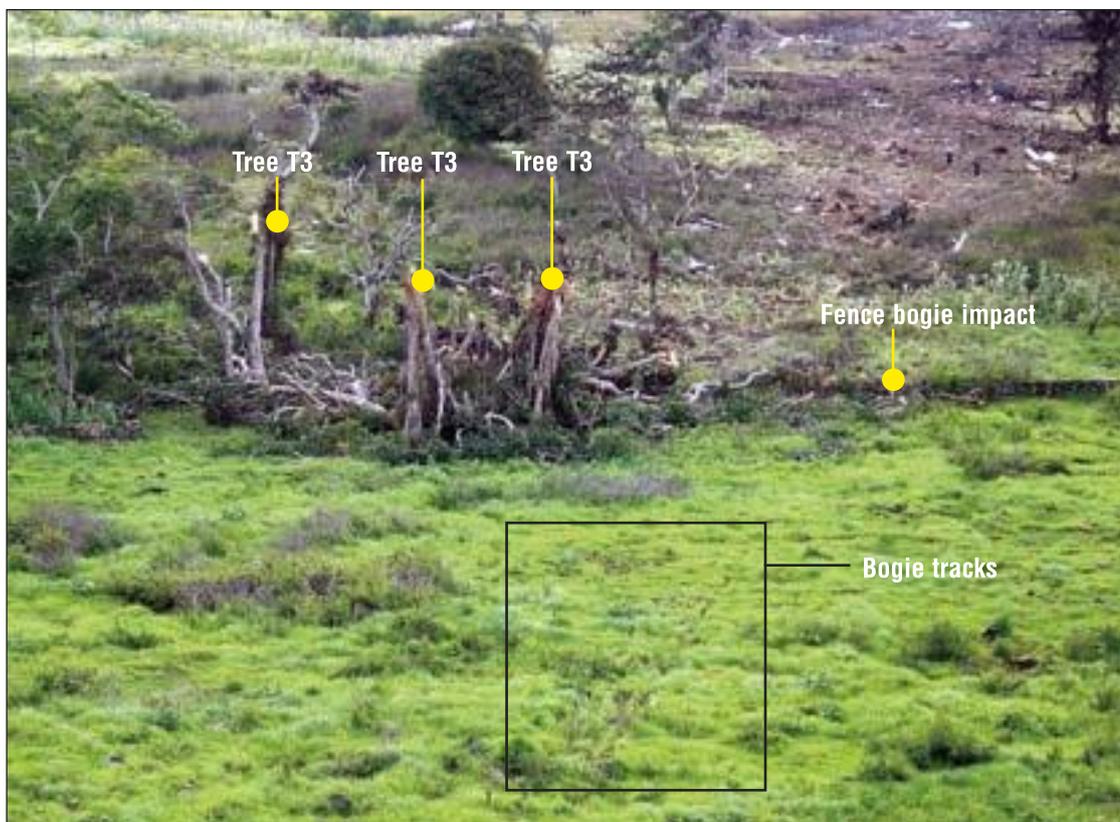
FIGURE 21:
The group of trees at the initial impact area

The first marks in the wreckage path were a single set of ground marks on slightly rising ground, consistent with ground contact of one of the main landing gear bogies. Those marks ran for about 39 m (128 ft) on a track of about 130 degrees magnetic. A single main landing gear bogie had impacted a 1.2 m (3.9 ft) high stone fence about 1m above the ground, nearly in line with, and 41 m (135 ft) from where the initial ground marks ended. Pieces of the lower cockpit windows and a windshield wiper blade were located not far down track from the fence that had been struck by the main landing gear bogie.

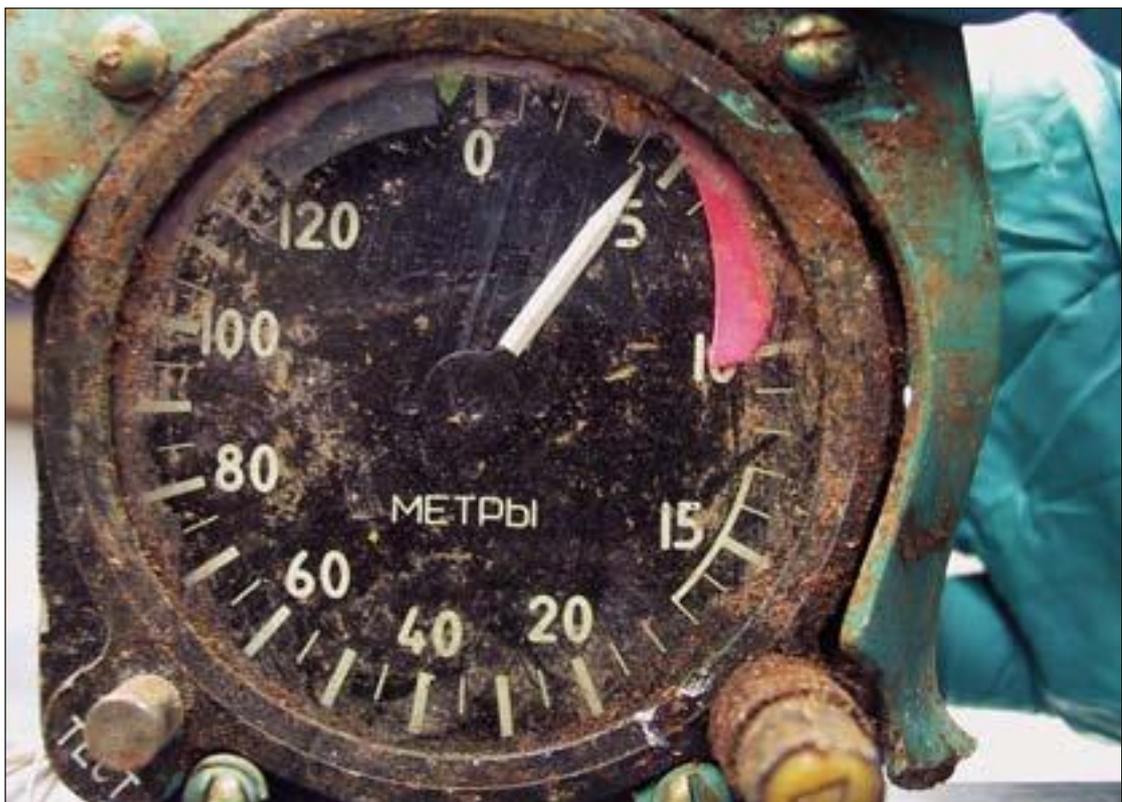
FIGURE 25:
The PB-150 radio altimeter indicator located in the aircraft wreckage

The reference bug on the indicator was not set to a positive altitude setting, but was parked in a position that was slightly less than the zero altitude reading.

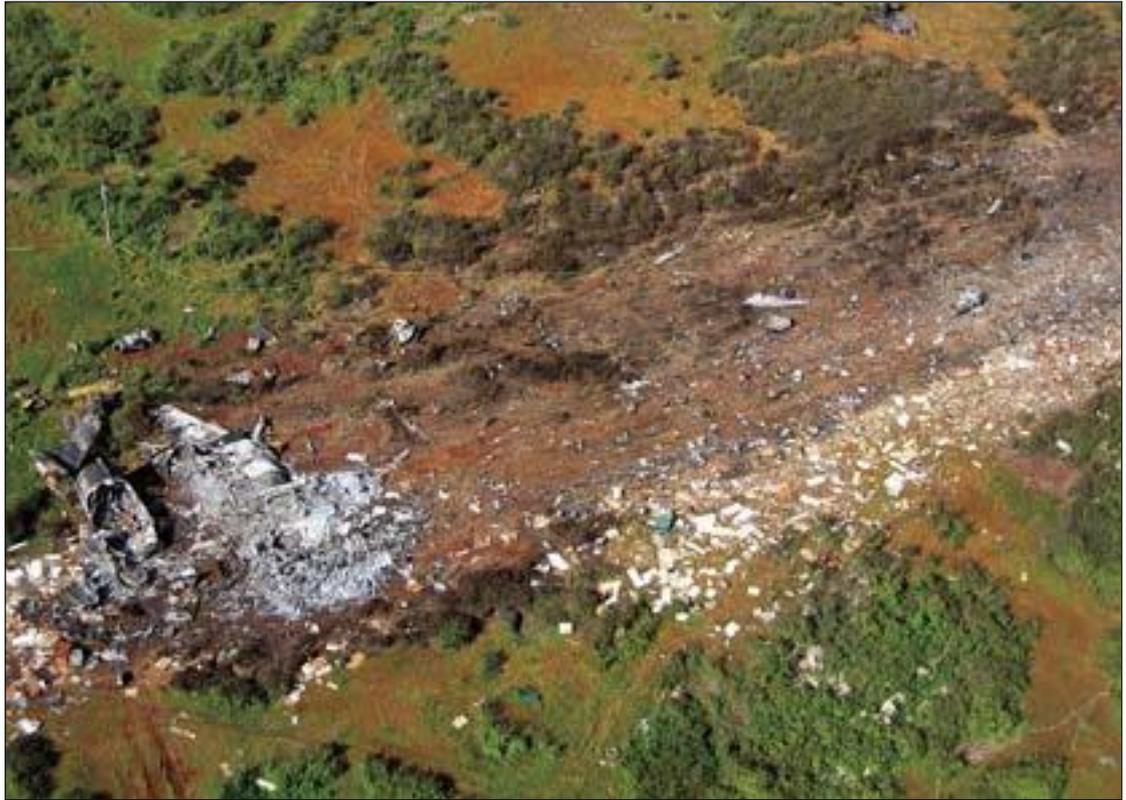
FIGURE 27:
Main wreckage area

The main part of the right and left wings and the wing carry-through structure were found in the correct context but in an inverted position about 190 m (623 ft) beyond the left wing tip light fragments (see Figure 27).

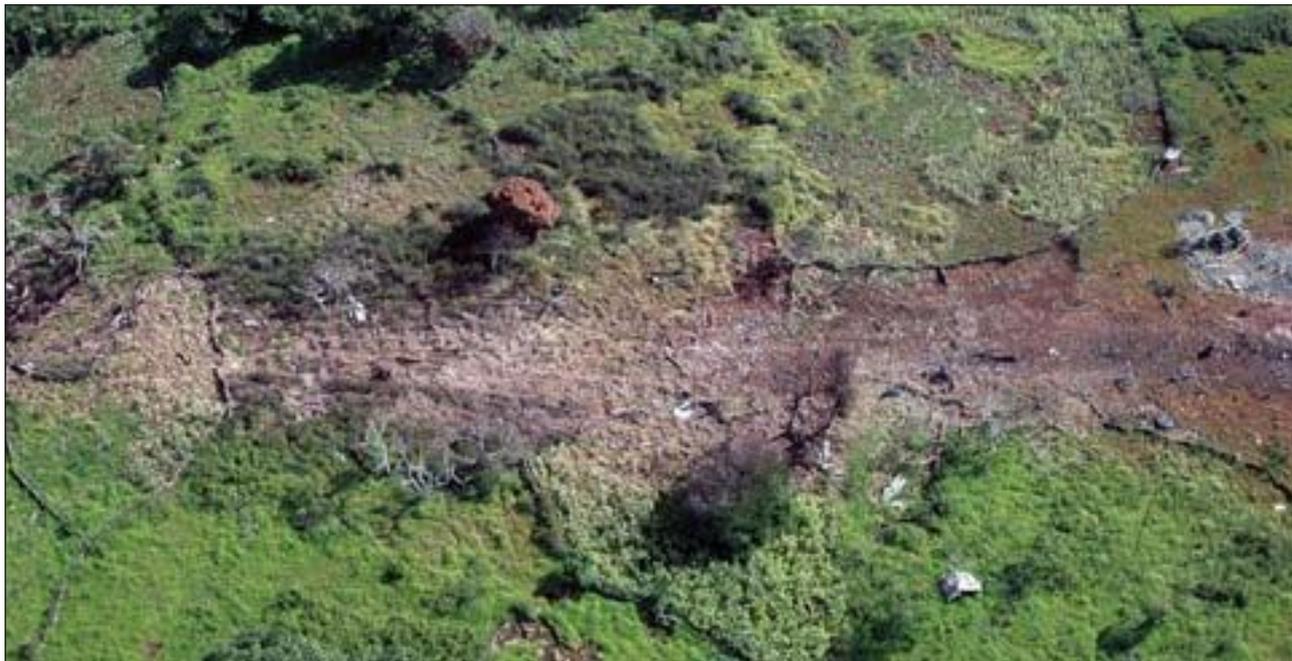
FIGURE 29:
Chemical damage from fuel spillage

Crops near the wreckage trail were also damaged from a combination of turbine fuel, which sprayed from the aircraft fuel tanks as they ruptured during the impact sequence, and from the post-impact fire.

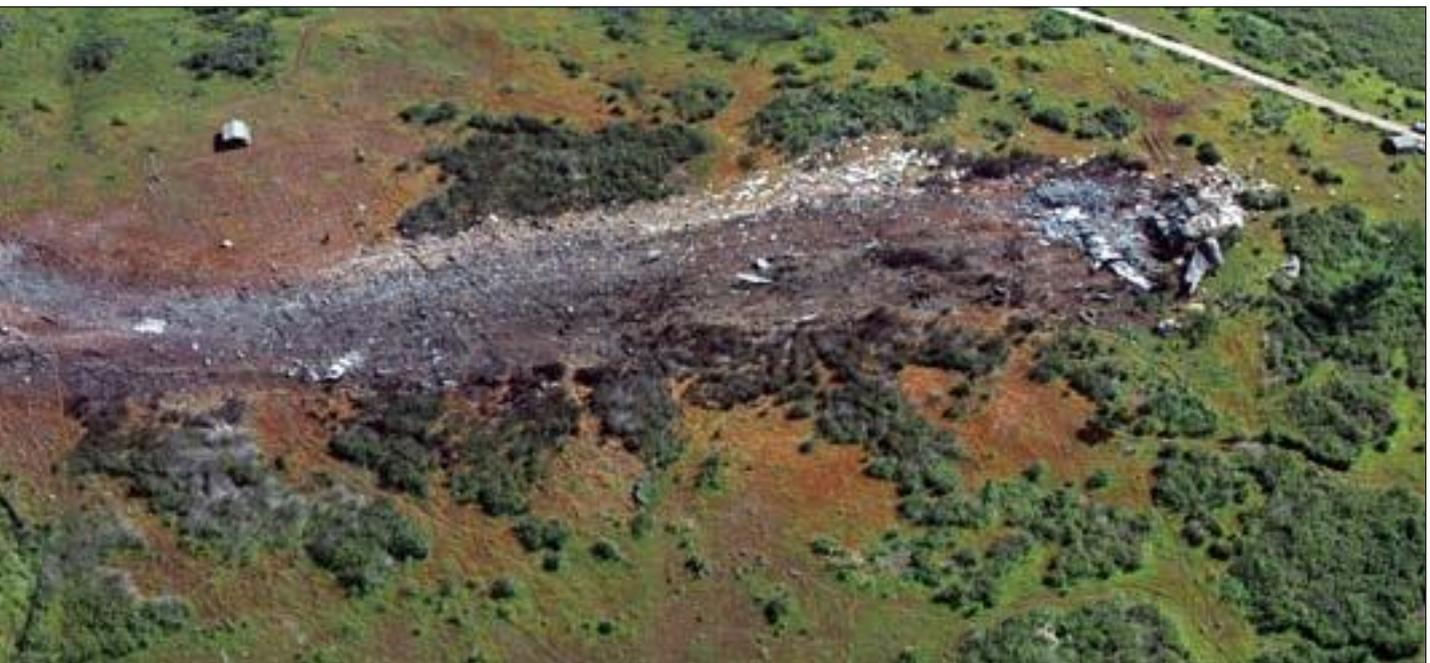
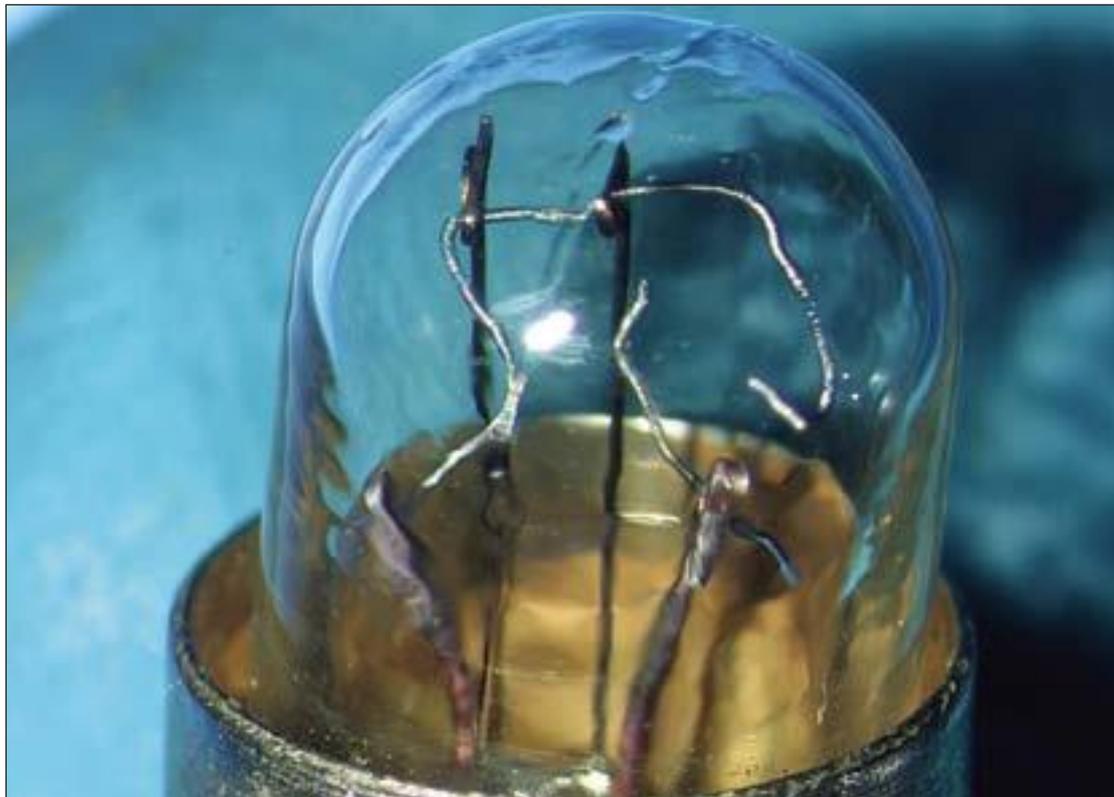
FIGURE 30:
Damaged light bulb filament from the PB-150 radio altimeter indicator

The glass face of the indicator was undamaged, however the rear part of the instrument casing had been damaged, and the gear train assembly within the instrument was not intact. The reference bug adjustment knob was jammed due to damage, and could not be rotated to move the bug. The small light bulb located behind the amber lens inscribed with the delta (Δ) symbol on the reference bug adjustment knob was removed and examined to determine whether it was illuminated at the time of impact (see Figure 30).

The globe envelope was unbroken, and displayed no signs of discolouration. The bulb filament was not severely stretched, and was fractured in one location. The coils had remained mostly symmetrical, and showed little evidence of gross stretch or distortion. The filament was also only slightly elongated.

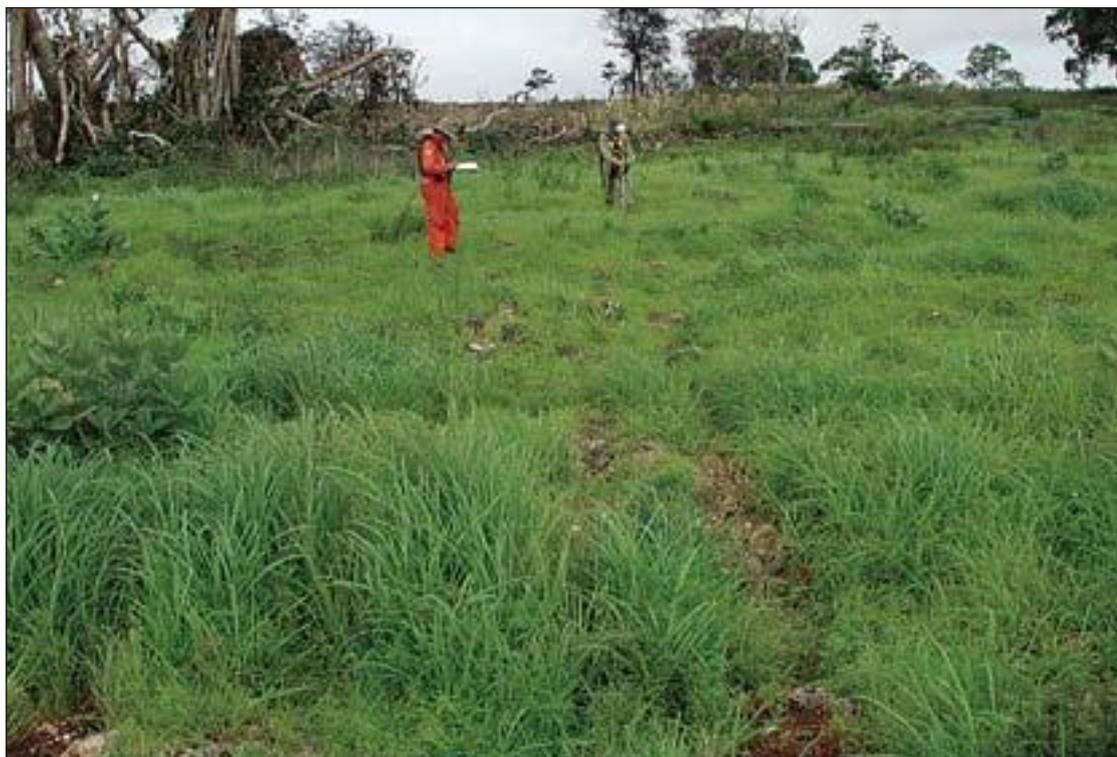
FIGURE F.1:
Witness scars at the first point of ground contact

The distance between ground witness marks indicated that they had been produced by one of the main landing gear bogies. The impressions in the ground also indicated that the aircraft had been in a slightly nose-up attitude during the period that the main landing gear bogie was in contact with the ground. That notion was substantiated by the fact the ground marks were of an even depth along the rising ground, and by the fact that there was no evidence of contact with the ground by the nose landing gear.

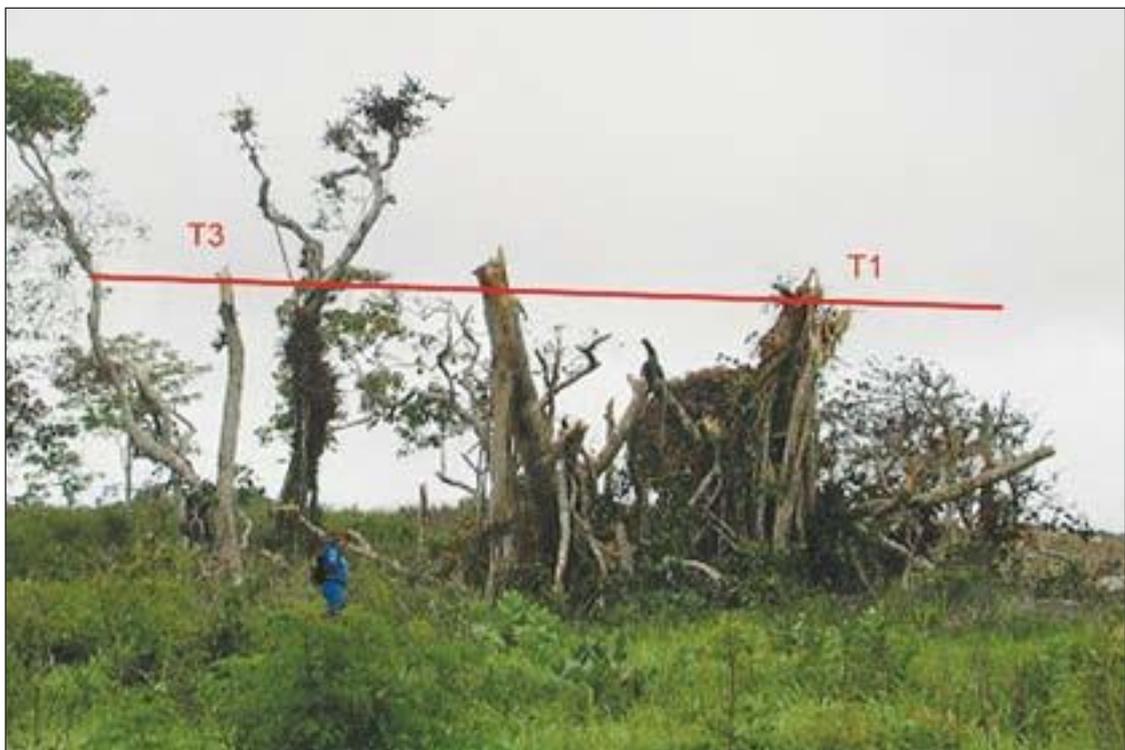
FIGURE F.2:
Impacted trees

Under those circumstances, the perpendicular distance between the left main landing gear bogie and tree T1 when it was abeam that tree would have been 11 m. That would have resulted in the left wing striking tree T1 just outboard of the outboard engine (engine number-1). The furthestmost damaged tree, T3, would therefore have been struck by the left wing about 1 m inboard from the wing tip. That was consistent with a piece of the outboard aileron and various other pieces of the wing having been found directly under the trees. Engine fan blades were also found in the vicinity of the trees and extending away from the trees in the direction in which the aircraft had travelled.

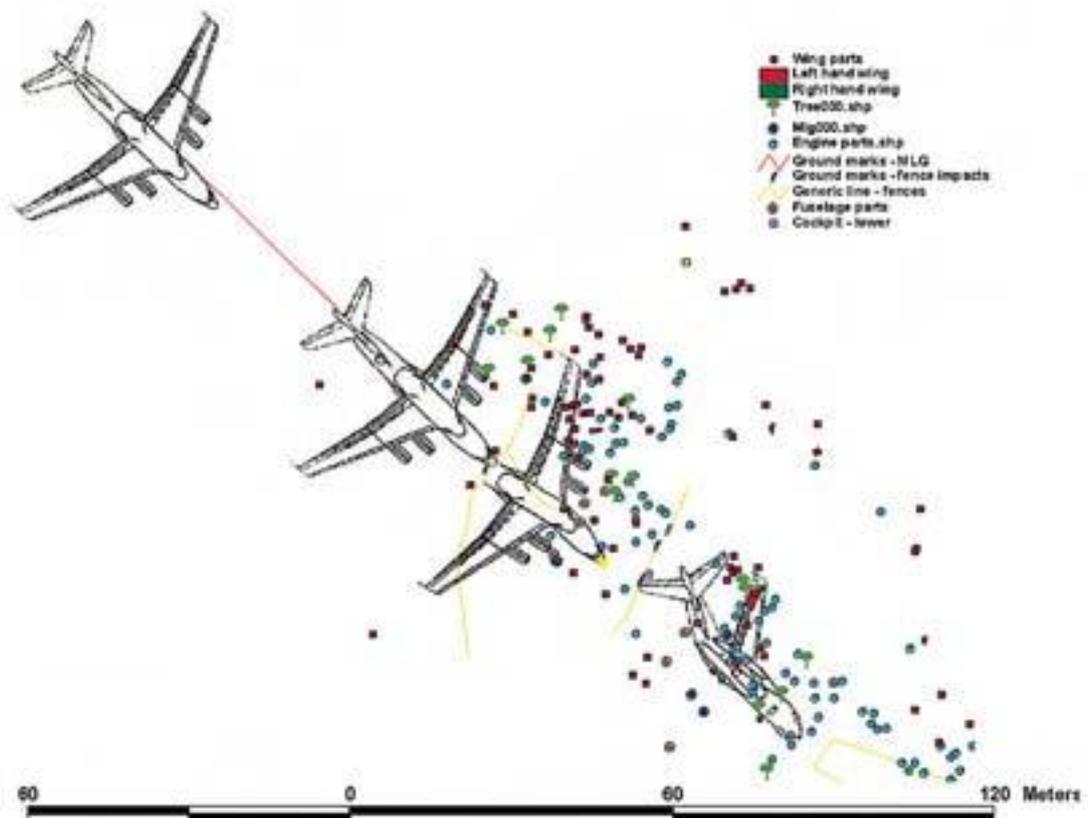
FIGURE F.3:
Initial break-up sequence

The airframe would have experienced considerable structural loads because of the deceleration force when the left wing impacted the trees, and from the resultant sudden and violent yaw to the left. The combination of those structural loads, asymmetric aerodynamic lift, and the subsequent roll to the left, seems likely to have initiated the partial separation of the aft-most fuselage section from the main body of the aircraft.
