Uncontrolled pressurisation change involving Boeing 737, VH-XMO

near Melbourne Airport, Victoria, 6 July 2021

Aviation Occurrence Investigation (Short)

AO-2021-030

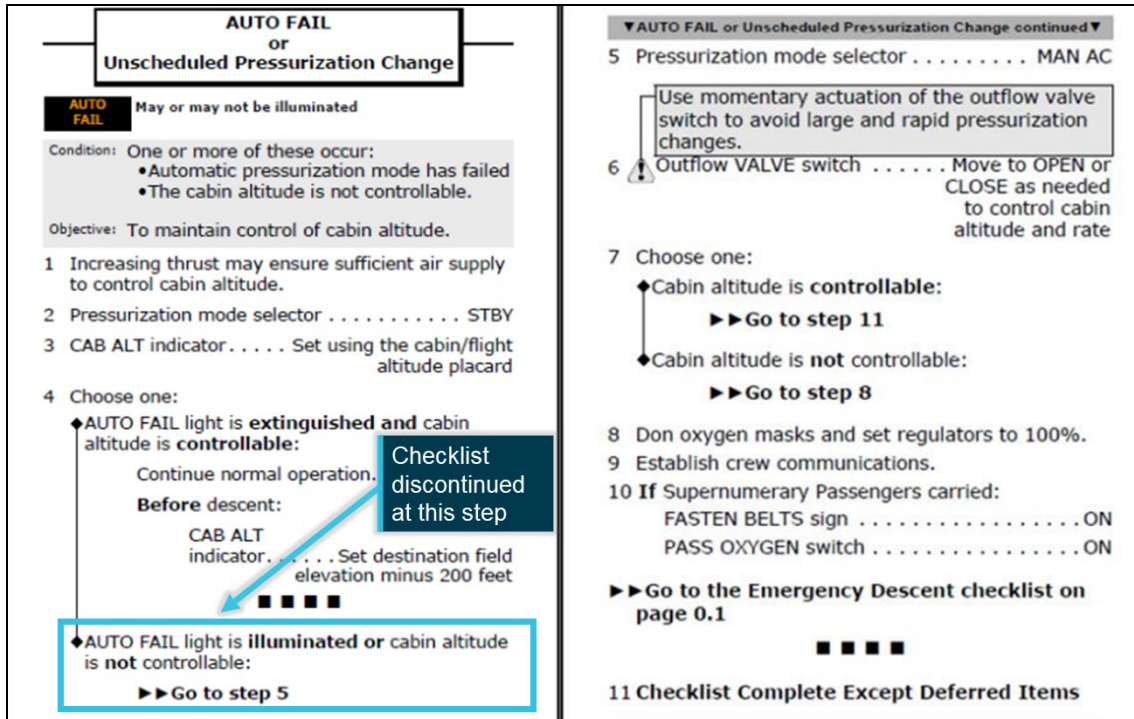
Figure 1: Non-normal checklist

The flight crew consulted the quick reference handbook (QRH)⁴ and conducted the non-normal checklist⁵ procedure for an 'AUTO FAIL or Unscheduled Pressurization Change' (Figure 1). The flight crew conducted the non-normal checklist up to and including step four and noted that the AUTO FAIL light had extinguished but the cabin pressure was not controllable.

The flight crew completed the steps up to and including step four and determined that the cabin altitude was not controllable. The flight crew elected to discontinue the non-normal checklist at this stage due to the aircraft already having depressurised, and being at 4,000 ft on the approach to land.

The ATSB assessed that the decision by the flight crew to suspend the non-normal checklist at 4,000 ft was appropriate due to the aircraft being already depressurised and on approach to land.

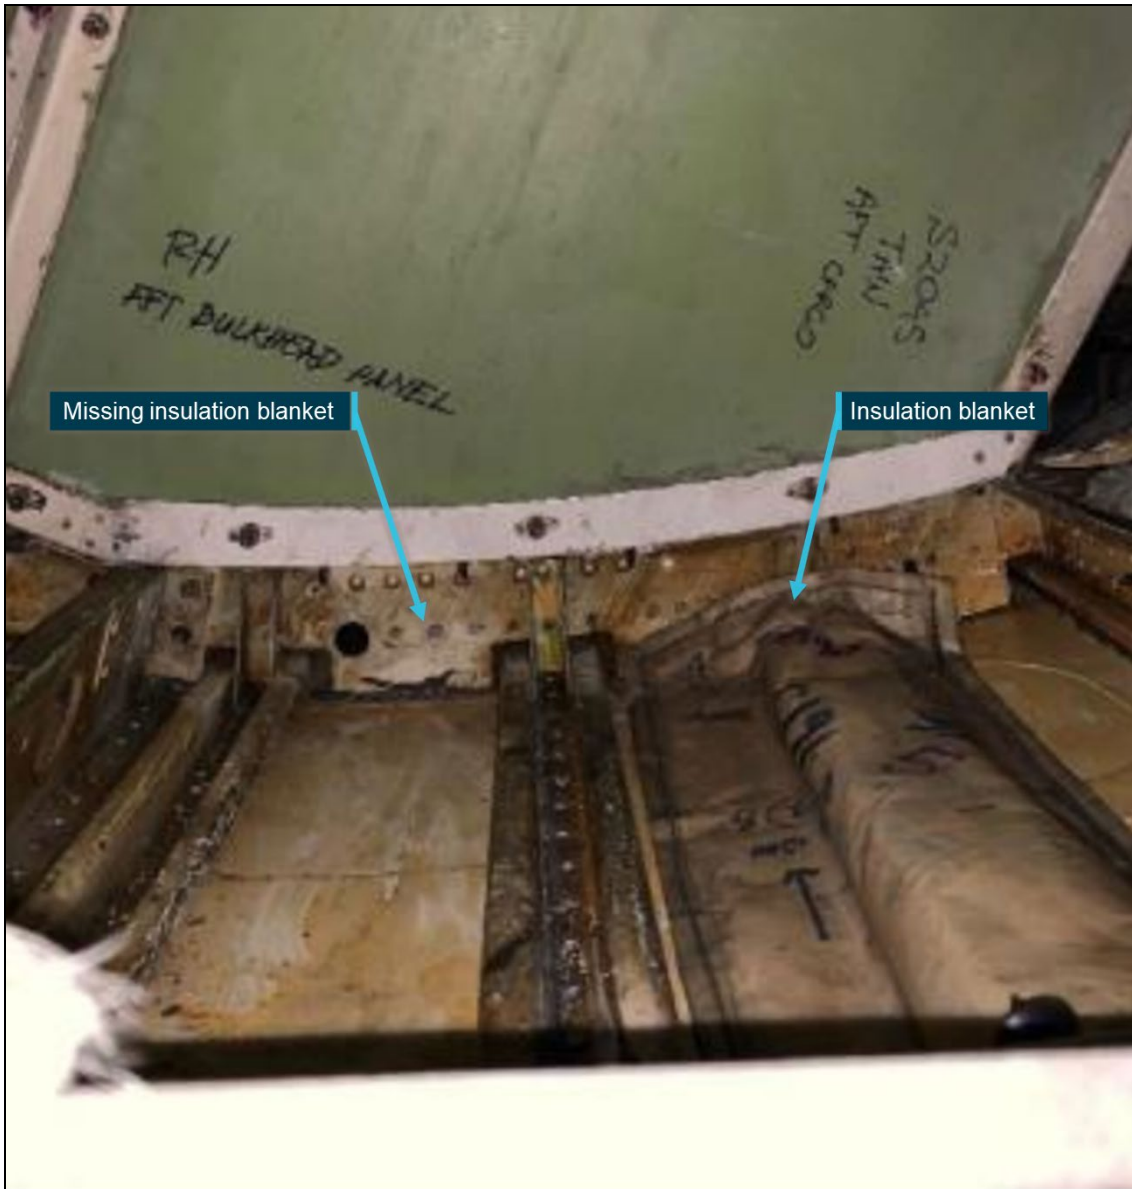
Figure 2: Missing insulation blanket aft cargo bay

After landing, the captain contacted engineering control to discuss the occurrence and completed an entry in the aircraft’s technical log. Engineering personnel conducted internal and external inspections of the aircraft including the cargo compartments and the main outflow valve. The engineering inspections revealed multiple aft cargo bay insulation blankets were either missing (Figure 2), installed incorrectly or unsecured and one had been partially ejected from the main outflow valve (Figure 3).

During post occurrence troubleshooting and inspections, the engineers discovered multiple aft cargo bay insulation blankets either installed incorrectly, damaged, unsecured or missing. This included an insulation blanket protruding from the main outflow valve, inhibiting its operation. As part of the post occurrence rectifications, the engineers correctly orientated and installed new blankets where required.

Prior to XMO's return to service, engineers replaced the main outflow valve assembly, the main outflow valve heater gasket, multiple insulation blankets, and multiple insulation blanket stand-offs. Correct orientation of the aft cargo bay insulation blankets was also carried out as required.

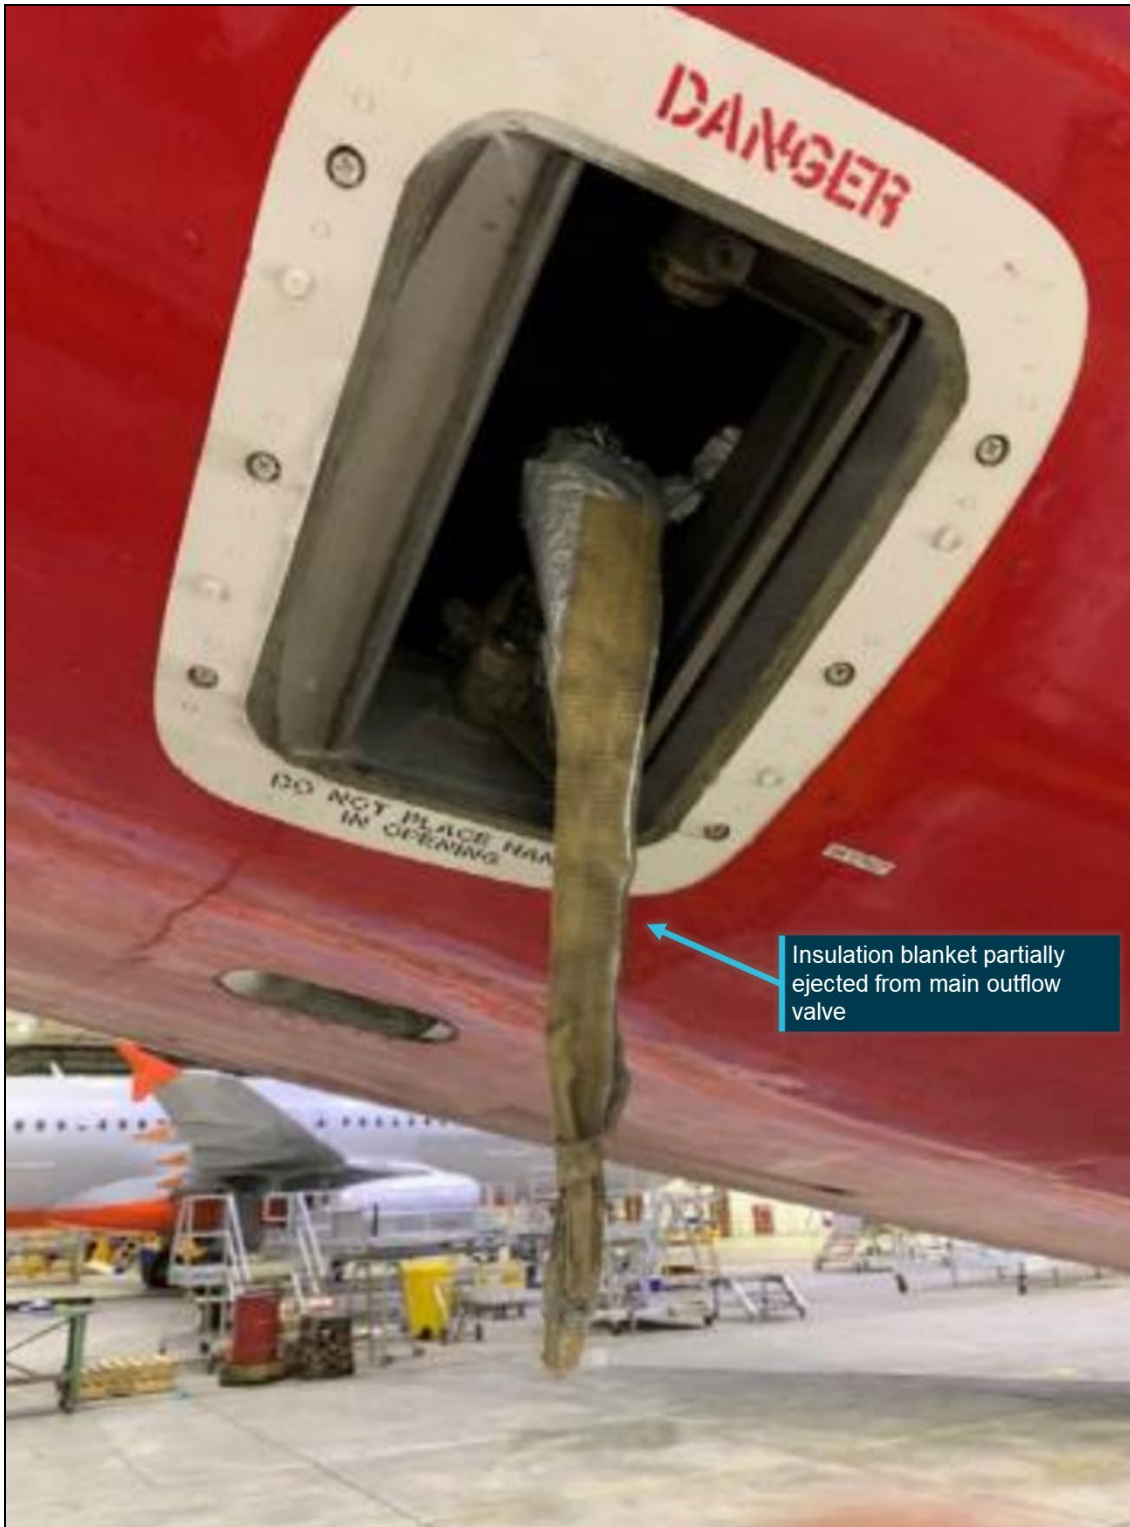
Figure 3: Main outflow valve after occurrence

The ATSB found that an aft cargo bay insulation blanket had not been secured correctly during a previous maintenance activity. During the descent, the unsecured blanket became lodged in the main pressurisation outflow valve, inhibiting its ability to control aircraft pressurisation.

During descent, the main outflow valve modulates increasing cabin pressure as ambient air pressure increases. It is possible that the failure of the main outflow valve heater gasket, identified by engineering personnel after the occurrence, resulted in the valve freezing in the closed position. As the aircraft descended into warmer air, the valve may have thawed resulting in its sudden opening and observed ingestion of the unsecured insulation blanket.

However, with the main outflow valve operation inhibited, it was unable to modulate allowing an unrestricted venting of pressurised cabin air. This resulted in the inability to control the aircraft's cabin pressure reported by the flight crew.

- An insulation blanket in the aft cargo bay was incorrectly secured leading to it coming adrift and inhibiting the main outflow valve operation. This resulted in uncontrolled pressurisation changes in the aircraft.

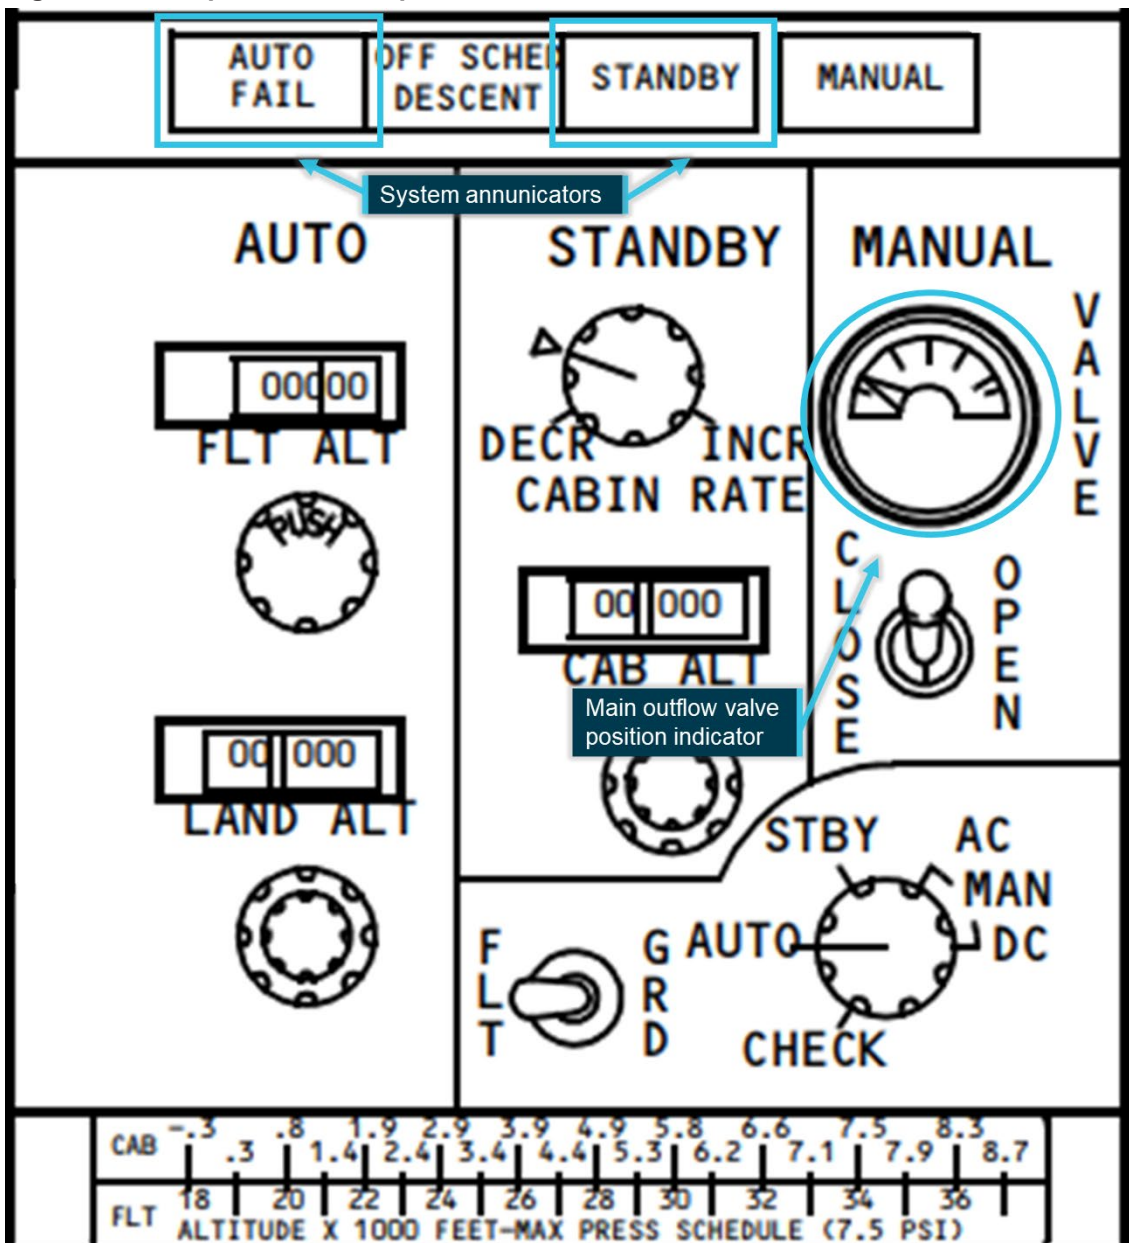
Figure 5: Cabin pressurisation panel

At about 1453, the flight crew commenced their planned descent to Melbourne Airport. While descending through 8,000 ft, the AUTO FAIL and STANDBY annunciator lights illuminated on the pressurisation panel (see the section titled *Pressurisation system* and Figure 5). The flight crew reported feeling a rush of cold air and a soreness in their ears. The flight crew also observed the cabin differential pressure³ gauge reading zero and the main outflow valve position indication gauge reading approximately 50 per cent open.

One of four conditions is required to illuminate the AUTO FAIL annunciator on the pressurisation panel. The pilots reported a rush of air and a soreness in their ears, indicating that an ‘excessive rate of cabin pressure change (1,890 sea level ft/min)’ was probably detected by the cabin pressure control system resulting in the illumination of the AUTO FAIL annunciator. The STANDBY annunciator illuminated due to the pressurisation system unable to automatically operate and switching to the STANDBY mode of operation.
