Flight below minimum altitude involving Aero Commander 500-S, VH-LTP

near Adelaide Airport, South Australia, on 12 August 2021

ATSB Transport Safety Report

AO-2021-033

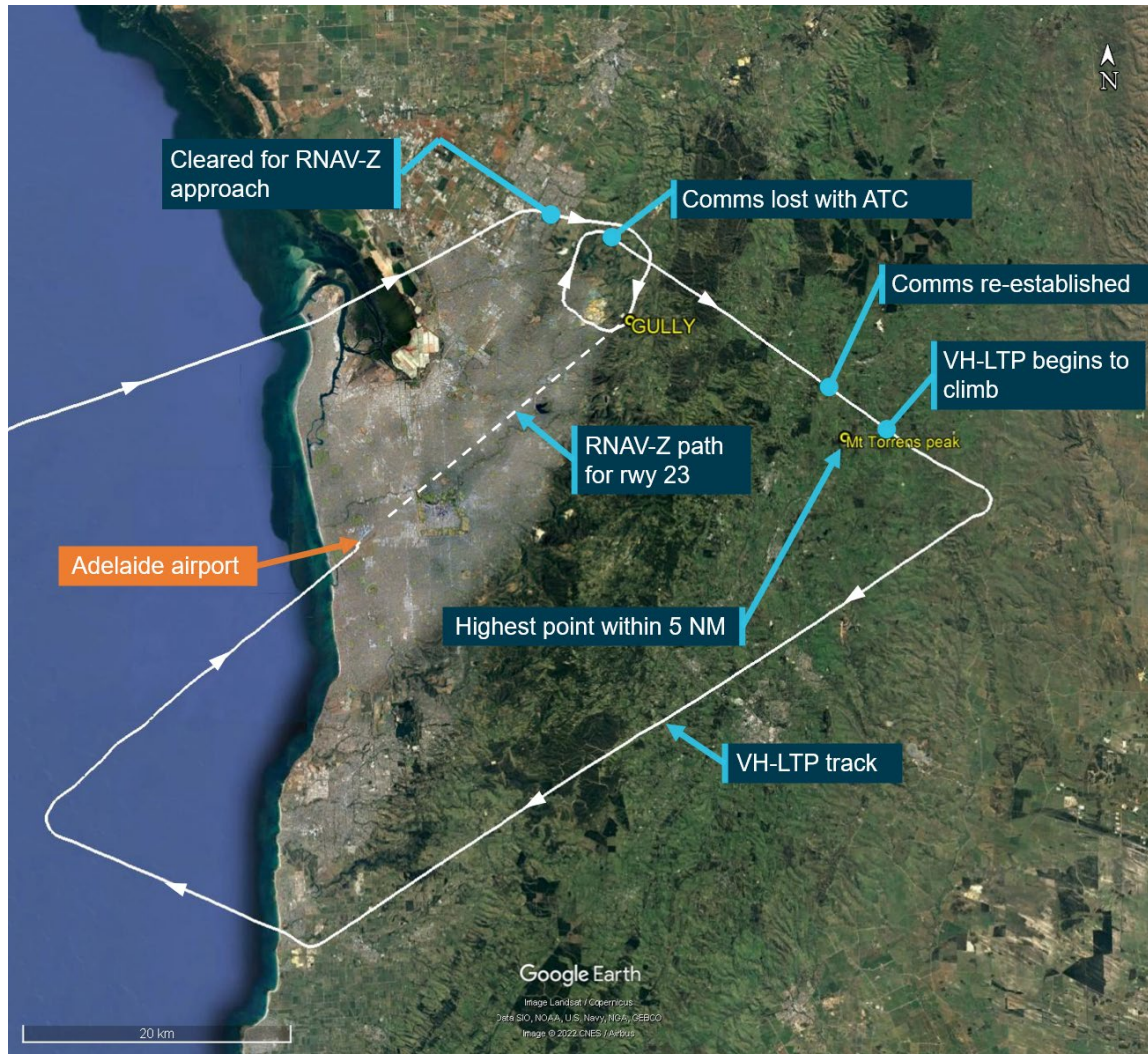
Figure 1: VH-LTP flight path (dotted line shows RNAV instrument approach path)

The pilot began tracking to GULLY and reported having difficulties entering the RNAV approach details into the aircraft's touchscreen multi-function display (MFD) due to the turbulence. By the time the pilot had correctly entered it, the aircraft had just passed the GULLY waypoint and when the pilot then selected the 'Direct-To' option on the display, the autopilot commanded a sharp turn to the right, to orbit back around to recapture the waypoint (Figure 1).

Observing the aircraft's track away from the waypoint, the controller, at 0951, advised the pilot they had missed the approach and instructed them to maintain 3,800 ft. They then instructed the pilot to turn right on a heading of 360° and to expect vectors back to GULLY. After turning to the assigned heading, the aircraft started a gentle climb. At 0953, the controller instructed the pilot to turn right onto heading 120° and to expect a clearance to navigate to GULLY shortly. The pilot correctly read back the clearance and later recalled having commenced a descent, realising the aircraft was then above the assigned altitude. This was the last radio call the pilot received from the Adelaide Approach controller before the pilot inadvertently switched the radio frequency back to Melbourne Centre.⁵

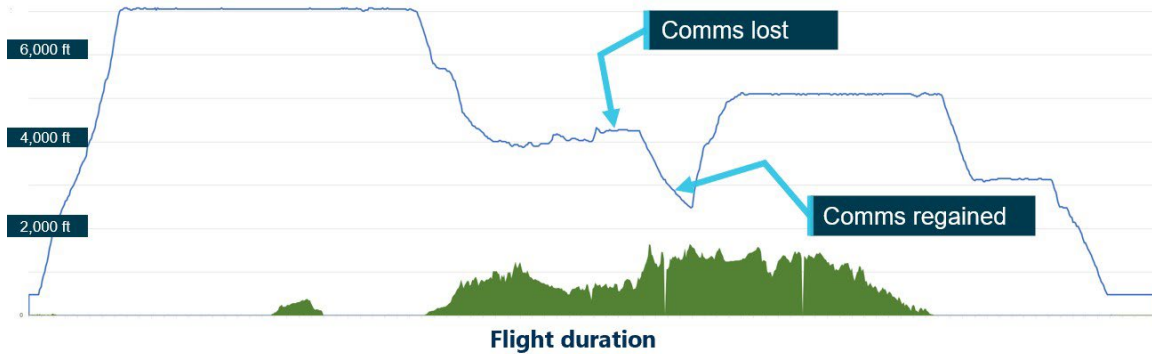
Figure 2: VH-LTP’s altitude relative to the terrain (in feet)

After observing no increase in the aircraft's altitude for almost 1 minute, the controller contacted the pilot and asked them to confirm climbing to 5,000 ft. The pilot confirmed and the aircraft began to climb. The lowest altitude the aircraft descended to was 2,480 ft, the highest point within 5 NM of the aircraft's track was 1,913 ft (Figure 2).

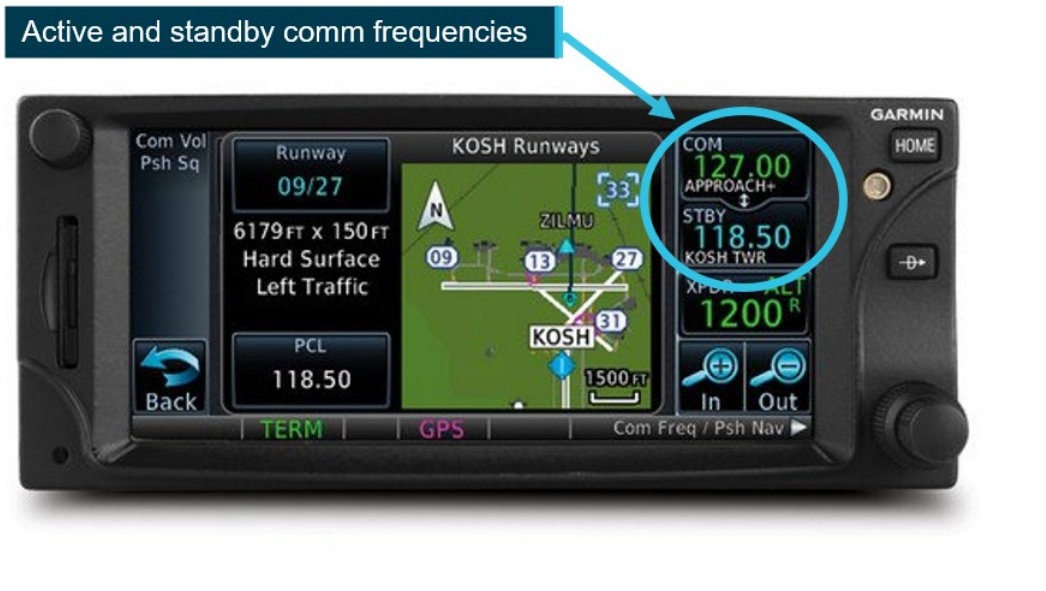
Figure 3: Garmin GTN 650 display screen

The pilot reported that when operating in turbulent conditions, they usually put two fingers on the side of the display to stabilise their hand and use their thumb to enter the data. After missing the initial approach fix, and during the second attempt to enter the waypoint into the MFD, the pilot reported that their finger slipped and inadvertently selected the Melbourne Centre frequency, which was the previous frequency selected.

The pilot's data entry difficulties were consistent with the research conducted on touchscreen interfaces. During turbulent conditions, aircraft touchscreen interfaces have been known to increase data input errors and create slow interaction times. This is due to the display moving or vibrating independently of the pilot's body, which is itself also vibrating. A study conducted by Dodd and others (2014) found that while operating in moderate turbulence, it took pilots over 2 minutes longer to complete a given task when compared to operating in no turbulence. Although necessary when operating in turbulent conditions, stabilising the hand on the edge of the screen can also increase the risk of accidental presses on the edge of the screen (Coutts and others, 2019).
