# Collision with terrain involving a Rockwell International 114, VH-WMM

1 km north of Redcliffe Aerodrome, Queensland, on 19 December 2021

**ATSB Transport Safety Report**

AO-2021-053

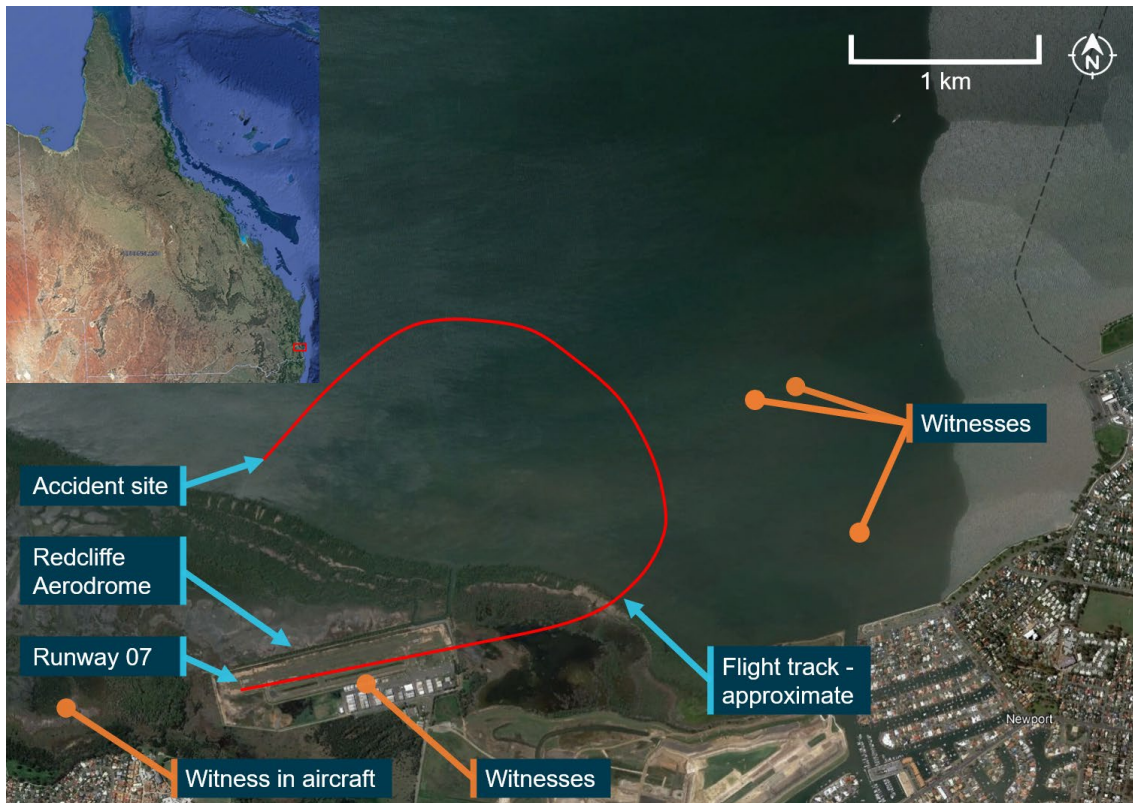
**Figure 1: Redcliffe Aerodrome and VH-WMM approximate flight path and accident site**

A number of witnesses located at the aerodrome, on the water in pleasure craft, and in other aircraft, observed VH-WMM (Figure 1). Witnesses at the aerodrome stated that, after VH-WMM took off from runway 07,<sup>2</sup> the landing gear was retracted and, a short time later, the engine ran rough for a brief period before stopping completely.

According to witnesses, the pilot of VH-WMM made 2 left turns, which were consistent with manoeuvring the aircraft back toward the western end of runway 07. During the return to the aerodrome, the pilot extended the landing gear. Description of the flight from the witnesses was consistent with controlled flight during this period.

As the aircraft neared the mangrove tree line to the north of the aerodrome, it was observed to descend and ditch into the water, about 170 m from the shoreline. During the ditching, the aircraft flipped over, coming to rest inverted in about 2 m of water.

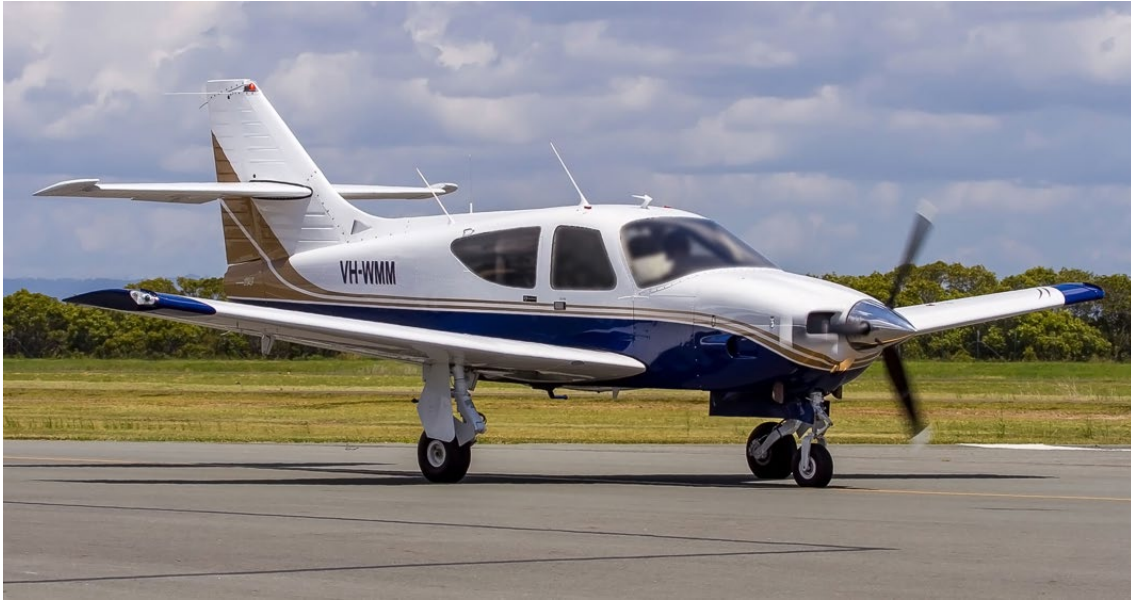
**Figure 2: VH-WMM**

The aircraft type has 2 doors for pilot and passenger access, one on each side at the front of the aircraft cabin (Figure 2).

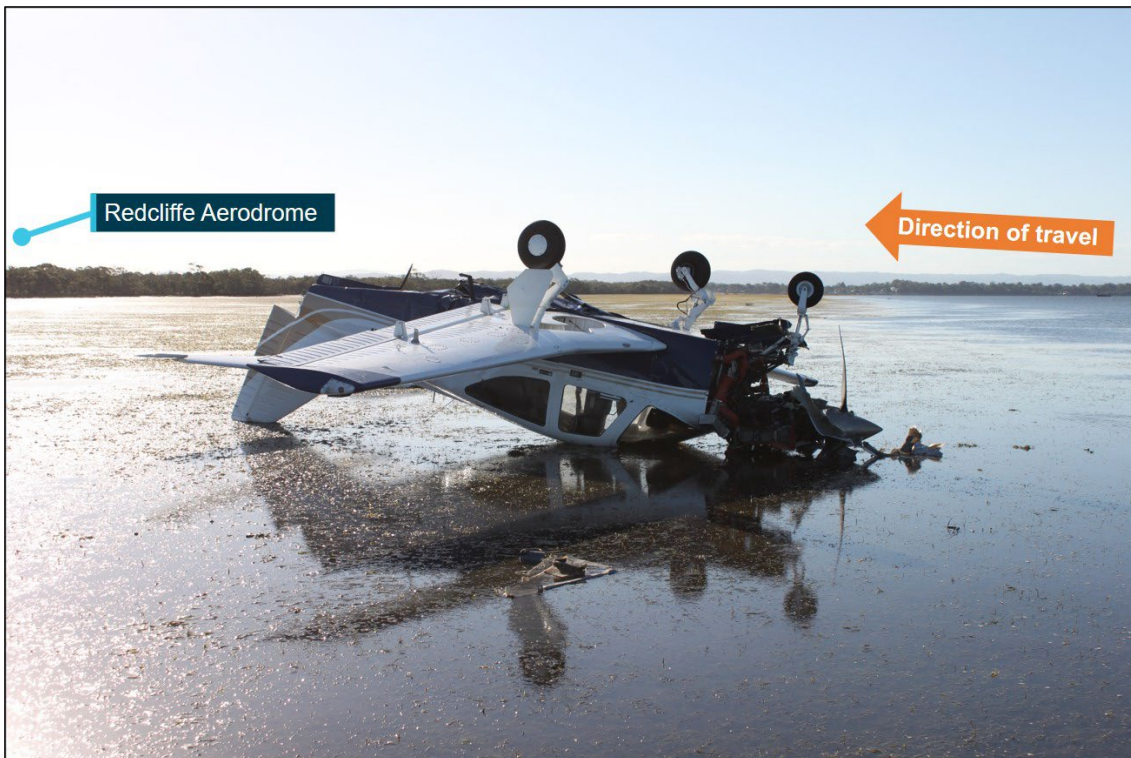
**Figure 3: VH-WMM accident site at low tide**

The wreckage was located about 1 km north of the Redcliffe Aerodrome, on a tidal flat (Figure 3). The accident occurred about 40 minutes before high tide, and the water depth at the time of the accident was about 2 m.

The aircraft had impacted the water in a slight nose-down and upright attitude with the landing gear in the extended position. After contacting the water, the aircraft flipped over in the direction of travel, resulting in the aircraft being inverted.

The impact had torn the engine from its mounts and there was structural damage to the fuselage underside and right wing. Fuel was leaking from the right underwing fuel vent, and a strong fuel smell was evident at the site. The flaps were in a retracted position at the time of the accident.

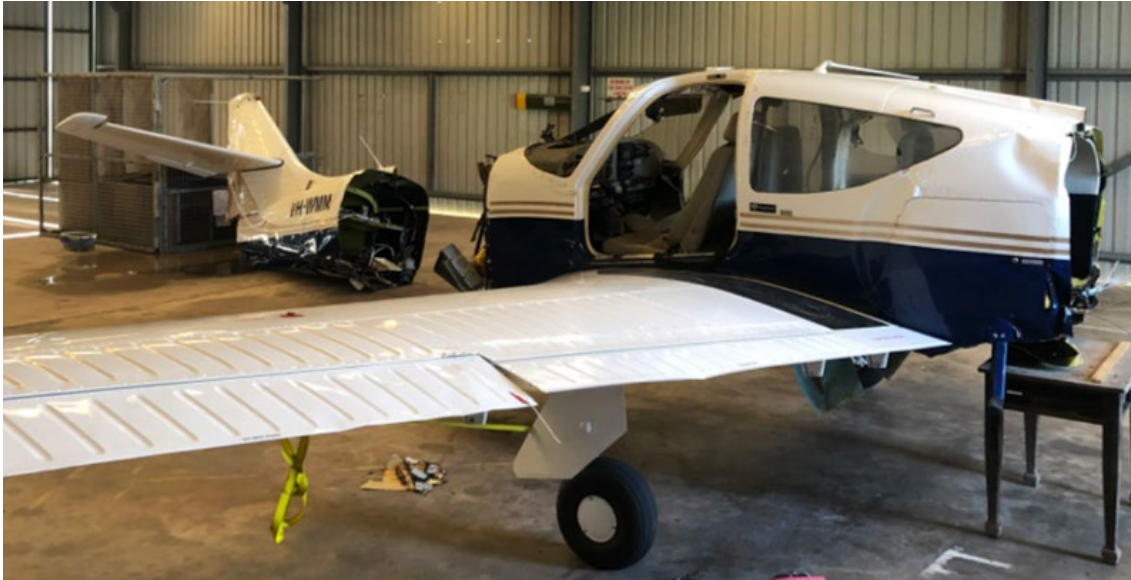
**Figure 4: VH-WMM recovered for examination**

A marine salvage company recovered the aircraft the following morning on high tide and, after floating the wreckage to the Scarborough boat ramp, it was transported to a secure storage facility for a detailed examination (Figure 4). Removal of the rear fuselage and engine was carried out to necessitate transportation by road.

- all components of the aircraft were accounted for at the accident site
- no pre-impact defects were identified
- a quantity of fuel was removed from the aircraft
- the engine and propeller were able to be rotated.
