Landing gear malfunction involving Airbus A320, VH-VFN

Sydney Airport New South Wales on 1 August 2019

ATSB Transport Safety Report

AO-2019-039

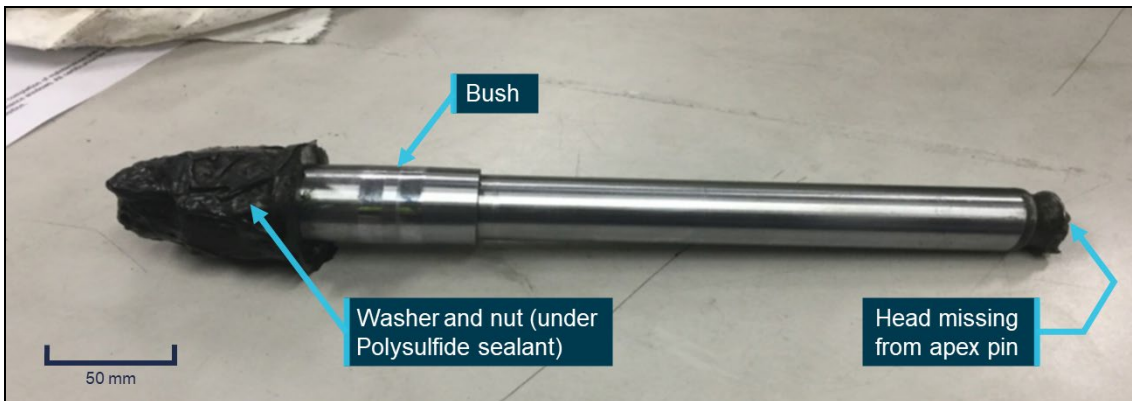
Figure 2: Apex pin as recovered from taxiway

At 1042, Ground simultaneously contacted two Jetstar aircraft taxiing for take-off. They were instructed to contact their engineering department as 'one of the safety officers has found a large piece of metal at the juncture of Bravo 4 and Charlie and it is believed to be from a Jetstar 320...'.⁶

At the same time, the Sydney Departures controller (Departures) informed the flight crew of VH-VFN of a 'large piece of metal' found on a taxiway. The flight crew then told Departures they required a return to the airfield. In a follow up discussion a minute later, Departures informed the flight crew 'they believe it might be a part of the landing gear' to which the captain responded, 'that would make sense'. Shortly after the aircraft entered a holding pattern off the coast.

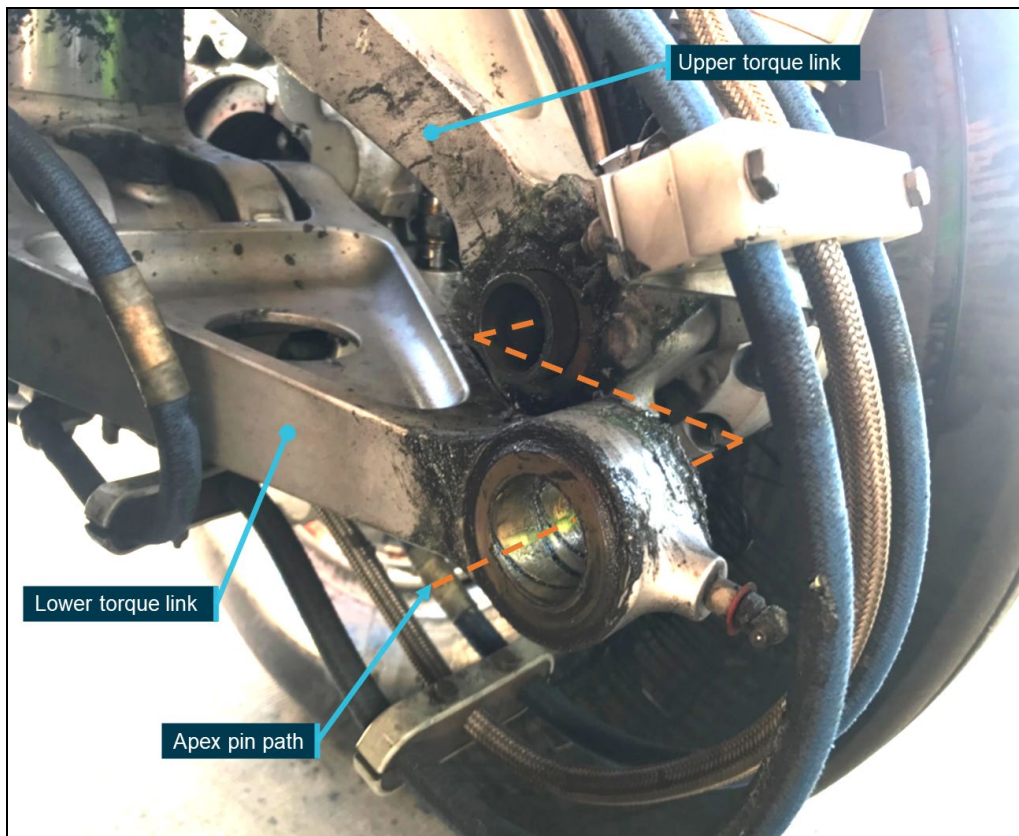
Figure 3: Main landing gear torque link assembly upon landing

The aircraft was then taxied on taxiway B to just short of taxiway B4 where Line Maintenance personnel inspected the MLG. The inspection found the left MLG¹⁰ torque link apex pin was missing along with two bolts from the associated damper unit (Figure 3). A brake hydraulic hose was also frayed to the point of allowing fluid to escape. The aircraft was then slowly towed to the gate.

After passenger disembarkation, the aircraft was to be towed to a hangar for inspection and repair. To reduce the potential for further damage, and as no spare apex pin was available, the failed pin was reinstalled and temporarily secured in place to ensure the landing gear stayed correctly aligned.

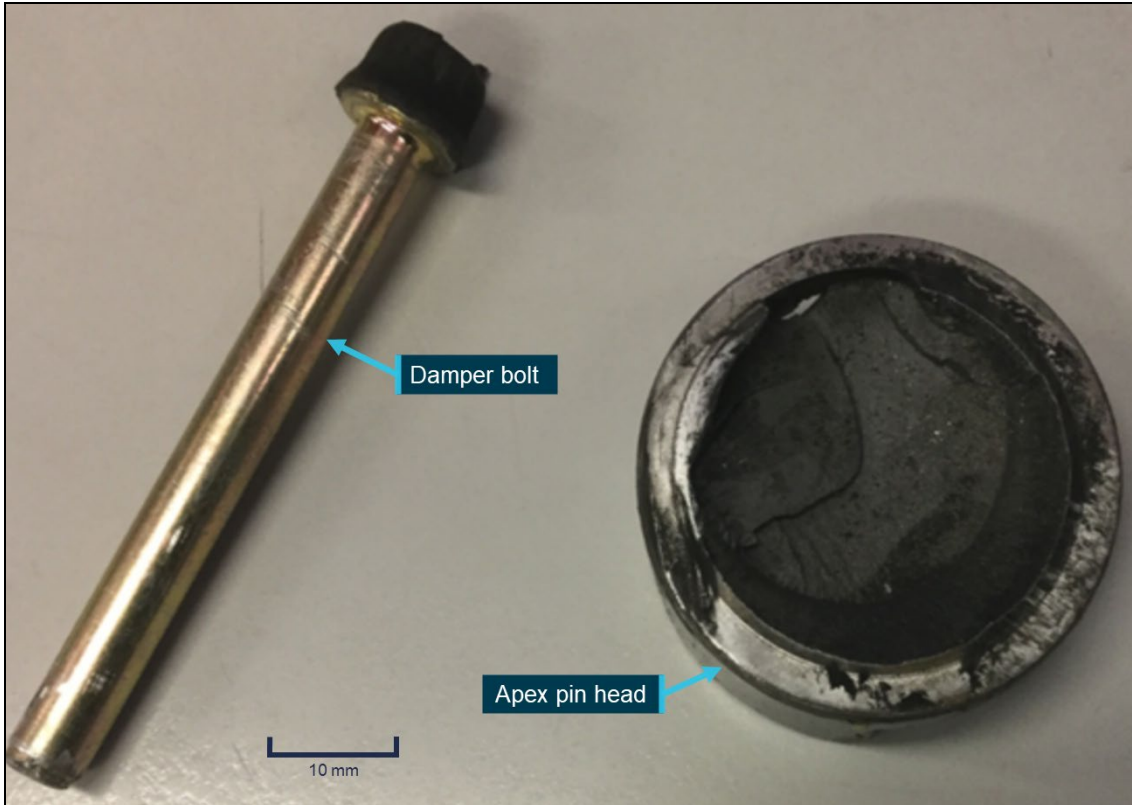
Figure 4: A damper bolt and head of apex pin retrieved from runway 34R

The following afternoon, the missing head of the apex pin and one damper bolt (Figure 4) were found by airport staff adjacent to the T3 intersection of runway 34R. Fifteen days later the second missing damper bolt was found during a routine FOD inspection of runway 34R.

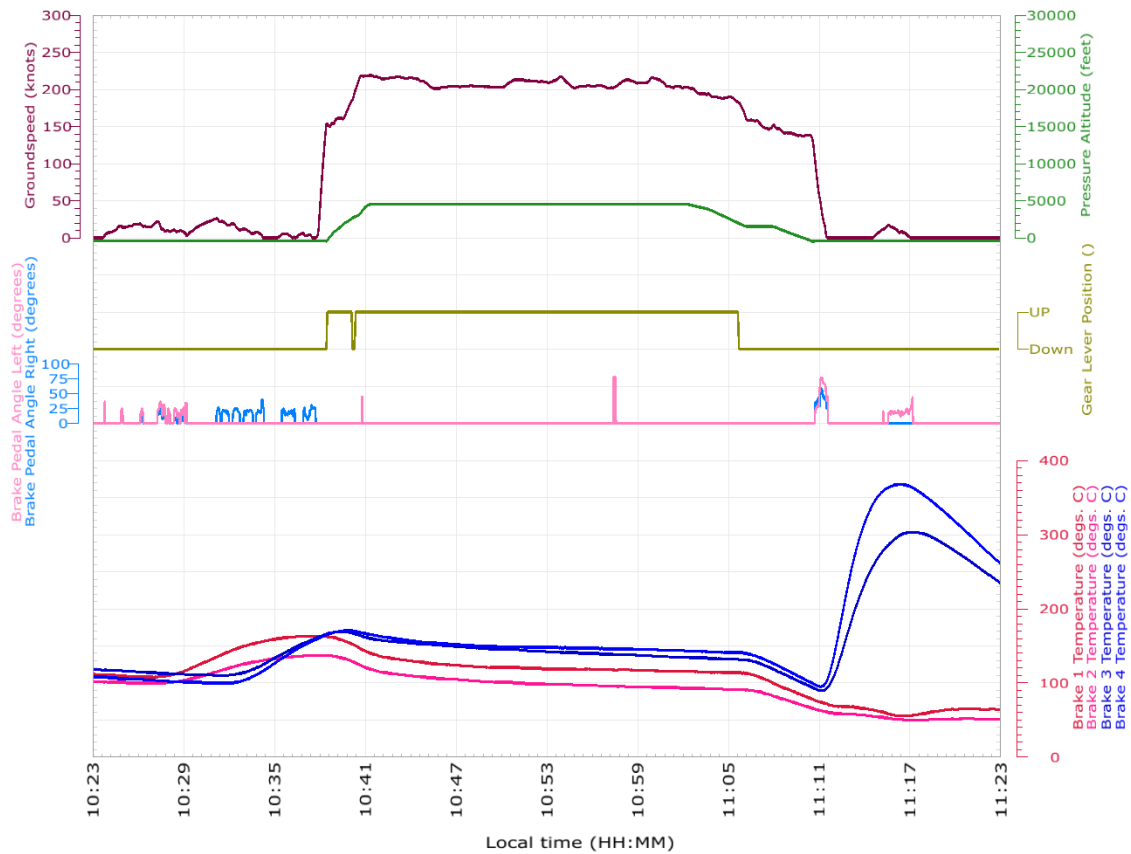
Figure 5: Recorded data for the complete flight

Quick Access Recorder (QAR) data (Figure 5) was retrieved from VH-VFN for the incident and prior flights. A review of the data from the previous two flights did not identify any anomalies.

During the initial climb on the incident flight, the aircraft did not successfully complete a full undercarriage retraction sequence, with the aircraft failing to sense the MLG up locks engaging and the gear doors closing. Approximately 90 seconds later the undercarriage extension/retraction was cycled with the landing gear being selected down successfully and then reselected up. Again, the aircraft failed to record a complete retraction of the MLG.

QAR data also showed that, on the taxi to the departure runway, left and right wheel brake applications were matched by temperature rises in the corresponding brakes. This was indicative of the brakes working correctly. On landing, despite application of both brakes, only the right wheel brake temperatures rose while the left brake temperatures continued to cool, implying the left wheel brakes were not functioning.

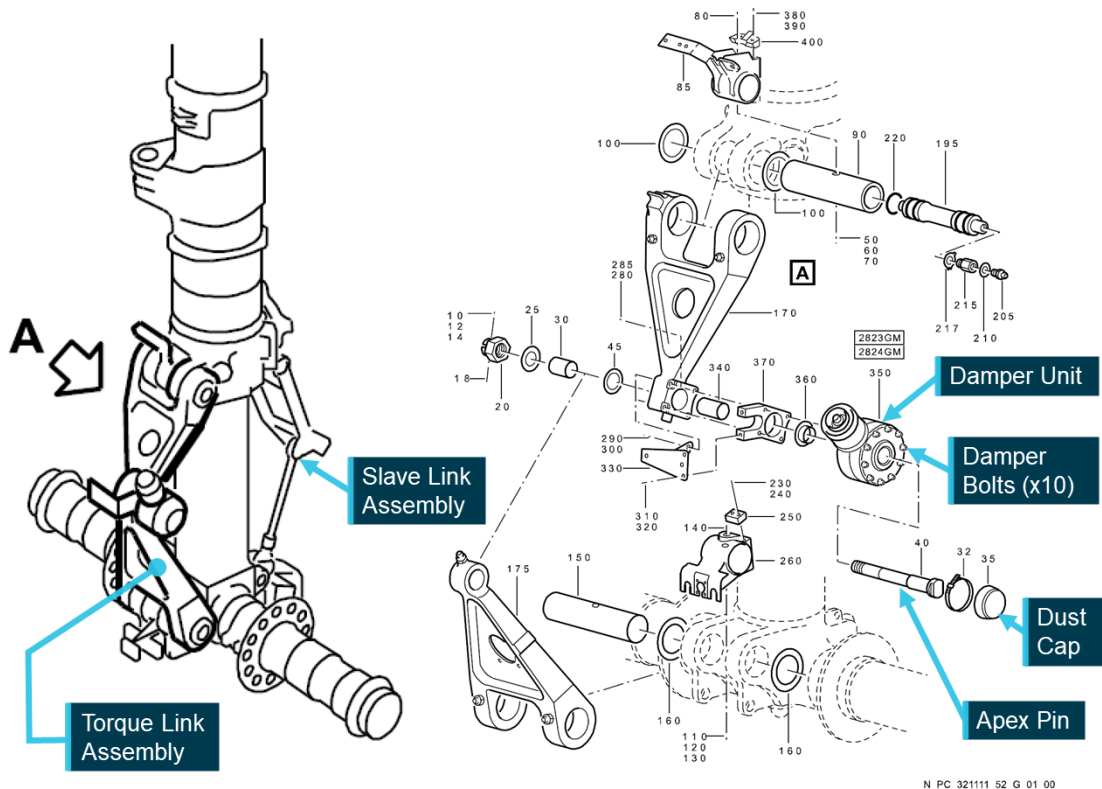
Figure 6: MLG assembly and exploded torque link assembly

The apex pin also passes through a damper unit that attaches to the upper torque link. The head of the pin is protected from the environment by a rubber dust cap. The tail of the pin, nut, washer and locking pin assembly are protected by a coating of polysulfide sealant.

Detailed inspection of the aircraft MLG after the flight determined that, in addition to the failed apex pin, other items on the MLG were missing or damaged. These included:

- three hydraulic hoses damaged or frayed by contact with the wheel rim, with one hose leaking
- scoring damage to the apex damper unit following contact with the wheel rim and tyre, and two missing through bolts
- scoring damage to wheels, tyres and brakes from contact with the upper torque link and damper unit
- a cut wiring harness
- bending of the slave link.

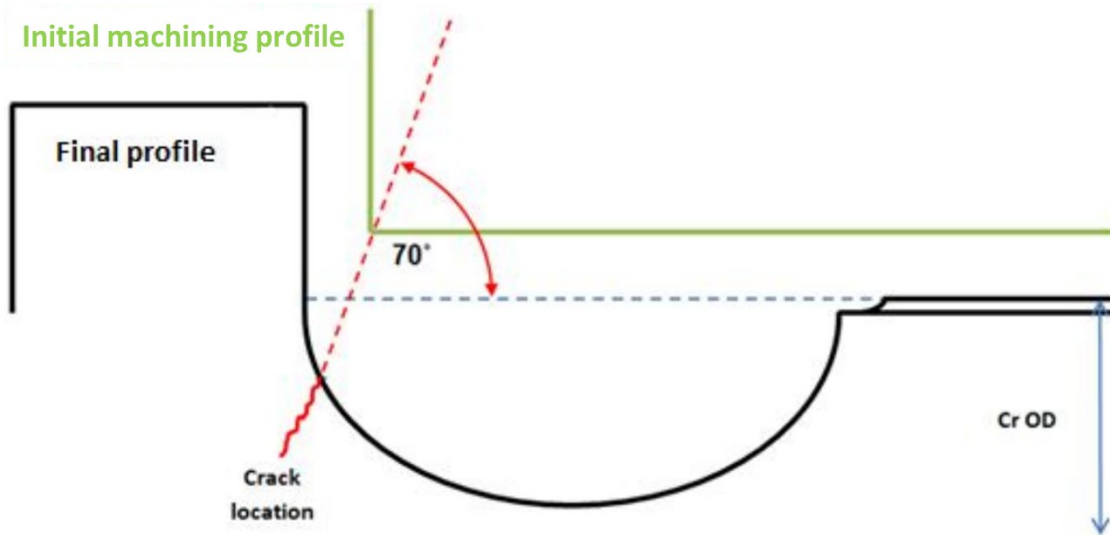
Figure 7: Crack location

Safran determined that the small radius under the head of the initial machining introduced a stress concentration during a subsequent heat treatment quench hardening process,¹⁵ that in some pins, resulted in the formation of a crack. The crack plane was found to align with the initial machined undercut (Figure 7). Despite a final machining process removing more material and providing a large relief radius under the head, some cracks were large enough so as not to be eliminated. Temper discolouration on the crack surface of some returned pins was indicative of the crack being initiated either during the quench process, or between the quench and temper steps of the heat treatment activities.¹⁶

In summary, Safran concluded the cracks were initiated during the manufacturing process and were not caused by environmental effects in service.

The apex pins were manufactured by initially machining an oversize profile, which was then heat treated and finally machined to size including a large relief radius under the pin head. The identification of temper scale on the crack face from the heat treatment was conclusive evidence that the crack found on the occurrence pin (and several others) was induced as part of the quenching process. The initiated cracks were large enough they were not completely removed by the subsequent machining process.

While it was established that the radius of the initial machining under the head was too small to prevent heat-related cracking, most pins did not crack. It was concluded that another factor, or factors, were required, in combination with the size of the radius, to initiate a flaw. These factors included variations in cutting tool sharpness, undercut surface roughness and/or the quenching bath temperature, even though these features may have been within prescribed tolerances.

In 2014, some apex pins were found cracked during a manufacturing inspection. With no evidence of prior inspection failures nor cracks being found in-service, no action was taken against parts already produced. However, in response to the defective batch, the initial radius under the head of the machined pin was increased.
