# Wirestrike and collision with terrain involving Robinson R44, VH-HNF

69 km south-east of Hay Airport (Steam Plains), New South Wales, on 31 July 2020

AO-2020-040

Final – 4 March 2022

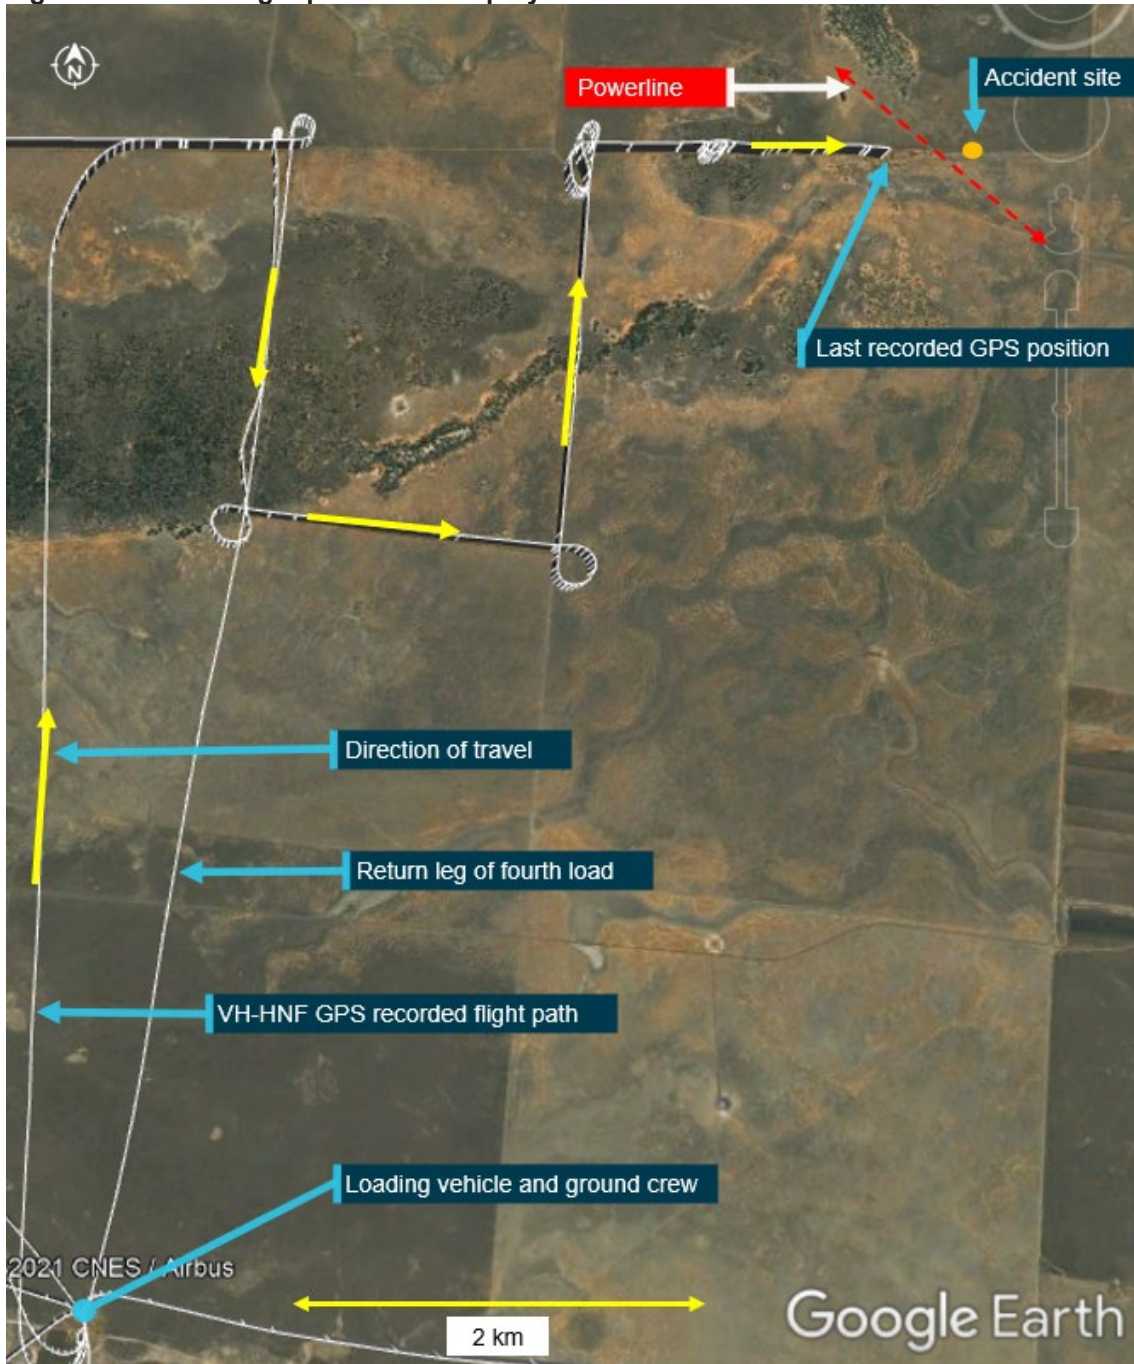
Figure 1: VH-HNF flight path for fifth spray load

The helicopter subsequently collided with terrain about 120 m beyond the powerline, resulting in fatal injuries to the pilot. The helicopter sustained substantial damage.

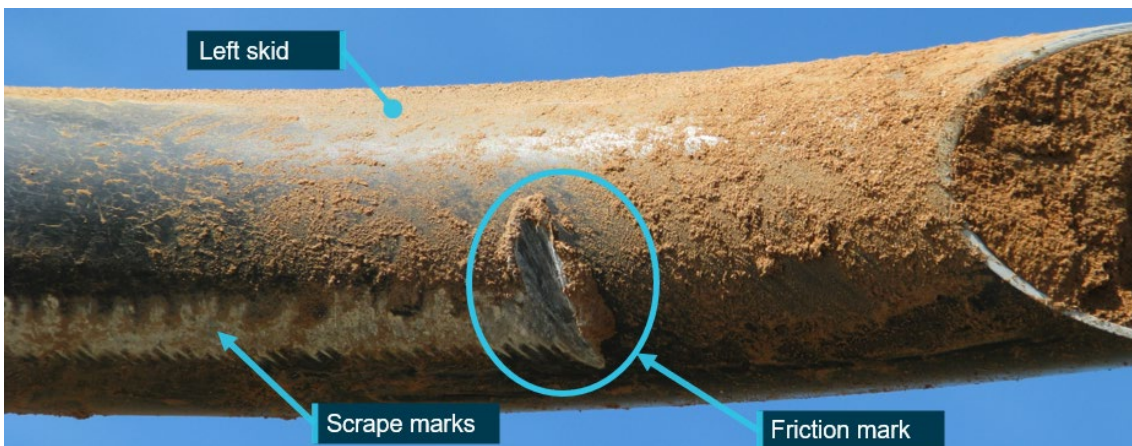
**Figure 3: Wire marks on VH-HNF’s left skid**

- the main rotor had impacted the tail boom during the accident sequence, resulting in loss of control of the helicopter
- the helicopter collided with the ground on its left side in a nose-down attitude of about 30°
- the main rotor blade and landing gear dug into the ground, resulting in the helicopter bouncing, rotating about 180°, and coming to rest on the right side.

The ATSB examined the helicopter and did not identify any evidence of in-flight breakup, birdstrike, or pre-existing defects that may have contributed to the wirestrike. Consistent with

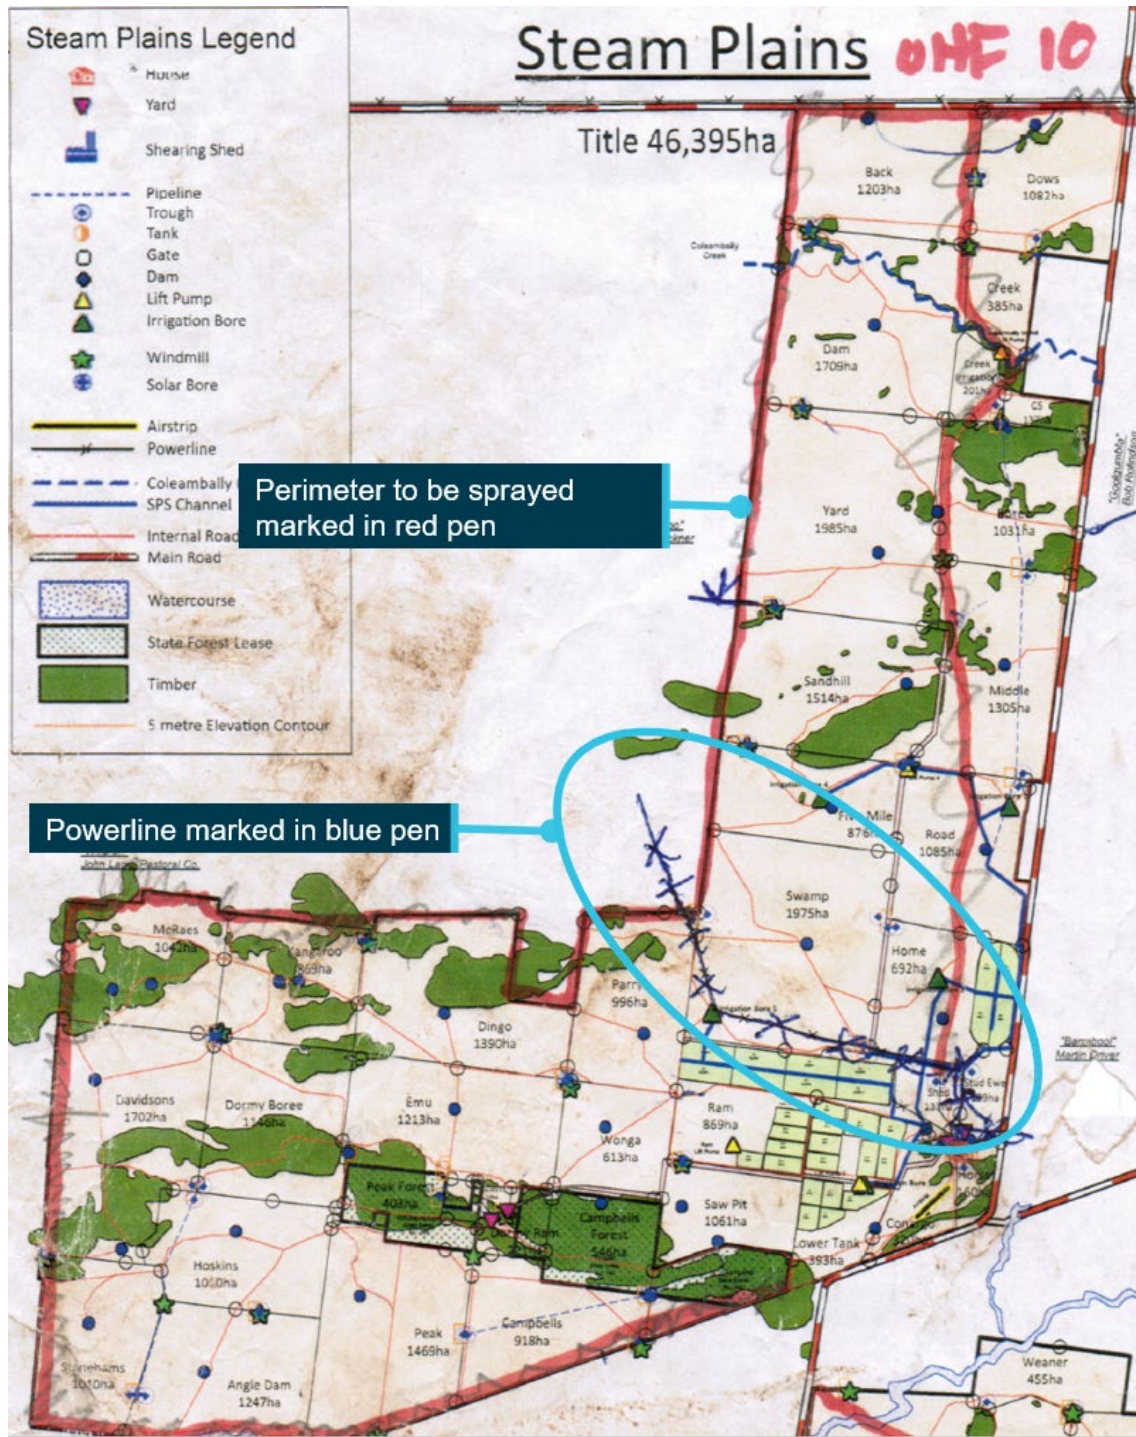
Figure 4: Map of Steam Plains Station showing spray path (red) and powerline (blue)

Prior to the fifth (accident) load, the pilot fuelled the helicopter and discussed with the chief pilot the shape of the boundary fence to be sprayed on the next sortie and the location of the powerline.

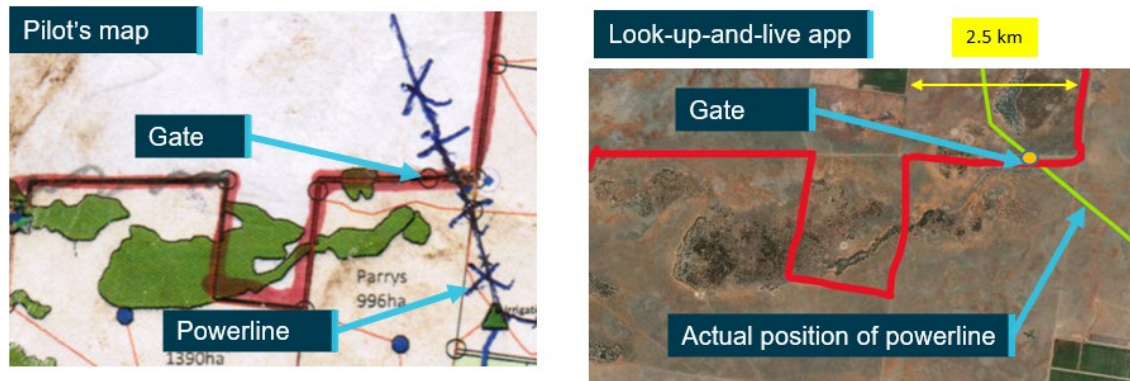
**Figure 5: Map location compared with actual powerline location**

instructor who conducted the pilot's annual flight review and proficiency check in 2019 commented that pilots are trained to expect that planning information may be inaccurate, and reinforced the importance of verifying it by conducting an aerial inspection.

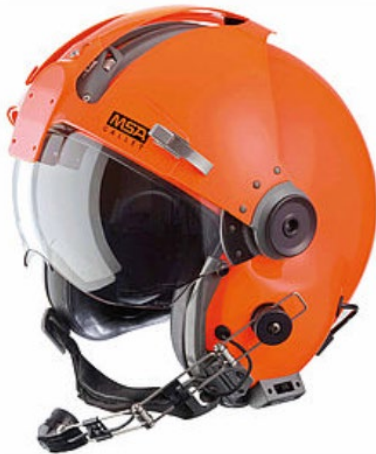
**Figure 8: MSA LH250 helmet**

The helmet was found at the accident site, on the ground on the left side of the helicopter, the opposite side to the final resting position of the helicopter on its right side and the pilot in the right seat. The helmet sustained extensive structural damage, with significant cracking of the shell on the top and on the left side. The structure around the left ear and visor attachment was crushed and there was a dent in the shell above the left eye. Most of the outer visor and track had broken off from the right side, and there was paint transfer and scrape marks on the top of the helmet.

In any event, the diffuse brain injuries sustained by the pilot indicate the helmet did not attenuate the acceleration forces to the brain to a survivable level. It was not possible to determine if the impact forces exceeded the helmet's specifications and/or whether the helmet's effectiveness was compromised by any of the above considerations. However, it is important for pilots to remember that to be fully effective, a helmet must be fitted properly, worn correctly and maintained in accordance with manufacturer instructions.

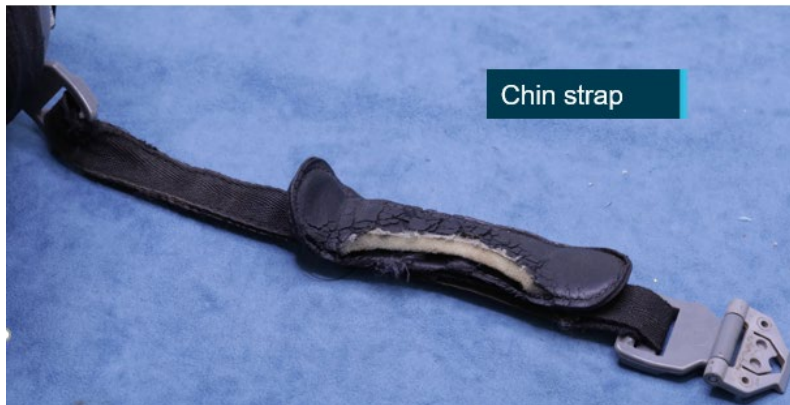
**Figure 9: Helmet chin strap**

The LH250 helmet comes in two shell sizes, which can be personalised with pads to fit the wearer’s head. The manufacturer advised that the pads degrade over time and should be replaced to ensure optimum fit. The fit of the helmet was not able to be assessed in this instance. The helmet was fitted with a chin strap and locking buckle, which met US DOI and US Military standards. The chin strap was noted by the ATSB to be worn and frayed (Figure 9). This was indicative of the chin strap being worn securely fastened over a long time.

The pilot had very likely been wearing the same helmet during a helicopter accident in 2018, in which the pilot sustained facial injuries. It could not be determined whether the helmet sustained an impact in that accident, or whether any subsequent inspection or maintenance was conducted, although it was confirmed that the helmet had not been sent to the distributor from which it was purchased.

The chin strap was found intact and attached to the helmet but undone. It could not be determined whether the chin strap came undone during the accident sequence or was not secured at the time. Although the primary impact was on the left side of the helmet, there was also some damage to the right side of the helmet and visor and the chin strap clasp was on the right side. However, there was no visible damage to, or in the vicinity of, the clasp. Although the ATSB found that the clasp could come undone with a direct 'bump' force applied to it, there were no witness marks to indicate the clasp was opened from being caught on something during the impact sequence or directly impacted or bumped. The poor condition of the chin strap may also have resulted in it being uncomfortable to wear secured under the chin. Its poor condition was, however, consistent with the pilot having regularly worn it secured in the past.

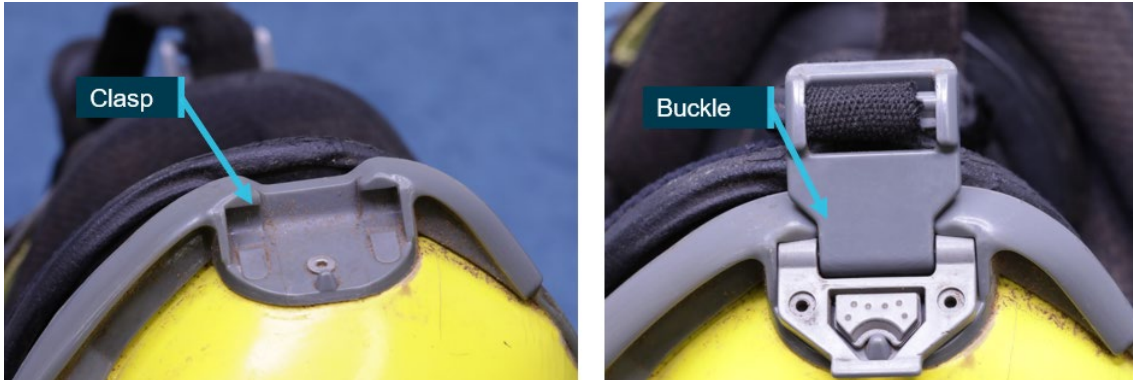
**Figure 10: Helmet clasp and buckle**

The chin strap was found undone with dirt lodged in the clasp. The chin strap fastened on the right-hand side of the helmet (Figure 10). The post-mortem report did not identify chin injuries to indicate that the helmet had been forcibly removed with the chin strap properly adjusted and secured. However, any such injuries may have been obscured by facial hair. Post-accident testing of the helmet by the ATSB found it was possible to undo the clasp with a relatively small ‘bump’ applied to the clasp. As the clasp was on the right side, this force needed to be applied opposite the (left) side of the initial impact. Although there was no evidence of damage to the clasp or scuff marks near the latch to indicate contact, the damage to the right side of the helmet was consistent

with a secondary impact on that side. There was also no documented history of this latch coming undone in accidents.

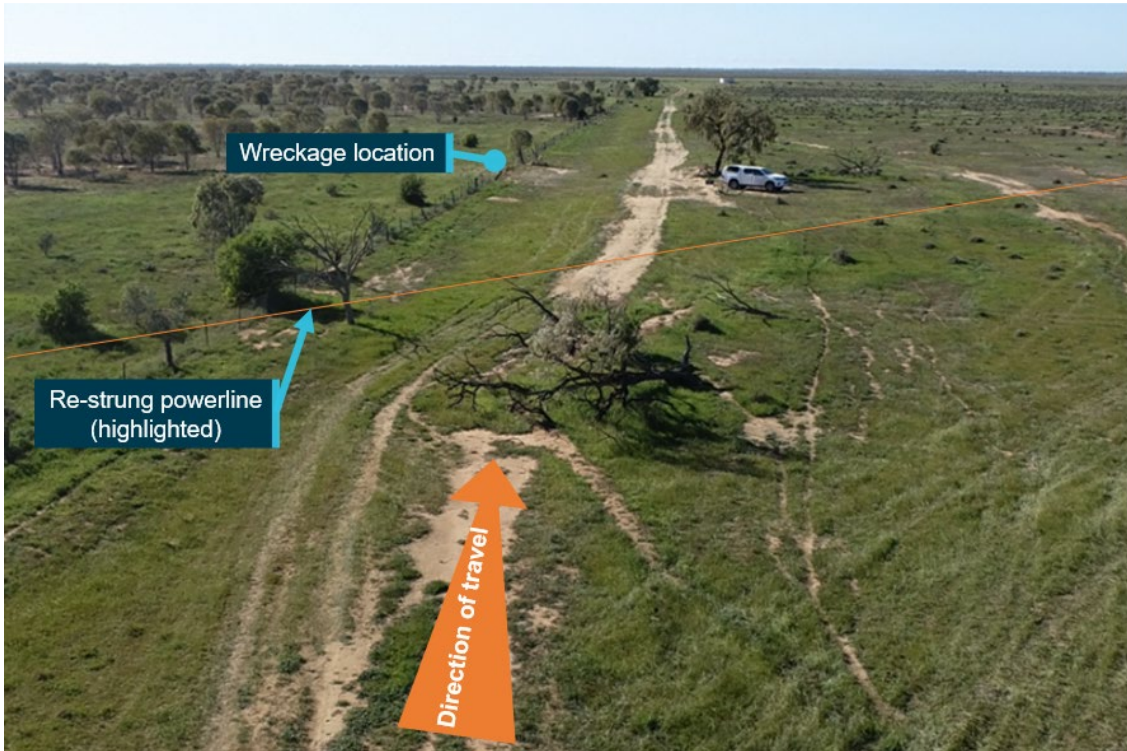
Figure 11: RPA image 50–75 m prior to the powerline showing the accident location, taken at 1028 on 4 August 2020, with powerline highlighted

Imagery taken from the ATSB's remotely piloted aircraft (RPA), while following the helicopter's estimated flight path at about the same time on a subsequent day, found that the wire would have been extremely difficult to see (Figure 11 and Figure 12).

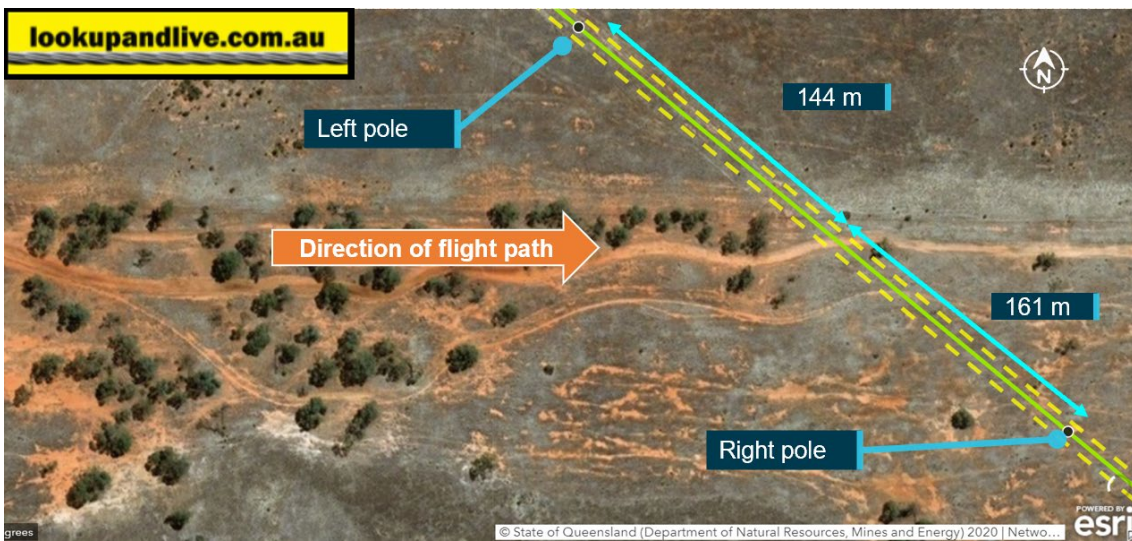
**Figure 13: Power poles either side of flight path**

Figure 13 shows the two closest power poles located either side of the helicopter's flight path. From ATSB RPA footage taken along the estimated flight path, at times, both poles were obscured by trees and lacked contrast and texture variation from their background (Figure 14 and Figure 15). The two power poles should have been visible within the pilot's peripheral vision, however it is likely that the pilot's visual acuity was affected by contrast sensitivity, resulting in the pilot being unable to discriminate the poles from their background. Additionally, based on the powerline's location on the pilot's map, the pilot may not have been looking for cues at that time.
