Runaway and derailment of loaded ore train M02712

Near the 211 km mark south of Port Hedland, Western Australia, on 5 November 2018

ATSB Transport Safety Report

RO-2018-018

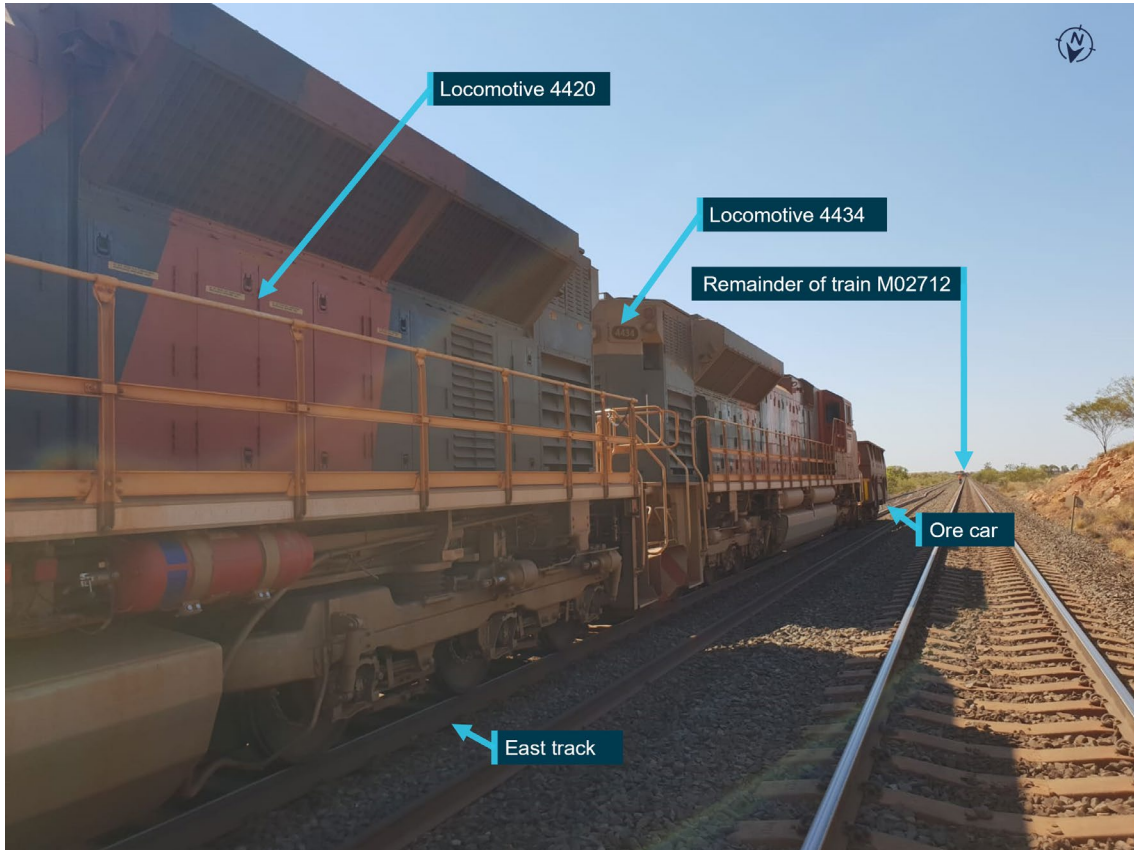
Figure 2: Locomotives 4420, 4434 and first ore car at Turner South

The derailment destroyed the 2 remote locomotives, 245 ore cars and about 2 km of track infrastructure at Turner South (Figure 4). There was no injury to any person from the runaway or derailment.

Image viewed in a southerly direction of locomotives and ore car at Turner South. The lead locomotives 4420 and 4434 and one ore car remained upright, however the ore-car had derailed.
Source: BHP, annotated by the ATSB

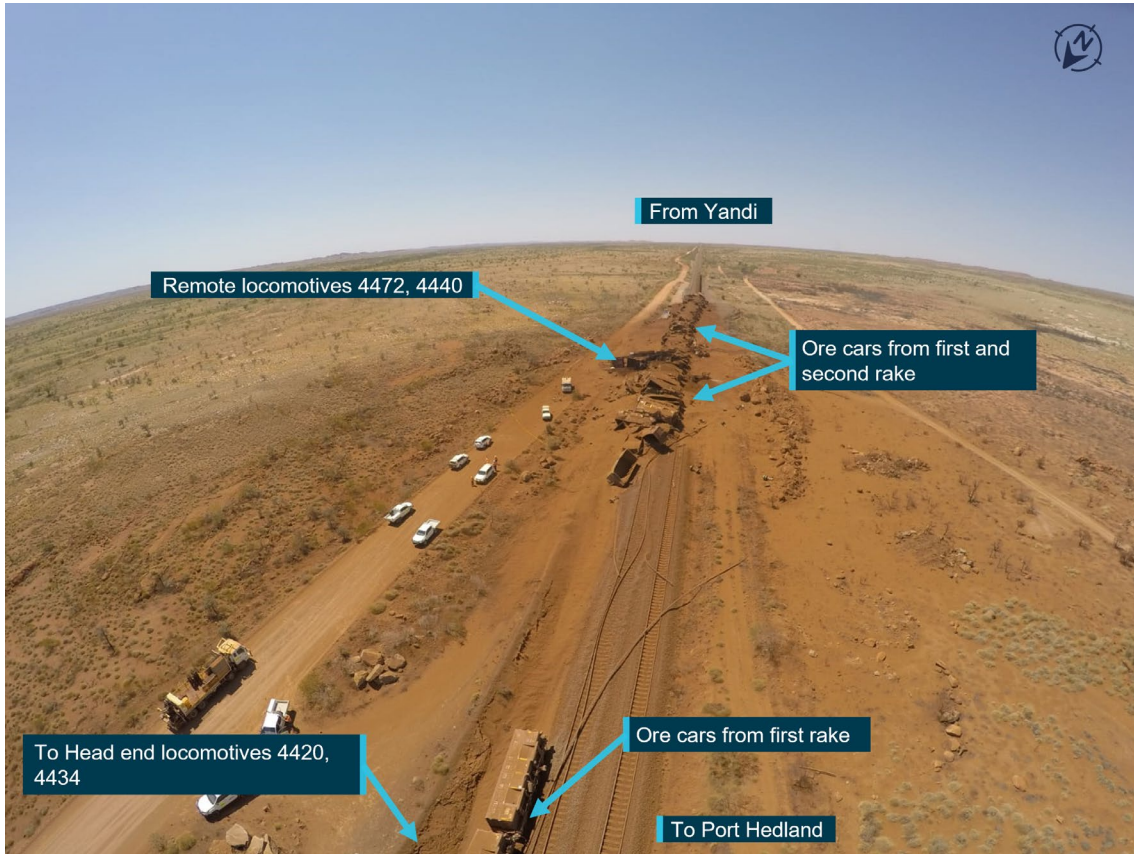
Figure 3: Train M02712 wreckage near the crossover at Turner South

Aerial image viewed in a southerly direction of train wreckage and track damage at Turner South. The lead locomotives 4420 and 4434 remained on track and were coupled with one ore car that had derailed (out of frame in the foreground).
Source: BHP, annotated by the ATSB

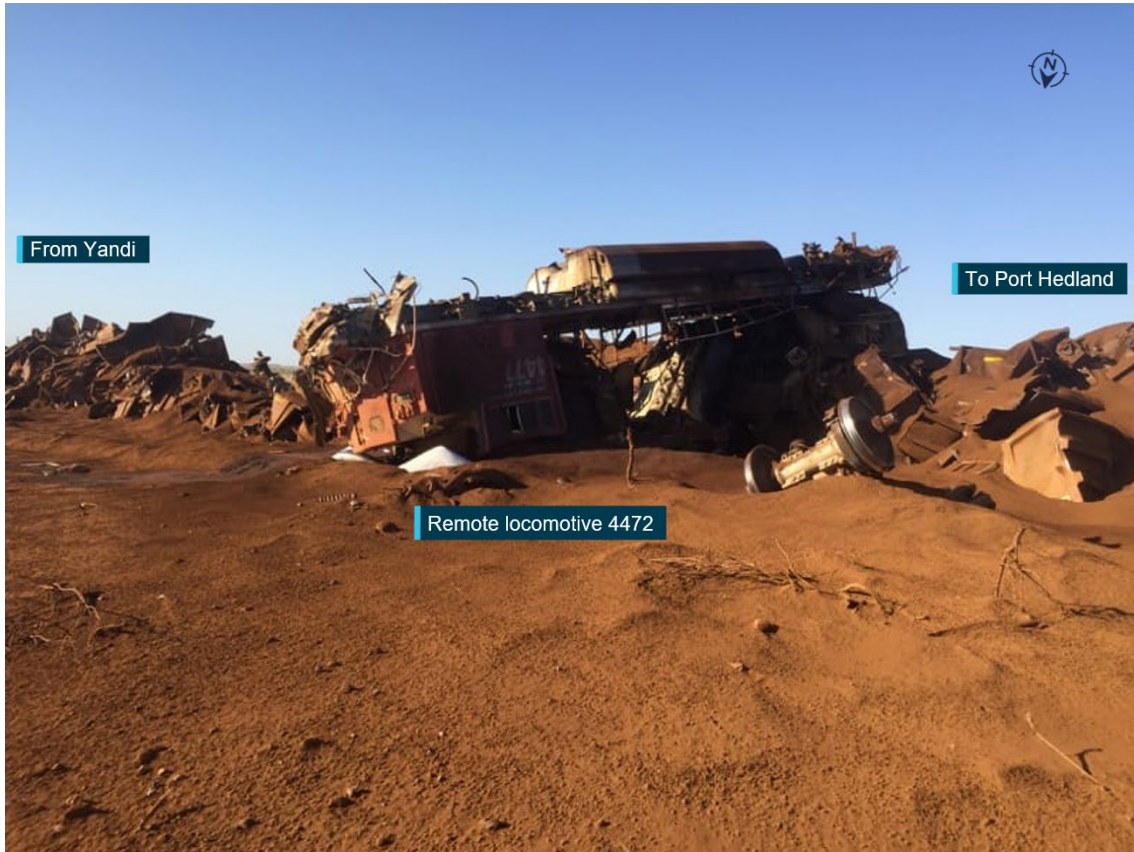
Figure 4: Ore cars and remote locomotive 4427 wreckage at Turner South

*Wreckage of remote locomotive 4427 and ore cars from rakes A and B viewed in a south-westerly direction at Turner South.
Source: BHP, annotated by the ATSB*

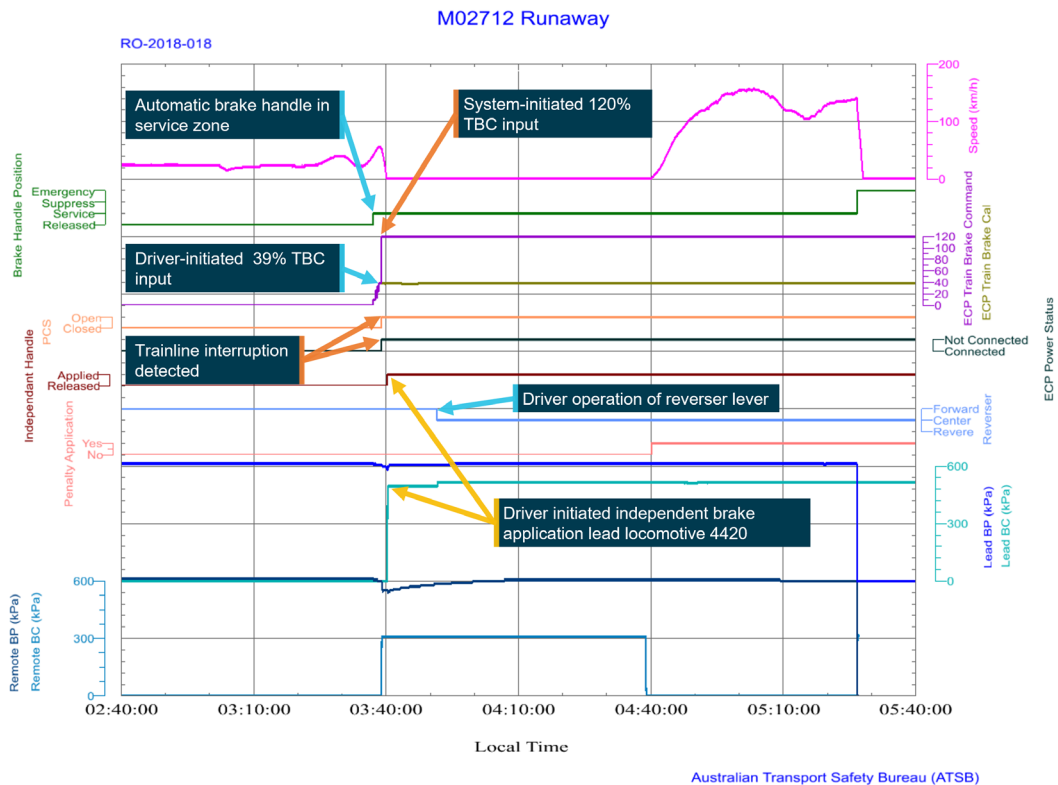
Figure 8: Event logger extract from locomotives 4420 and 4472, locomotive 4420 (HEU) brake control applications

About 30 seconds later, at 0338, the interruption in trainline continuity caused several critical alarm conditions in the HEU locomotive's onboard systems. The loss of trainline communications between the EOTM and HEU beacon triggered a system-initiated emergency application of 120% TBC to lead locomotives and operative CCDs that remained in communication with the HEU (Figure 8).

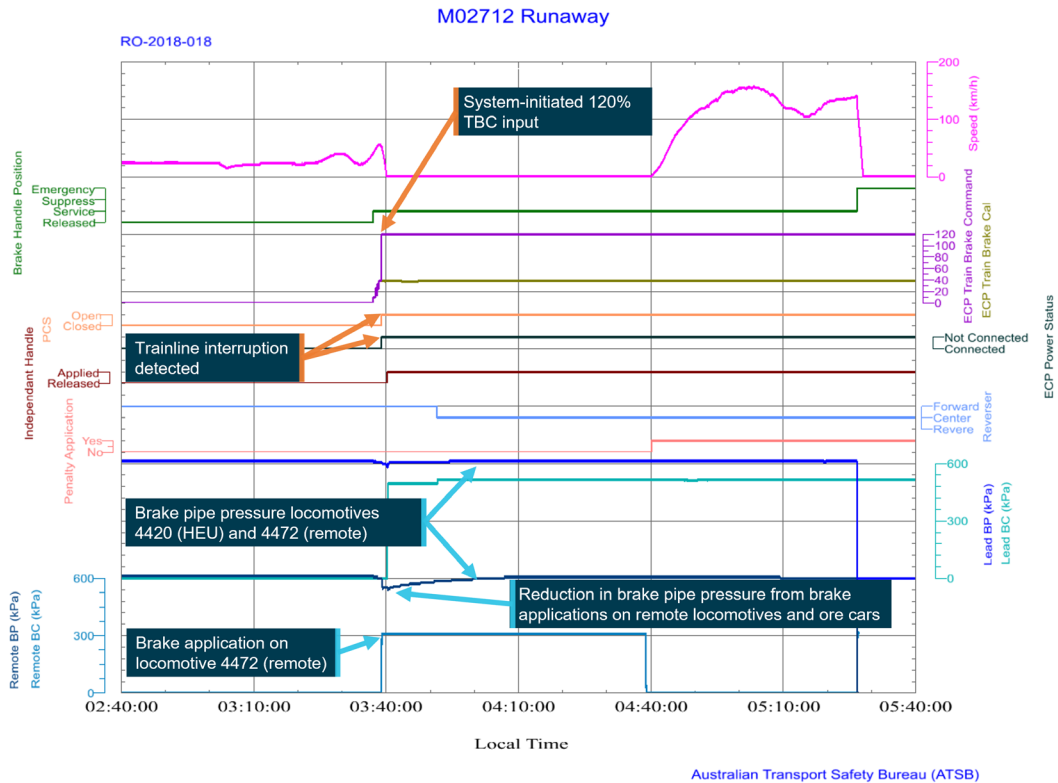
Figure 9: Event logger extract from locomotives 4420 and 4472, locomotive 4472 (remote) and ore car CCD brake application

The CCDs, remote locomotives and EOTM beacon that could not detect the HEU beacon via the trainline cable subsequently broadcasted an exception message, which was received by the other devices along that portion of the trainline. As each device received more than one exception message within 5 seconds, all operative CCDs and remote locomotives self-initiated an emergency ECPB brake application to stop that part of the train. As this was a system-initiated application and only the trainline communication was interrupted, the brake pipe remained intact and fully charged (Figure 9).

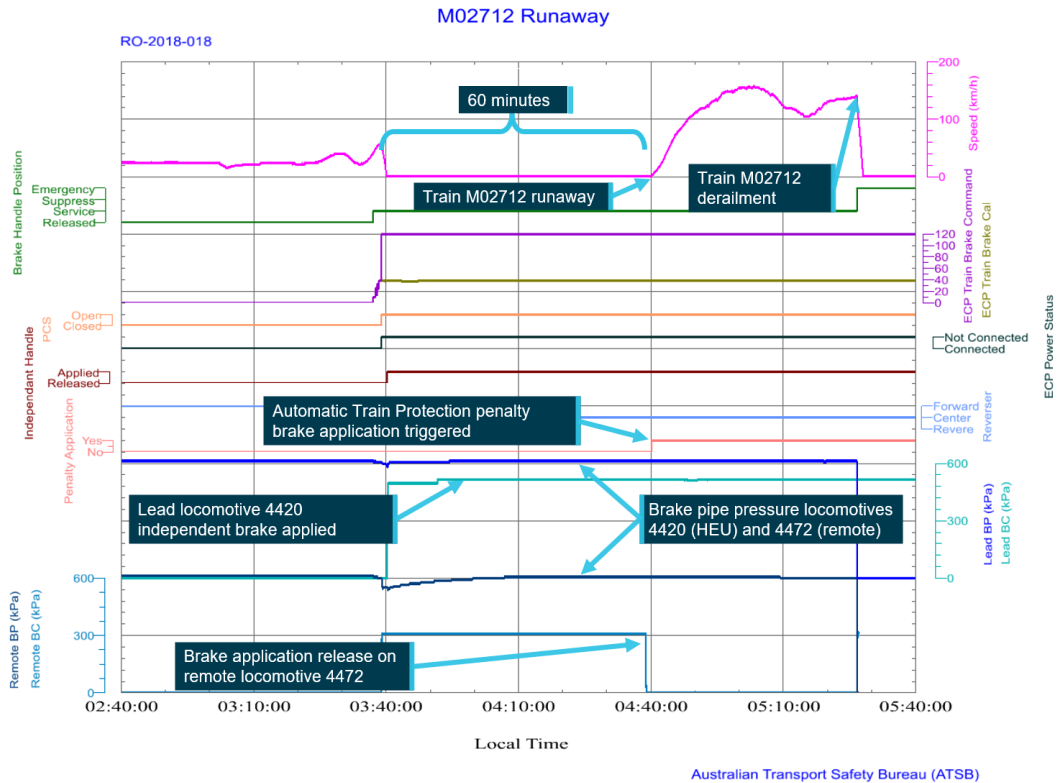
Figure 10: Event logger extract locomotives 4420 and 4472, locomotive 4472 (remote) and ore car CCD brake release

For train M02712 the operative CCDs, remote locomotives and EOTM that were not in contact with the HEU beacon shut down about 60 minutes after the loss of power supplied by the trainline cable (that is, at about 0438). As the brake pipe remained charged, the air brakes released on these ore cars and the remote locomotives. The release of these air brakes and the incomplete application of handbrakes on train M02712 resulted in the train commencing to roll away at about 0440 (Figure 10).

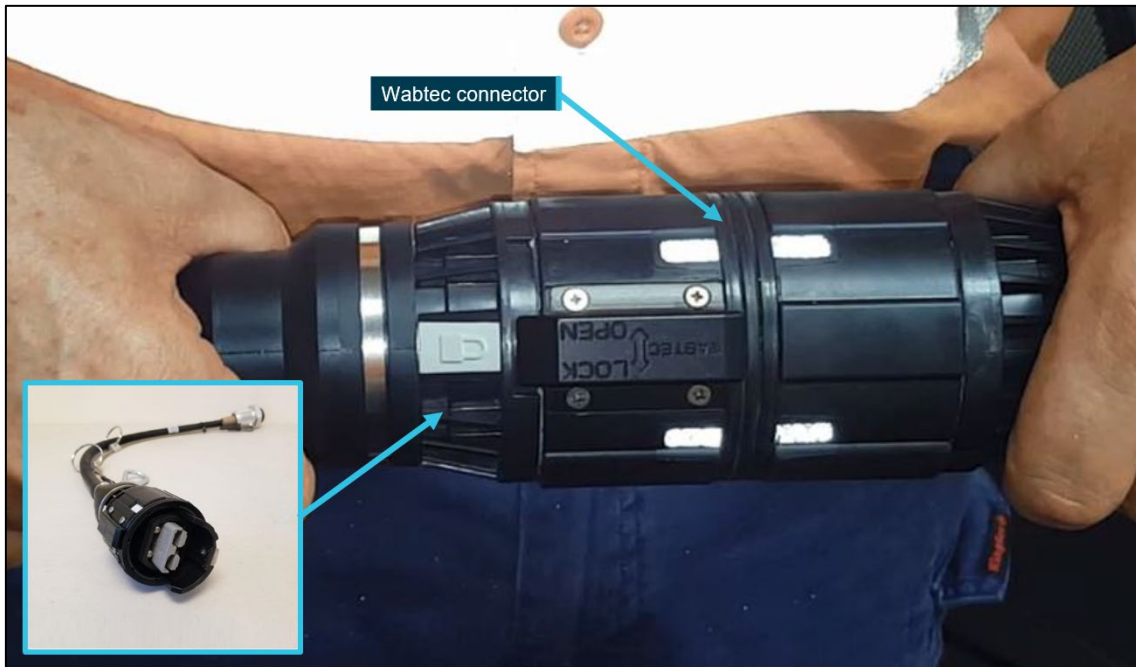
Figure 13: Wabtec inter-car connector

In mid-2018, BHP initiated a trial of a Wabtec type connector (Figure 13) to address repeated service delays associated with trains receiving a 120% TBC brake application due to a loss of trainline power and communications from continuity faults within the existing connector. Associated with the service delays, BHP also noted that, depending on the track location, the failure required the application of handbrakes to secure the train. Undertaking this task increased exposure of the train crew and support personnel to a potential injury.

Trial was aborted due to an alleged cable striking a crossing and having an emergency brake application. When the cables were installed the car was empty however when loaded the cable may have been hanging low. Trial will have to be repeated with checks conducted to ensure cables on all types of ore cars are not hanging too low allowing them to make contact with infrastructure.
