Australian Transport Safety Bureau

# Safety Advisory Notice

Number: AO-2018-053-SAN-004

## Alerts and guidance for unreliable airspeed indications on take-off

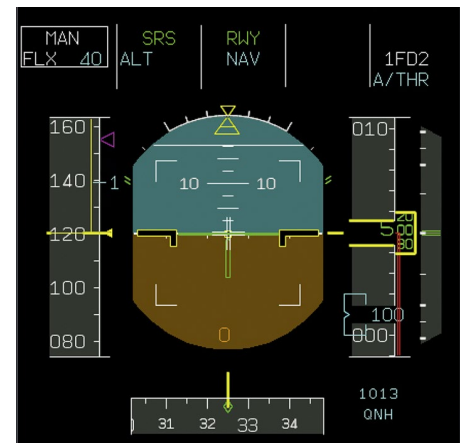
On the night of 18 July 2018, an Airbus A330 commenced take-off from Brisbane, Queensland with covers left on the aircraft's three pitot probes (airspeed sensors). The primary flight displays showed red speed flags in place of the airspeed indication early in the take-off, and either speed flags or unrealistically low airspeeds for the remainder of the flight. The standby airspeed display was also invalid throughout the flight.

The flight crew did not see or respond to the speed flags until the aircraft's speed was too high for a safe rejection of the take-off. The take-off was continued and the aircraft returned to Brisbane.

**AO-2018-053-SAN-004:** The Australian Transport Safety Bureau encourages all manufacturers and operators of larger air transport aeroplanes to consider what types of unreliable airspeed events can occur, how the information is presented to flight crews, and what responses are the safest in different phases of the take-off and in a range of potential situations. Aircraft alerting systems, flight crew procedures, and flight crew training should be designed to provide sufficient assurance that flight crews become aware of and understand how to appropriately respond to unreliable airspeed on take-off in a timely manner.
