Incorrect configuration involving Bombardier DHC-8-402, VH-QOY

near Sydney, New South Wales, on 12 July 2021

ATSB Transport Safety Report

AO-2021-028

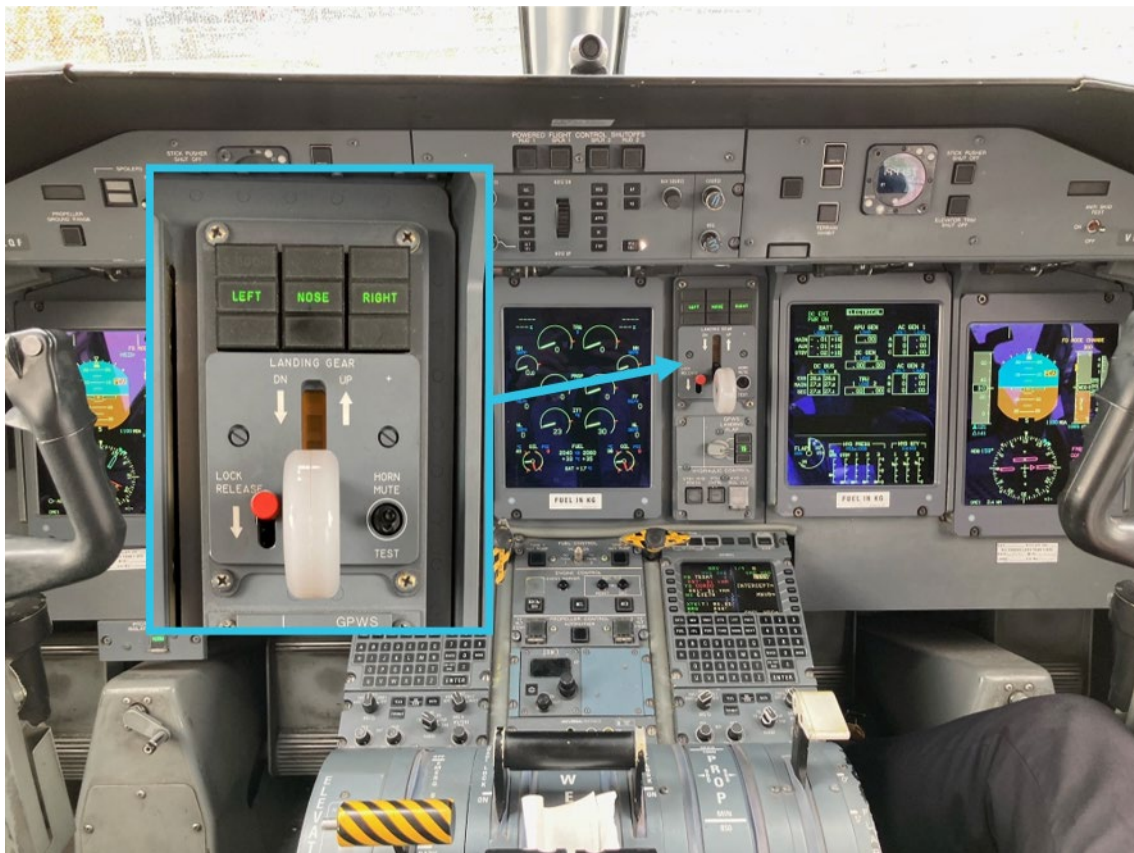
Figure 1: Landing gear handle and advisory panel

The aircraft was equipped with a retractable tricycle landing gear. Operation of the landing gear was via a handle on the main instrument panel on the flight deck, in front of the FO's seat. The handle illuminated when the landing gear was transiting between positions, and 3 green lights on the landing gear advisory panel indicated the gear was down and locked (Figure 1). When the gear was fully retracted (in the 'up' position), there were no lights illuminated.

When actioning the after-take-off checklist on this occasion, the 'landing gear' item was called by the captain (as pilot monitoring) but neither pilot identified the problem. The captain observed that the 3 green landing gear lights were illuminated, but did not identify it as being problematic for that stage of flight. Although the FO could not recall what they saw at that stage, they also recalled seeing the 3 green lights later in the flight and not thinking it was problematic.
