Carbon monoxide indication during flight involving Piper PA- 28, VH-PZG

Near Bankstown Airport, New South Wales, on 8 March 2021

ATSB Transport Safety Report

AO-2021-011

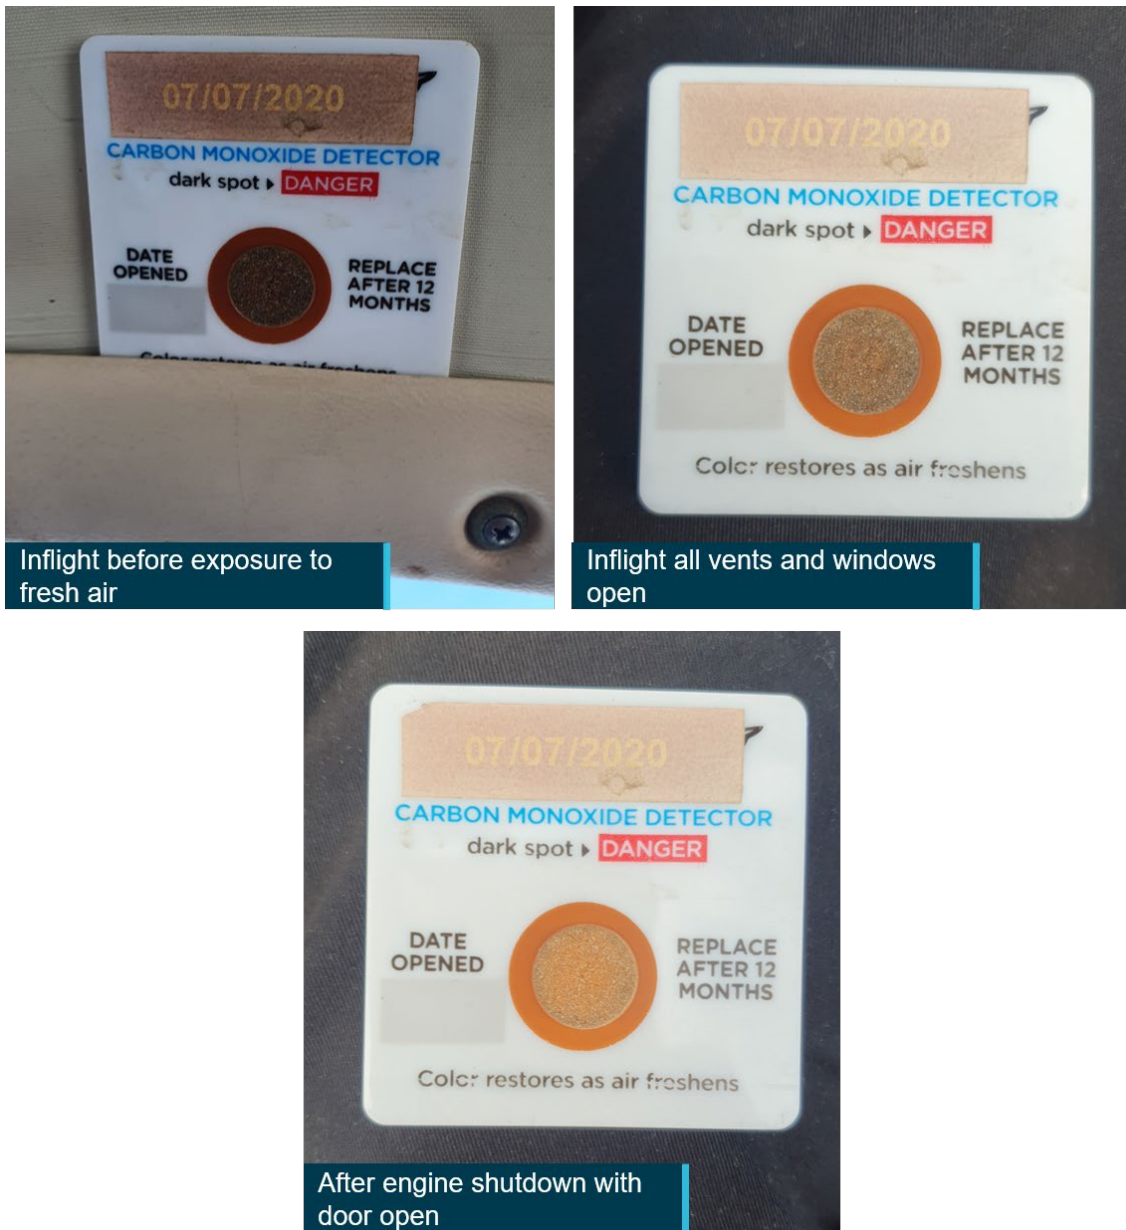
Figure 1: Discoloured carbon dioxide detector during different stages of the flight

During climb, between 1,500 ft and 2,000 ft, the instructor noticed warm air coming from the right floor air vent. Soon after, at the top of climb, at about 4,000 ft near Warragamba Dam, the instructor detected a faint exhaust gas smell and recalled feeling a little more tired than when they took off and mildly lightheaded. The instructor then looked up at the CO detector card, that was located on the ceiling above their head, and observed a localised discolouration (Figure 1 left).

The crew reported observing a discoloration of the carbon monoxide (CO) detector and experienced very mild symptoms and cognitive effects. While it was possible for CO card detectors to give an unreliable indication, the same aircraft was involved in two other incidents, nine months prior, and the detector was replaced with a new one two days before the second

incident. In addition, the crew's blood tests after this incident indicated mildly elevated carboxyhaemoglobin levels, which in conjunction with the card indication, was consistent with CO in the cabin.
