Loss of control and near collision with terrain, Leonardo Helicopters AW139, VH-TJO

26 km east of Goulburn Airport, New South Wales, 24 July 2020

ATSB Transport Safety Report

AO-2020-038

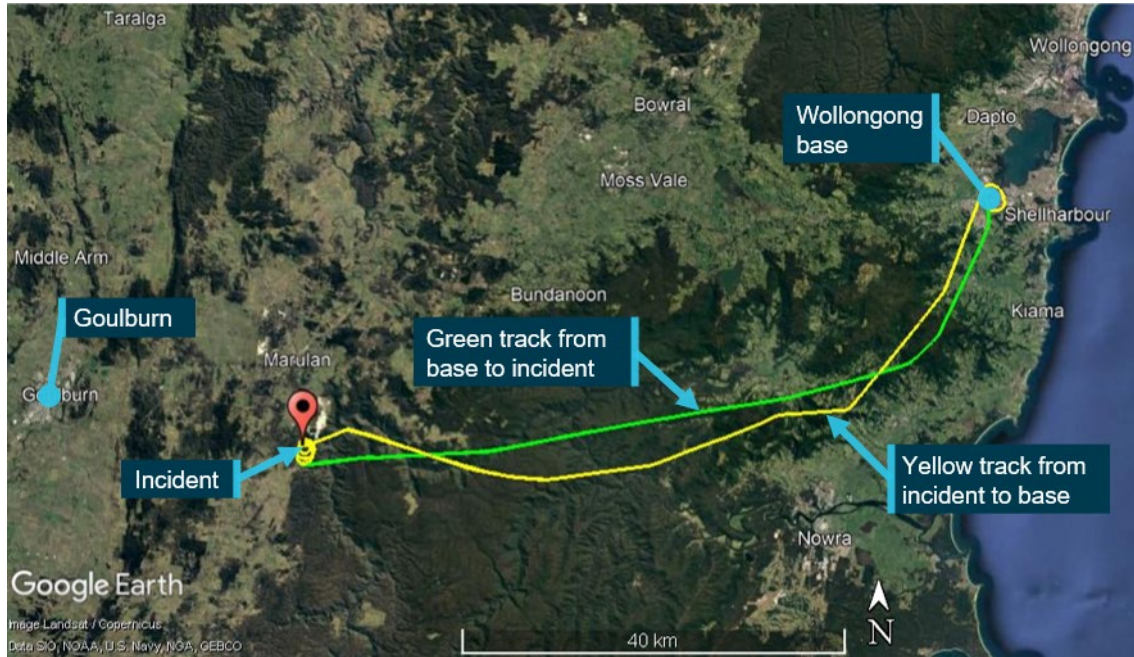
Figure 1 - Flight path from Wollongong base to search area and return

VH-TJO departed the Wollongong base at 2234, transited to the site and arrived over the search area at about 2255 (Figure 1).

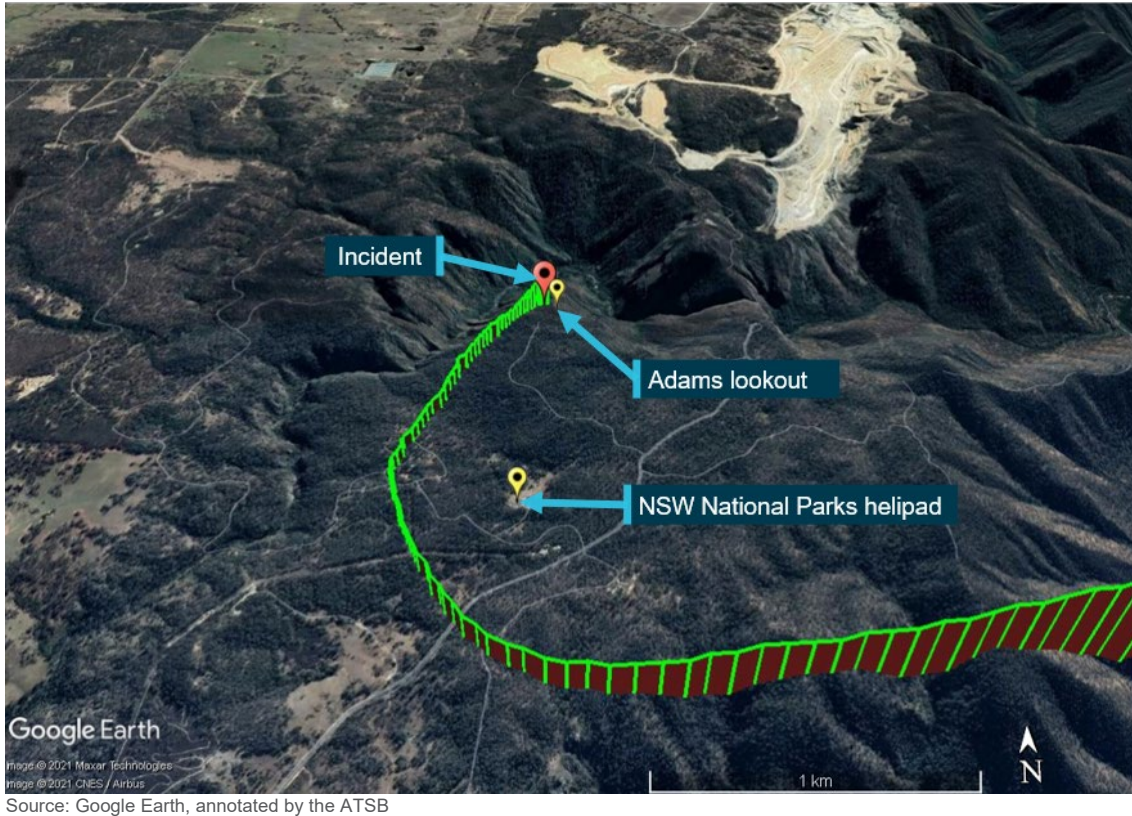
Figure 2 - Flight path of helicopter on approach to the incident location

Once below 240 ft, the pilot turned on the right moveable landing light and the crew attempted to identify several features of the area. The crew intended to track the helicopter past a New South Wales National Parks and Wildlife Service helipad then onto the bushwalkers' location (Figure 2). However, the crew were unable to identify this helipad, but positively identified the area where the rescue services were set up on the ground, as well as Adams Lookout due to vehicle and personnel lights on the ground (Figure 2). This lookout had been mentioned during police communications with the crew in reference to the bushwalkers' location, which was reported to be near the lookout but in the lower ground off the edge of the escarpment.

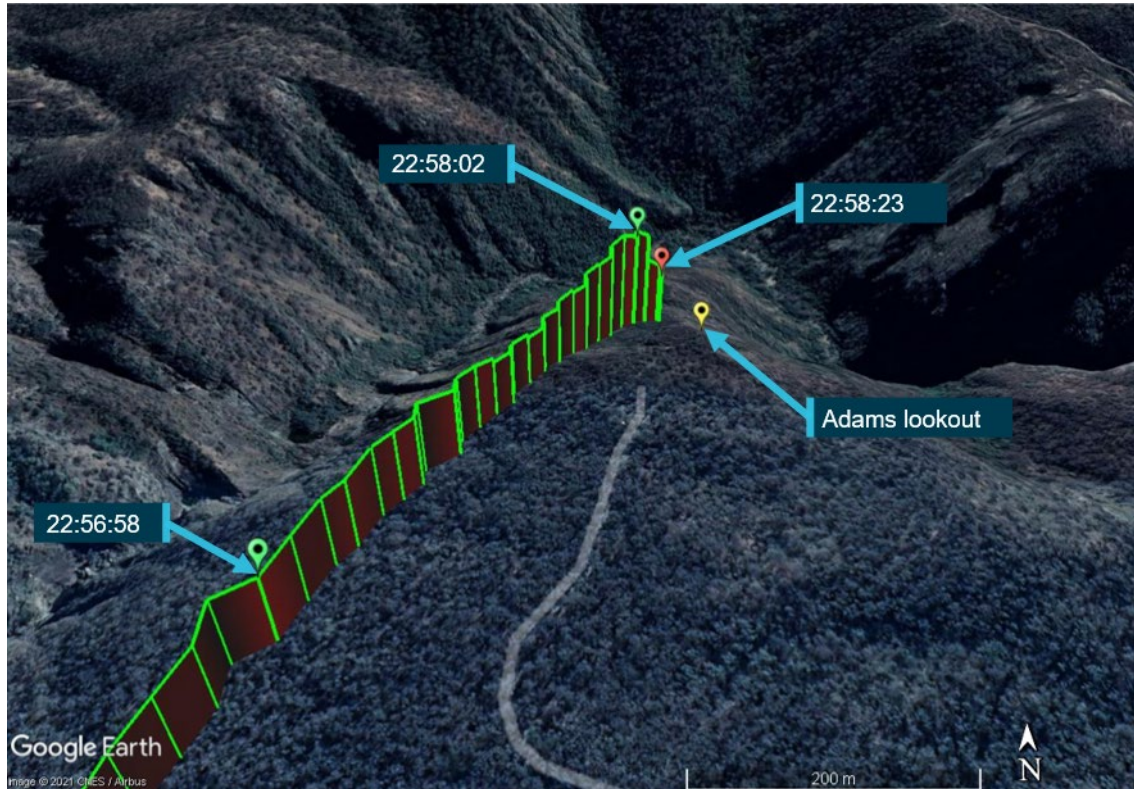
Figure 3 - Flight path leading up to incident with time stamps

At 2257 while the aircraft was still over the escarpment, the ground party made an initial radio call to the paramedic in the helicopter (Figure 3). The paramedic responded to the ground party and two-way communication commenced, discussing the bushwalkers. This communication continued throughout the incident.

At 2258:02 recorded flight data (see the section titled *Recorded data*) indicated that the nose of the helicopter was raised to approximately 16° nose-up while engine power was reduced to approximately 78 per cent. The data also recorded a rate of descent increasing past 160 ft/min (Figure 3). The ACO stated that he felt the aircraft had come to a high hover at that point.
