Department of Transport
Bureau of Air Safety Investigation

INVESTIGATION REPORT
9401043

Douglas DC3 VH-EDC

24 April 1994

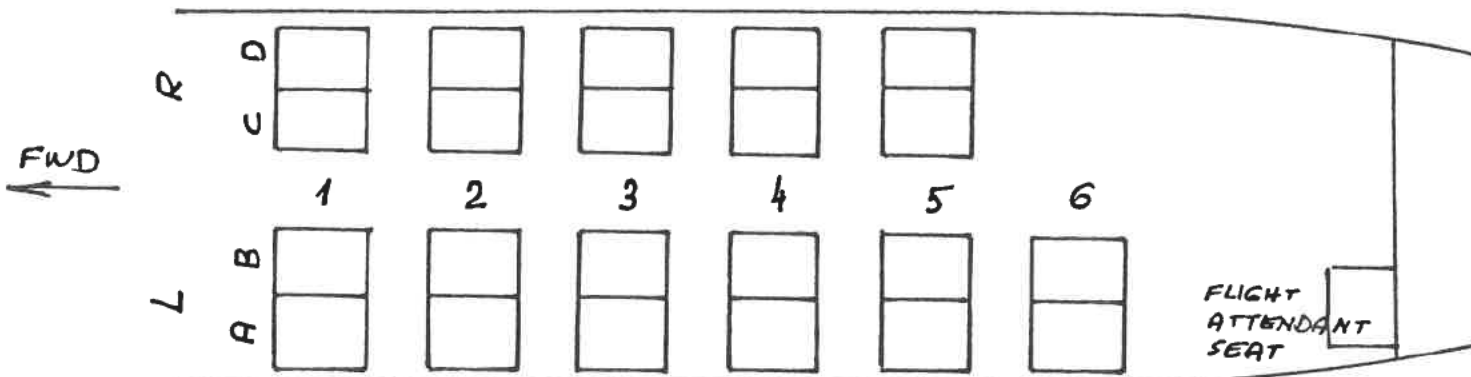
Figure 1: Seat location

The aircraft was fitted with two sets of "Flying Service Engineering and Equipment" model 2090-001 double seats. There were six rows on the left side and five seats on the right side - see Figure 1.

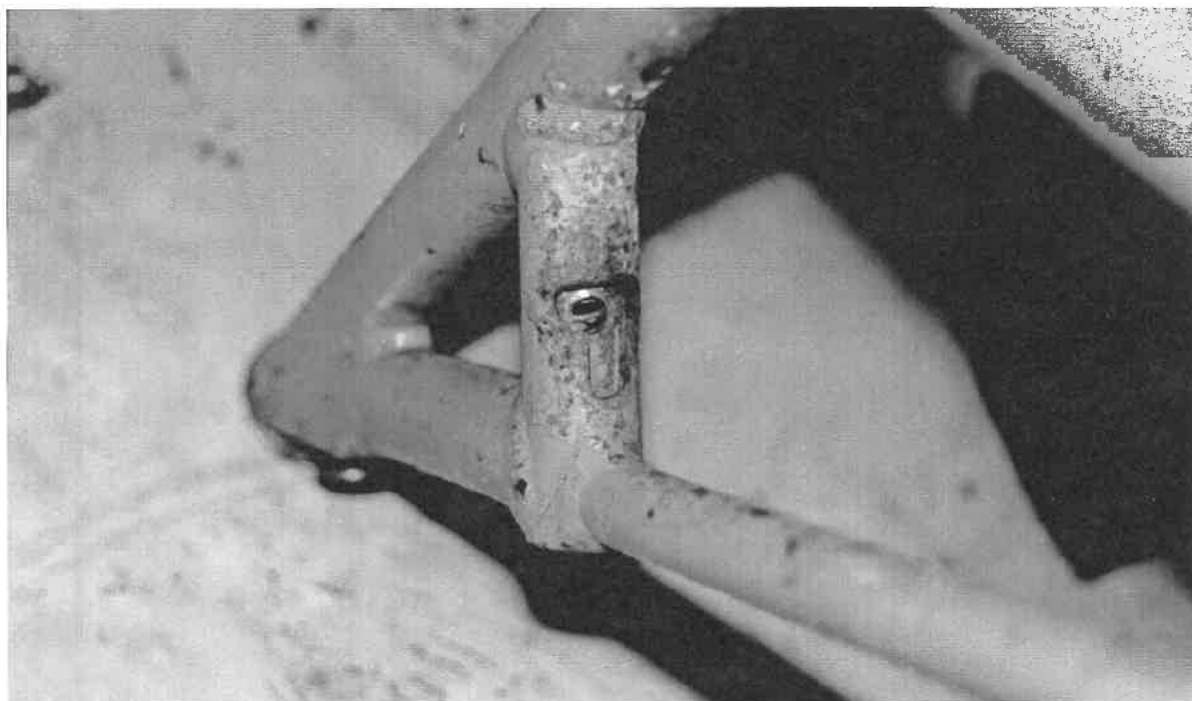
- Two rear feet on the outboard side of the 1 R seat were dislodged from the rail, just sitting on top of it, while the front foot was in the rail groove. Flexibility of the seat frame, however, permitted the foot to travel along the rail and would have allowed it to become dislodged under the load. The locating pin was found stuck in the upwards, stowed, position within its guiding tube, its operating arm missing. There was no evidence to suggest that the pin was damaged or the arm torn off during the accident, indicating that this situation probably existed for some time prior to the flight - see Figure 2. Neither the feet nor the rail were damaged.

Figure 2: The locating pin stuck within the tube, the operating arm missing.

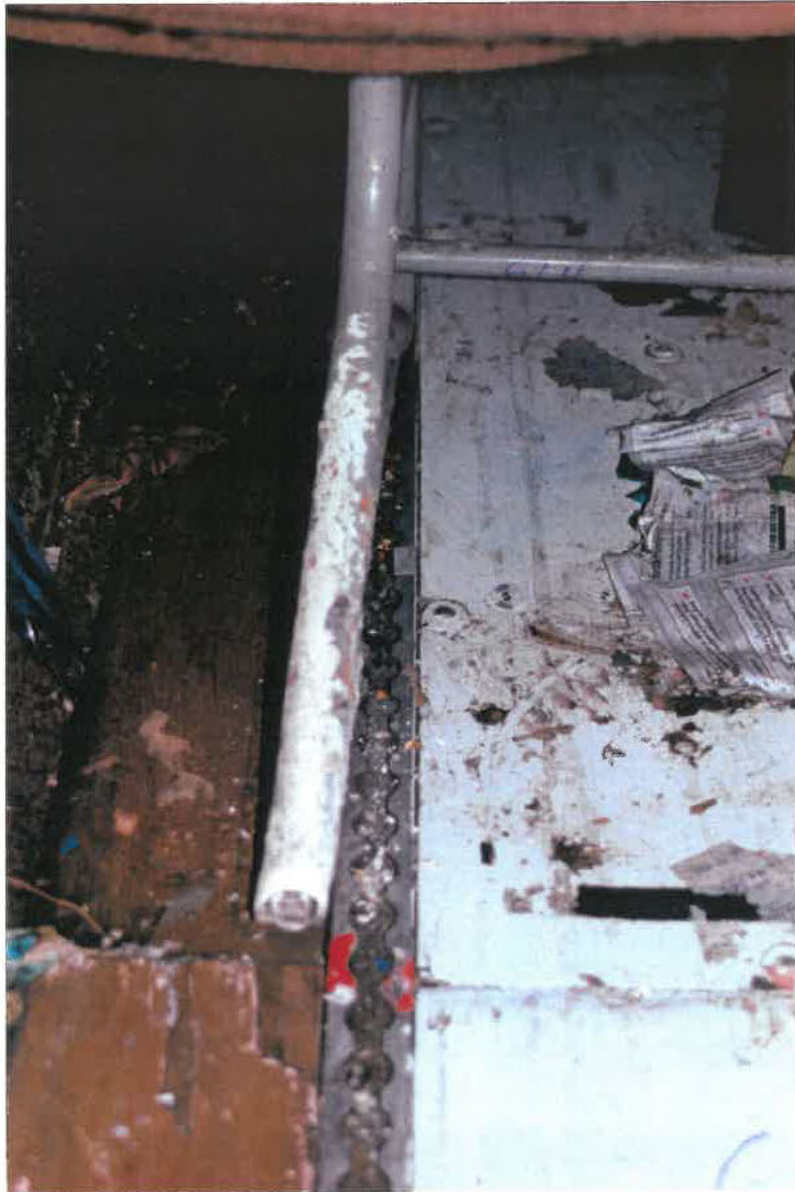
- The 5 L seat two outboard rear feet were also dislodged from the rail, while the front foot was in the groove and the locating pin was correctly engaged. None of the seat structure or the rail were damaged to offer any explanation for the feet to become dislodged. It appears that this situation must have existed from the time the seat was installed.

Figure 3: Deformation of the rear portion of the seat frame.

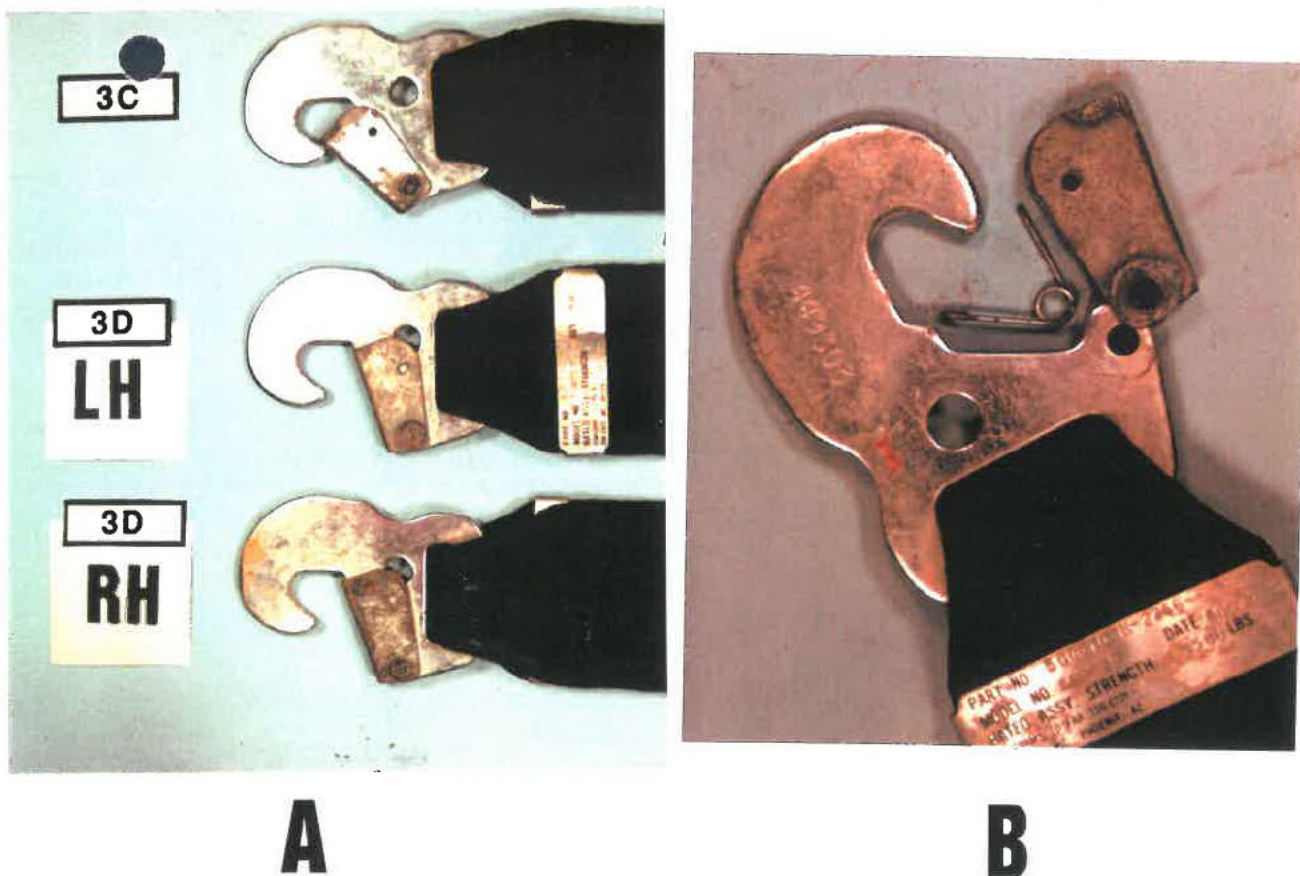
Examination of the remaining seat straps and their end fittings revealed the spring from the gate on the right half of the 2 C seat strap was also missing. The gate itself was deformed and partially open. The deformed and partially open gate was also found on the right half of the 5 C seat strap, though, the spring was present.

Figure 4: A) 3 D seat straps as found, with the gates jammed in the open positions. 3 C seat strap is shown for comparison to demonstrate position of the correctly functioning gate.

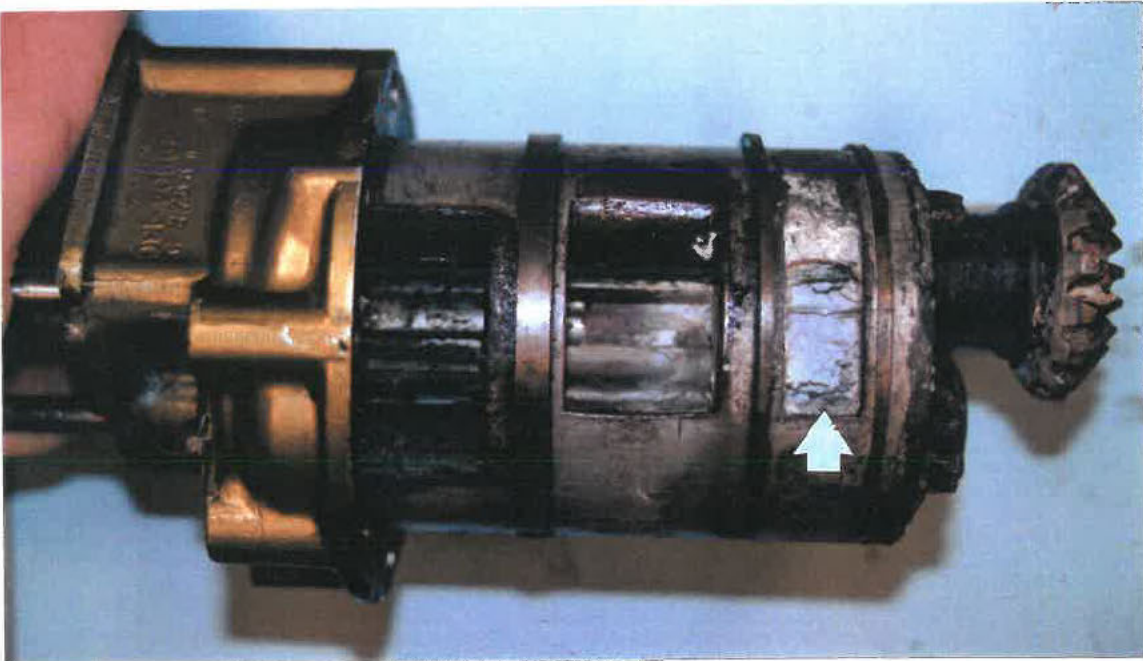
The pump consists of three individual sections, one supplying oil to the engine, the remaining two picking up oil from the rear case and the main sump. The pump was covered by mixture of iron and aluminium oxides resulting from the components being submerged in the sea. The pump front end plate side section contained the greatest amount of corrosion products literally covering both gears - see Figure 1.

Figure 1: The oil pump showing the amount of corrosion products present on the front end plate side section.

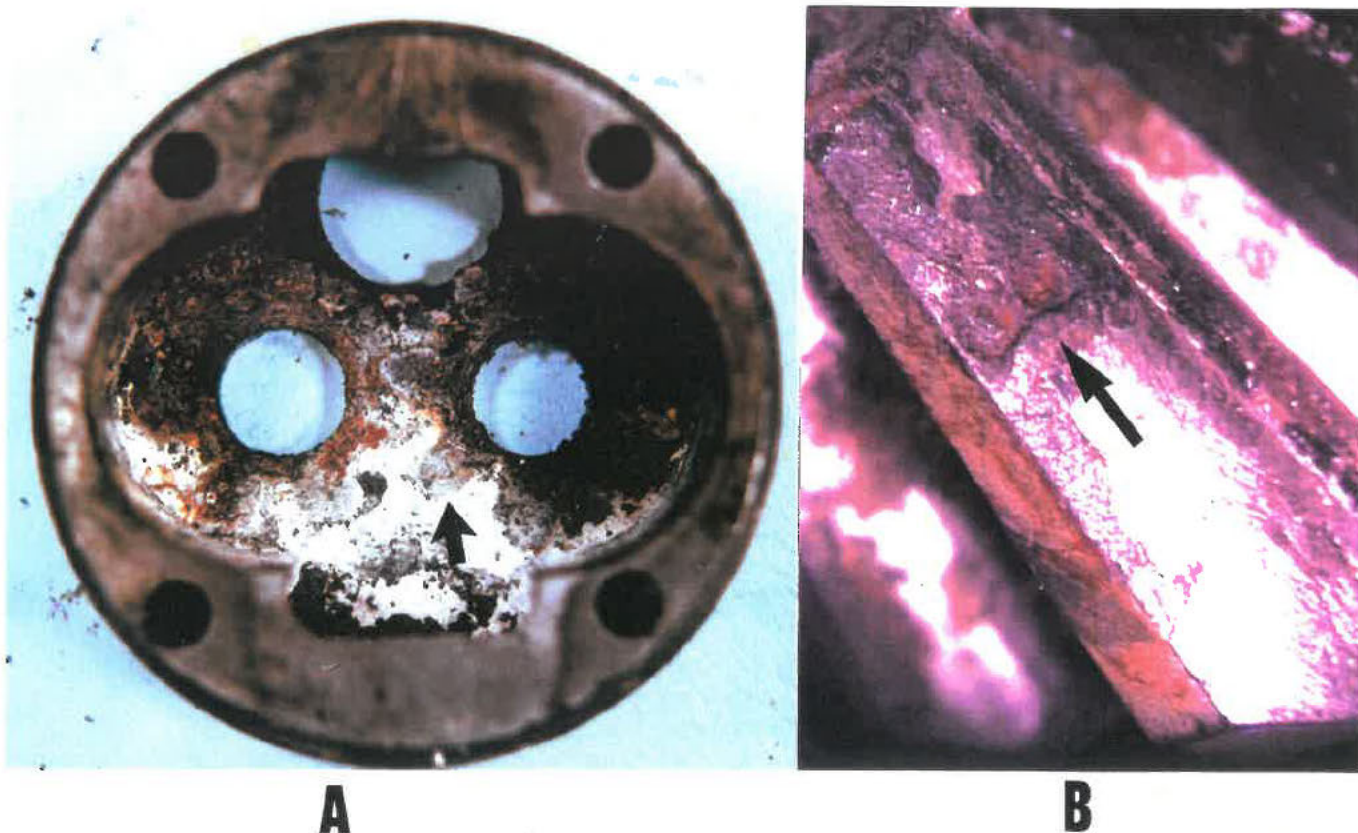
During the pump disassembly the gear teeth imprints, surrounded by the corrosion products, were found inside the individual section cases - see Figure 2 A. It indicates that it was the corrosion growth preventing the shaft from rotating freely when operated by hand and that the corrosion took place only after the gears become stationary and pump exposed to sea water. No pitting was observed on the shaft or the sump case. This would have indicated that the corrosion had started some time prior to the accident.

The amount of corrosion products covering the pump teeth and the shaft passage through the end plate was the only reason for the shaft not rotating freely.

Figure 2: A) The pump gear teeth surrounded by the corrosion products.

B) The corrosion pits of crater size on one of the pump teeth, the hardened layer is broken and mostly missing.

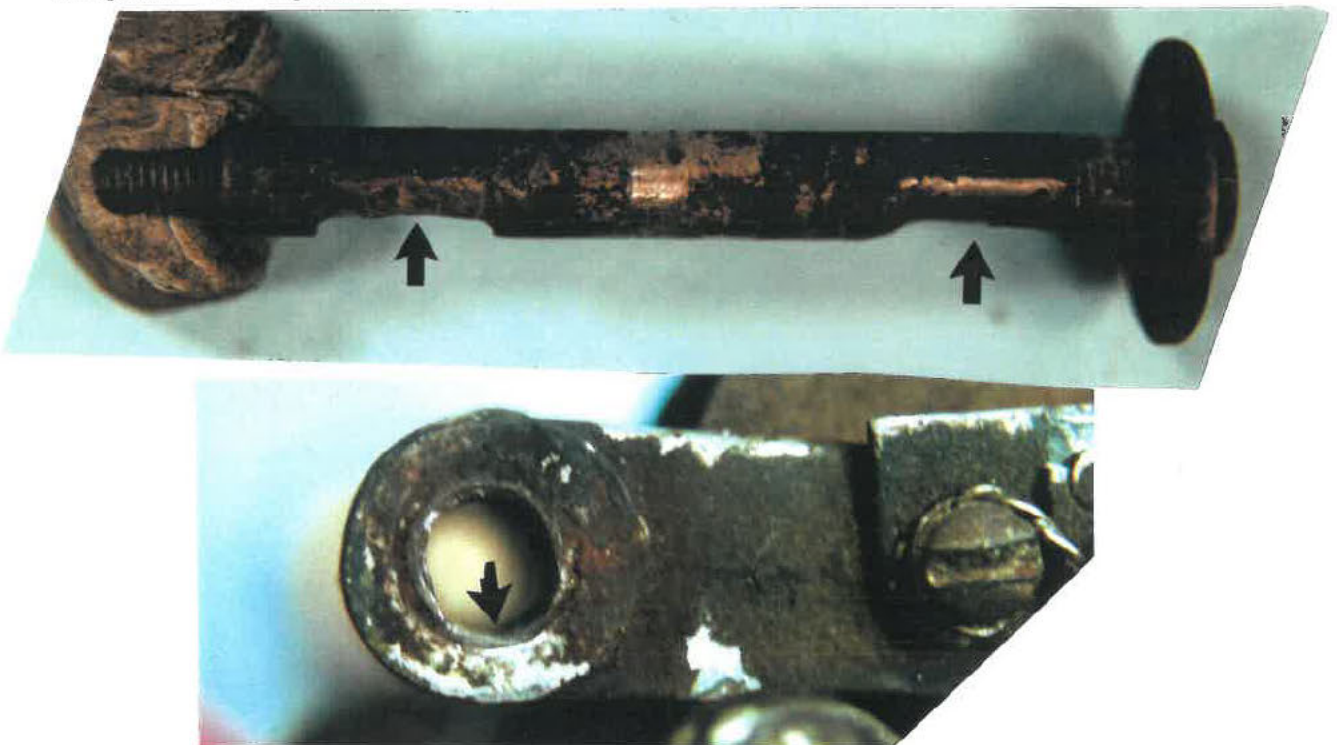
The 4.7 mm diameter bolt has a 7.9 mm diameter aluminium alloy sleeve inserted on it. The sleeve had worn through the wall thickness in two locations corresponding with the pulley assembly arms positions. Holes in the assembly arms exhibited corresponding wear and elongation - see Figure 3.

Figure 3: The worn out sleeve and elongated holes in the pulley assembly arm.

The pulley assembly is fitted with a spring to provide continuous preload to the control cables. The operation of cables is likely to result in a minute rotation of the assembly, the bolt providing the pivot point. The observed sleeve wear is not compatible with the recorded assembly time in service.

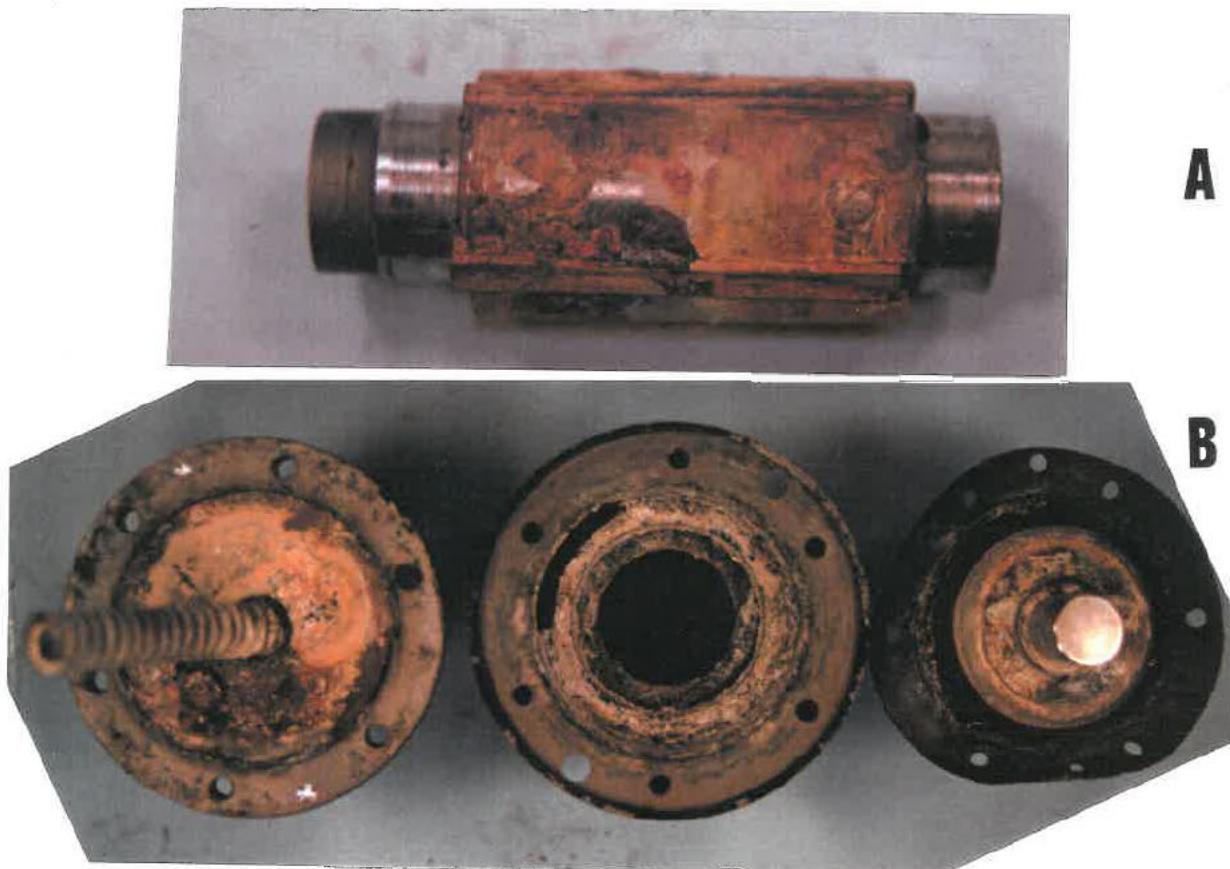
The pump rotor with four vanes rotated within the stator which was in turn inserted into the pump body. The stator and the rotor components were made of steel, the pump body was made of a cast aluminium. The appropriate fuel passages were provided within the casting. The steel components were covered by a thin layer of fresh corrosion products, consistent with the pump having been submerged in sea water - see Figure 4 A. Some vanes were free to move in their appropriate slots, the movement of the others was restricted by the presence of corrosion.

Figure 4: A) The pump rotor.

B) Corrosion products inside of the pump fuel pressure regulating valve.

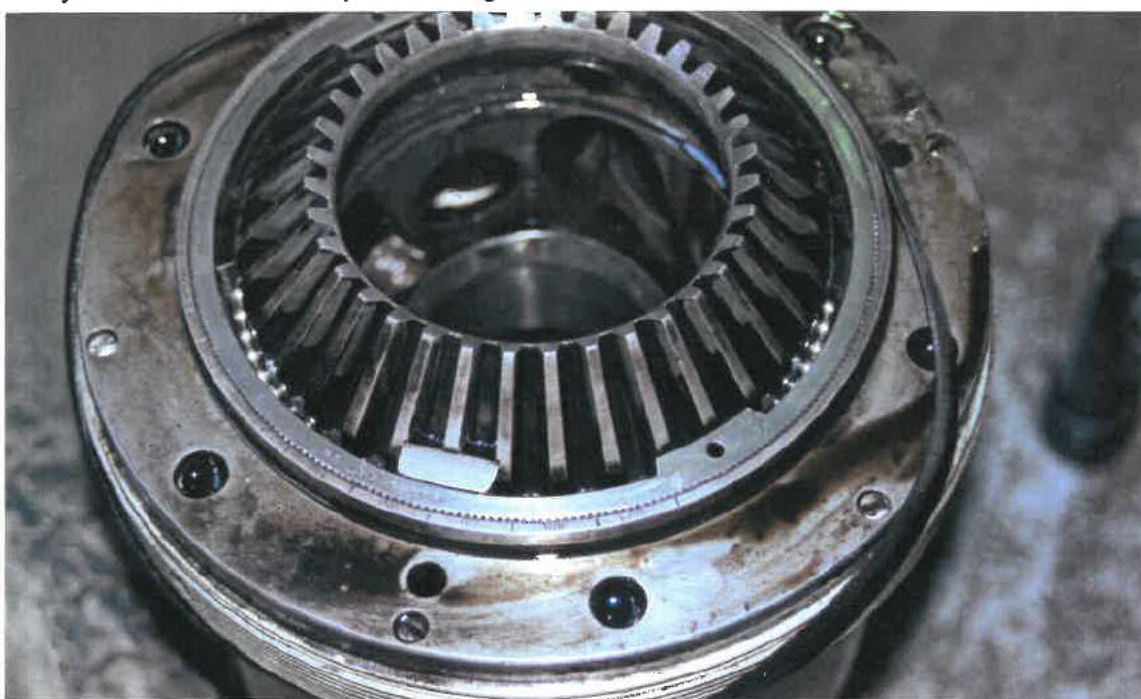
During the aircraft on-site examination it was noticed that the blades were not in the fully feathered position. Readings of the blades pitch angle from the vernier scale on the outside cam and from the scales on two blade butts, no scale was present on the third blade butt, confirmed the blade pitch angle to be 65 - 66° - see Figure 1. The pitch angle of the fully feathered blades should be 88°. Neither the blades nor the hub exhibited any obvious damage likely to effect the blades pitch setting.

Figure 1: The vernier scale on the outside cam with feather stop giving blade pitch angle of 65 - 66°.

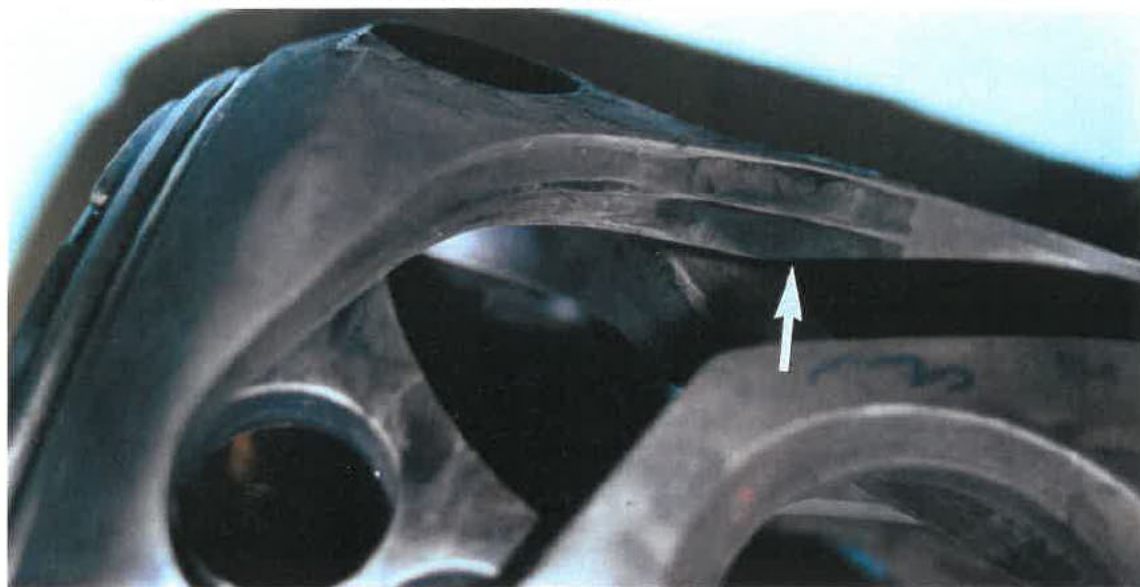
- Both the internal and the external cams to rollers contact surfaces contained heavy contact marks extending along the blades operational range. The fine pitch to cruise pitch range contained the heaviest marks - see Figure 2. All four roller assemblies rotated freely and contained no flat spots. The depth of marks would require the cams to be overhauled before they could be placed back into the service.

Figure 2: Contact marks on the outside cam.

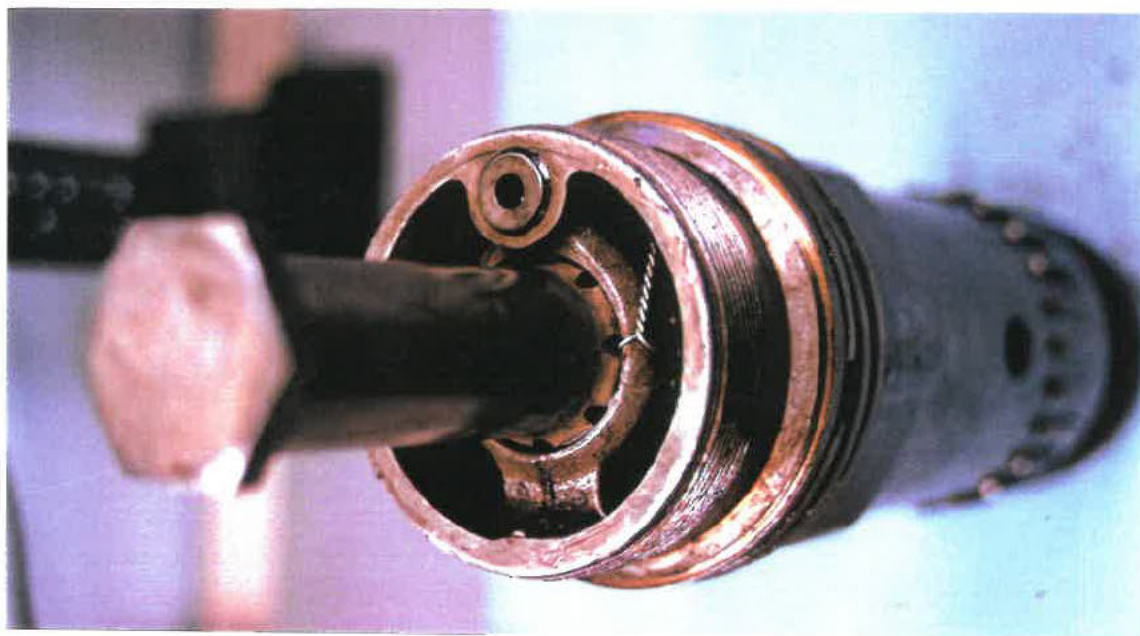
Apart from the light DV surface corrosion there was no other damage present. The spring housing was lock wired, its position relative to the DV body is shown in the Figure 3. On removal, the spring showed nothing abnormal, its constant was not measured. The spring facing side of the washer placed between the spring and the valve contained a substantial amount of sludge. The valve fitted snugly into the DV body, once removed it showed no evidence of abnormal wear or any other damage. As far as it could be examined, without considerable DV disassembly, the valve lands were in good condition. There was no evidence of any port having been restricted or of any wear, corrosion or cavitation damage between any two ports. No apparent wear to the relief valve, likely to affect its function, was found.

Figure 3: Position of the spring housing relative to the DV body.

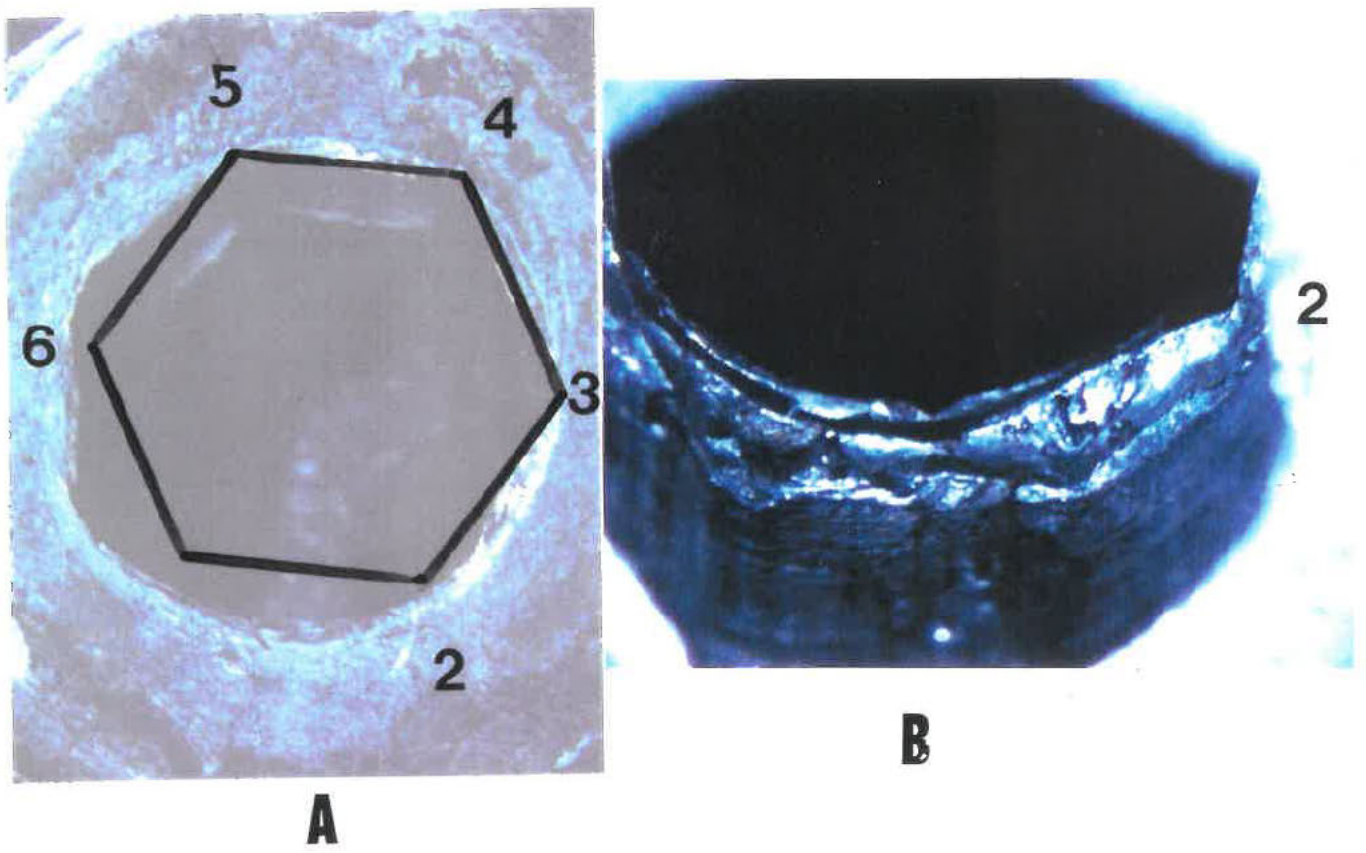
The pulley was placed on the shaft with the mark No 5 aligned with the mark on the shaft, this being the normal service position. The pulley was then rotated by the hand while it was simultaneously pushed towards the governor. It could be turned by some 40 - 45 ° in the clockwise direction i.e. from the position No 5 to the position No 4 - see Figure 5. Note, that in order to adjust the governor, the pulley had been placed from the position No 5 to the position No 6 i.e in the anticlockwise direction. It is thus considered likely that the pulley could have rotated on the shaft when the tension was applied to the propeller pitch control cables during the engine separation at impact.

Figure 4: A) The amount of the pulley wear and distortion of its original hexagonal shape is highlighted by the comparison with the superimposed shaft hexagonal profile. Also marked are the corresponding pulley index marks.

B) Wear of the hole when viewed from the inside. The original hexagonal shape of the hole is outlined by the white markers.

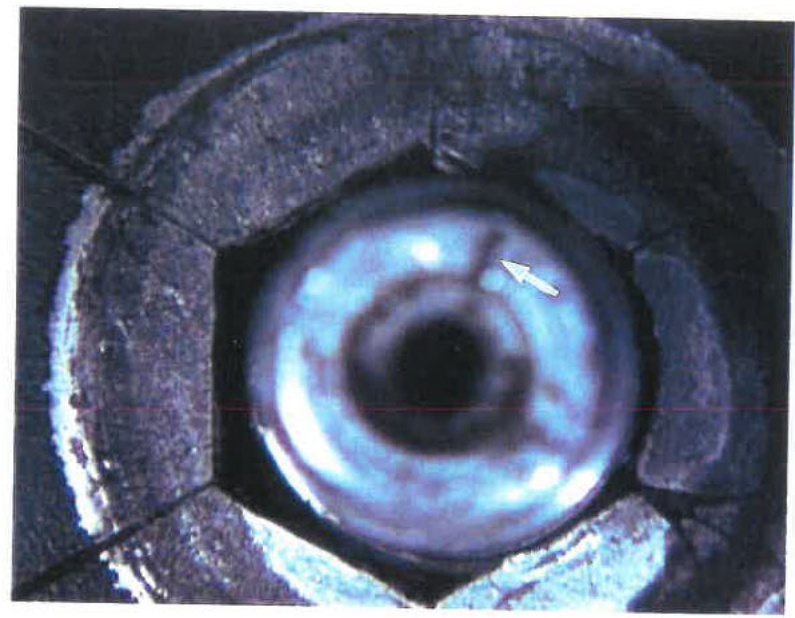
Figure 5: The amount of the pulley free rotation on the governor shaft due to the pulley hole excessive wear.

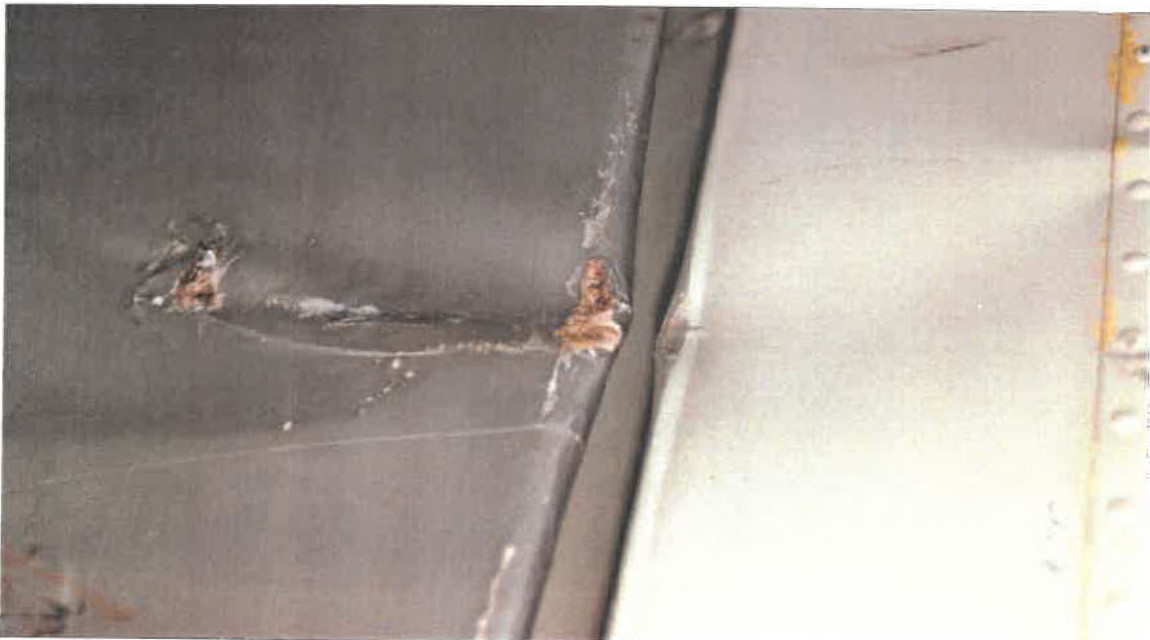
- Left aileron; there was a mark on the wing lower surface, about a metre from the tip, extending onto the aileron surface. The marks could only be matched if the aileron was placed in or close to the neutral position. However, there was no evidence allowing to ascertain whether the mark was made during the ditching or the recovery stage - see Figure 1.

Figure 1: Mark on the aileron and wing lower surfaces.

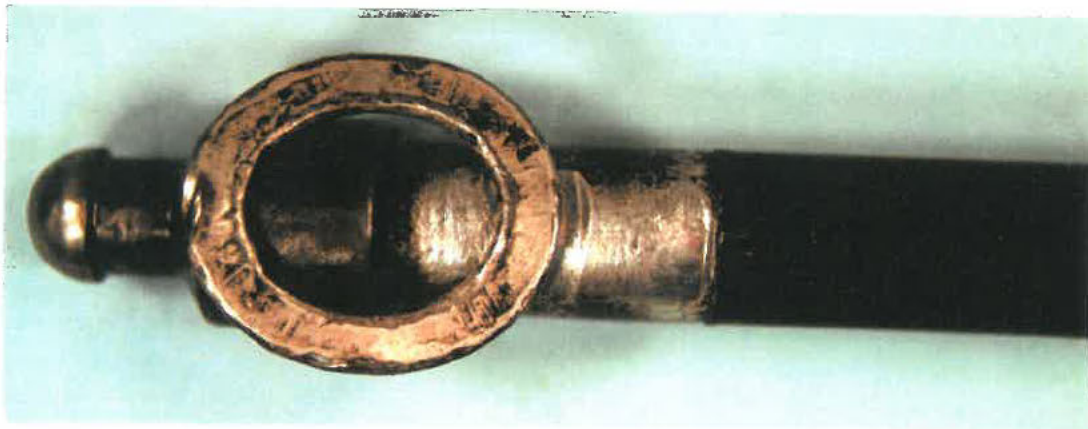
The washer was deformed into an ellipse and was bent in its plane. It contained three fresh marks, two could be matched with the push rod upper end fitting, the third one matched with the inside edge on the rocker arm half balled end. The rocker arm side of the push rod contained heavy rub marks, two of them penetrated deep into the rod surface. Their curved edges matched with the shape of the washer - see Figure 7.

Figure 7: Deformed washer and deep rub marks on the push rod.

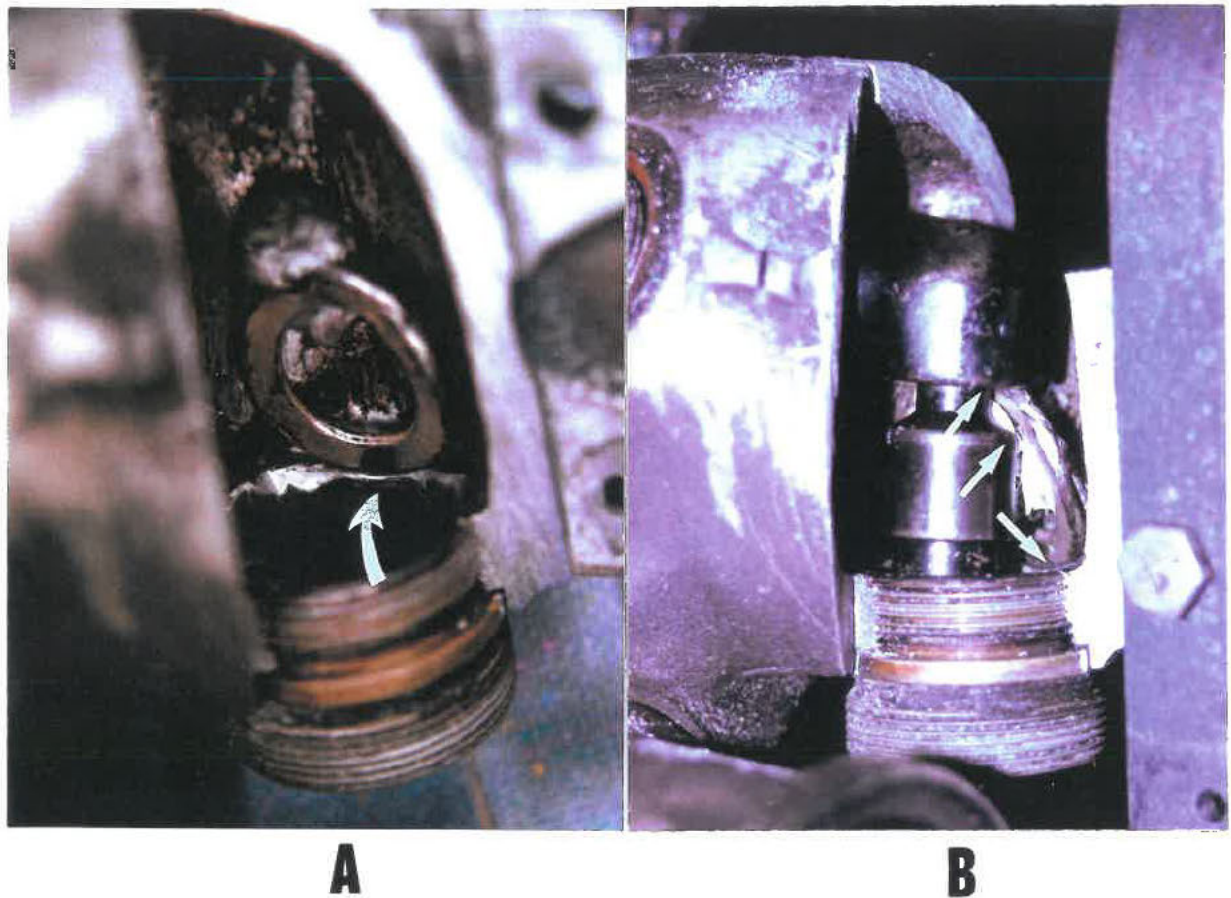
This is likely to cause the manifold pressure to fluctuate considerably, reflecting the cylinder power cycle pressure peaks. Further, it is possible for the mixture in the intake manifold to become ignited, depriving the remaining cylinders of fresh air/fuel mixture. The overall effect being the loss of engine power and irregular running.

Figure 8: A) The mark on the edge of the push rod entry hole. Its shape matched the shape of the washer.
 B) The washer with one end thrusting against the push rod entry hole edge, while the opposite end is jammed between the rocker arm and the push rod upper end. To facilitate demonstration, blutack was used to hold the washer in place.

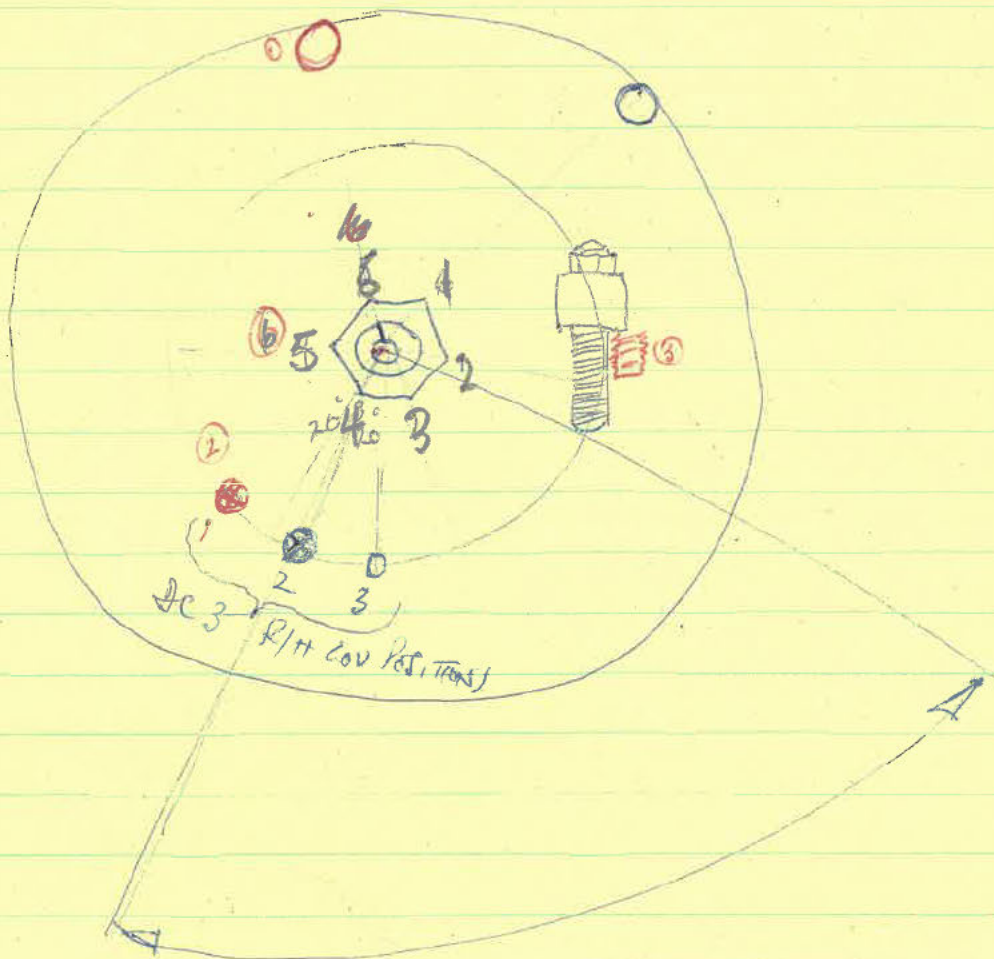
At Round - (PULLEY) SITTING IN NULL POSITION BETWEEN LOCK & R/W

TO CORRECT RIGGING ① ROTATE PULLEY 60° ON HEX SHAFT (1 FEET)
ALIGN SERIS MARK WITH NO 6.

- ② MOVE STOP SCREW 1 HOLE CW TO POSITION 1.
- ③ SCREW STOP SCREW ANTI-CW 8 TURNS TO NO POSITION.
