Aircraft flight preparation occurrence involving Boeing 787-9, VH-ZNJ

Melbourne Airport, Victoria on 22 September 2021

ATSB Transport Safety Report

AO-2021-040

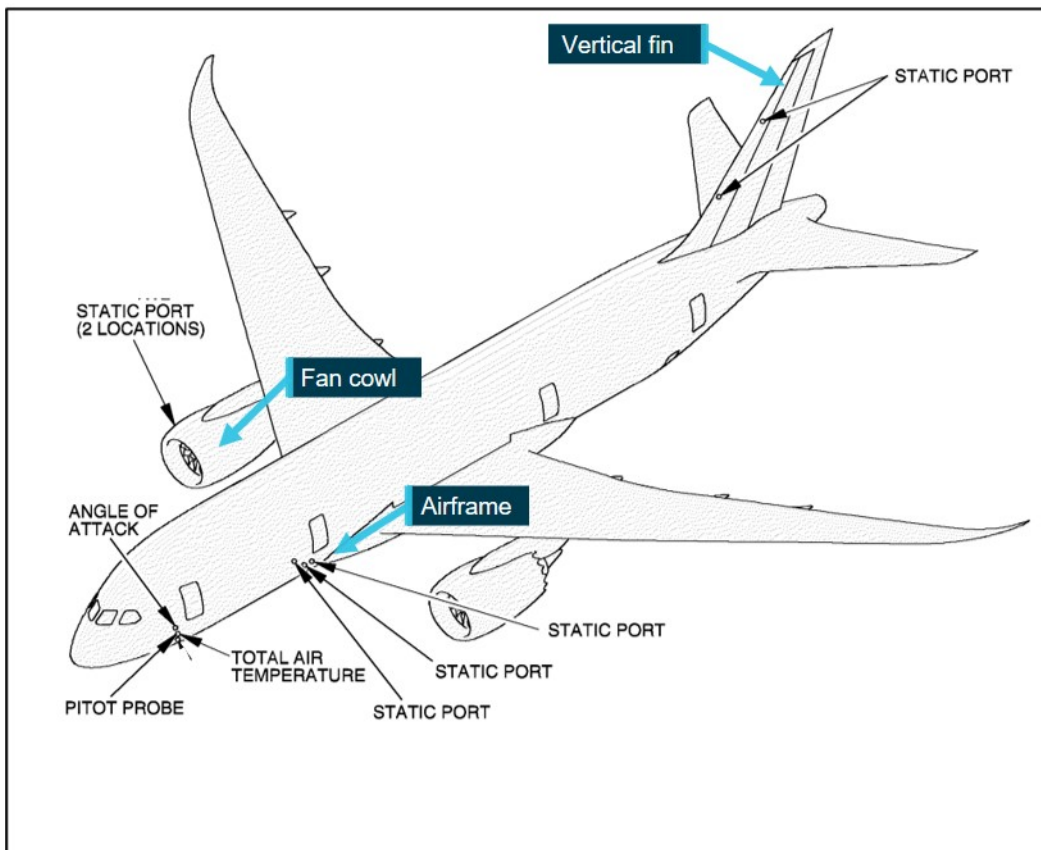
Figure 1: Static port locations (duplicated on the opposite side of the aircraft)

- 6 fuselage, 3 each side
- 4 fan cowl, 2 per engine (located at approximately the 4 and 8 o'clock positions, with the fan cowl ground clearance between 68 and 80 cm)
- 4 vertical fin, 2 each side.

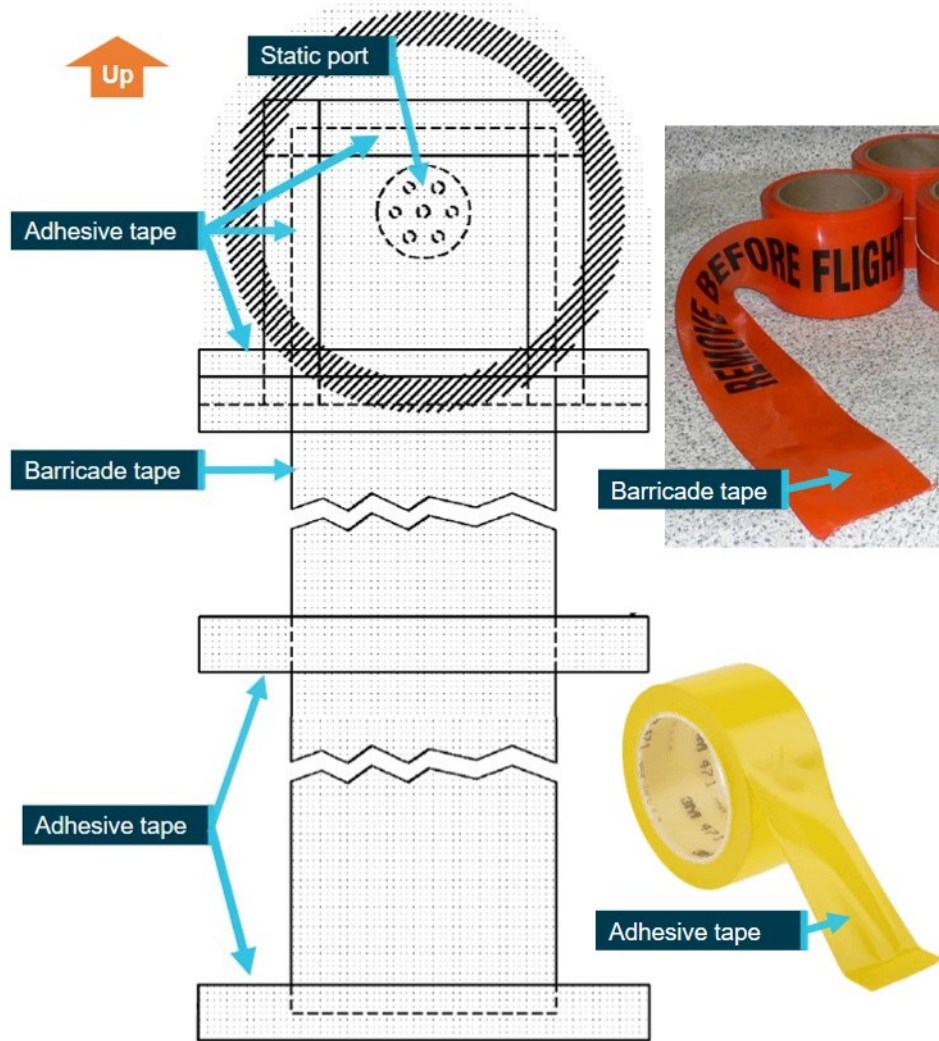
Figure 3: Boeing static port cover procedure

The Boeing procedure for covering all the static ports described placing one end of a metre-long piece of barricade tape⁶ over the port (Figure 3). Adhesive tape sealed the top and sides of this end to the fuselage or cowl. Adhesive tape was then placed over the barricade tape at the bottom of the port, leaving an opening for moisture to drain. Finally, adhesive tape was to be applied to the barricade tape, about half length, and at the bottom end.

Boeing advised that, taping down the end of the barricade tape was intended to prevent it being torn from the fuselage by strong winds. The use of 1-metre-long red barricade tape, along with the yellow adhesive tape, was to enhance the visibility of the static port covers. Further, Boeing advised:

- Boeing’s static port cover procedure involving the taping down of the ‘streamer’ tail, although intended to prevent it being torn from the fuselage in strong winds, likely reduced the visibility of the fan cowl static port covers.

Boeing advised that, to increase visual awareness that the fan cowl static ports have been covered, they will add a procedural requirement to maintenance manual procedures that a warning tag be added to the flight control wheel specifically stating, 'engine static ports covered'. The revision is scheduled for release in June 2022.

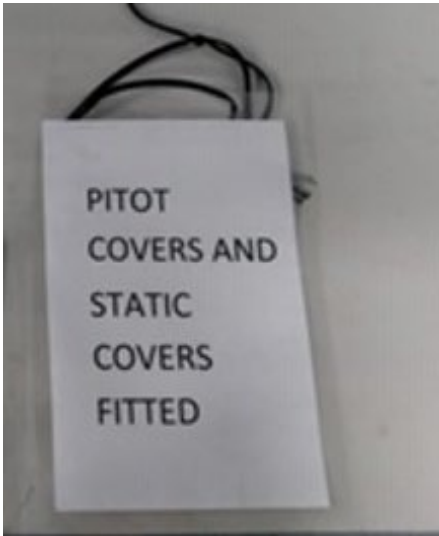
Figure 4: Control column warning placard

The JIC for parking between 24 and 72 hours prioritised certain tasks from the Boeing procedure, including fitting landing gear downlock pins, setting flight controls to neutral selections and electrical power deactivation.⁸ Pitot probe and static port covers were to be installed 'as soon after arrival as possible'. The task 'cover the static ports' and 'attach *static ports covered* tag', referenced the applicable section of the AMM. Qantas utilised a locally manufactured sign for the flight deck, which combined the two tags into one placard (Figure 4).

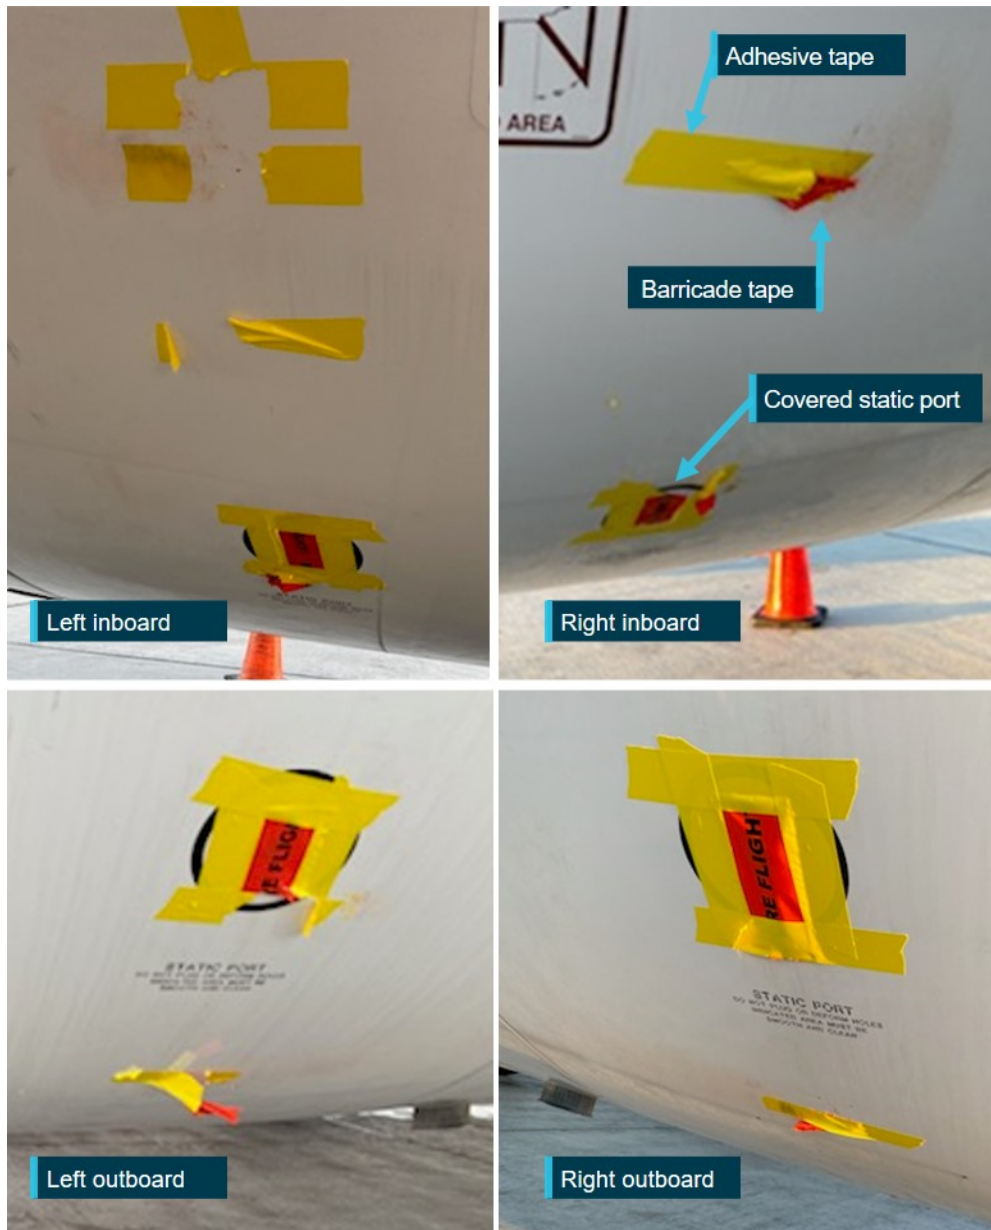
Figure 5: VH-ZNJ on arrival at Los Angeles, showing remains of fan cowl static port covers.

Images of the covers on the 4 fan cowl static ports taken post-flight showed that while the ‘tail’ of the barricade tape was missing, the remaining adhesive tape was consistent with the Boeing static port cover procedure. The only exception being the inboard ports were covered with the tail oriented up, in line with LAME 1’s actions (Figure 5).

The static ports were still covered however, the remains of the ‘tail’ can be seen in the images. In addition, the images show that the inboard port covers had the tail oriented up with the outboard covers oriented down.
 Source: Qantas, annotated by ATSB

- Tape covering the 4 engine fan cowl static ports was not removed by engineering, as per the manufacturer’s procedures, nor identified by flight crew or dispatch during pre-departure checks. This resulted in the aircraft departing with reduced redundancy to the engine electronic control system.
- Qantas procedures did not identify all of the aircraft’s static ports and the procedure for restoring the aircraft back to service did not reference Boeing procedures. This allowed different interpretations of which ports would be covered.

- Amended job instructions cards to link with Boeing maintenance procedures and identify static port locations.
- Memo issued to engineering personnel highlighting the fan cowl static port location on the 787 aircraft.

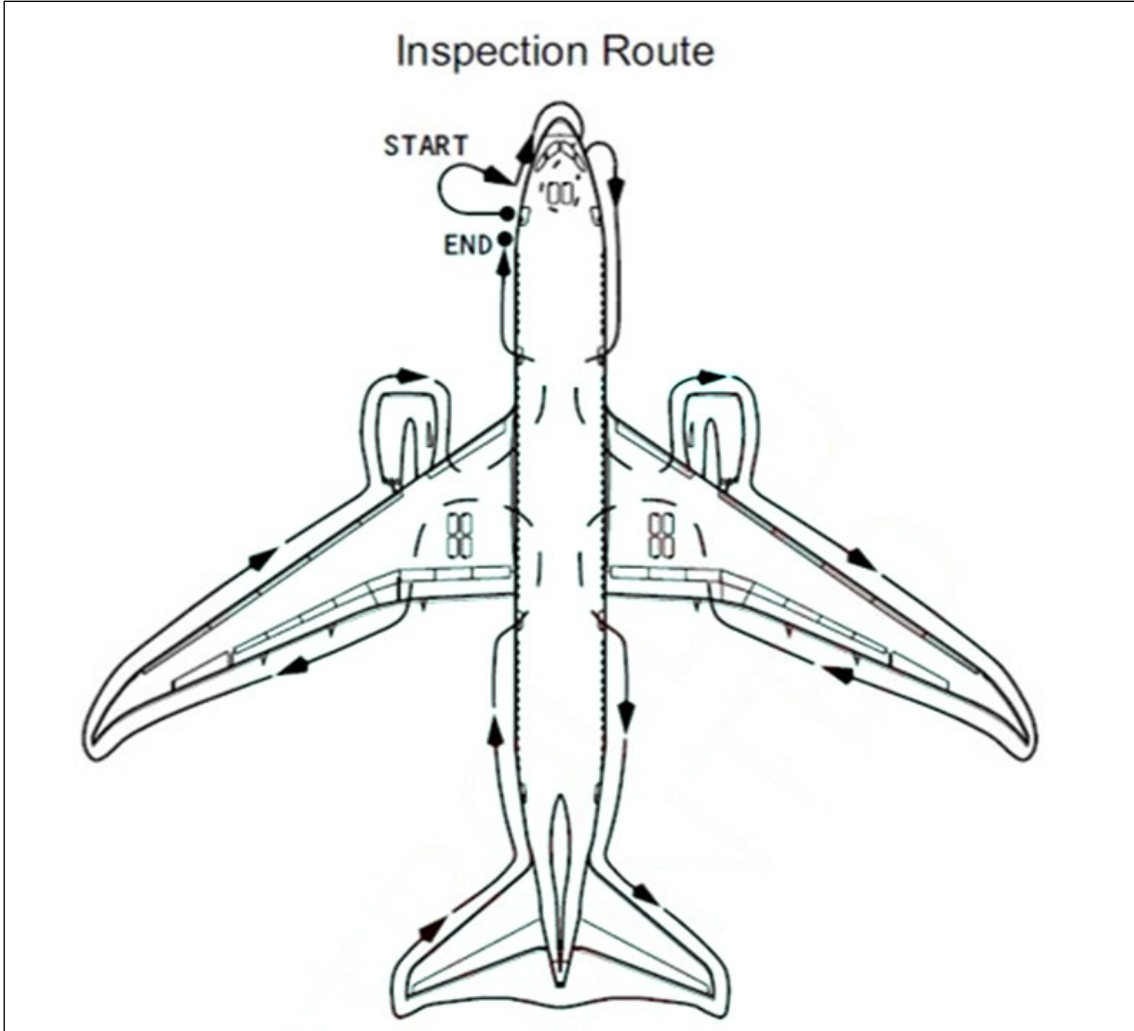
Figure 6: Exterior inspection route

- the SO and the dispatcher did not conduct their exterior inspections in line with the documented procedures and exterior inspection route.
