Near collisions involving Piper PA-28-151, VH-SEW; Cessna 172, VH-JBC; and Cessna 182, VH-BMS

overhead Parramatta, New South Wales, on 15 April 2020

ATSB Transport Safety Report

AO-2020-024

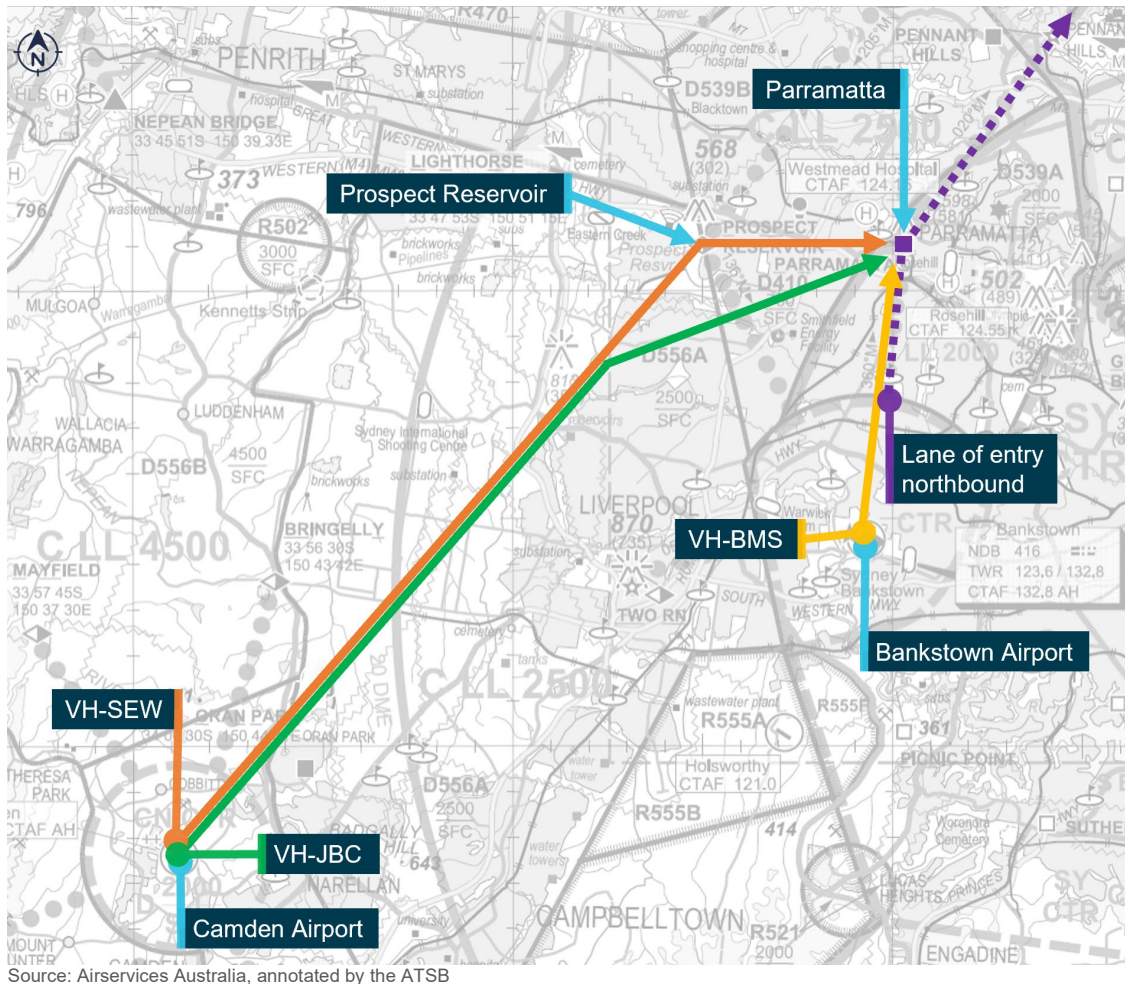
Figure 1: Approximate aircraft flight paths

Figure 1 shows the approximate tracks of the 3 aircraft.

At about 1330, the instructor in JBC identified traffic (being SEW) in the 9 o'clock⁶ position and confirmed this with the student pilot. Shortly after, the instructor observed SEW descend 'rather sharply' and they lost sight of the aircraft in the urban background. The student pilot slowed the aircraft before the instructor observed SEW climb from the left and in front of JBC in close proximity. The instructor took control of the aircraft and manoeuvred to avoid SEW. The pilot of SEW reported that they had not seen any other aircraft operating in the area at that time. Air traffic control radar data showed that SEW and JBC were both at 1,900 ft, with a minimum horizontal separation of 0.2 NM (0.4 km).

As BMS approached Parramatta, the student verbally indicated that they had sighted 2 aircraft ahead (SEW and JBC). The student elected to maintain 1,700 ft. They continued up the LOE and commenced overtaking JBC. However, the manoeuvre made by JBC to avoid SEW put JBC in close proximity to BMS. At about 1331, the radar data showed a minimum vertical separation of 200 ft and horizontal separation of 0.2 NM (0.4 km) between JBC and BMS. The instructor of JBC then requested flight following⁷ from Sydney Centre to assist with their awareness of other traffic.
