Derailment of freight train 9281

Near Charters Towers, Queensland, on 30 December 2020

ATSB Transport Safety Report

RO-2020-023

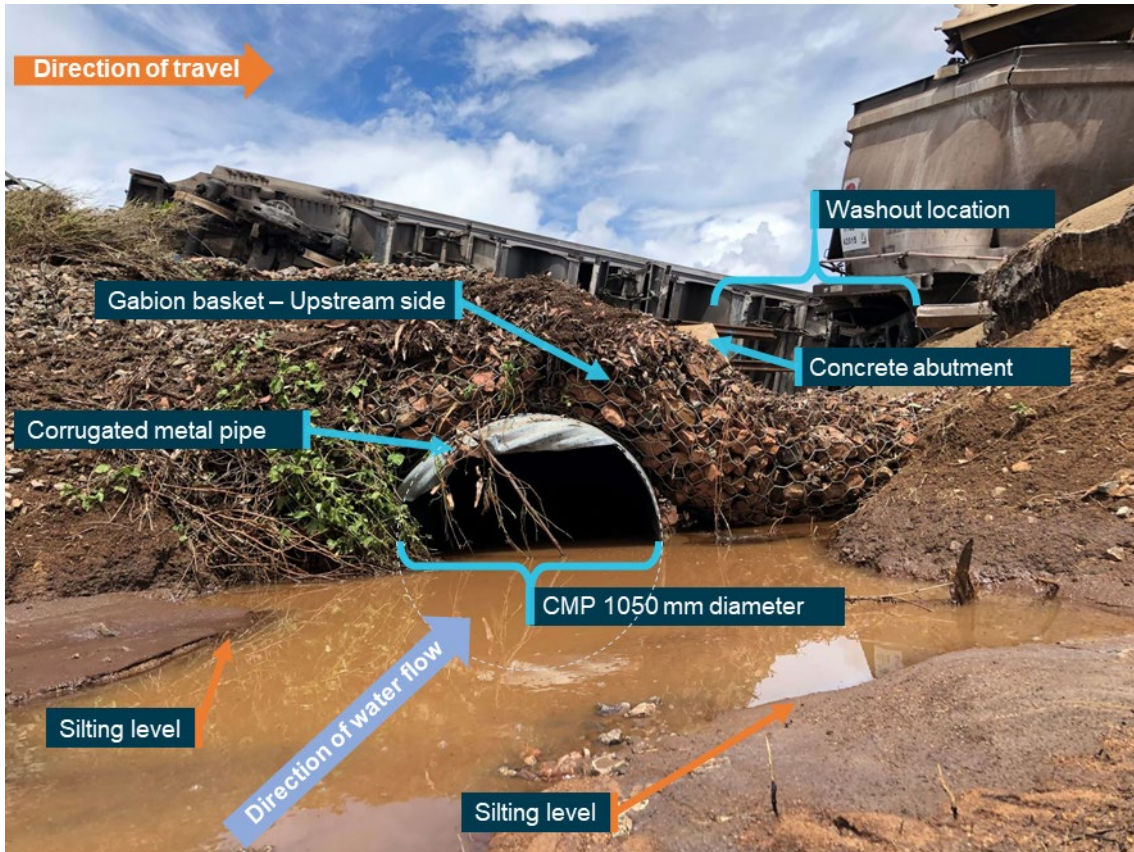
Figure 2: Washout location

Evidence collected by Queensland Rail at the site of the derailment indicated it was the result of a washout of the track infrastructure. The washout was on the downstream beside a culvert and uncovered an old concrete abutment within the foundation (Figure 2).

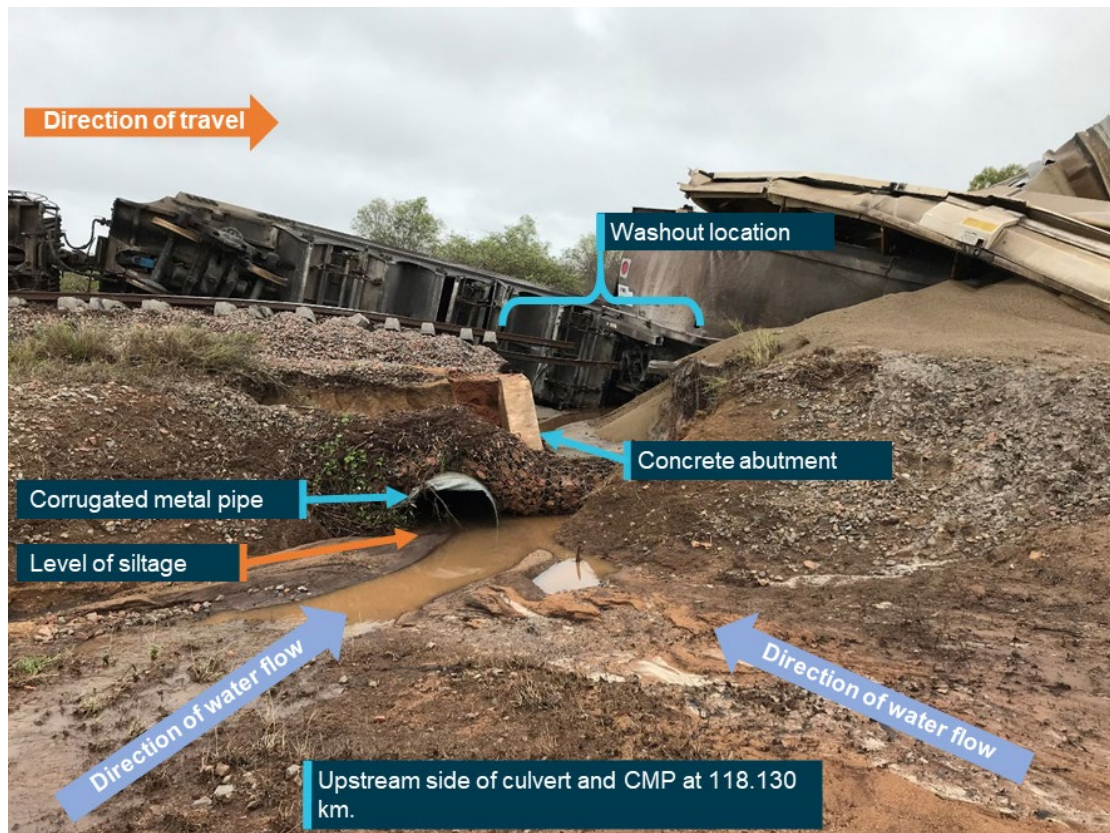
Figure 8: Drainage system

chainage was of a cross drainage design (Figure 7) with water flowing from a catchment area into longitudinal drains and progressing through a single CMP under the track infrastructure. The CMP was about 3 m below the rail head height (Figure 8).

Between 30 March and 29 April 2020, the CMP at the 118.130 km to 118.131 km was identified as scouring and sinking, which was the location of the derailment. A corrective work order further noted that the gabion baskets on the right side were rolling off the CMP. The CMP was also noted as scoured and sinking on the right side, which was clarified by Queensland Rail as the downstream side of the CMP.

The sinking of the CMP would restrict the outflows of any rainwater that would be diverted to the culvert from the local catchment area. If the CMP was restricted, the design flows would be reduced, and rainwater would pool if input flow from the catchment exceeded the output flow. The report of sinking on the northern side indicated that the CMP was sinking on the downstream side, which suggested that the siltage would be at a greater depth at the outlet.

The work order stated the gabions were to be removed and replaced with two 4 m by 1 m by 1 m gabion baskets. This work was given a low priority of 26 weeks, which was in accordance with the CESS. The work order was closed at the time of the derailment, which indicated that the work had been completed. While the replacement of the gabion baskets would alleviate the scouring around the formation, they would not address the sinking of the CMP.

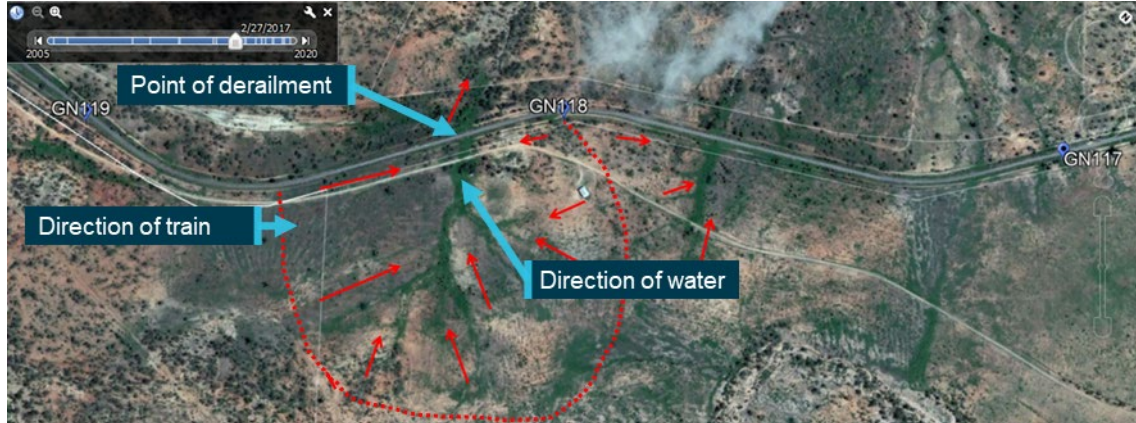
Figure 9: Drainage catchment system

The catchment area, south of the derailment site, as provided by Queensland Rail in their preliminary hydraulic assessment,⁶ was about 30 ha (300,000 square metres, Figure 9 dotted red line). Within a 30-ha catchment area, this would have produced about 23,400 m³/h, or 6.5 m³/s (based on 78 mm/h).⁷

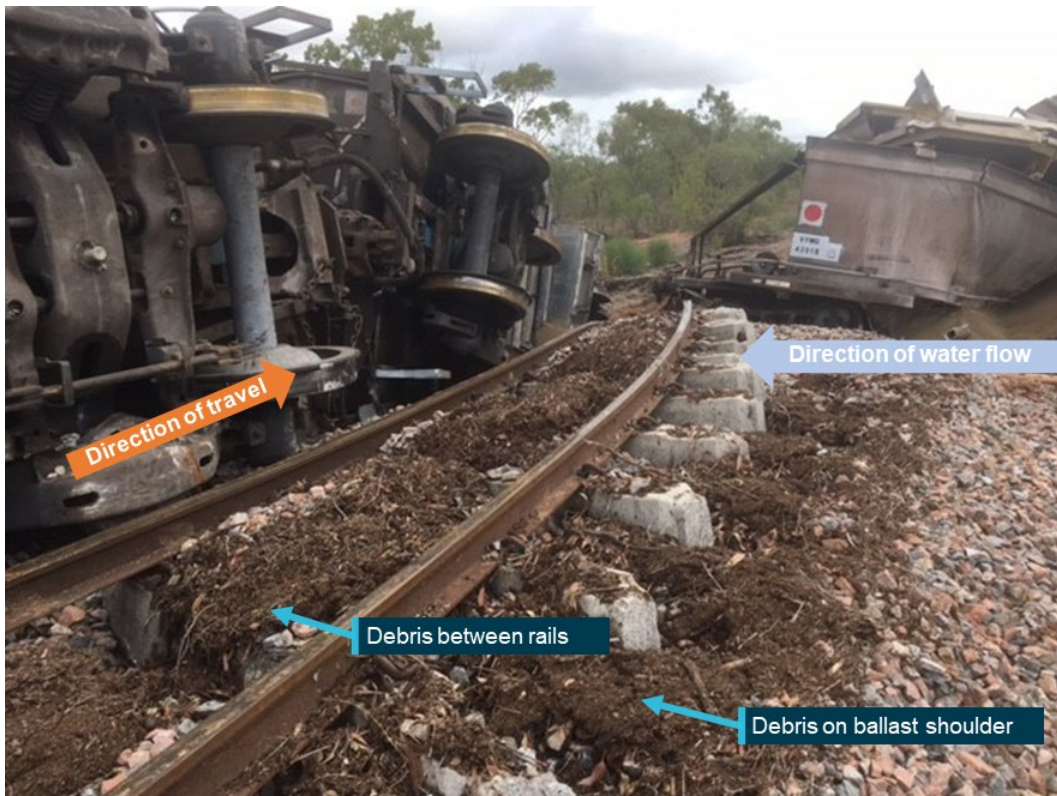
Figure 10: Evidence of debris on ballast shoulder and between rails

Photographs provided by Queensland Rail show that there was debris located on the ballast shoulder on the upstream and downstream side of the track and between the rails, which indicated over-topping of the track infrastructure at that location (Figure 10). Water over-topping of the rail would likely create a waterfall effect and scouring on the downstream side of the track infrastructure (Figure 11). The waterfall effect could also cause the gabion baskets on the downstream side to slide over the exit of the CMP, thereby further restricting the outflows from the CMP.
