Collision with terrain involving Cessna A150M, VH-CYO

5 km west-south-west of Peachester, Queensland, on 23 June 2021

ATSB Transport Safety Report

AO-2021-025

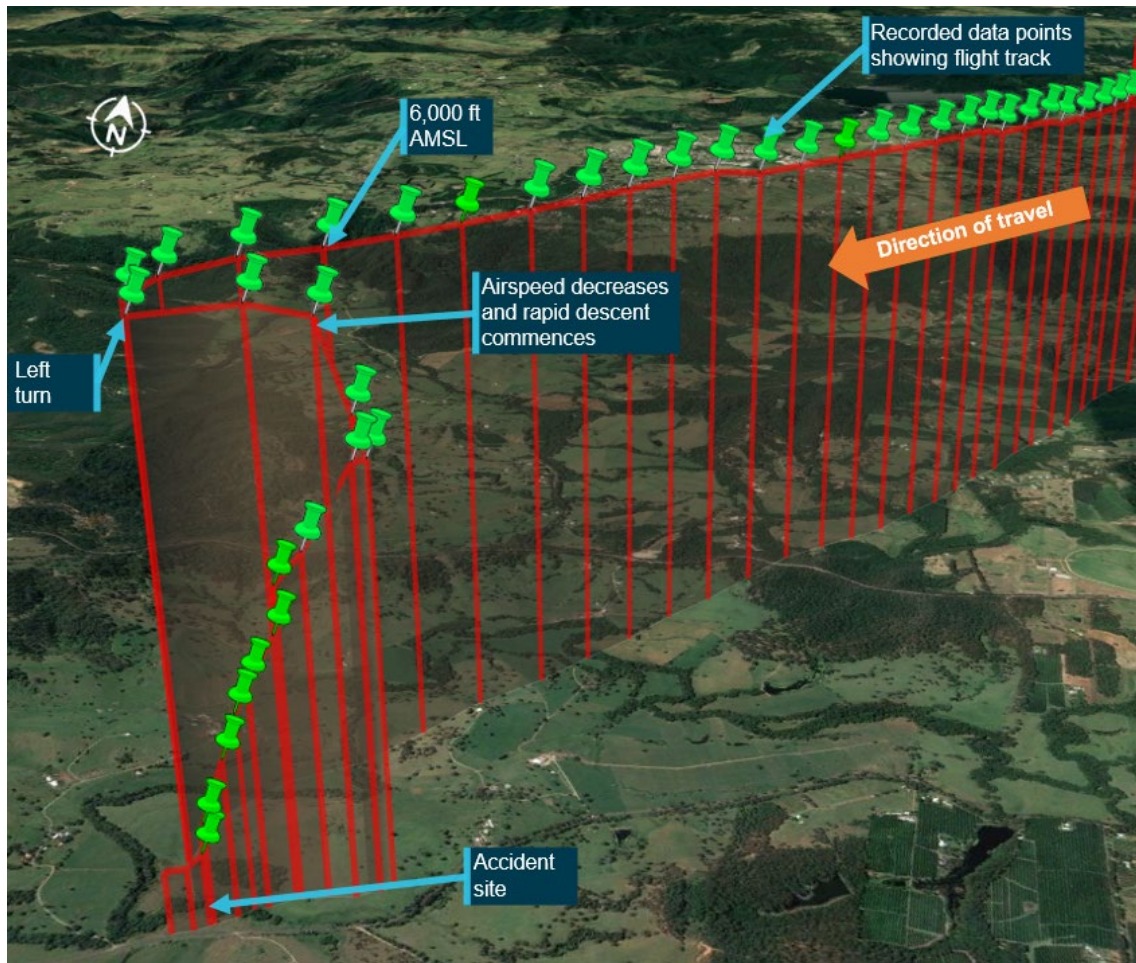
Figure 2: VH-CYO last 3 minutes of recorded flight data viewed from the left and above

Figure 2 shows recorded radar data for the last 3 minutes of the flight. It indicated that, within the last 90 seconds, the aircraft conducted a 180° left turn, decelerated while maintaining altitude, and then descended rapidly, with the point of descent beginning at 5,800 ft above ground level (AGL). That manoeuvring was indicative of the planned entry into a spin.

At about 1122, 55 seconds after the initiation of the spin, the aircraft impacted terrain. The aircraft was destroyed, and the 2 occupants were fatally injured.

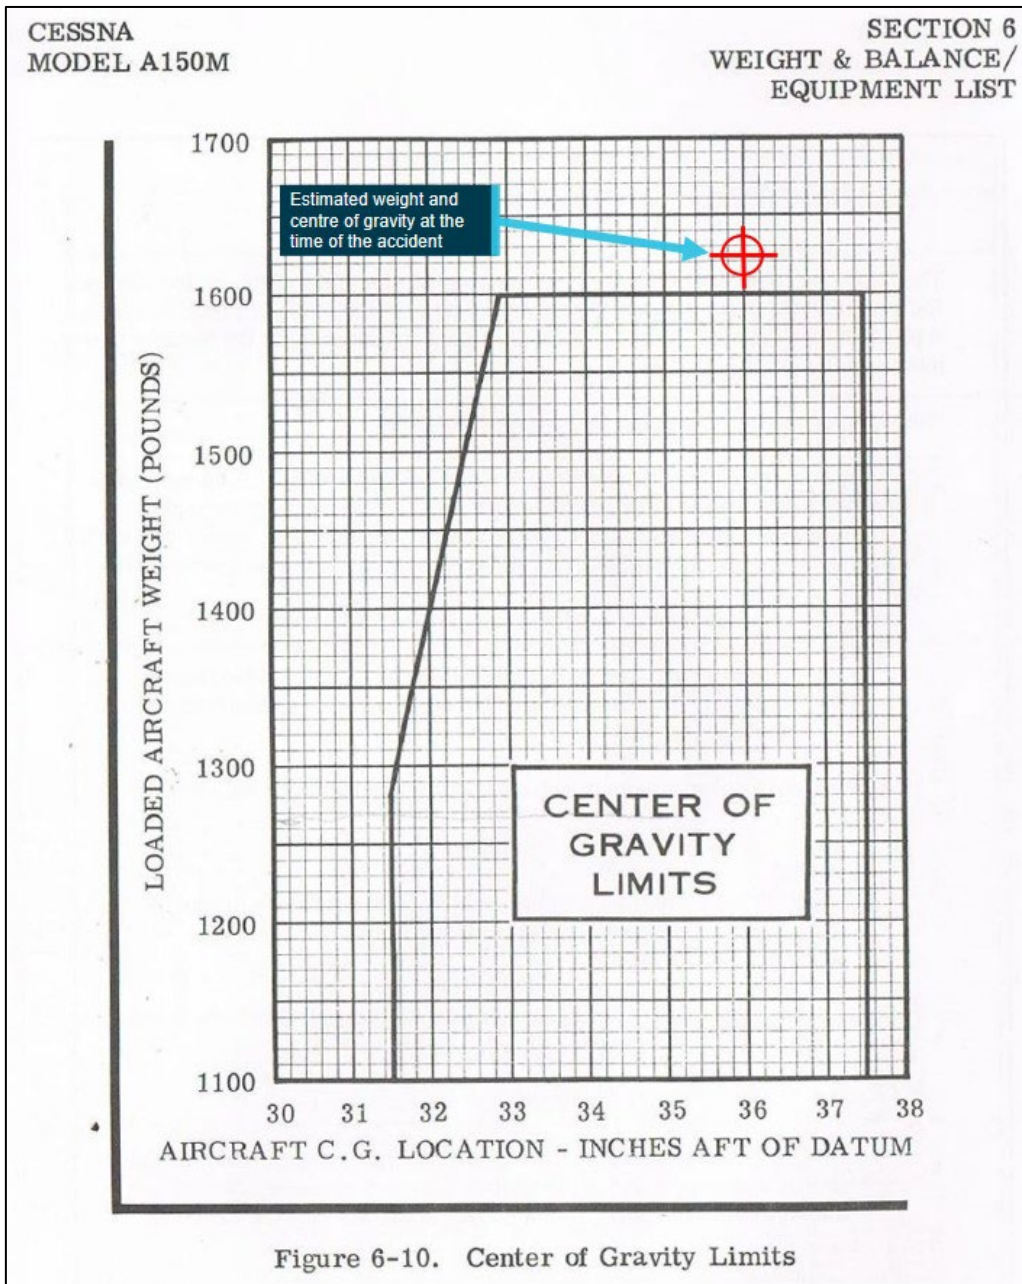
Figure 4: Estimated weight and balance

Taking into consideration the aircraft’s calculated weights at take-off, and at the time of the accident, a centre of gravity (CG) calculation could not be carried out, as the aircraft’s weight was outside that of the published CG calculation limits (Figure 4). As the aircraft was over the MTOW, the data was extrapolated outside of the chart limits to get an estimate of the CG location at the time of the accident. The extrapolated value placed the CG aft of mid-range, but well forward of the aft limit.

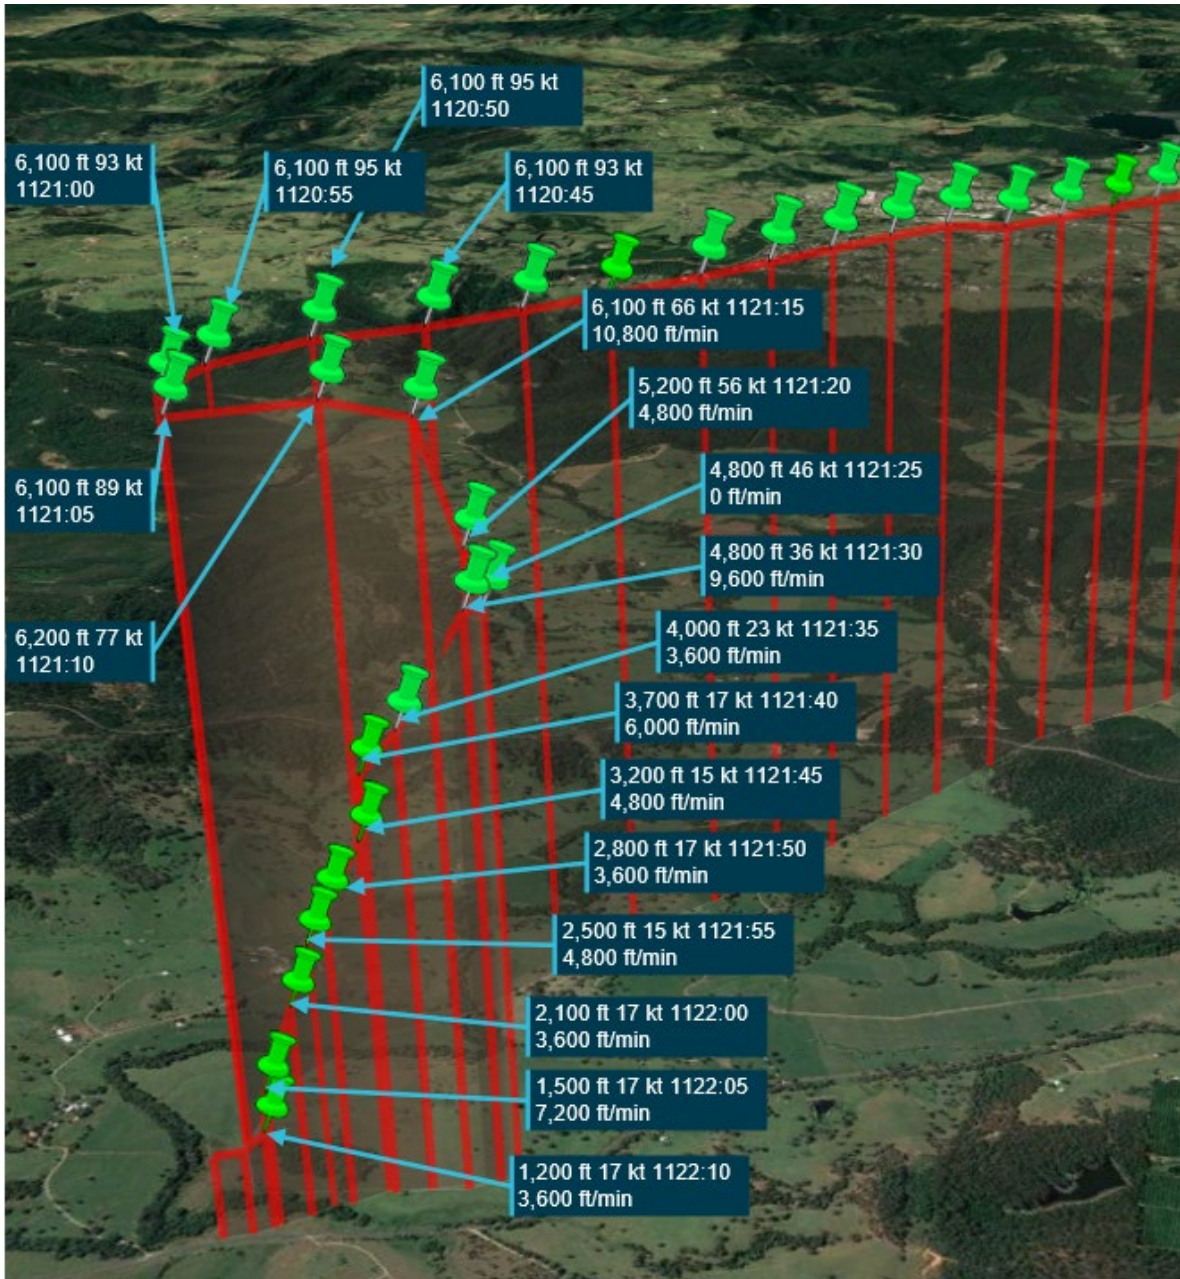
Figure 5: Radar data with timestamp, airspeed, altitude and vertical decent rate labelled

The last 2 recorded data points without pins were considered to be predictive and not an accurate representation of the aircraft position.

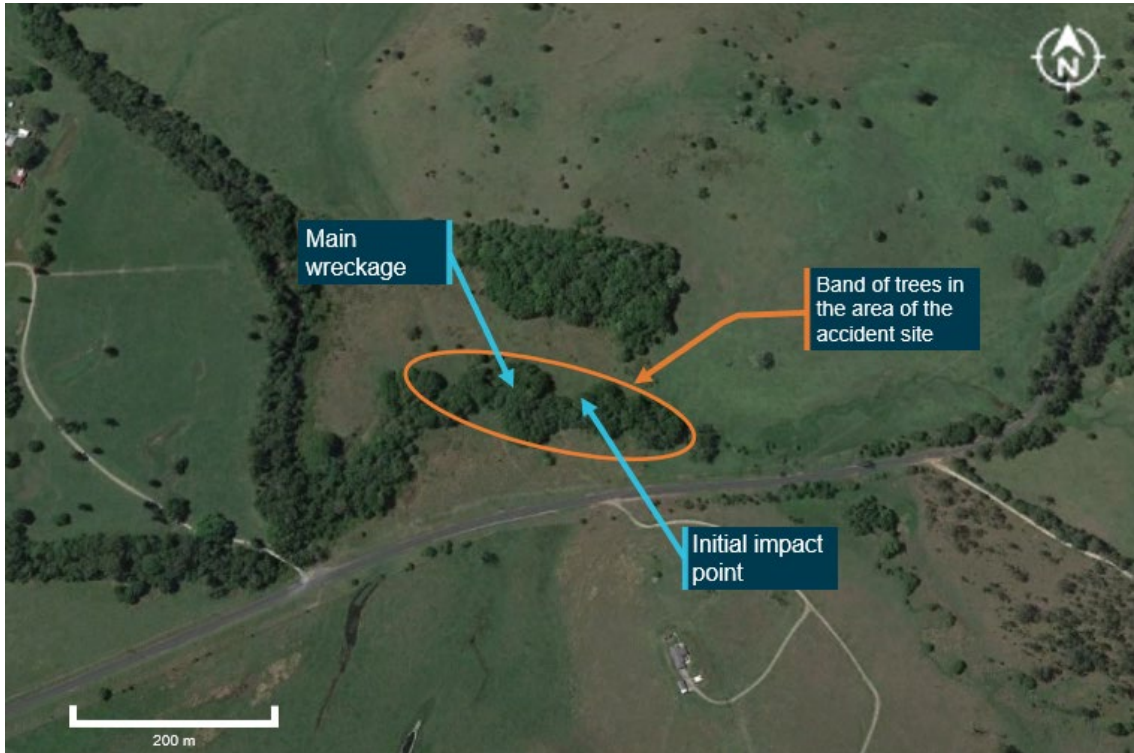
Figure 6: Area of accident site

The accident site was located in a dense stand of trees that stood about 15–20 m high and straddled a creek line in a band about 50 m wide, with open areas of farmland on either side (Figure 6).

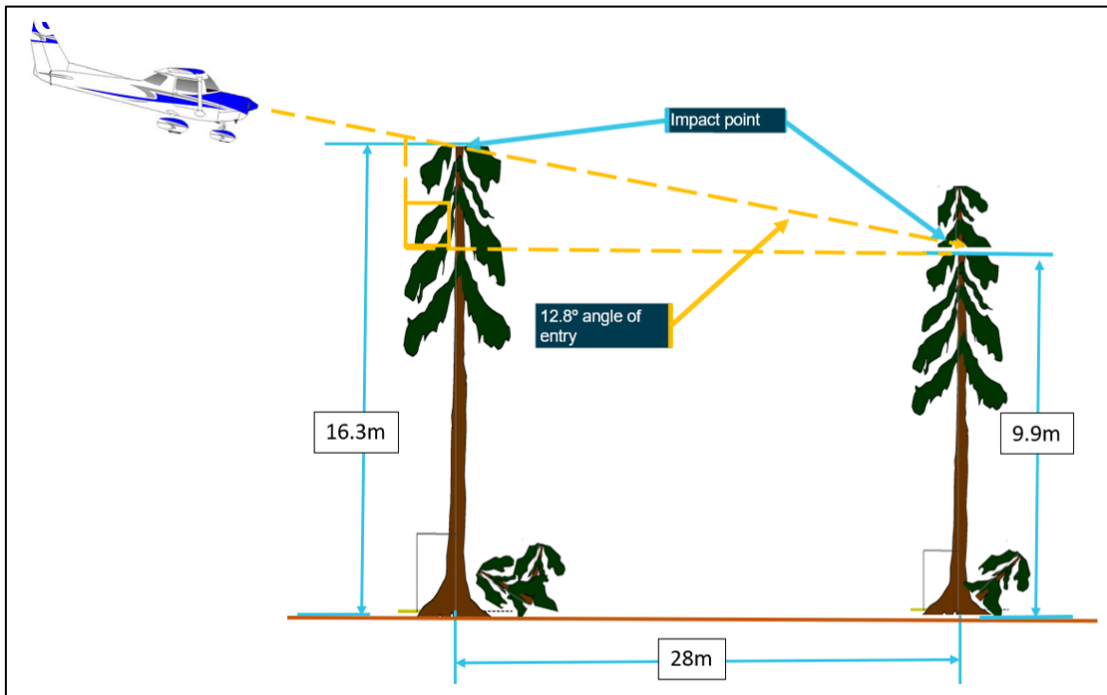
Figure 7: Final flight path angle of entry

The wreckage trail extended about 50 m from the initial tree impact point, until the final piece of wreckage, oriented in an east-west direction. There were several notable tree impact points, including trees that had been broken in half or completely felled by the impact forces. Calculations of the tree impact damage heights indicated the final flight path angle was a descent of 12.8° (Figure 7).

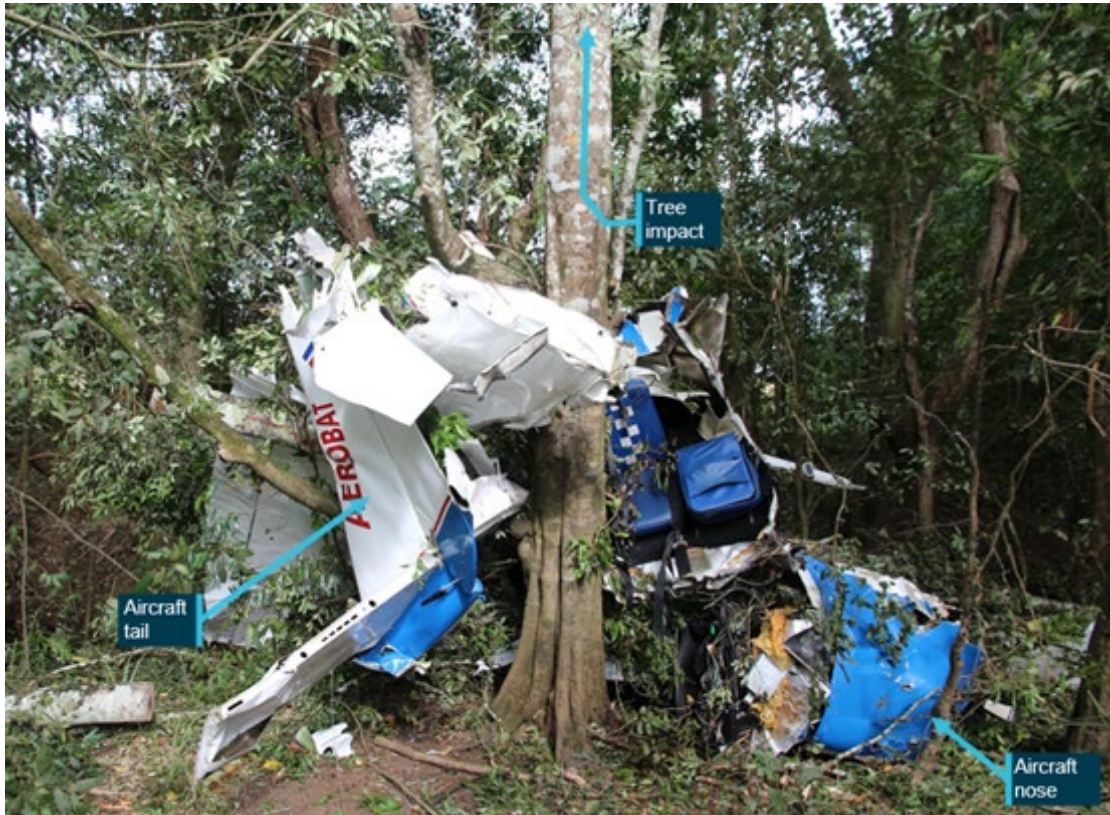
Figure 8: Aircraft main wreckage at the base of a large tree that was struck

The main wreckage came to rest at the base of a tree that was struck at a height of about 10 m. The aircraft structure was significantly disrupted as a result of impacting several trees (Figure 8).

The ATSB conducted an examination of the aircraft wreckage. The examination identified that:

- the disruption to the aircraft and foliage, coupled with the length of the wreckage trail, indicated that the aircraft had significant forward speed at impact
- the flaps were in the retracted position
- the aircraft had no evident pre-impact defects with the flight controls or aircraft structure
- the aircraft was intact prior to impact with terrain
- the engine had no obvious defects upon external examination, was free to rotate and had compression on all 4 cylinders
- the throttle setting was captured at an idle position (full out and bent to one side) during the accident sequence
- the propeller rotational damage signatures were minimal, indicating a low power setting
- both seats were in the full aft position.
