Hard landing involving Kavanagh Balloons B-350, VH-BSW

2 km south of Lilydale Airport, Victoria on 31 December 2021

ATSB Transport Safety Report

AO-2022-003

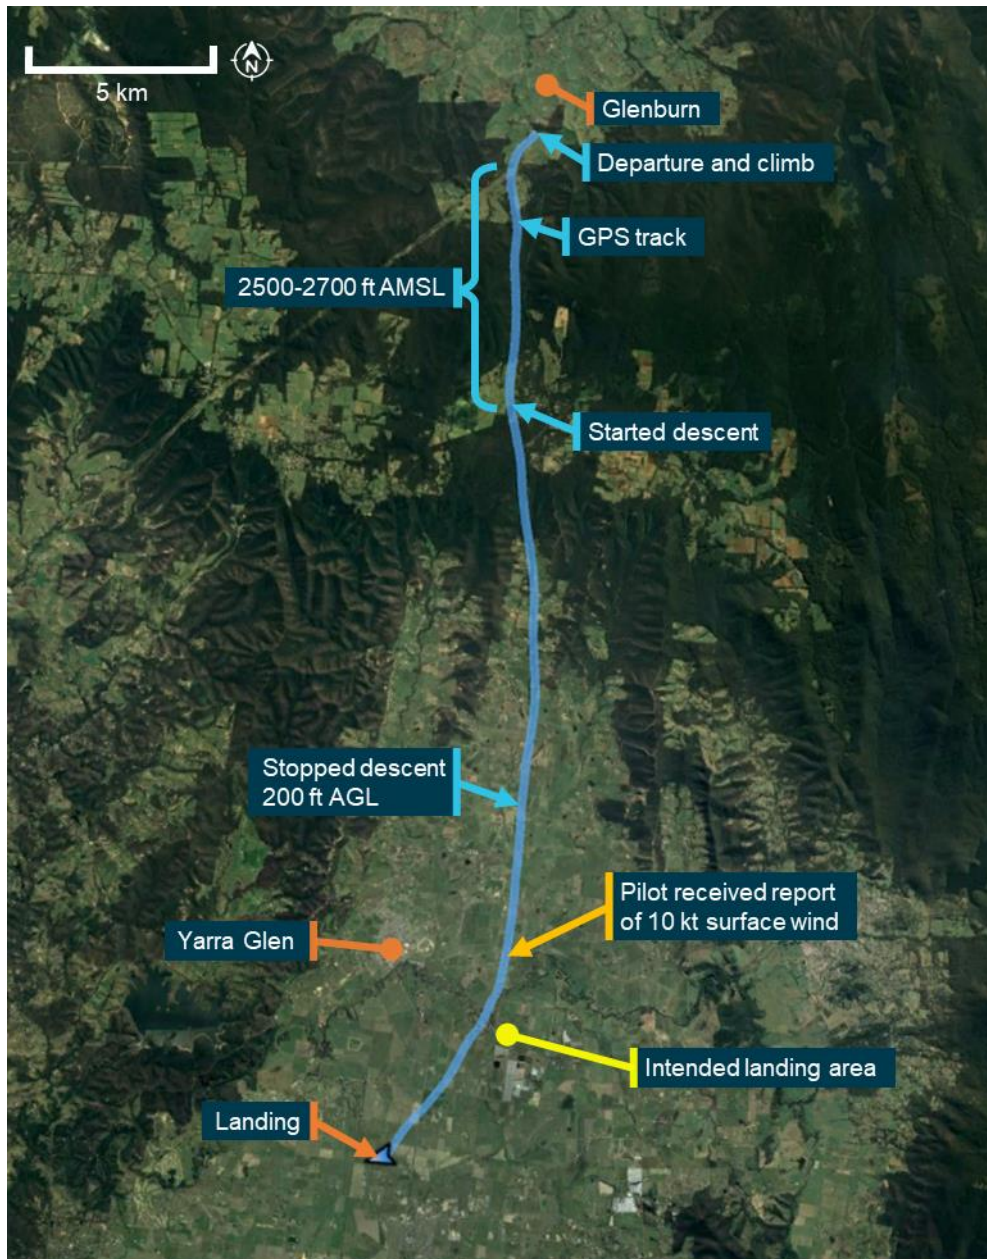
Figure 1: Balloon flight track

At about 0420 Eastern Daylight-saving Time,¹ the pilot of VH-BSW obtained relevant weather information from both the Bureau of Meteorology and another balloon pilot and assessed the conditions as suitable to depart. The pilot intended landing south-east of Yarra Glen (Figure 1).

At about 0629, the pilot heard the radio broadcast of a ground crew member from another balloon operator that the surface winds were increasing to about 10 kt near the intended landing area. At this time, the pilot started looking for landing sites.

At about 0632, the pilot instructed the passengers to take up landing positions and made an approach to the intended landing area. As the balloon descended, the wind turned the balloon west, away from the site, preventing the landing from being completed. The pilot continued to assess landing options over the next 14 minutes (see the section titled *Potential landing sites*). During this time, the balloon's groundspeed varied between 9 and 15 kt.

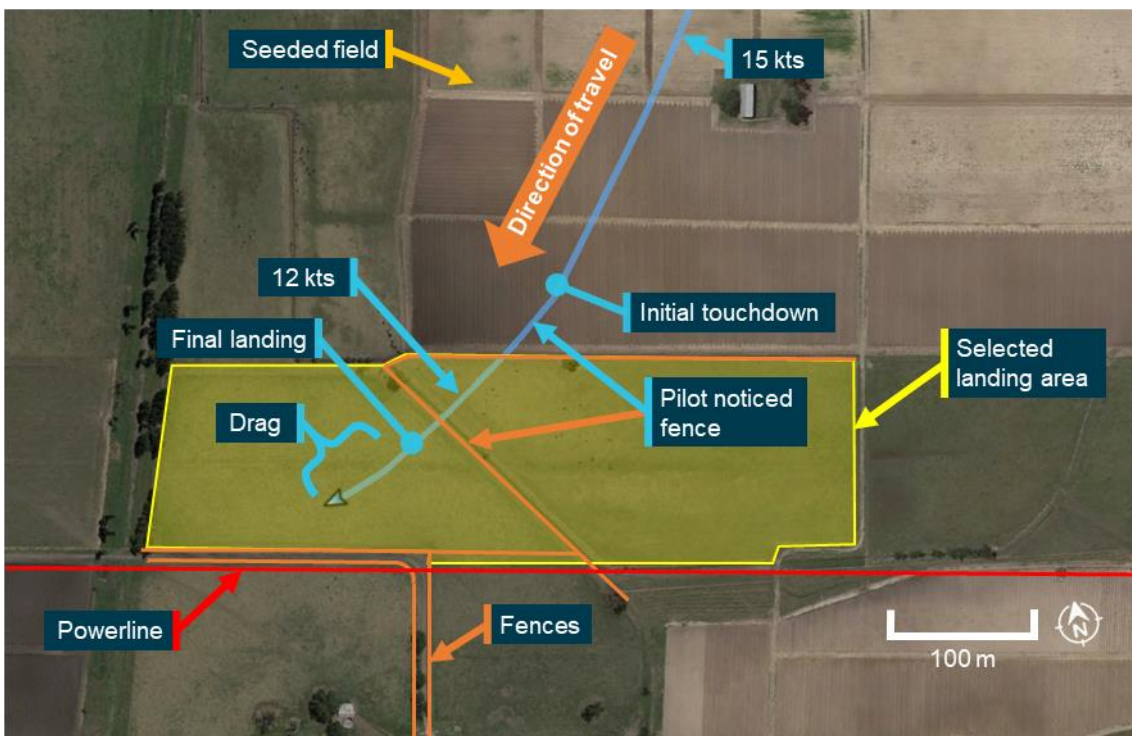
Figure 2: Balloon approach and landing

Shortly after, the balloon started descending faster than the pilot anticipated. The pilot operated the burners but was unable to arrest the balloon's descent and the bottom of the basket contacted the ground. The balloon then started rising so the pilot pulled on its rip line, opening the vent to deflate the balloon (see the section titled *Balloon information*), intending to touchdown over a nearby fence.

After the balloon climbed into the air, the pilot noticed another fence running diagonally across the intended landing area along the flight path. The pilot held the rip line to maintain the size of the vent opening, and the balloon continued over this fence, reaching a height of about 40 ft. The pilot then resumed pulling the rip line, opening the vent further and the balloon descended rapidly, landing hard in the field at about 0648. After the basket touched down, it tipped over and was dragged for 30-40 metres along the ground before coming to rest.

Further complicating the situation was the late identification of a fence during the approach. This fence needed to be manoeuvred over and probably contributed to an increase in the maximum height that the balloon reached after the first touchdown. With the relatively high wind conditions and the distance to the powerlines reducing, the pilot pulled the rip line further resulting in the rapid descent and hard landing. While undesirable, the hard landing was the safer option instead of risking contact with the power lines.

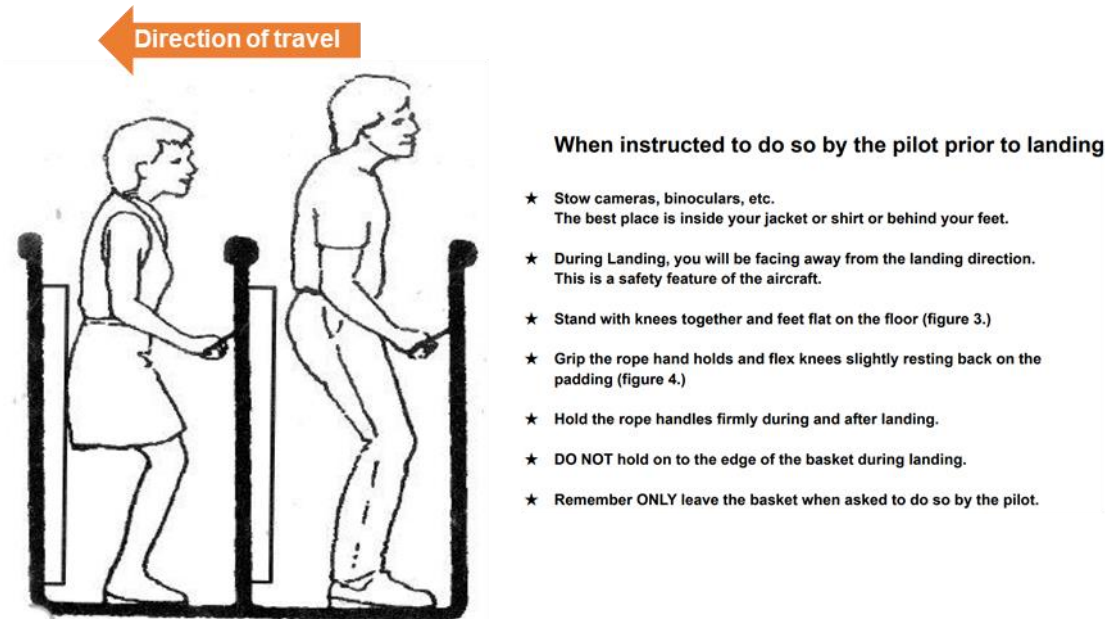
Figure 4: Operator safety briefing card

The briefing cards provided information on balloon safety, including landing instructions, and a pictorial representation of the body position to adopt during landing (Figure 4).

The passengers were not asked to review the safety briefing cards before or during the flight. The pilot reported not using the cards during recent pre-flight briefings because the passengers on these flights had primarily been English speaking and the pilot believed that the briefing cards were only effective with non-English speaking passengers.

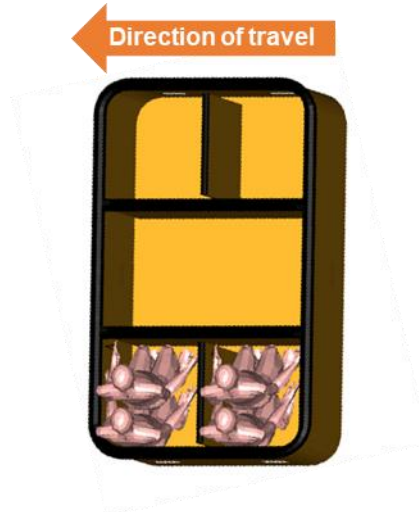
Figure 6: Sideways landing position (double T-partitioned basket)

Flight camera images showed the passengers facing sideways during the pre-flight briefing, and before the initial touchdown. Just before this touchdown, the two passengers that were subsequently injured lowered themselves further into the basket than the other passengers who remained more upright. The long side of the basket was orientated perpendicular to the direction of flight during the initial touchdown as shown (Figure 6). After the first touchdown, the two injured passengers, and another one, lowered themselves further into the basket, probably crouching in a deep squat position with the knees bent more than 90 degrees. They remained in those positions during the final landing.

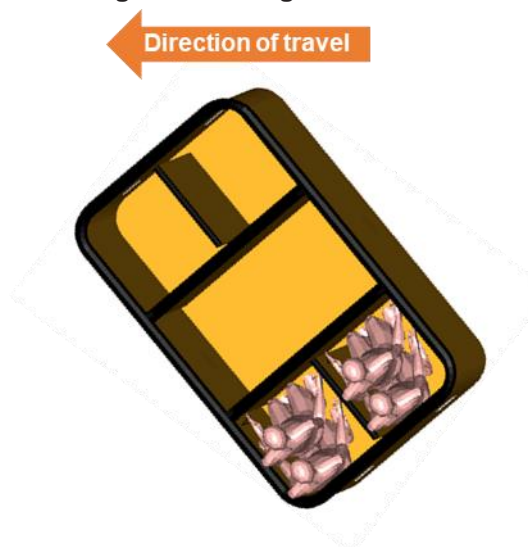
Figure 7: Basket orientation during final landing

The Australian Ballooning Federation *Pilot Training Manual* stated that a descent rate greater than 400 feet per minute on landing could cause personal injury and damage the equipment. The ATSB determined that during the final landing the average descent rate was at least 470 feet per minute. Just before the balloon landed, the balloon had turned such that the long edge of the basket was orientated about 50° from the direction of travel (Figure 7).

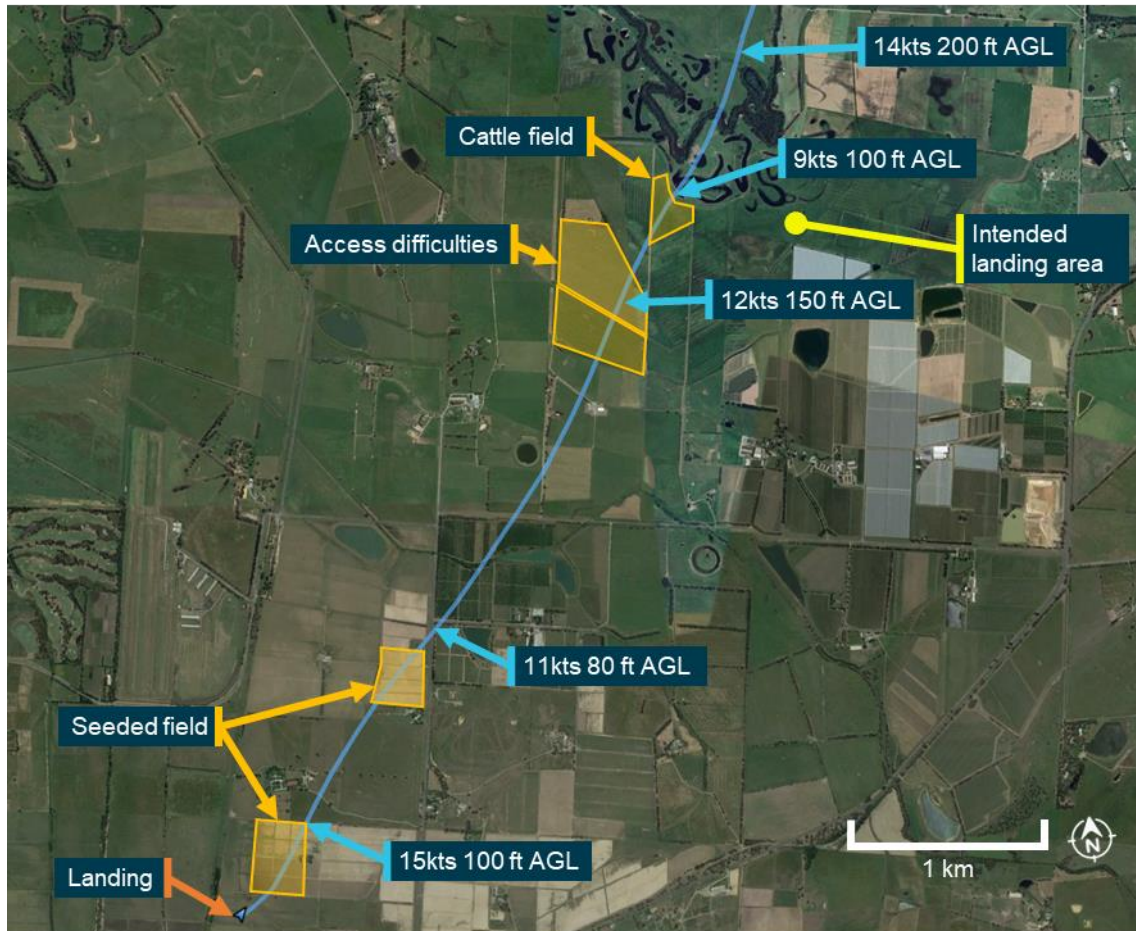
Figure 8: Flight track with potential landing sites

The pilot acknowledged that apart from the final landing location, there were other potentially suitable landing sites along the balloon's path but did not consider that the wind conditions warranted an attempt to land in these fields. These sites were rejected as one had cattle, another had locked gates that would have posed logistical problems with passengers and balloon retrieval, while others had been seeded for crops (Figure 8). These fields were longer than the final landing site and had no power lines nearby.

The pilot also stated that the final landing field was the last known landing site along the balloon's path, and that beyond this, the potential landing fields were smaller. A review of the flight track indicated that built up suburban areas were about 3 km further along the flight path from the balloon's final landing location.

Since the wind conditions would probably degrade further, it would have been prudent for the pilot to select a large field with minimal obstacles and alternative landing sites nearby as a backup. However, the pilot rejected several large landing sites to avoid probable logistical difficulties with passenger and balloon retrieval or perceived negative impact on future operator-landowner relationships, which progressively reduced the number of safe landing sites available. Rejecting these landing sites, particularly the last two large seeded fields, in favour of a relatively small field with fences, power lines downwind, and no known alternate sites, increased the risk of obstacle collision and a hard landing in the prevailing wind conditions.
