In-flight fire and collision with terrain involving Beechcraft B58 Baron, VH-NPT

near East Kimberley Regional Airport, Kununurra, Western Australia on
16 April 2022

ATSB Transport Safety Report

AO-2022-026

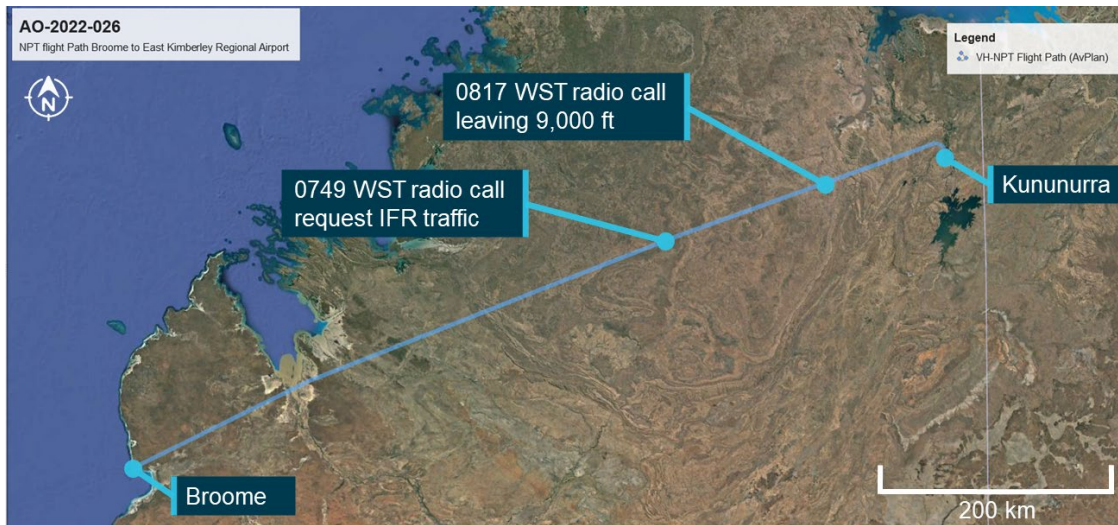
Figure 2: NPT flight path and Brisbane Centre radio calls

At 0749 WST the pilot called air traffic control (ATC) requesting traffic for a direct track to waypoint Kununurra Whiskey Foxtrot (KNXWF) for approach to runway 12 at Kununurra (Figure 2). At 0817 the pilot of NPT contacted ATC advising that they were leaving their cruising altitude of 9,000 ft on descent for Kununurra.

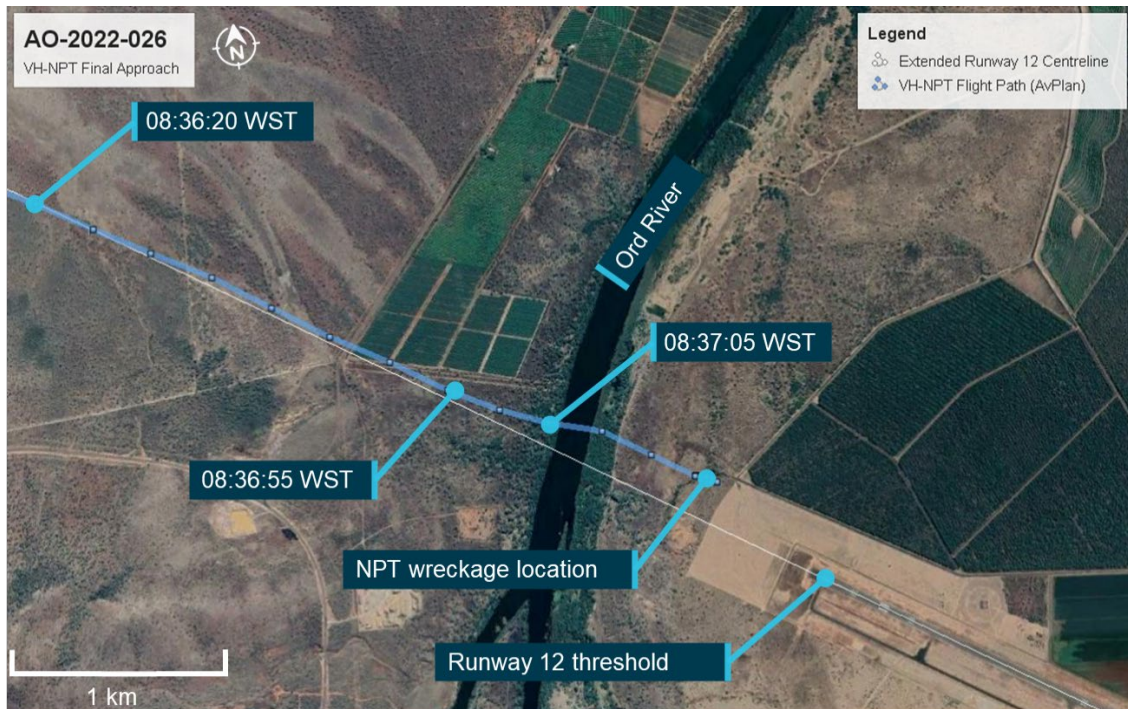
Figure 4: NPT final approach and wreckage location

Recorded flight data indicated that, at 0837, the aircraft started diverging significantly left of the extended runway centre line, crossing the Ord River at low level approximately 1.5km from the threshold of runway 12. The aircraft subsequently collided with terrain about 600m beyond the river and about 800m from the runway 12 threshold (Figure 4) and was consumed by a significant post-impact fire.

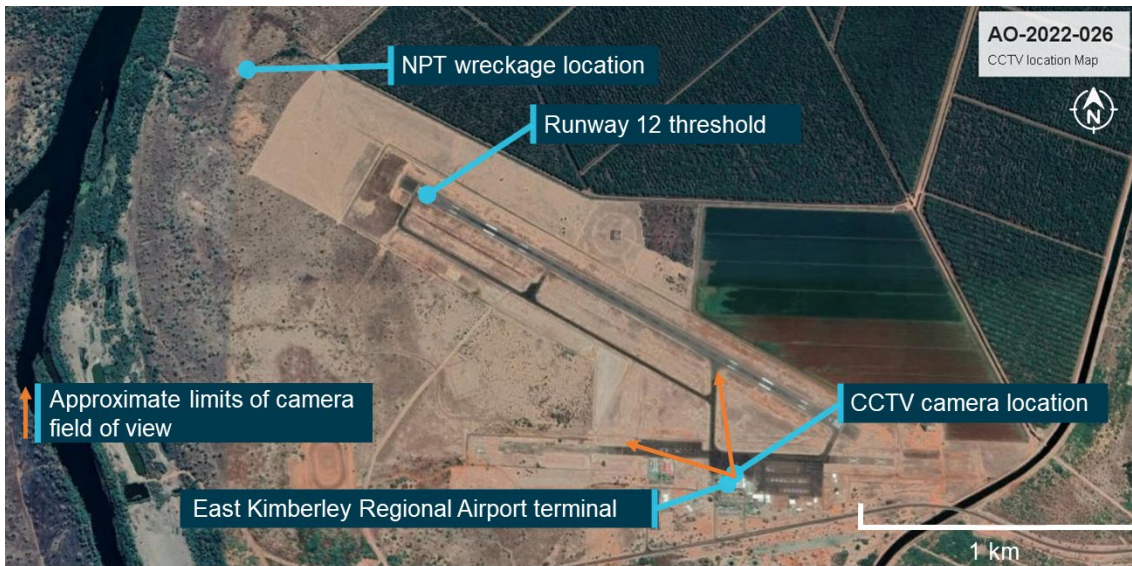
Figure 5: Location of CCTV camera

The ATSB also reviewed CCTV footage from the East Kimberley Regional Airport. Figure 5 shows the location of a camera covering the regular public transport apron, with the threshold of runway 12 in the background. The camera image showed, consistent with the METAR, a smoke plume rising near-vertically from the accident site approximately 3 minutes after the accident indicating little to no wind immediately after the accident.
