ATSB TRANSPORT SAFETY INVESTIGATION REPORT
Rail Occurrence Investigation Report 2006005
Final

Derailment of Train 5MB7

Benalla, Victoria

2 June 2006

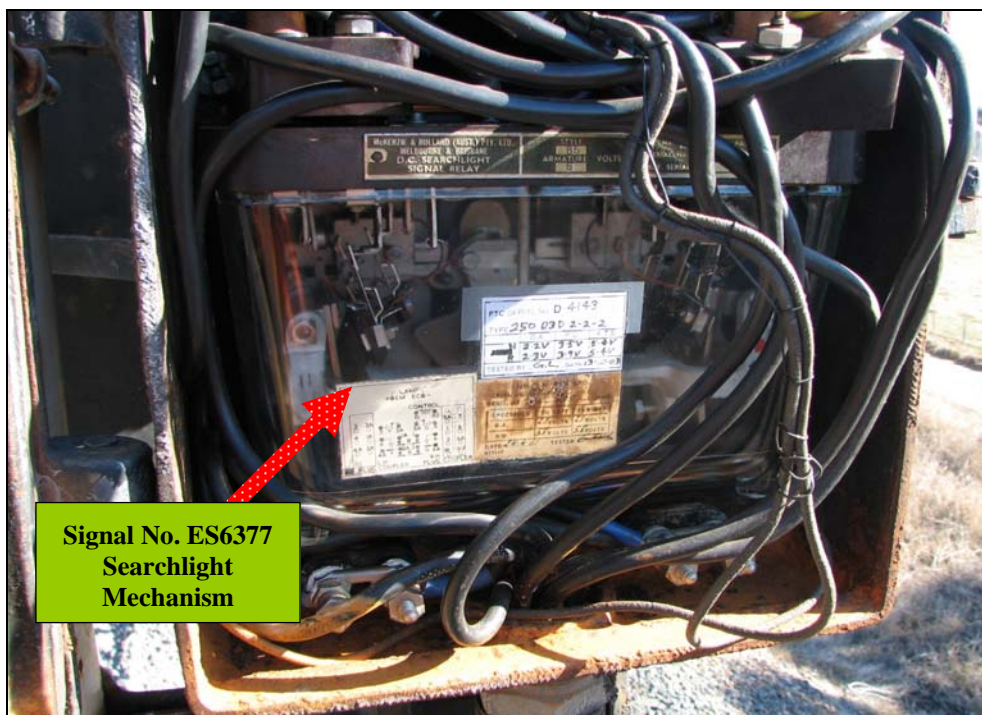
Figure 9: Searchlight signal mechanism ES6377, Benalla

ES6377 was finally examined for correct mechanical function. There were no signs of wear in the mechanism or observations that would suggest the mechanism had been stuck or malfunctioned. The mechanism was observed to operate freely and returned to the 'Stop' position under gravity when electrical power was applied and then removed.

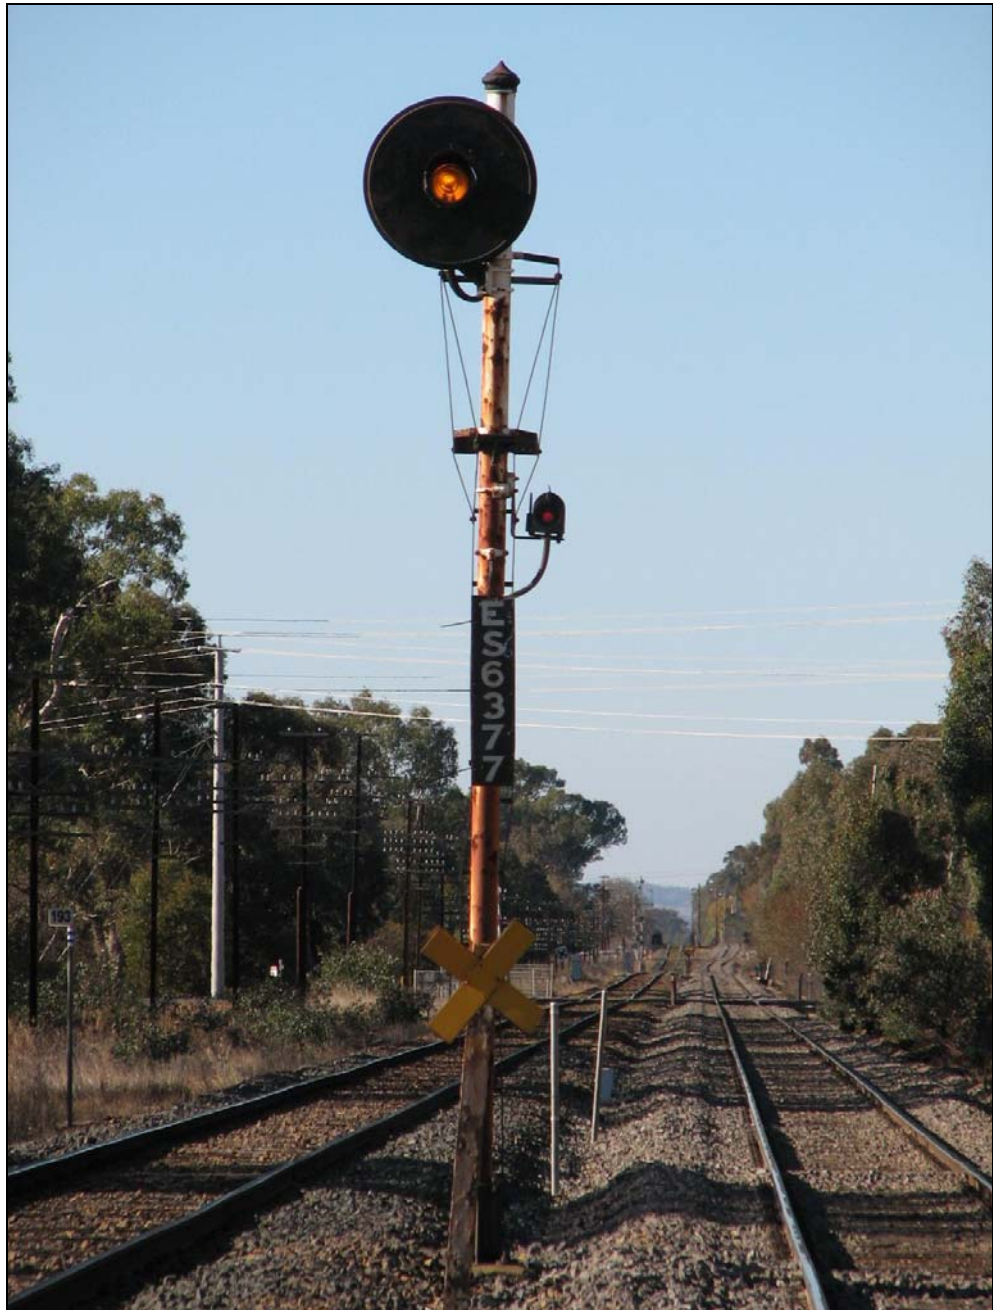
Figure 14: Outer signal No. ES6377 looking towards Benalla. ES6377 is a three aspect signal. Top arm as shown is displaying 'Normal Speed Proceed – Yellow Aspect'

In his statement, the driver indicated that he was sure that signal ES6377 was displaying a 'Clear (normal speed)' aspect (Fig. 15). Had he seen this aspect it would be natural to interpret this indication to mean that the route was set for the main line, ie No. 3 points was set normal and the train could proceed at full line speed, 115 km/h.

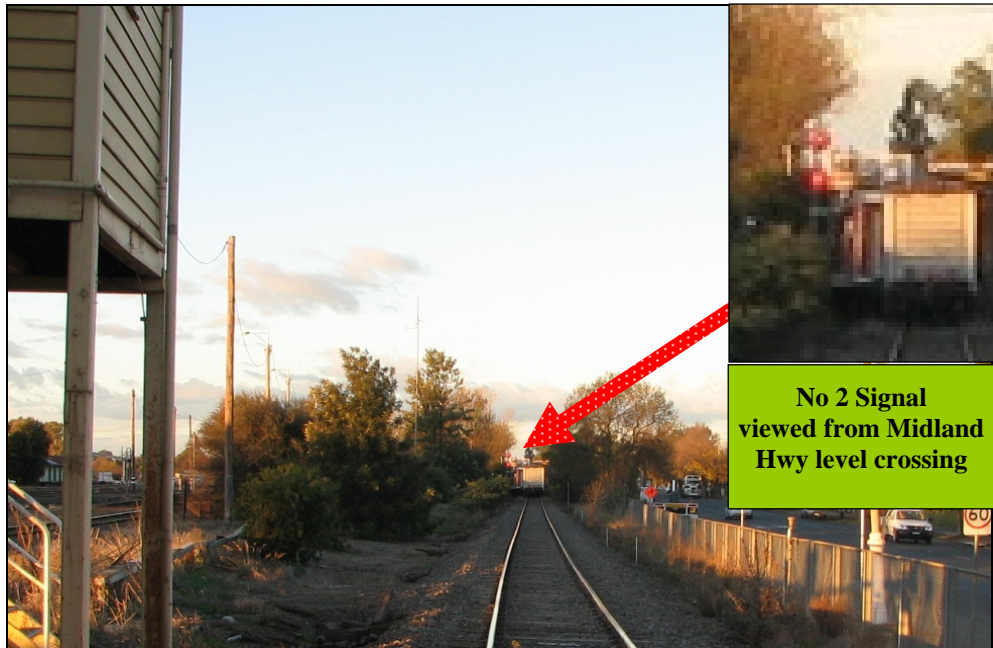
Figure 16: No. 2 Signal – Viewed from the Midland Highway level crossing at a distance of 320 m.

The final reset of the vigilance system occurred at 0643:43 when the train was just in advance of the Midland Highway level crossing and 350 m from No. 2 Signal (Fig. 16). At 0643:51 the train was 120 m from the signal and just in front of the Benalla passenger platform when the driver reacted to the 'Caution (low speed)' aspect displayed by No. 2 Signal (Fig. 17).

An examination of signal No. 2 established that the aspect was clearly visible at a distance of 510 m. Trees along the track that may have compromised the driver's view of the signal had been trimmed such that the limit of available sighting at this location was only due to track curvature. Fig. 16 shows No. 2 Signal viewed at a distance of 320 m:

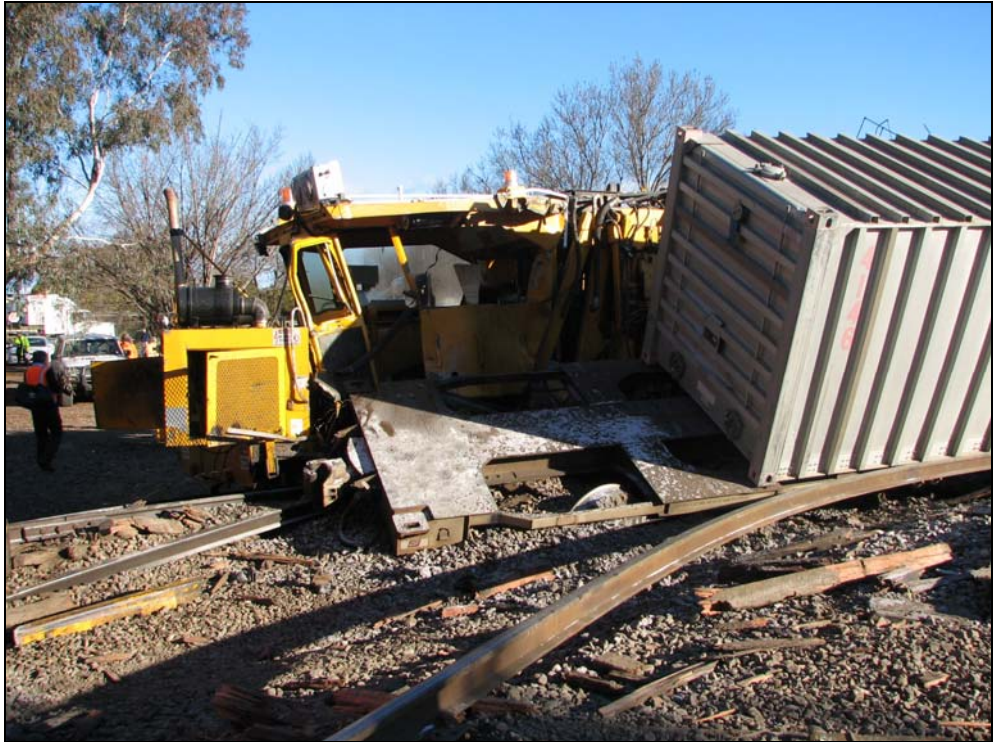
Figure 18: Damaged track machine (tamper) stabled within cripple road

Two track machines stabled within the cripple road adjacent the crossing loop were heavily damaged. The Victorian Railway Institute Hall near the site sustained severe structural damage and was subsequently demolished.

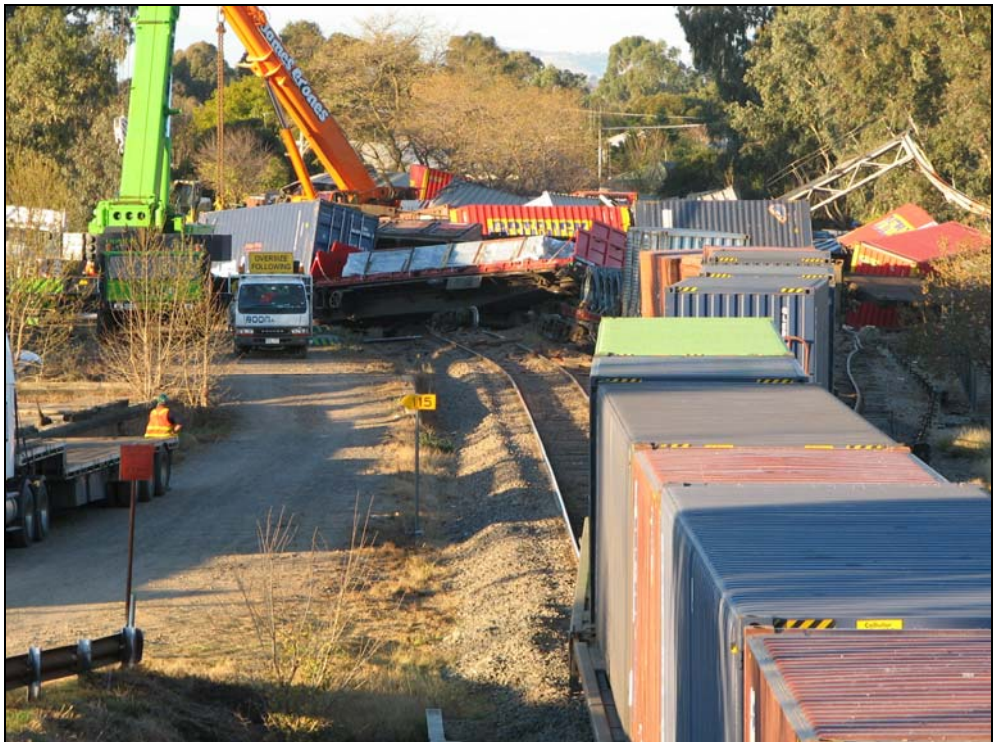
Figure 19: View of derailment site from 'Over-way Bridge' looking north east.

Two locomotives and 19 wagons derailed. The two locomotives involved in the derailment sustained extensive damage with an estimated repair cost of \$3 million. Of the 19 wagons derailed, 12 are likely to be repaired with the remainder being written off.

The two locomotives finally came to a stop at 0644:12 resting on their right hand side 370 m past No. 2 Signal. Of the 19 wagons derailed, (Fig. 19) 16 had sustained major damage.
