ATSB TRANSPORT SAFETY INVESTIGATION REPORT

Aviation Occurrence Report – 200505311

**Crosswind Landing Event
Melbourne Airport, Vic. - 26 October 2005
HS-TNA
Airbus A340-642**

At 1200 Eastern Standard Time on 26 October 2005, the outboard bead heel of the number-1 wheel tyre on the left main landing gear (MLG) of an Airbus A340-642 (A340) aircraft, registered HS-TNA, separated from the outboard rim of the wheel assembly during a landing on runway 16 at Melbourne Airport, Vic. The landing was conducted during gusting crosswind conditions.

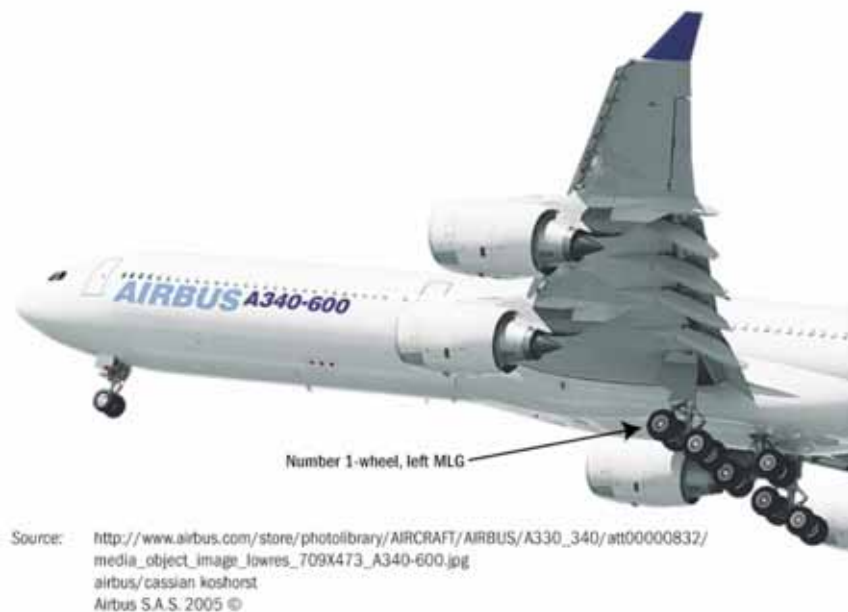
Figure 1: Number-1 wheel tyre

Following the number-1 wheel tyre deflation, the crew maintained control of the aircraft and, apart from some minor deviations, tracked along the centreline (see Appendix B).

There was no evidence that any pre-existing wear or deteriorated condition of the number-1 tyre resulted in its failure during the landing sequence. Additionally, the investigation identified no aircraft systems malfunctions that occurred during the flight from Bangkok to Melbourne that may have contributed to the development of the occurrence.

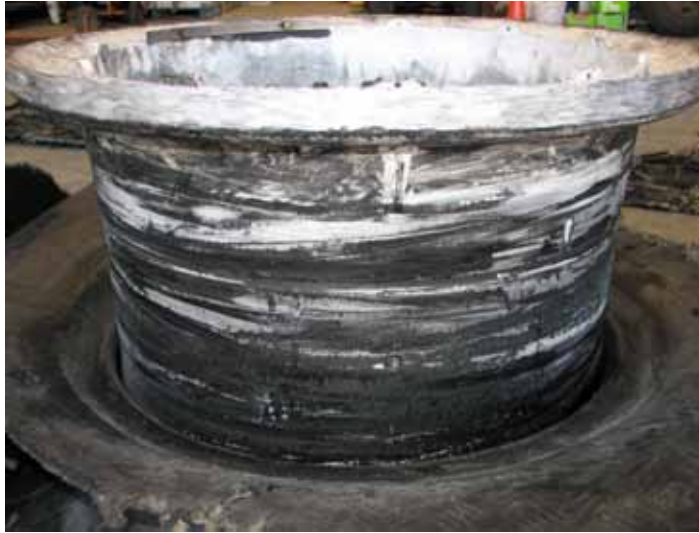
Figure 2: Damaged number-1 wheel assembly

Contact with the runway surface scored and scratched the outboard rim of the number-1 wheel assembly after the tyre deflated (figure 2).

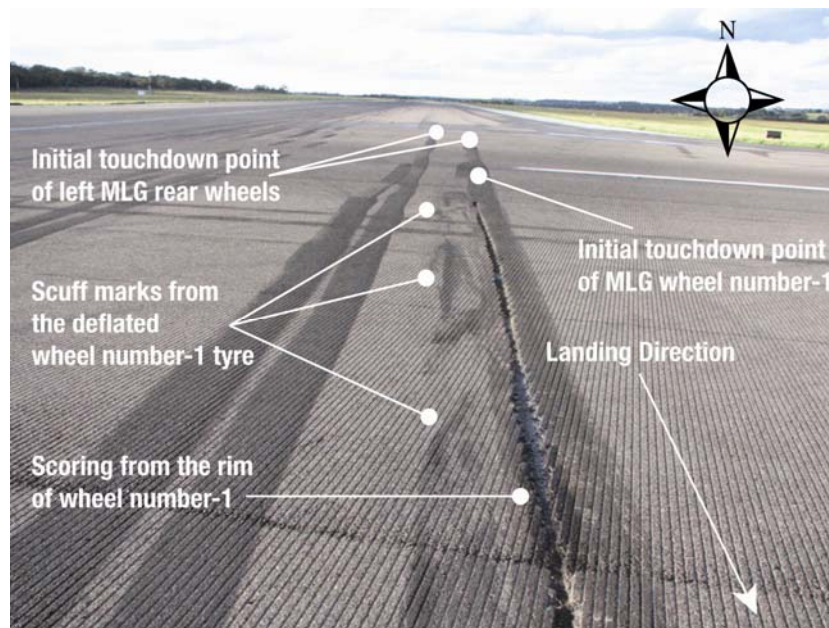
Figure 3: Markings and damage to the surface of runway 16

The number-1 wheel rim damaged the surface of runway 16 after the tyre separated from the wheel rim (figure 3). Appendix B depicts the extent of the markings and gouging to the surface of runway 16/34 as a result of the occurrence.
