ATSB TRANSPORT SAFETY INVESTIGATION REPORT

Aviation Occurrence Report – 200600563

Engine Failure

VH-KLP

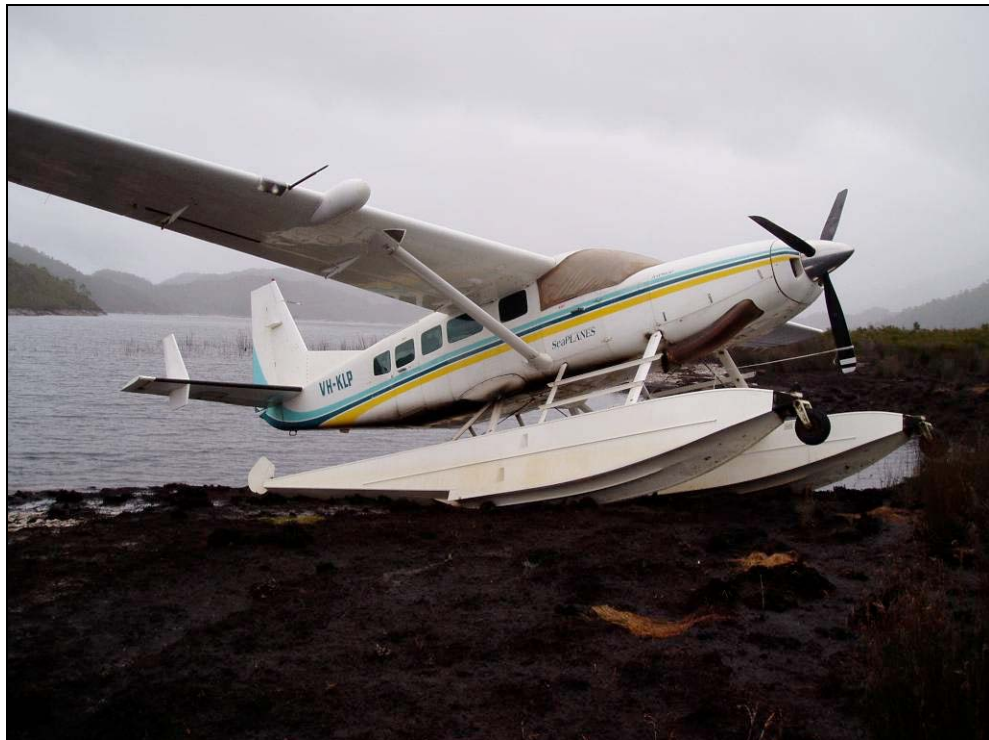
Figure 2: The Cessna 208's final position on the mud bank

The pilot reported that the aircraft landed heavily and that the forward speed could not be controlled. The aircraft came to a stop on a mud bank, with the floats clear of the water (Figure 2).

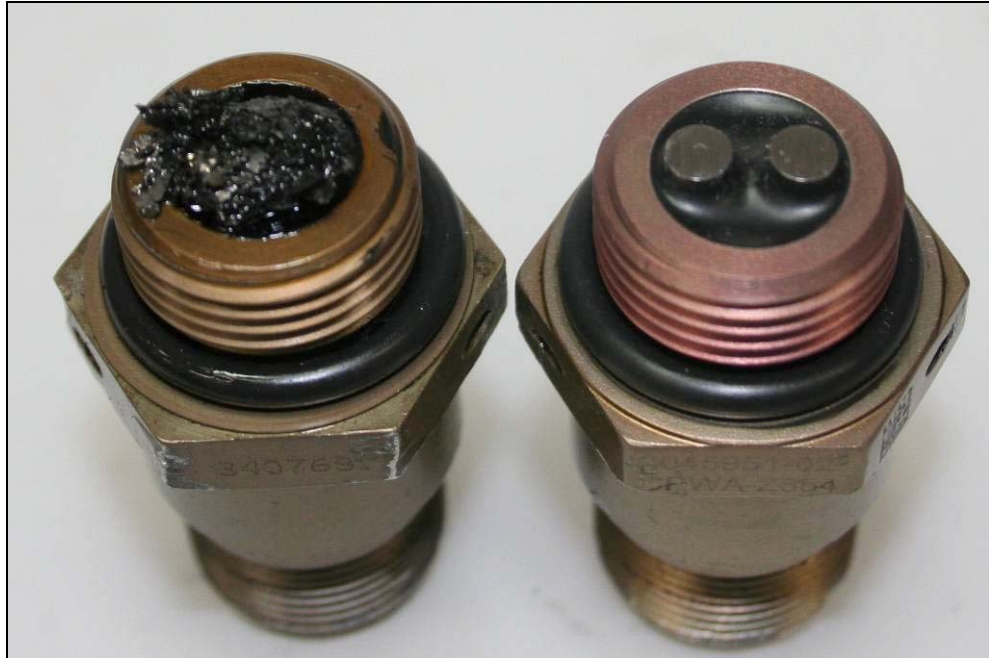
Figure 3: Chip detectors

Figure 3 is a picture of the accessory gearbox chip detector with metal particles still attached on the left and a clean chip detector of the same type on the right, with the two magnetic poles clearly visible.

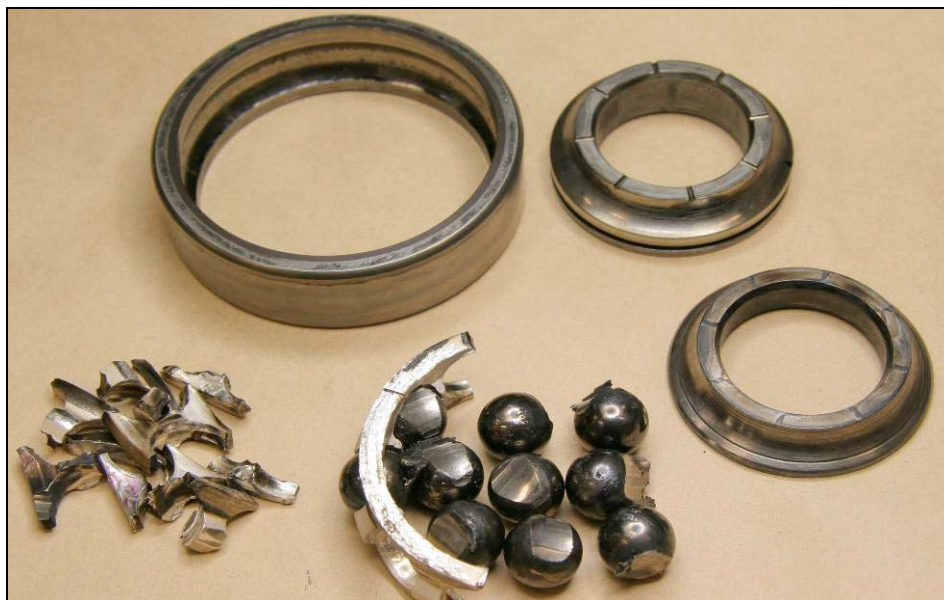
Figure 4: Failed number-1 bearing

The engine was disassembled and inspected in an approved US engine maintenance facility under the supervision of the US National Transportation Safety Board (NTSB) on behalf of the Australian Transport Safety Bureau (ATSB). The inspection revealed that the number-1 engine bearing, which was one of the two support bearings for the compressor rotating section, had collapsed due to mechanical and thermal distress associated with partial seizure (Figure 4).

A subsequent technical examination conducted by the ATSB indicated that there was evidence consistent with electrical discharge damage⁴ (EDD) from the starter-generator⁵ drive gear through to the number-1 bearing. Several damaged components were sent to the ATSB's laboratory for further analysis. The ATSB inspection and analysis confirmed a clear path of EDD from the starter-generator to the number-1 bearing (see Appendix A – ATSB Technical Analysis report BE/200600016).

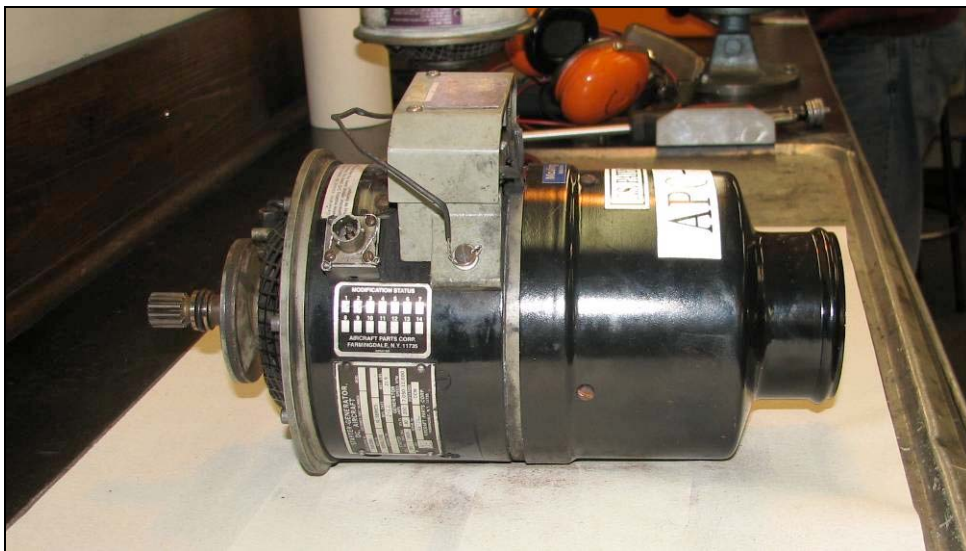
Figure 5: Failed starter-generator assembly

The failed starter-generator that was replaced 18.7 hours before the engine failure was taken to an approved starter-generator overhaul facility for disassembly and examination under ATSB supervision (Figure 5).

The examination revealed degraded insulation on the starter-generator armature windings. It was evident that the insulation had degraded due to an overheat event taking place during the start mode.

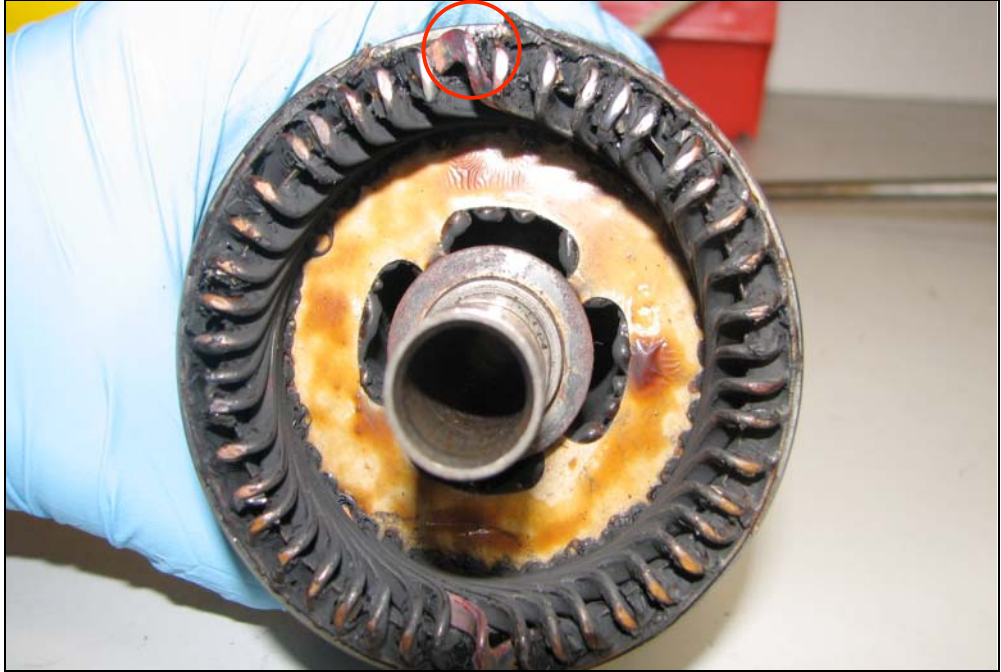
Figure 6: Starter-generator armature windings

Figure 6 illustrates the point of contact of the armature windings to the forward armature winding retaining band. The area inside the red circle indicates the initiation point for the EDD event.

The evidence indicated that, when the exposed armature windings came in contact with the forward armature winding retaining band, a hard short⁶ was created. A direct electrical current path then existed between the armature windings and the starter-generator output shaft. This allowed electrical current to discharge into the engine.

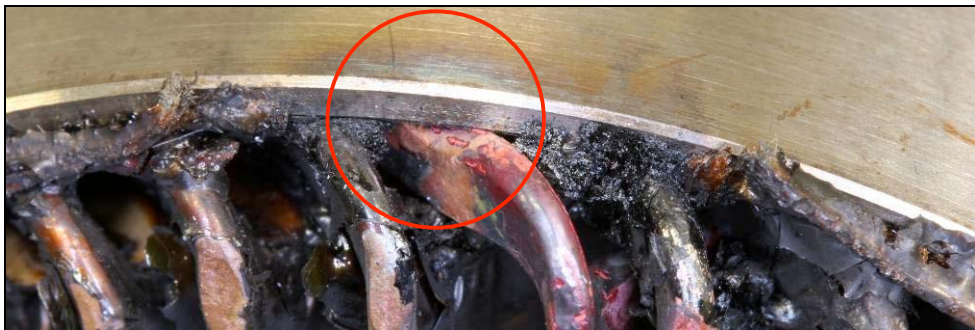
Figure 7: Armature windings

Figure 7 is an enlarged view of the area highlighted in Figure 6 and it shows the armature winding and the point of contact with the forward armature winding retaining band. Note the blackened and burnt insulation around the windings and the discoloured metal on the retaining band, indicating the initiation point for the EDD event.

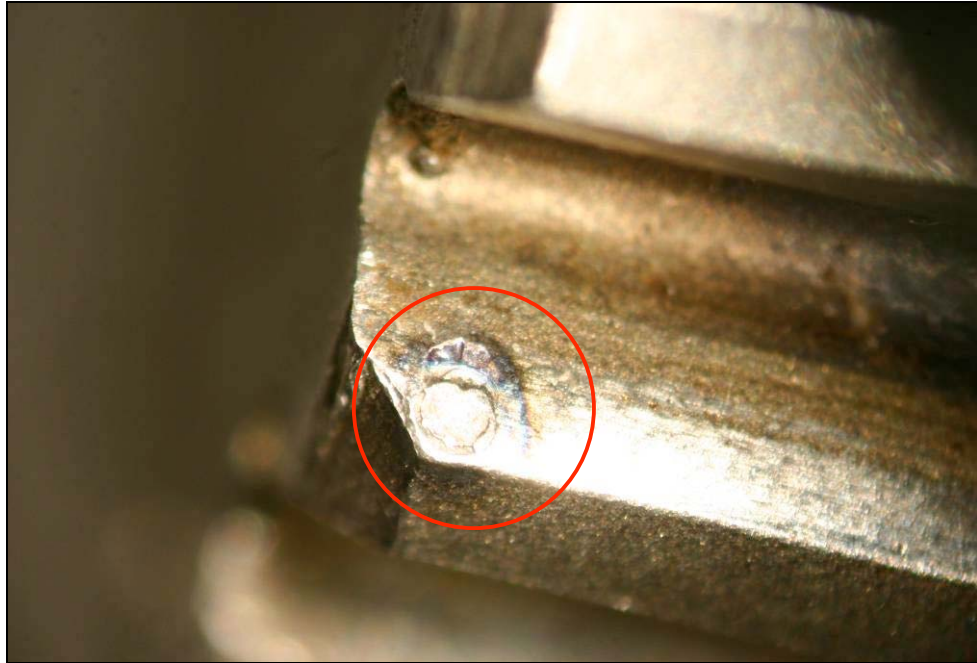
Figure 8: Starter-generator drive spline

There was evidence of EDD on the starter-generator drive spline in the area highlighted in Figure 8. There was also evidence of EDD on one of the starter-generator armature support bearings.

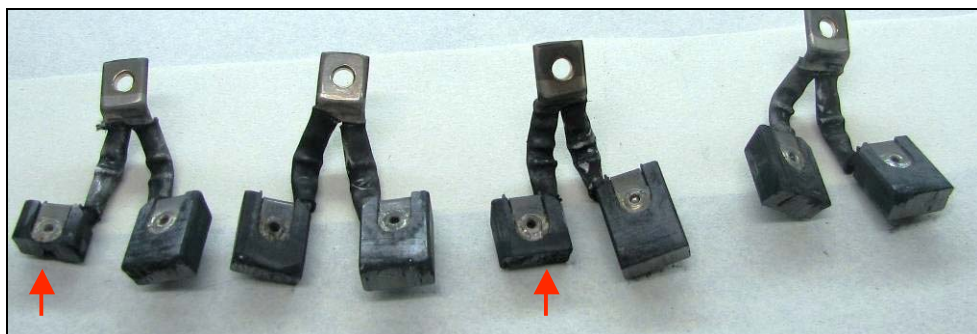
Figure 9: Starter-generator brushes

An inspection of the starter-generator brushes revealed that the brushes had worn unevenly and that two of the brushes were worn well beyond the allowable limits specified in the starter-generator maintenance manual. One of the brushes had worn down to the extent that the spring which keeps the brush in contact with the commutator had reached its stop, which meant the brush was no longer being held in contact with the commutator under positive pressure. It could not be ascertained if that would have contributed to the starter-generator failure. However, the performance of the starter-generator in start mode would have been reduced due to the worn brushes and reduced brush spring tension.

Figure 9 shows the worn starter-generator brushes, and the red arrows indicate the two brushes that were worn beyond limits. The brush springs that hold the brushes in contact with the commutator under a specific tension were checked and all found to be within maintenance manual limits. The brushes were inspected prior to removal and found to be fitted correctly. It could not be ascertained why the brushes were worn at different rates.

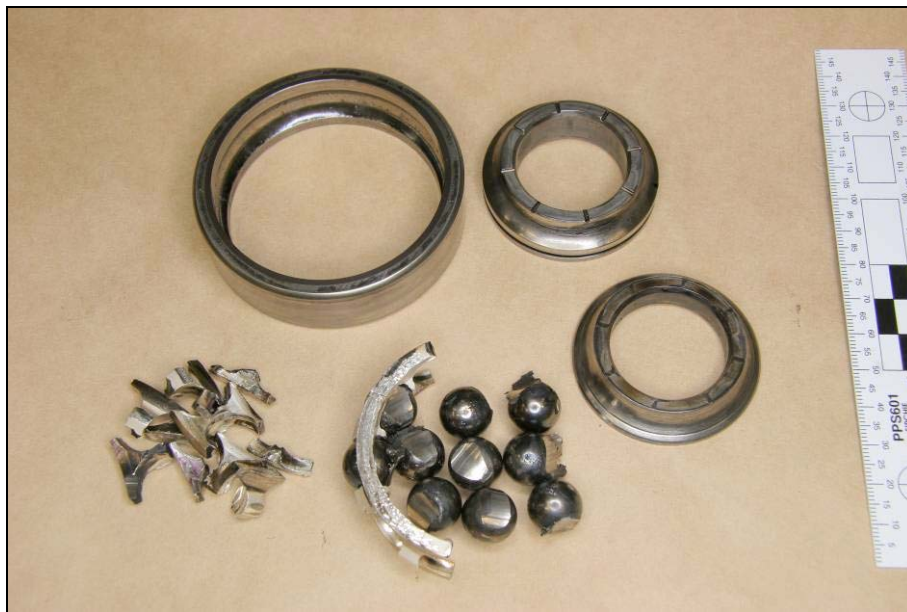
Figure 1: Remnants of the engine number-1 bearing unit

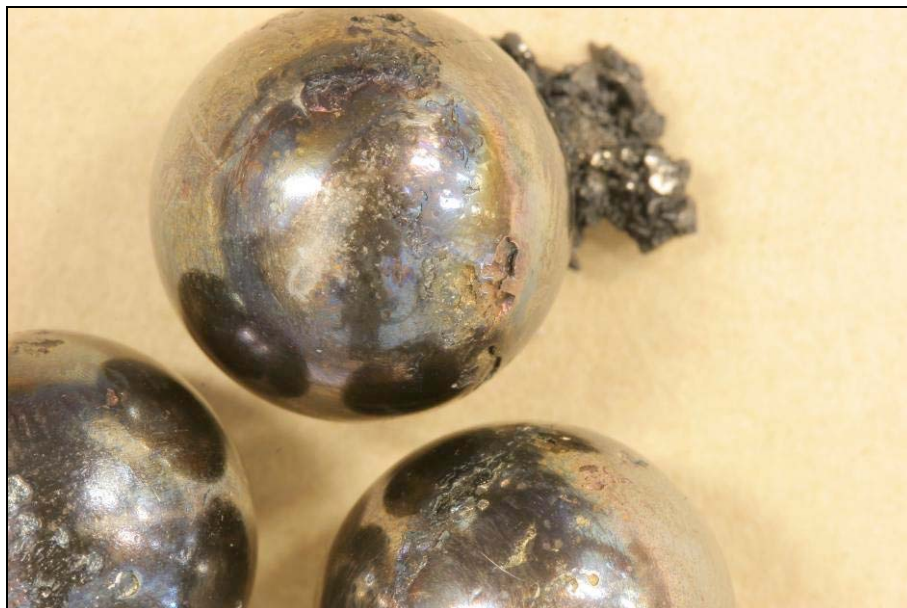
Figure 2: Rolling elements showing typical surface spalling damage

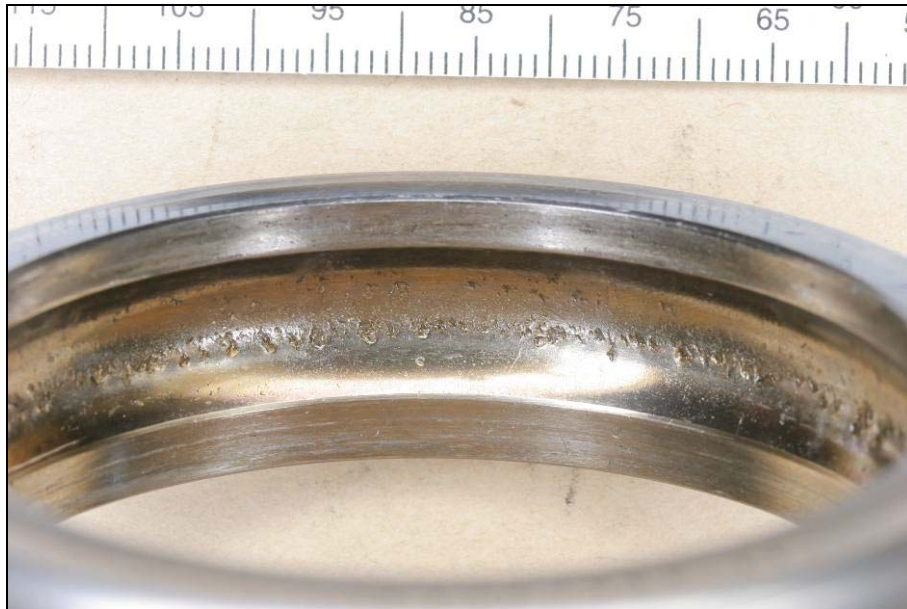
Similar pitting and spalling damage was noted around the contact surfaces of the bearing outer race, with accompanying surface bruising and indentation damage, see Figure 3. Amongst the paths of surface spalling, several localised areas presented a rounded and flowed appearance, atypical of the surrounding surface morphology. The region shown in Figure 4 was characteristic of these features.

Figure 3: Outer race of number-1 bearing showing spalling damage along the contact path

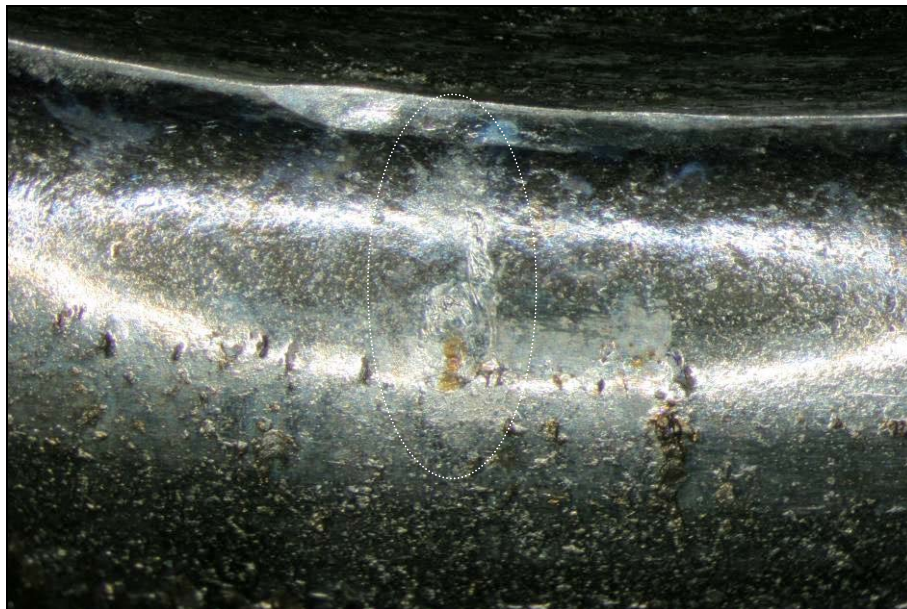
Figure 4: Atypical area on outer race surface (enclosed)

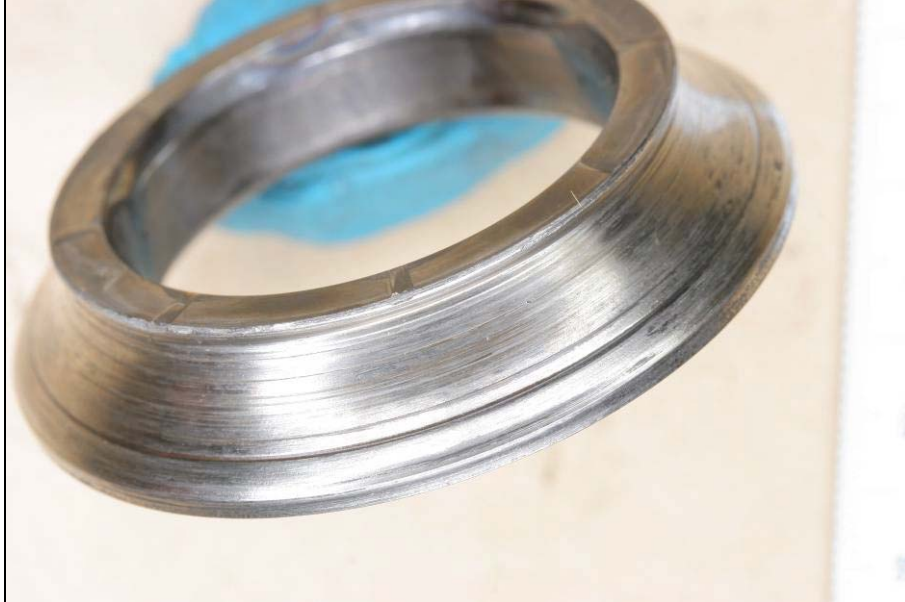
Of the two inner race halves, the forward (thrust) element showed severe scoring and abrasive metal loss of a nature similar to the ball elements, see Figure 5. The rear (non-thrust) race half showed distress predominantly toward the innermost areas of the contact path, with scoring, frictional heat-tinting and metal smearing effects, see Figure 6. As had been noted on the outer race, several unusual localised

Figure 5: Forward section of the number-1 bearing inner race – heavily scored

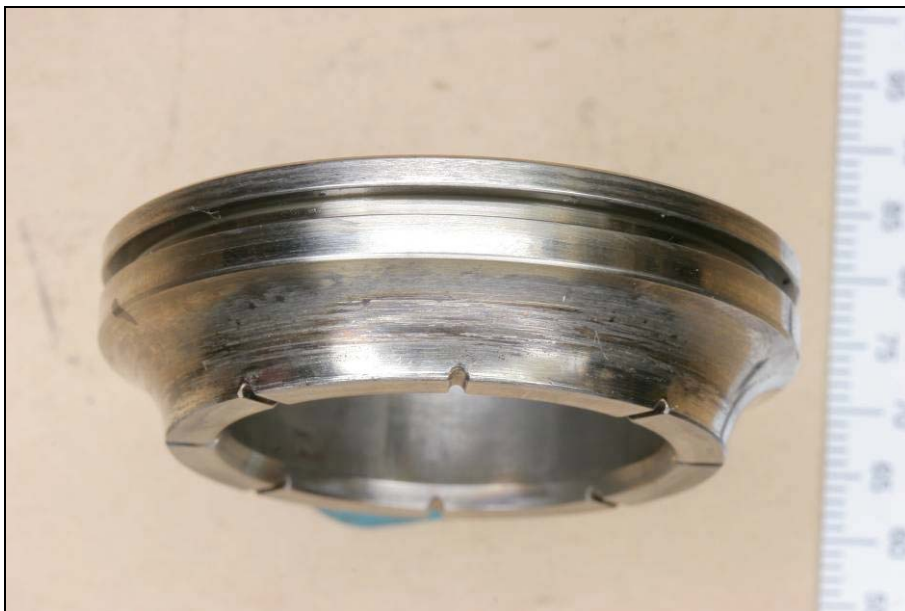
Figure 6: Rear section of the number-1 bearing inner race

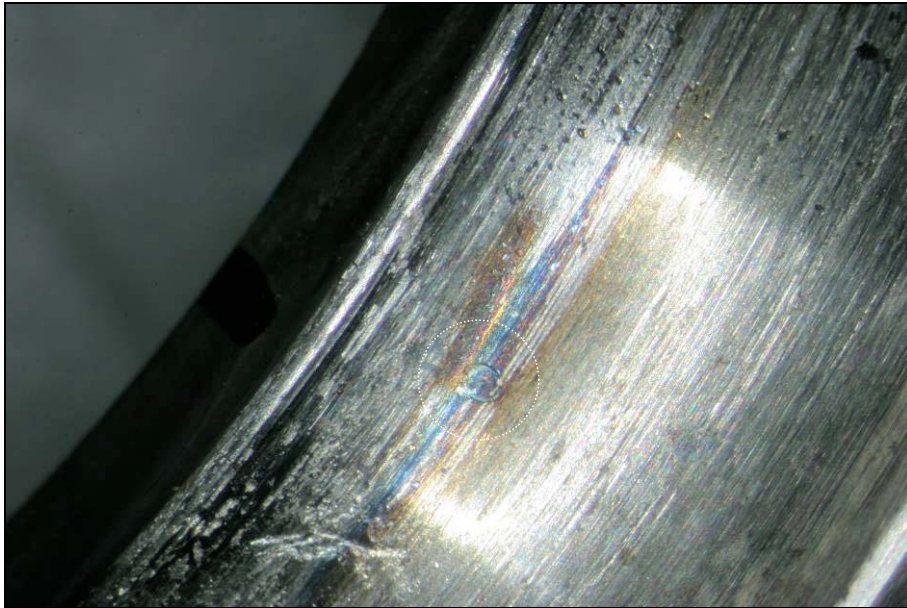
features were observed – presenting as isolated rounded depressions that had been over-scored by the passage of the ball elements, see Figure 7.

Figure 7: Isolated area of atypical damage on the rear section of the number-1 bearing inner race (circled)

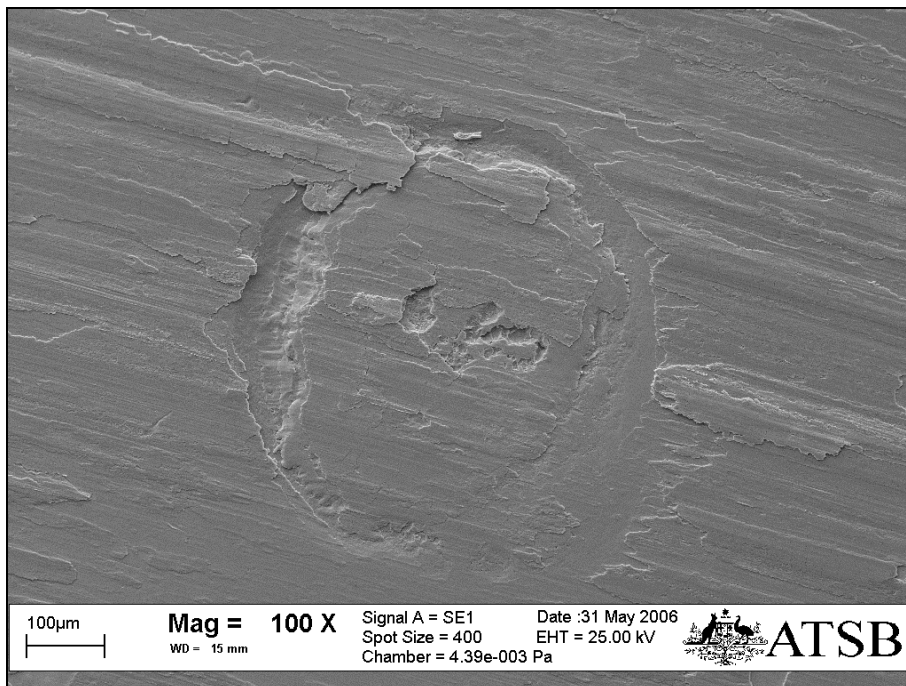
To further characterise the nature of the anomalous areas identified on the inner and outer bearing race elements, the areas shown in Figures 4 and 7 were examined under the scanning electron microscope (SEM), before being transversely sectioned and prepared for metallographic study. Figures 8 and 9 present the surface form of the areas under the SEM – both showed rounded features, with some evidence of surface metal flow, possibly characteristic of localised melting.

Figure 8: SEM image of inner race area shown in Figure 7

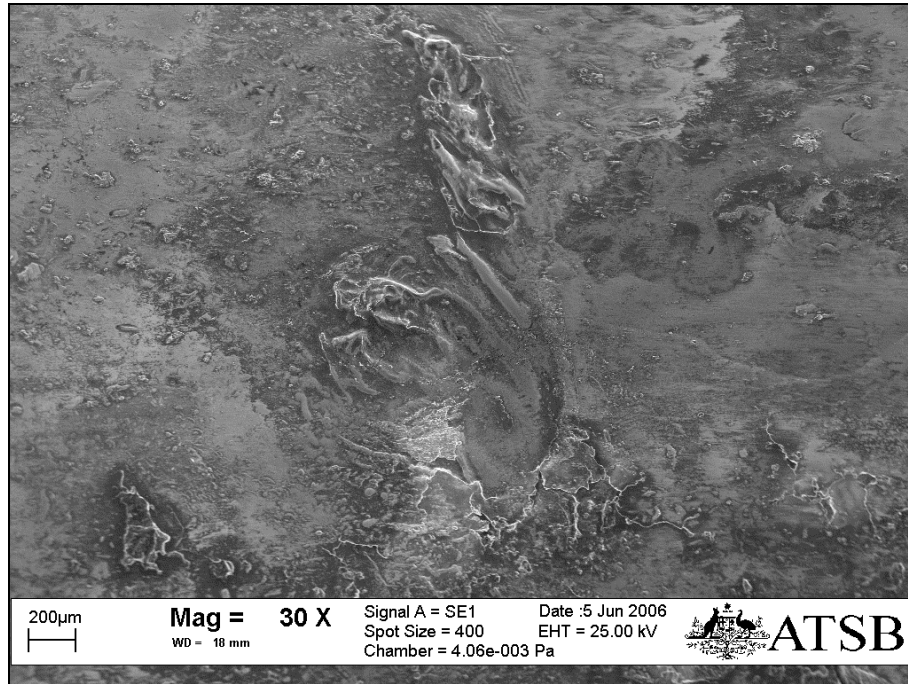
Figure 9: SEM image of outer race area shown in Figure 4

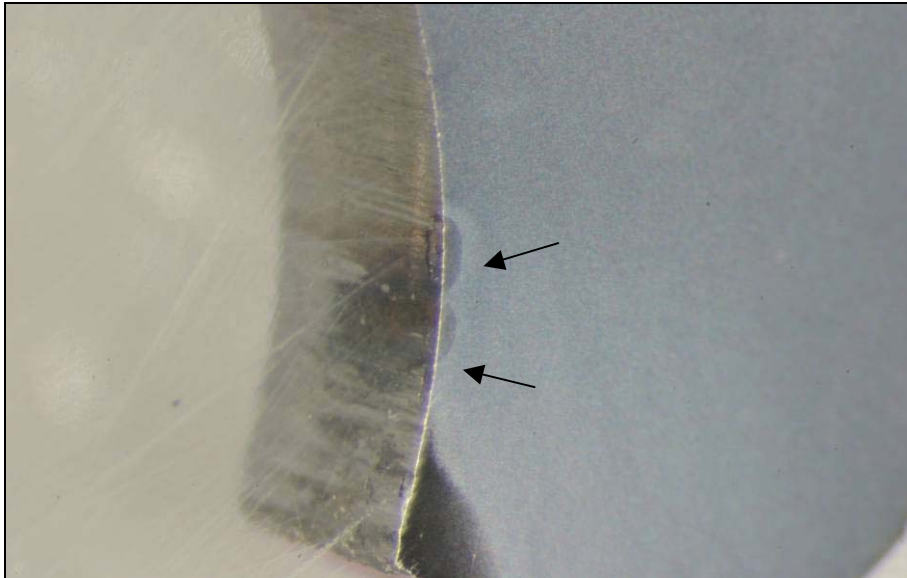
Microscopic study of transverse metallographic sections prepared through the areas of interest found notable zones of thermally affected microstructure (heat affected zones, HAZ) associated with and surrounding the surface features, see Figures 10 and 11. While many areas over the race surfaces exhibited thermal effects from frictional heating, such areas tended to present as broad bands or zones of affected material oriented along the axis of bearing rotation. The local areas in question, however, showed heat affected zones that were limited to the periphery of the surface feature and were inconsistent with having been formed by a frictional mechanism. Figure 12 illustrates the HAZ transition and parent material microstructure.

Figure 10: Transverse micro-section through the inner race area identified in Figures 7 and 8. Note the localised heat-affected zones (2% Nital etch)

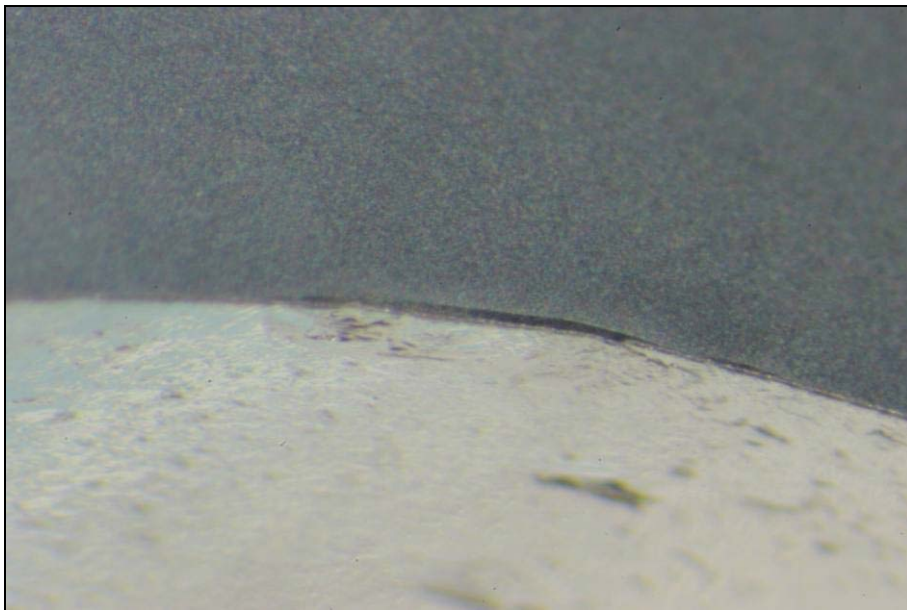
Figure 11: Transverse micro-section through outer race area shown in Figures 4 and 9. Shallow heat-affected zone. (2% Nital etch)

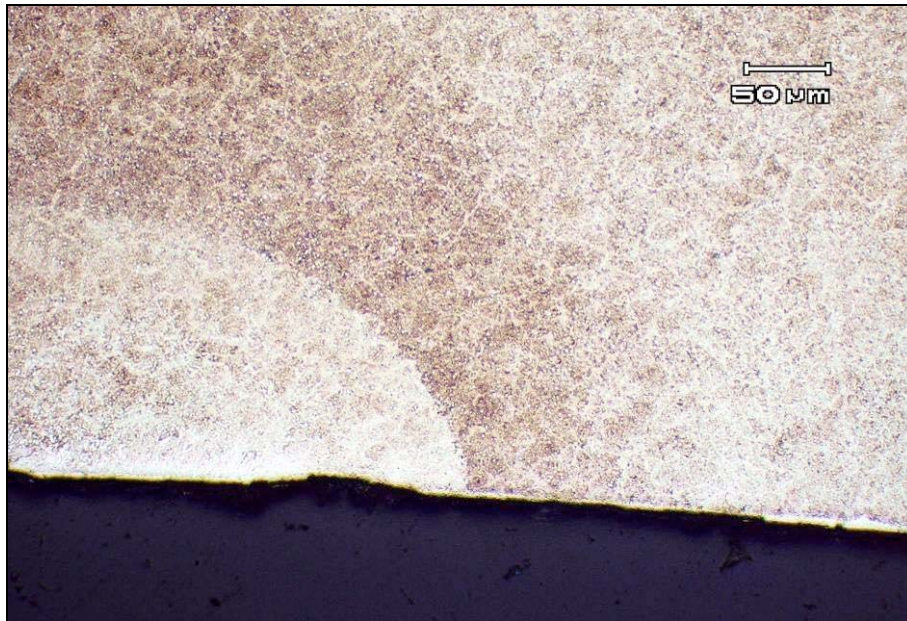
Figure 12: Heat affected zone microstructure of the inner race region shown in Figure 10 (2% Nital etch)

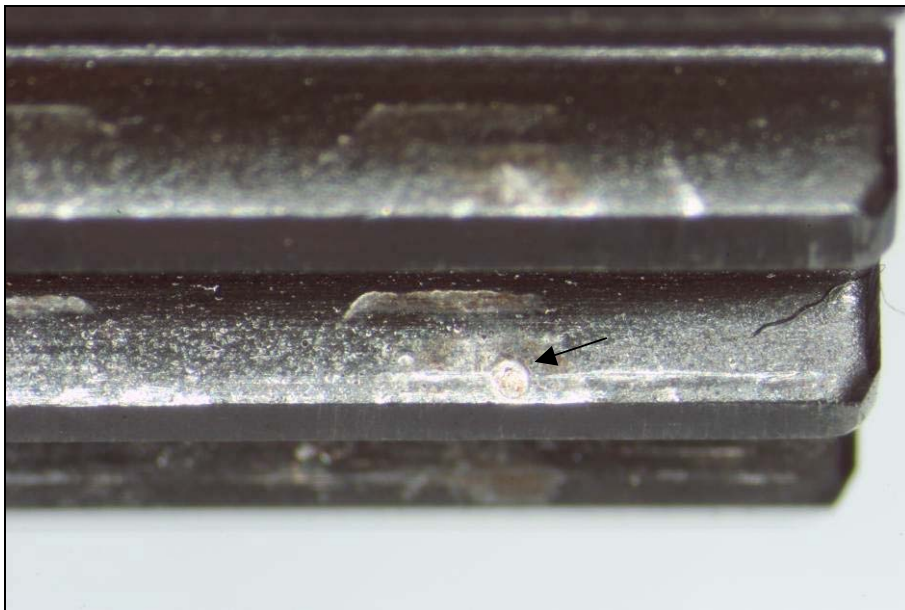
Figure 14: Pitting damage on the surface of a spline tooth (arrowed)

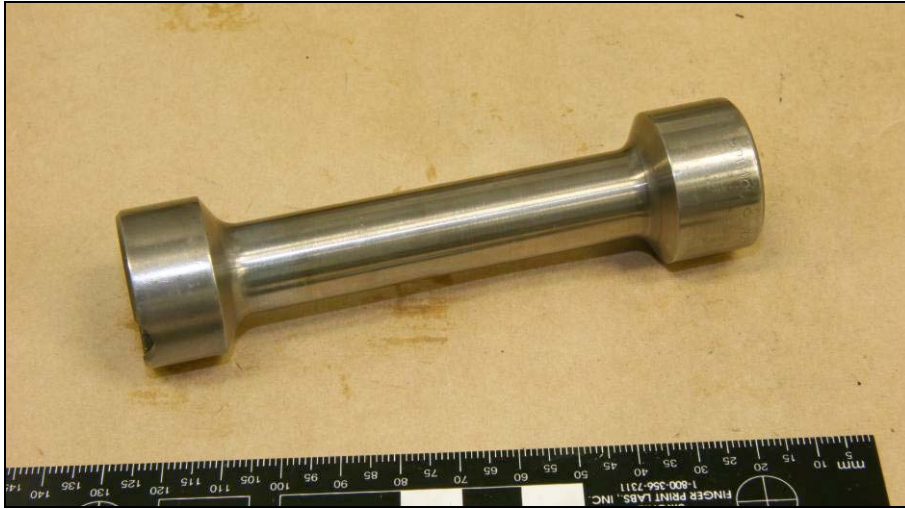
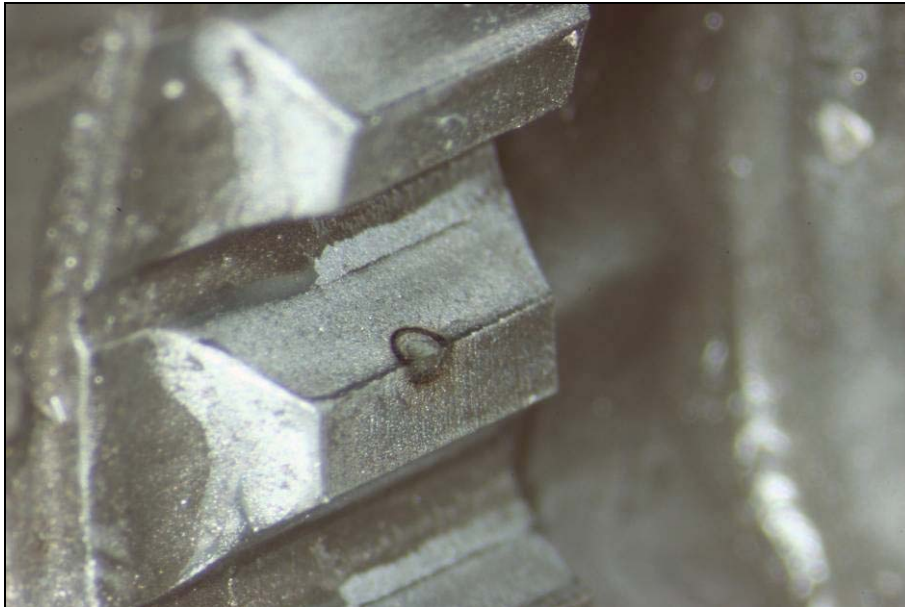
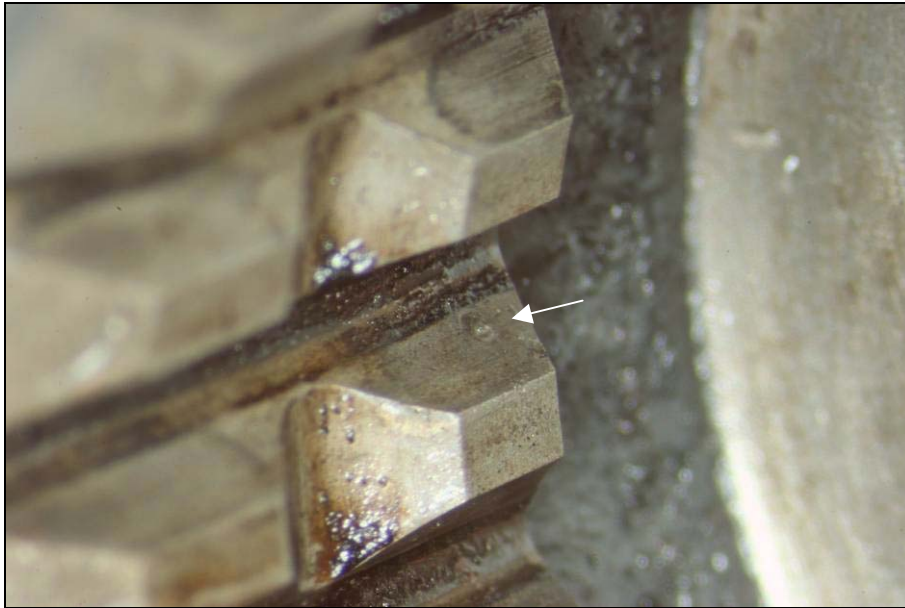
Multiple discoloured and slightly eroded spots of surface pitting and remelting damage were noted within the splined coupling connection at both ends of the shaft, see Figures 15 – 17. The appearance of the damage mirrored that presented by the mating male spline connections of both the compressor hub and the accessory gearcase input gear-shaft. With the exception of the identified damage, both connections appeared to be in sound condition.

Figure 16: Internal spline tooth pitting and re-melting (input drive gear shaft end)

Figure 17: Internal spline tooth pitting and re-melting (compressor rear hub coupling end)

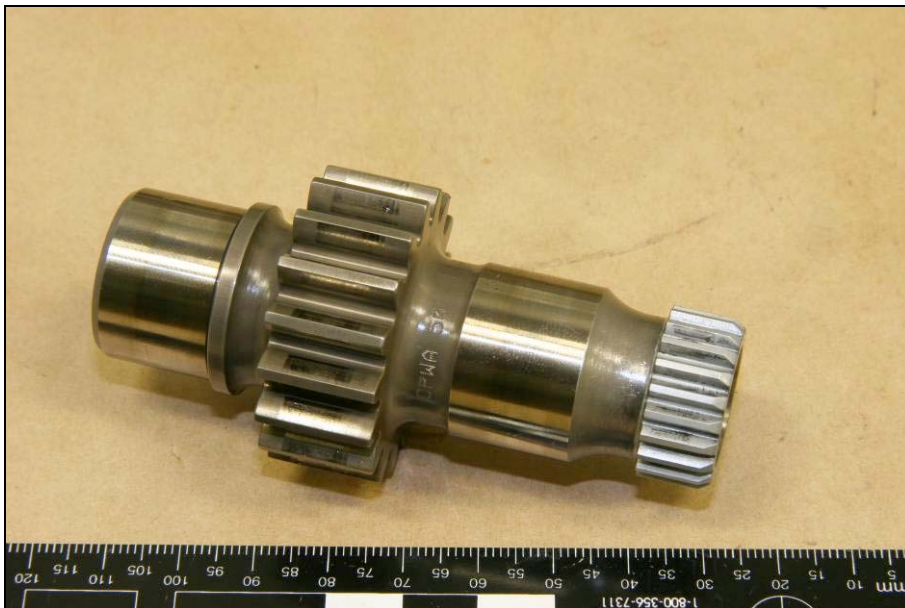
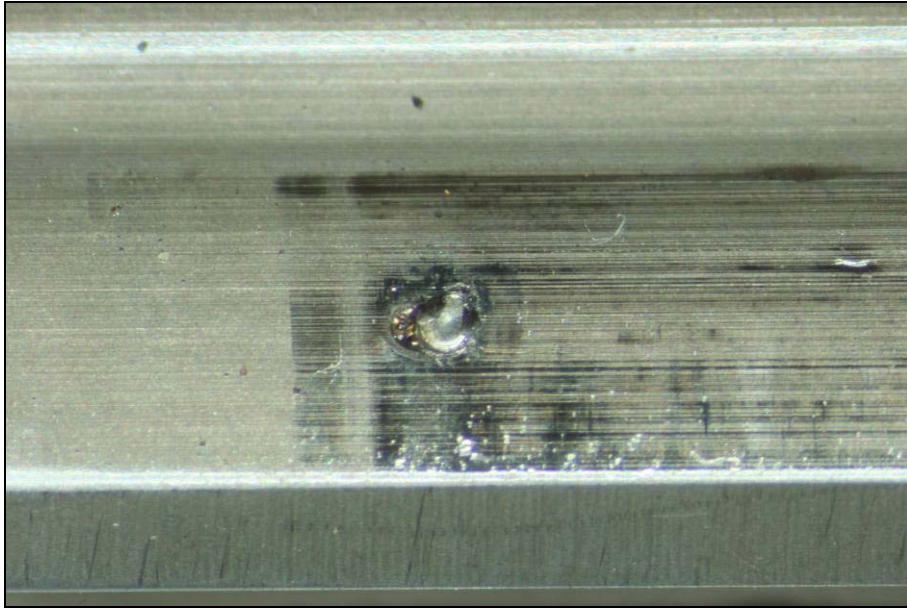
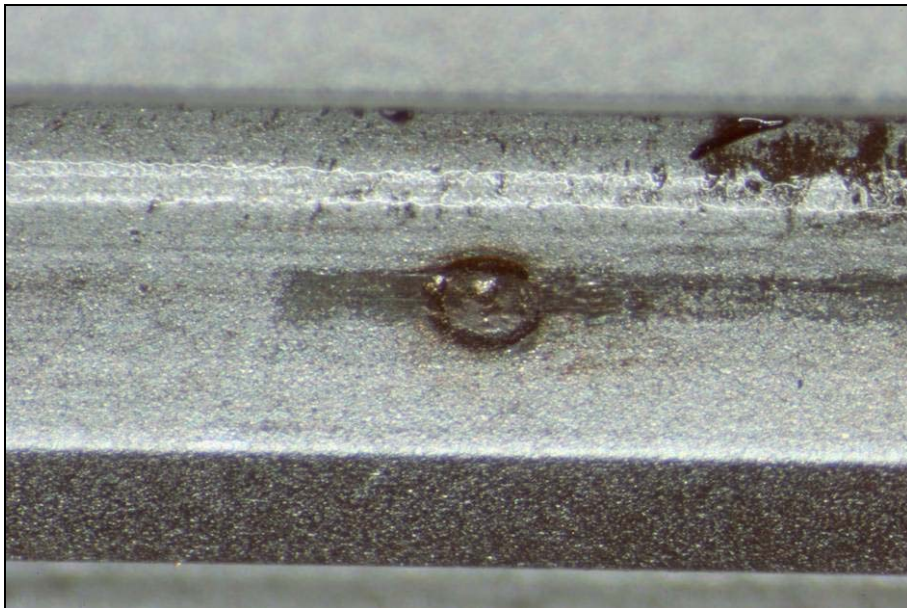
Figures 18 – 20 show the accessory gearcase input drive shaft and the similar pitting damage found on both coupling splines and gear teeth. Being particularly evident on the gear teeth, the damage showed the classic features associated with electrical arc re-melting. The gear contact surfaces showed no other evidence of mechanical breakdown, contact-fatigue spalling or indications of lubrication deficiencies.

Figure 19: Pitting and re-melting damage to a gear tooth

Figure 20: Pitting and re-melting damage to a tooth from the input drive gear shaft coupling

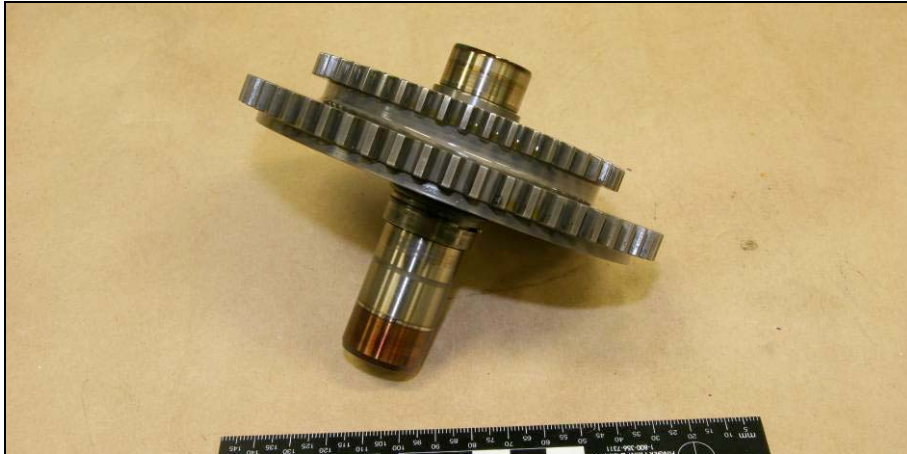
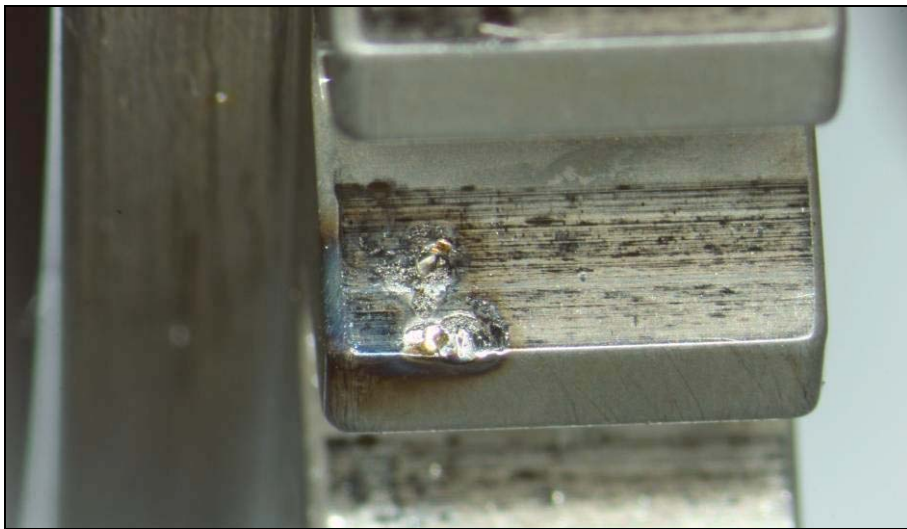
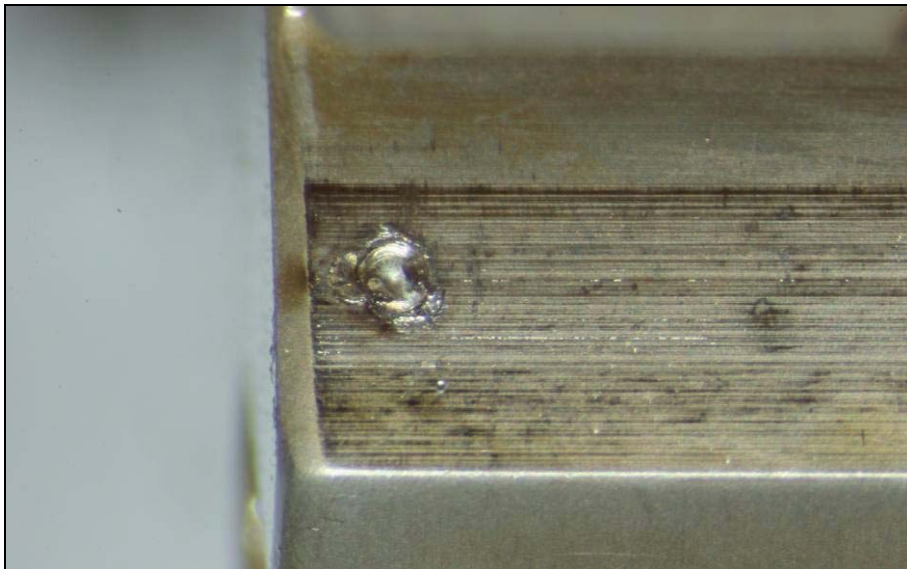
Providing for power transfer and speed reduction between the engine main-shaft and the starter-generator (SG) input shaft, the SG gear-shaft, see Figure 21, on examination, also showed clear evidence of an electrical arc discharge event, with two opposing areas of pitting and re-melting on the large gear wheel teeth, with associated heat tinting of the immediate surrounding surfaces, see Figures 22 and 23. The gear tooth surfaces were otherwise in sound condition, as were the bearing journal surfaces.

Figure 22: Prominent pitting and thermal tinting on a gear shaft tooth

Figure 23: More pitting on the gear shaft teeth – adjacent to the area shown in Figure 22

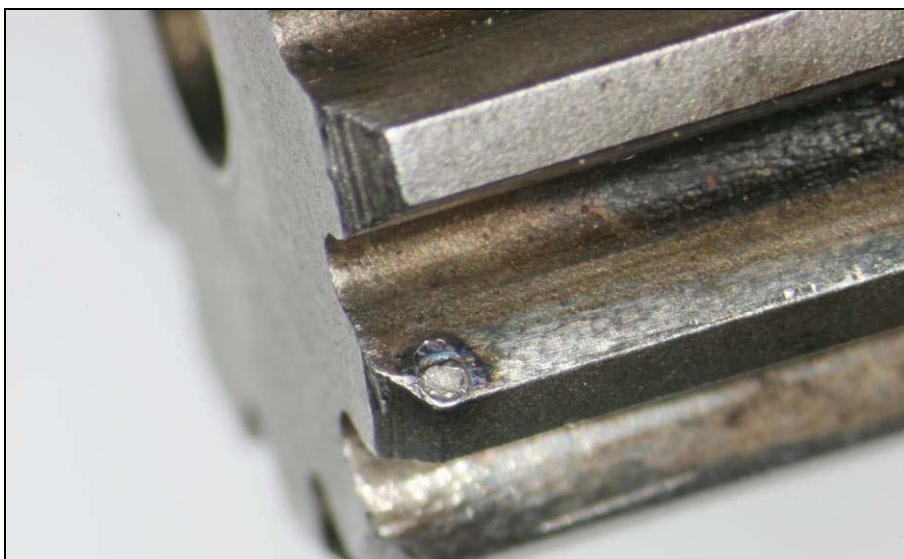
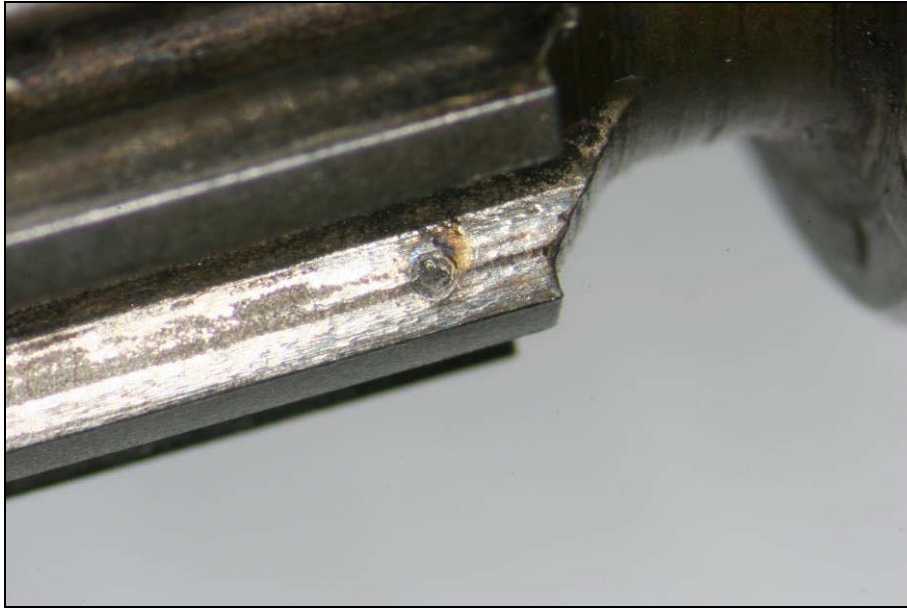
Figure 25: Spline tooth pitting damage

Figure 26: Pitting toward inner end of starter-generator drive spline

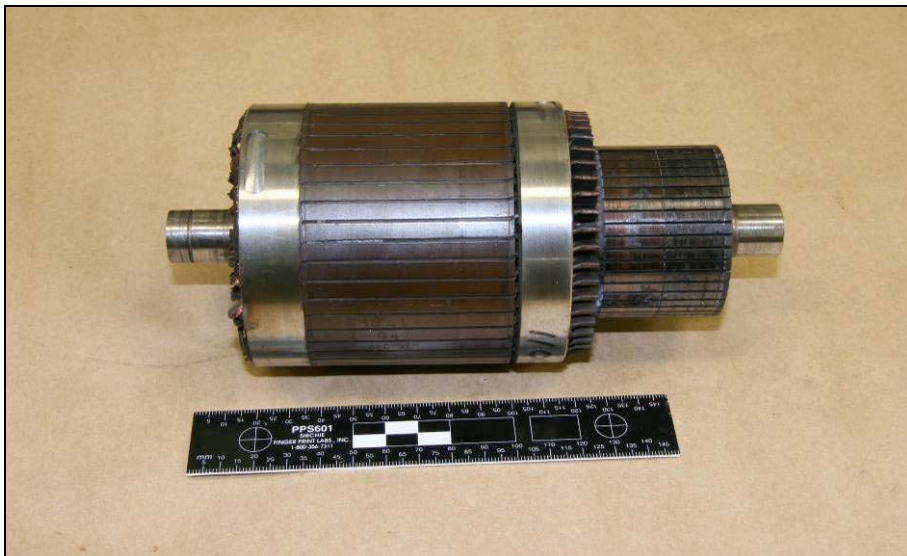
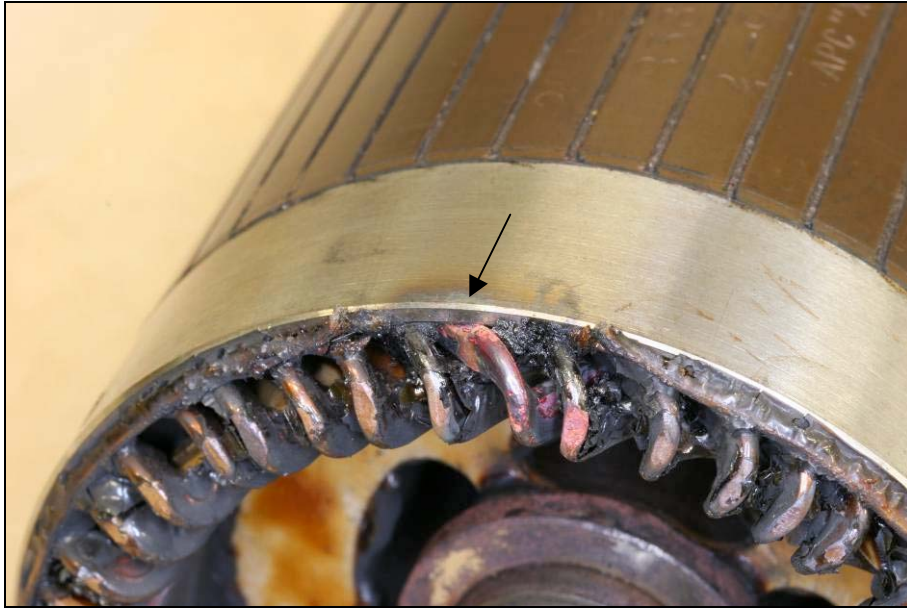
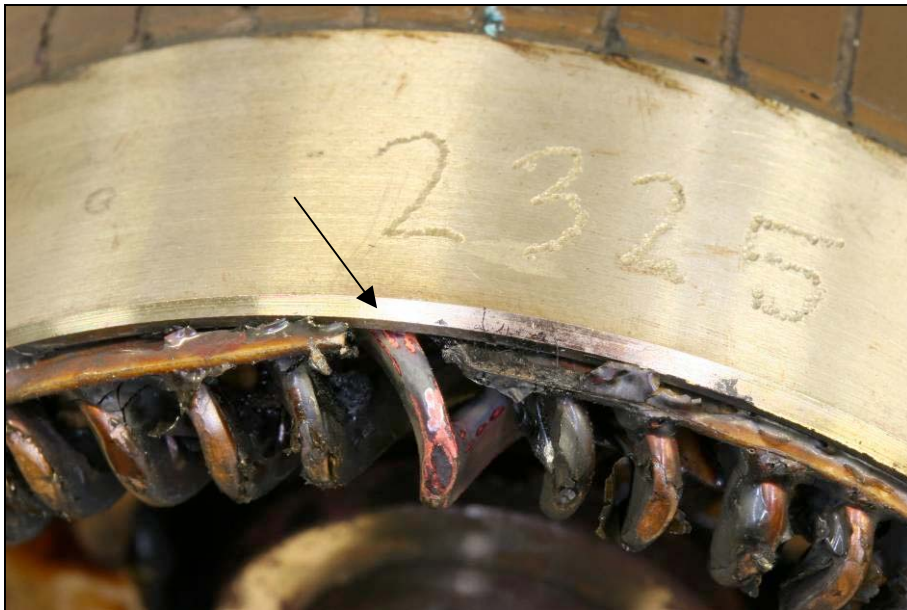
Upon examination, the SG armature unit, see Figure 27, showed clear evidence of the electrical shorting of a single core winding against the drive-end ring, see Figure 28. The insulating material between windings and end ring had been charred and lost in the area of the short, and the point of physical contact was characterised by the thermal tinting of the ring surface. The affected winding itself appeared discoloured and oxidised, when compared against the adjacent windings, with the discolouration also evident at the opposite (commutator) end of the armature core, see Figure 29. Laboratory measurements showed a negligible electrical resistance between the affected winding and the body of the armature core.

Figure 28: Shorted winding at the forward (drive) end of the armature core

Figure 29: The shorted turn at the rear (commutator end) of the armature body

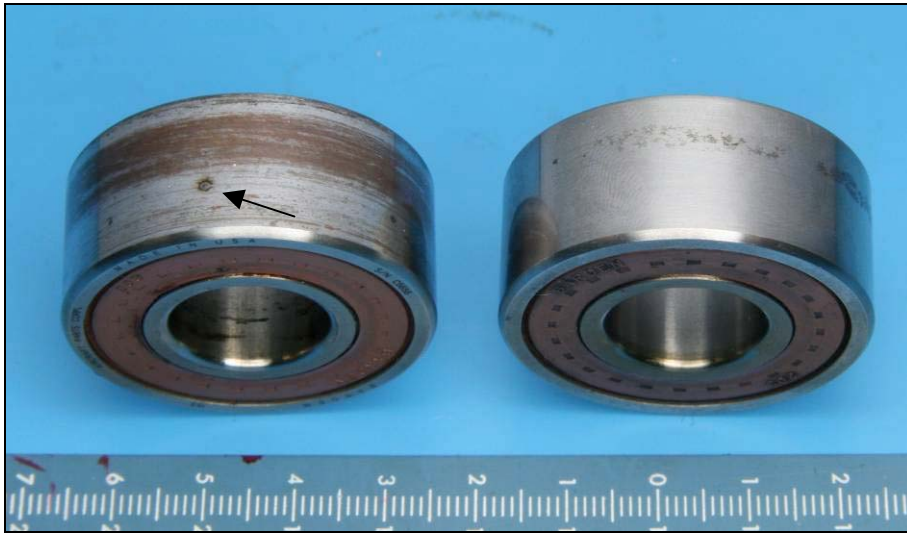
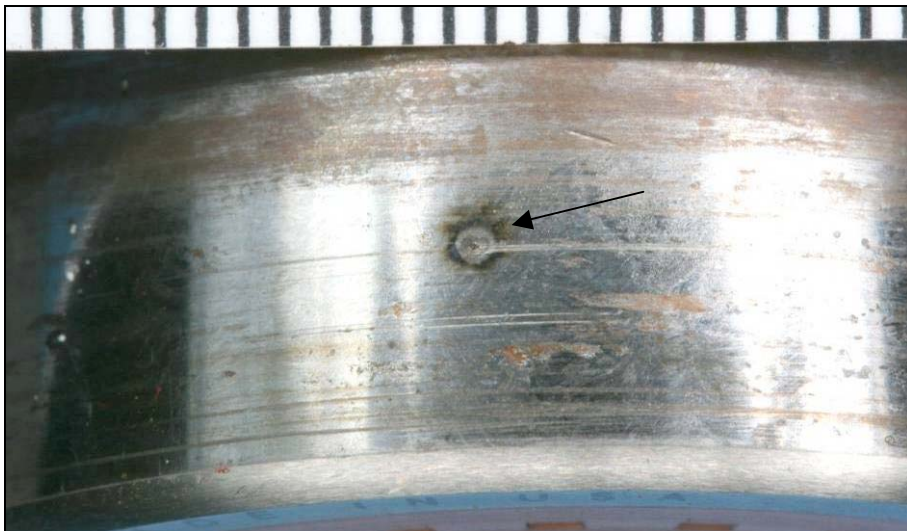
One of the two armature bearings, see Figure 30, showed multiple electrical arcing indications on the external cylindrical surface, see Figure 31. The affected surfaces of that bearing also showed circumferential scoring and light fretting damage, consistent with rotation and movement within the housing. The opposing bearing showed no evidence of external electrical arcing, nor did it exhibit any evidence of looseness or rotation within its housing.

Figure 30: Starter-generator shaft bearings – note damage at arrow

Figure 31: Typical pitting / re-melting damage as observed on the other accessory gear case components
