**ATSB TRANSPORT SAFETY INVESTIGATION REPORT**

Technical Analysis Investigation Report – 200601291

**Analysis of a Fractured Fuel Injector Line,  
Textron Lycoming IO540-C4B5 engine**

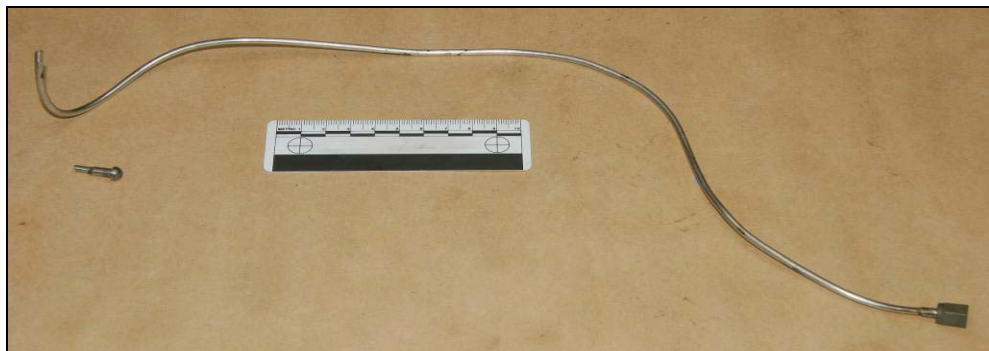
The fuel injector line (see figure 1) was identified with the part number LW-12098-0-210 and did not carry an identifiable serial number. Information received indicated the line was installed to the number-1 cylinder of the engine, which placed it in proximity to the front of the engine cowling. The injector line's total time in service (TTIS) was not available, however it was reported that the engine from which the line was removed had operated for 1,039 hours since overhaul (TSO), with the line being a return-to-service<sup>1</sup> item during that overhaul. It was also reported that the subject aircraft was based in Mackay, QLD and had operated for some time in a coastal / marine environment.

**Figure 1: Fractured fuel injector line, as-received**

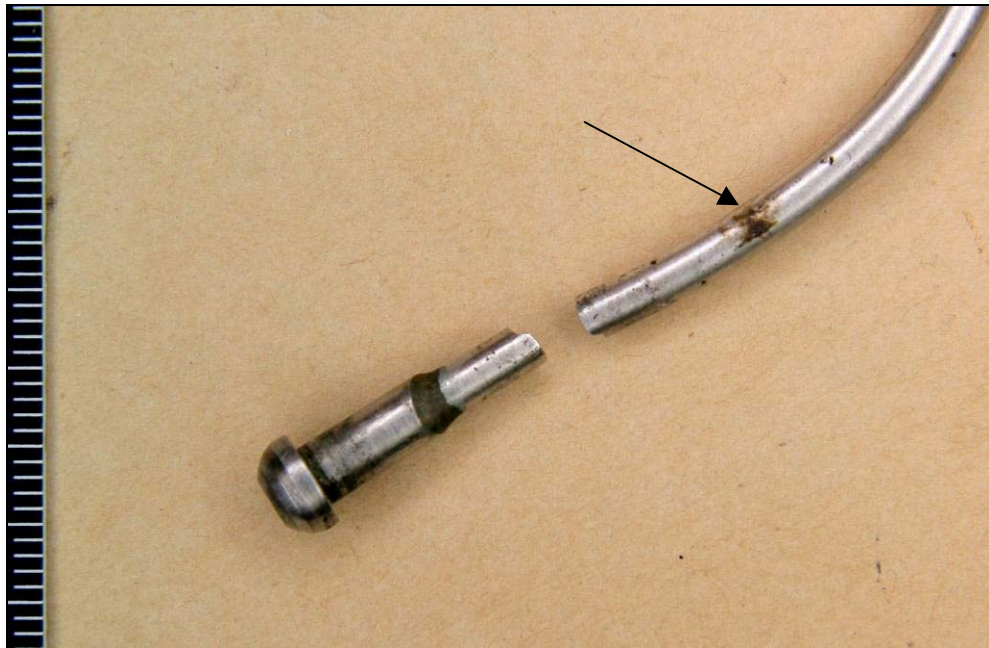
The fuel injector line presented as a formed, narrow diameter (3.16 mm) rigid metal tube, approximately 400 mm in length, with hemispherical compression nipple connections at each end. The line had fractured transversely through the plain tube section at approximately 80 mm from the injector connection (cylinder) end; the point of failure located 6.5 mm from the brazed connection with the nipple fitting (see figure 2).

**Figure 2: Location of injector line fracture, with pitting corrosion staining arrowed**

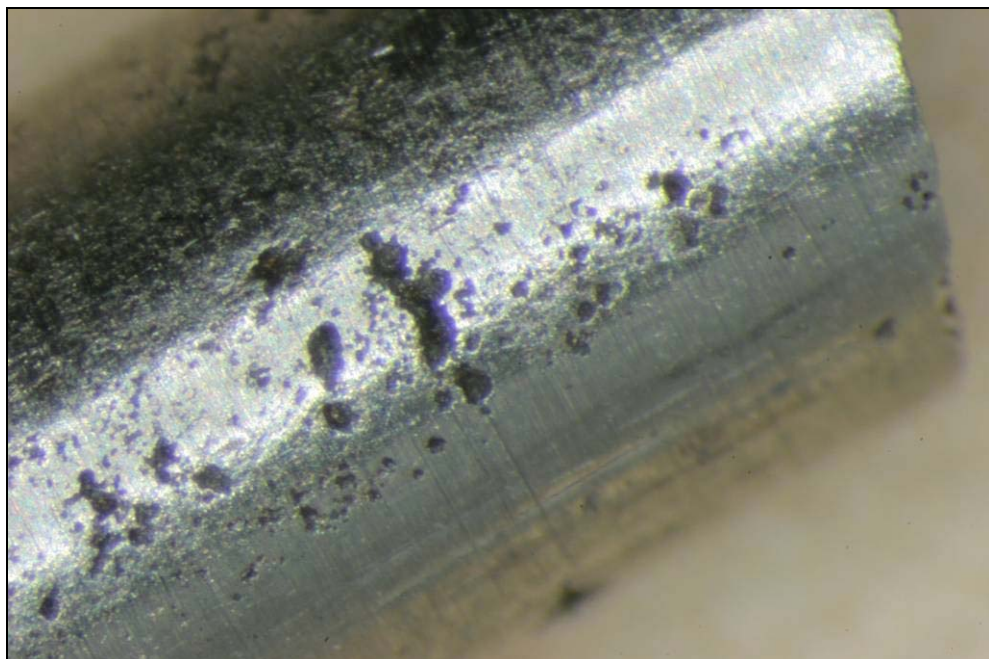
The external surfaces of the line showed several isolated areas of pitting corrosion damage with the associated brown oxide staining. Under low-power stereomicroscopic examination, several of the areas of pitting showed clusters of attack that had produced notable metal loss and wall penetration (see figure 3). The fillet of brazing alloy around the nipple fitting joint also showed a light surface verdigris film.

**Figure 3: Pitted external surface of injector line**

Following the ATSB investigation of this issue, the Civil Aviation Safety Authority revised airworthiness directives AD/LYC/90 and AD/CON/60 to include requirements for enhanced visual inspection of the lines, directing specific attention to the examination of lines for the presence of pitting and corrosion damage. The amended directives AD/LYC/90 Amdt 1 and AD/CON/60 Amdt 1 became effective on 31 August 2006.

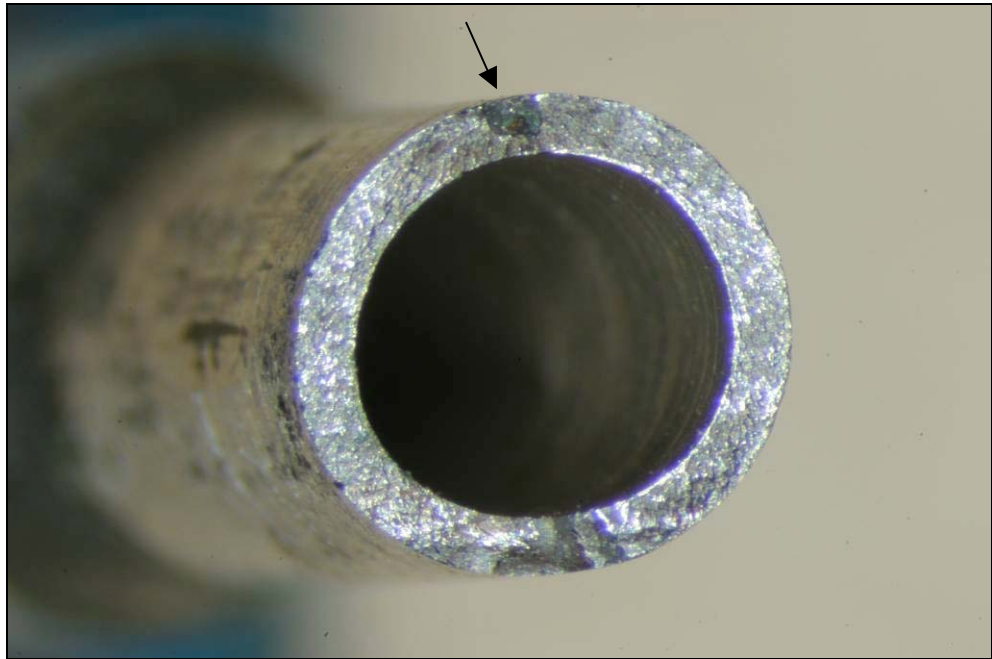
Under optical study, the injector line fracture surfaces were characteristically clean and undistorted (see figure 4). A vague chevron pattern extended away from a single large hemispherical corrosion pit that had been exposed by the fracture separation – the pit extending to a depth of around 75% of the original line wall thickness (see figure 5).

**Figure 4: Line fracture under low magnification. Fracture origin is at arrow**

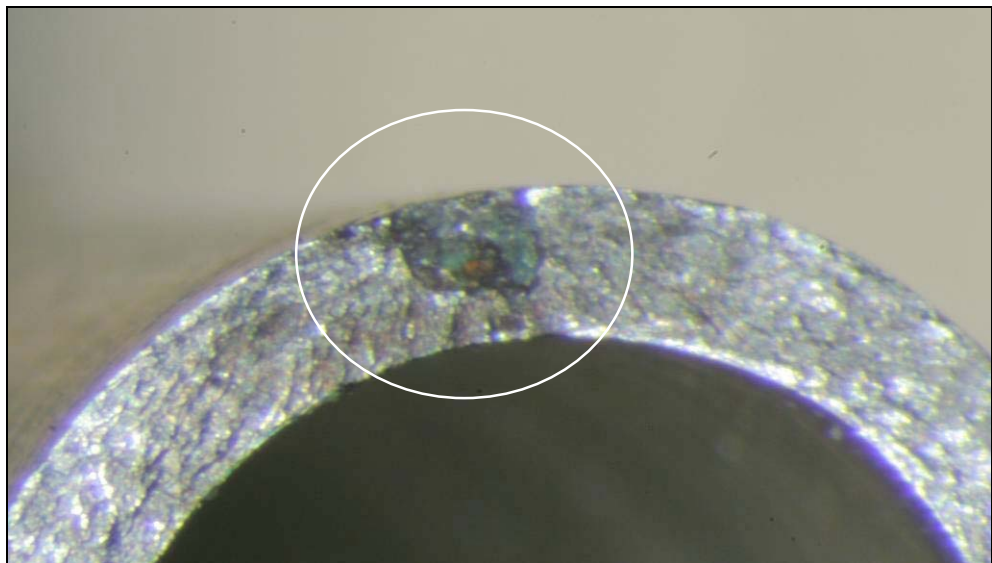
**Figure 5: Closer view of the large corrosion pit identified at the fracture origin (circled)**

The investigation determined that the examined fuel injector line had failed as a result of a unidirectional bending fatigue cracking mechanism, initiated at a large external surface corrosion pit. The fracture features were typical of fatigue crack growth occurring under the vibratory (high cycle) loading conditions associated with normal engine operation.

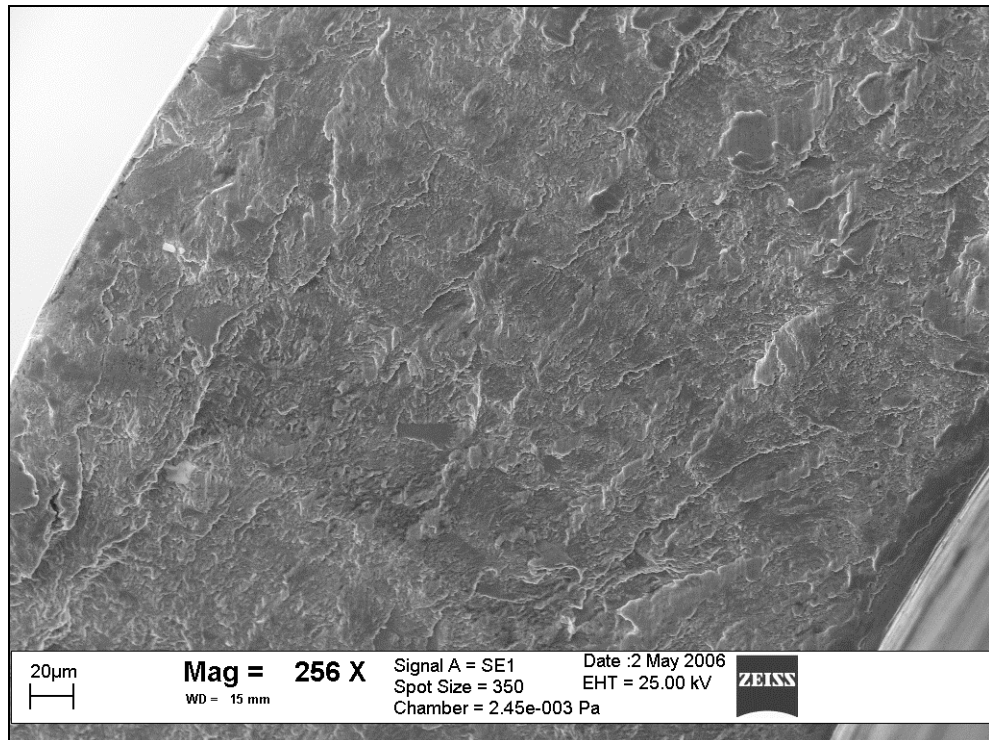
Under the scanning electron microscope (SEM), features typical of fatigue crack propagation were found across the majority of the fracture surfaces leading away from the corrosion pit (see figure 6). The surfaces also presented mechanical smearing and flow damage, consistent with repeated contact during the crack growth phase. The finely striated surfaces and small area of final ductile fracture opposite the origin, were consistent with crack initiation and growth under low-stress, high-cycle conditions.

**Figure 6: Electron image of the line fracture surface, showing vague banded appearance, characteristic of fatigue crack growth**

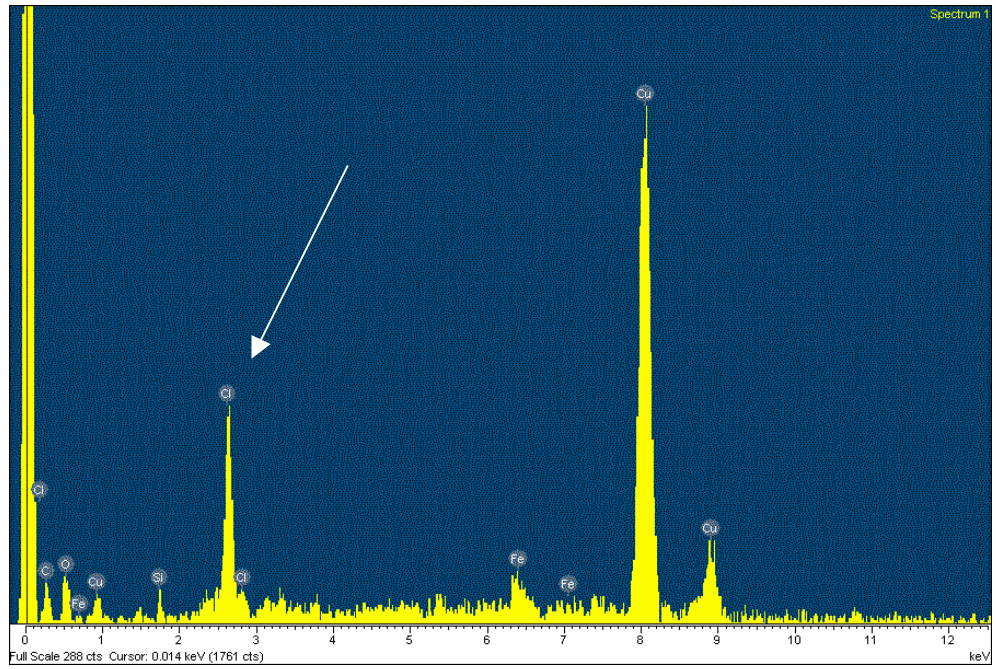
Energy-dispersive x-ray spectroscopy (EDS) of the corrosion product contents of several of the surface corrosion pits, showed most to contain chloride bearing compounds (see figure 7). Chlorine is elementally foreign to the stainless steel alloy chemistry and is most typically encountered as environmentally-borne sodium chloride (common salt).

Figure 7: EDS analysis spectrograph showing the elemental composition of the corrosion pit at the fracture origin (the chloride elemental peak is arrowed)

The fuel injector line had been manufactured from an austenitic stainless steel alloy, and was typical of many such rigid lines employed for delivery of pressurised fluids. Austenitic stainless steels, to varying degrees, are susceptible to pitting corrosion attack in the presence of chloride ions, with the aggressiveness of the attack being proportionate to the ambient temperature. Elevated temperatures typically accelerate rate of attack. With regard to the injector line examined, the presence of chloride compounds was confirmed within the proximity of the pits and corroded material. Given the reported operation of the engine/aircraft in a coastal region, it is probable that the chloride acting to advance the corrosion pitting had its origins in the salt-laden air of those environs.
