ATSB TRANSPORT SAFETY INVESTIGATION REPORT  
Marine Occurrence Investigation No. 220  
Final

Independent investigation into the fires on board  
the Panamanian registered accommodation platform

# Safe Concordia

12 and 18 September 2005

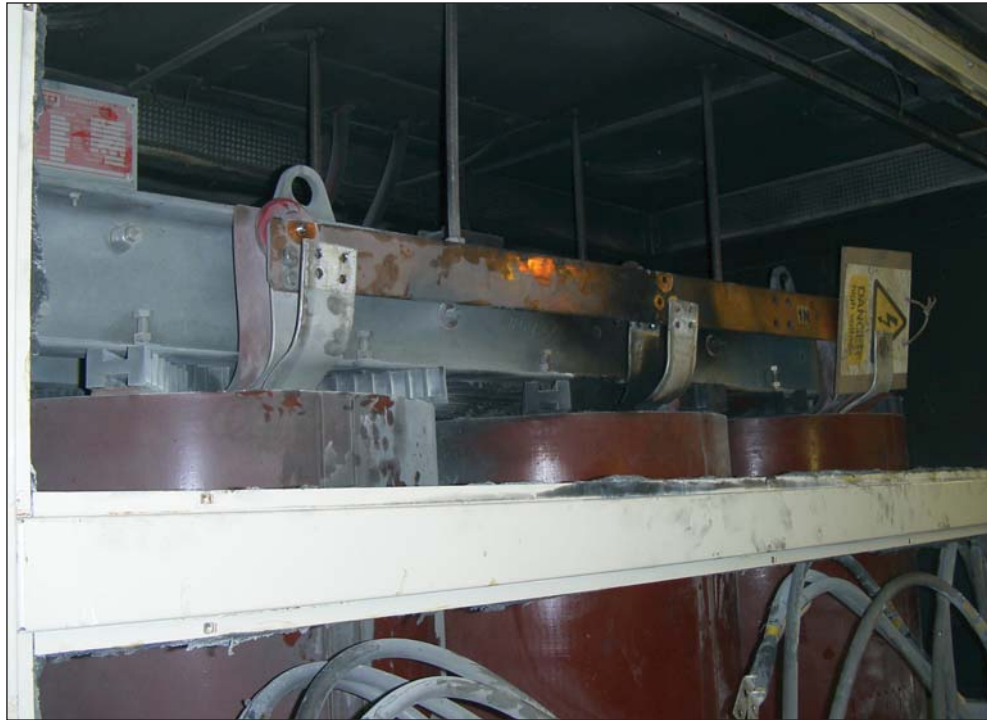
**Figure 7: Inside number four transformer cabinet**

The inner coils of the transformers were the secondary windings with a lower voltage and higher current. The outer coil was the primary or high voltage winding. All of the transformer coils were made from copper wire that was insulated with Class F<sup>9</sup> dry resin insulation. The ratio of wire turns between the primary and secondary windings determined the transformation or voltage ratio.

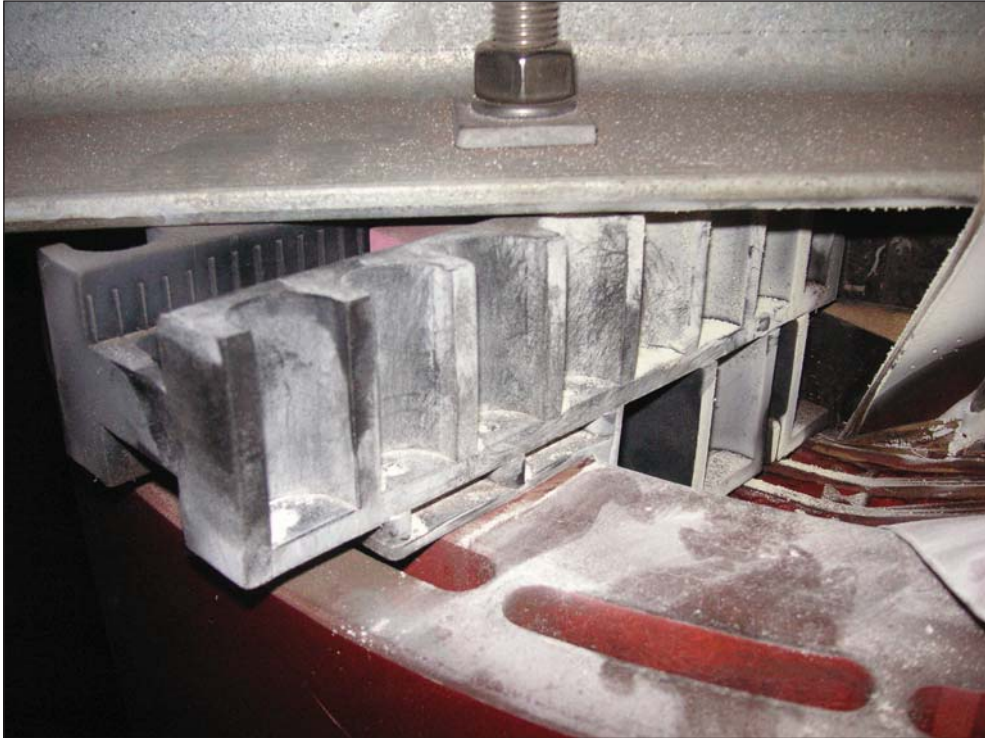
On 21 August 2005, number two and number four thruster circuit breakers tripped off almost simultaneously. Number four thruster was reset and restarted without any problems although number one thruster tripped off immediately after number four was engaged. Number two thruster was found to have blown most of the fuses in the VFD. After discussions with the manufacturer, the VFD was exchanged with a spare and a transformer inspection carried out. The inspection revealed that the transformer was coated with a layer of fine grey dust that could not be explained at that time (Figure 13). The dust was removed and the thruster was returned to service.

**Figure 13: Grey dust on a transformer top**

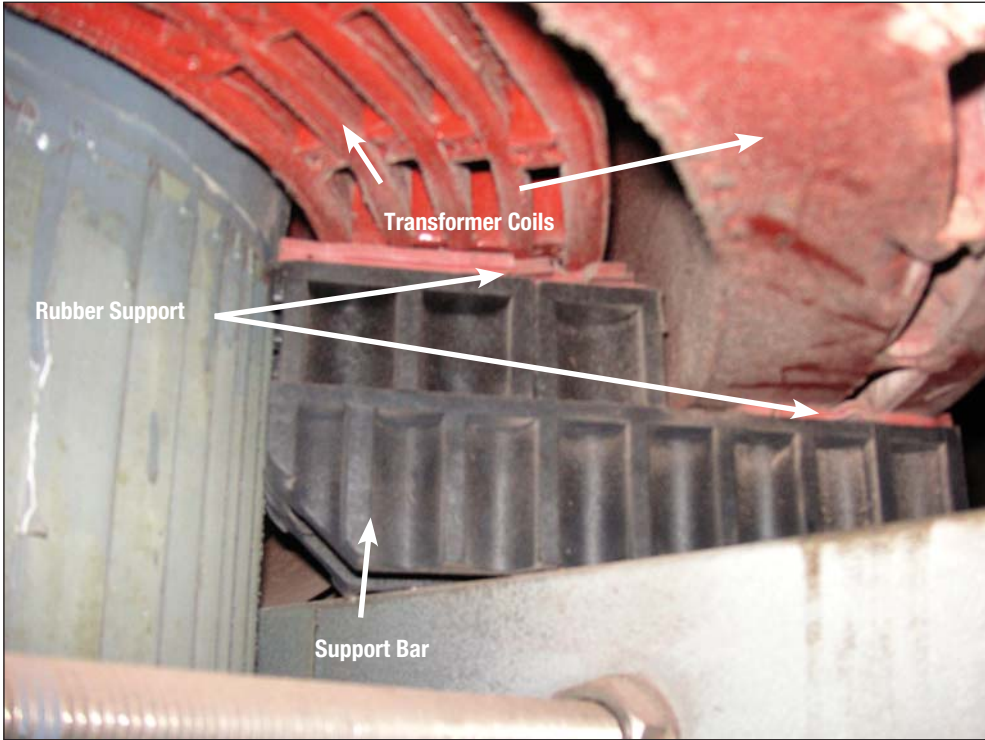
**Figure 14: Transformer bottom showing support bars and rubber supports**

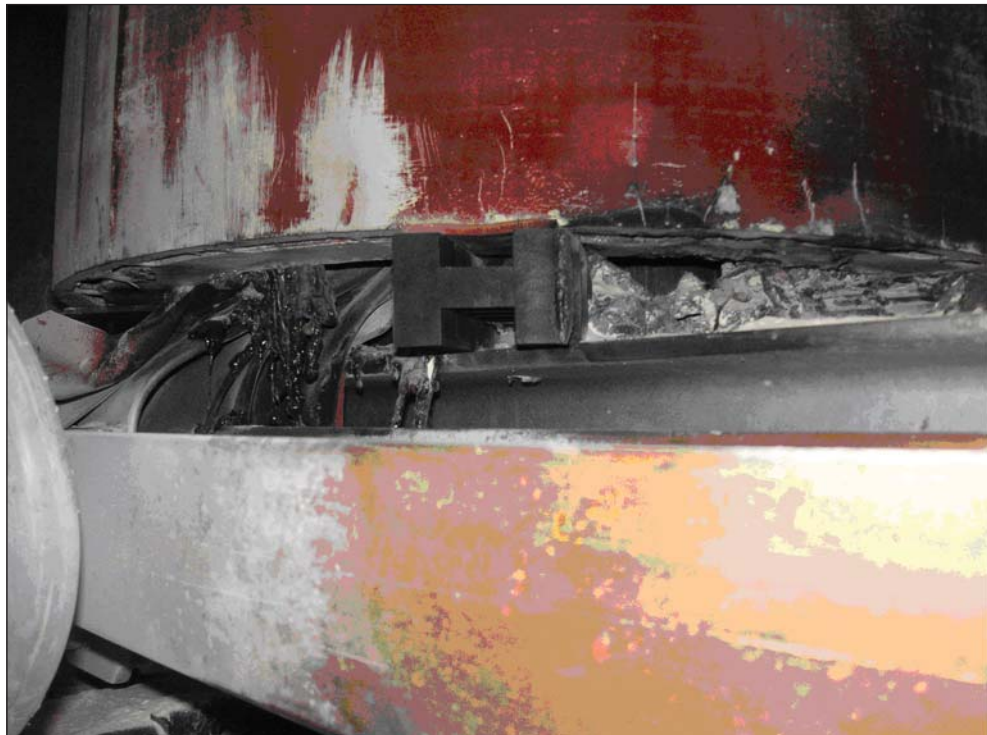
At 0048 on 12 September 2005, *Safe Concordia* suffered a fire in its number four thruster transformer. The damage to the transformer was localised and this indicated that the origin of the fire, and the fault that caused it, was contained within the centre coil of the transformer (Figure 16). The fire could only have been fuelled by the resin insulation within the transformer. These materials were probably ignited by electrical arcing within the transformer coil due to the failure of the insulation.

**Figure 16: Localised fire damage on number four transformer centre coil**

The overheating of the transformers on board *Safe Concordia* suggests that they were not able to withstand the harmonic currents. Furthermore, the system resonance and the unbalanced phases were causing the transformer to become saturated, i.e. unable to develop additional magnetic flux and, therefore, unable to provide increased output when the supply is increased. These factors, in turn, suggest that the transformer specification was not sufficient for its intended service conditions. The transformers did not have a suitable 'K-rating'.

The evidence suggests that the fire in the centre transformer coil of number four thruster transformer on 12 September was probably the result of an internal short circuit within the transformer. The short circuit was caused by a breakdown of the transformer insulation due to overheating of the transformer, probably due to the effect of the DC components and high harmonic currents supplied by the VFD, because the transformer was not suitably rated.

In January 2006, the platform was taken back to Singapore on board the heavy lift ship *Mighty Servant 1*. The thruster drive transformers were replaced with larger capacity units and the control software for the VFD was modified to address the harmonics and the power factor problems. The new VFD software was also designed to address the system's resonance.

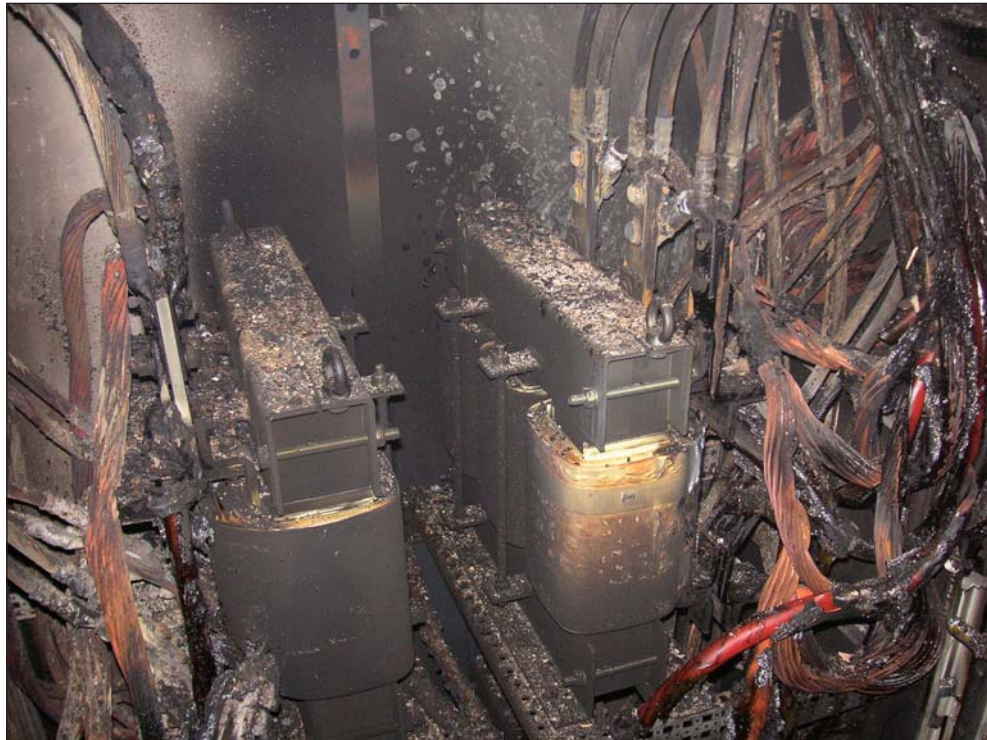
The work appears to have been rushed. I suspect that the possibility of intermittent connections was not contemplated, and was not obvious because of the crowded conditions. Some connecting busbars were done correctly. Some were not. It appears most likely that two different tradesmen were working in the area. One was careful. The other was not.

**Figure 17: Burnt out upper section of the choke cabinet showing extra cables**

At 0326 on 18 September, the insulation on the cables within the choke cabinet, and the rubber sheeting, caught fire while the electrical contractors were testing the system under load.

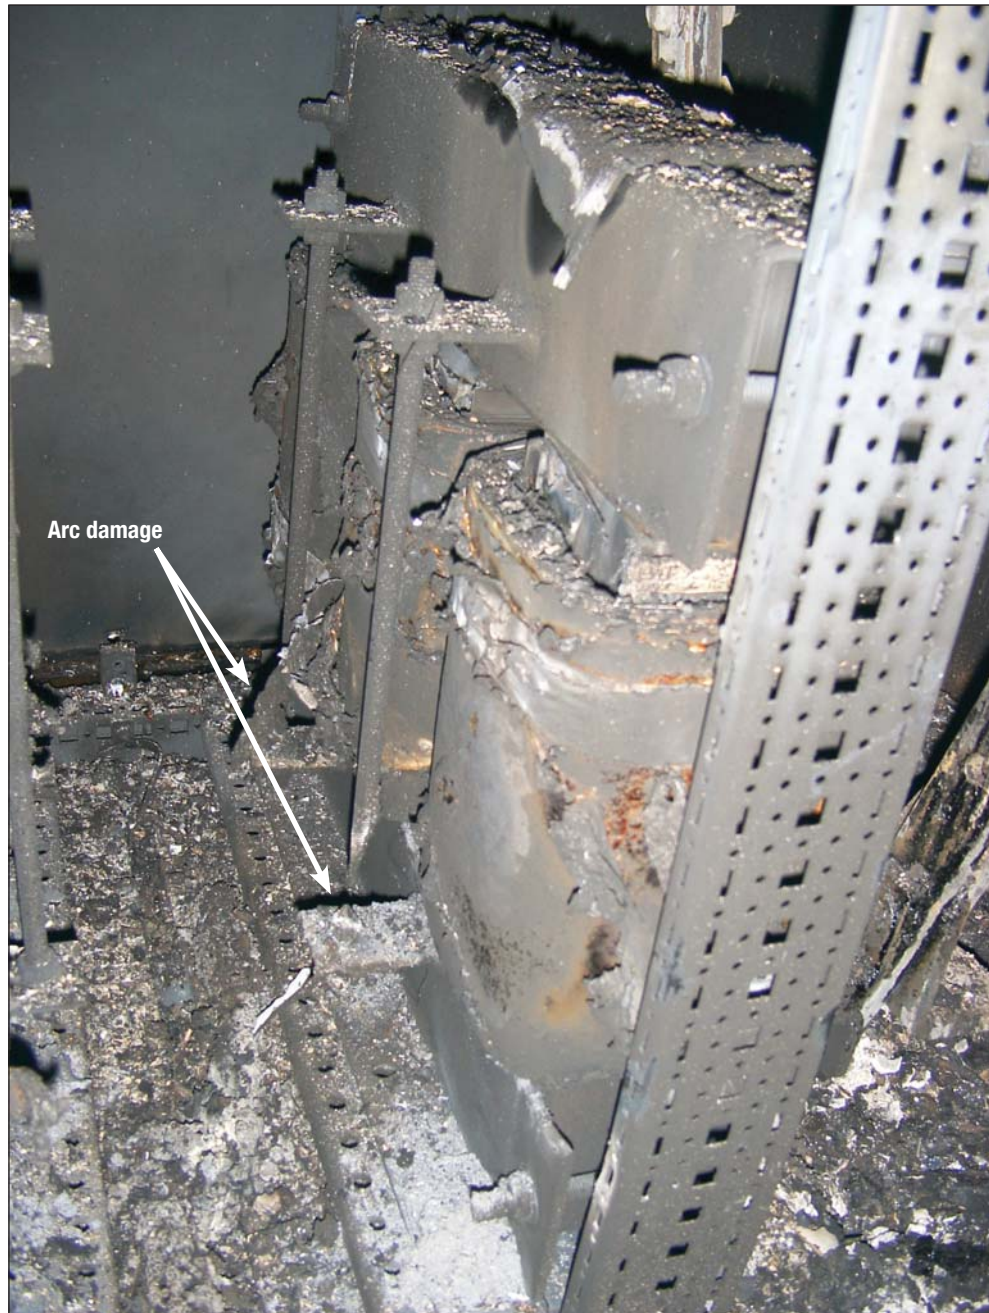
The fire, as observed by the testing team, appeared to start near the left hand side of the lower chokes and then spread to the right hand side of the choke cabinet. A detailed examination of the cabinet revealed that the tie bolts for the lower right hand chokes, between the two lower banks of chokes, had sustained arc damage. An arc had occurred between the lower turns of the adjacent coils and these tie bolts.

**Figure 18: Burnt out lower section of the choke cabinet showing arc damage**

An examination of the connections between the bridging cables and the terminal strips, after the fire, revealed arc erosion damage on the lower, right hand choke's centre connection. This was consistent with it not being sufficiently tight and an arc occurring across it. The same connection also showed signs of overheating, consistent with arcing or a high resistance across the connection due to it being insufficiently tightened.

There was also evidence of arcing between the new bridging cables and the existing, lower, choke terminals. This suggests that the extra cable length and weight had caused the connections to distort in the crowded cabinet and make arcing contact with the unused choke terminals.

insulation which, in turn, caused a fault to earth in the lower right-hand coils. This earth fault subjected the remaining lower chokes to about 1.73 times their normal voltage to earth. A second arc then occurred to earth, followed by a phase-to-phase fault between the chokes, by way of the chassis and the tie bolts.
