**ATSB TRANSPORT SAFETY INVESTIGATION REPORT**

Aviation Occurrence Report – 200605807

**Birdstrike**  
**Melbourne Airport, Vic.**  
**3 October 2006**  
**VH-OGJ, Boeing Co 767-338**

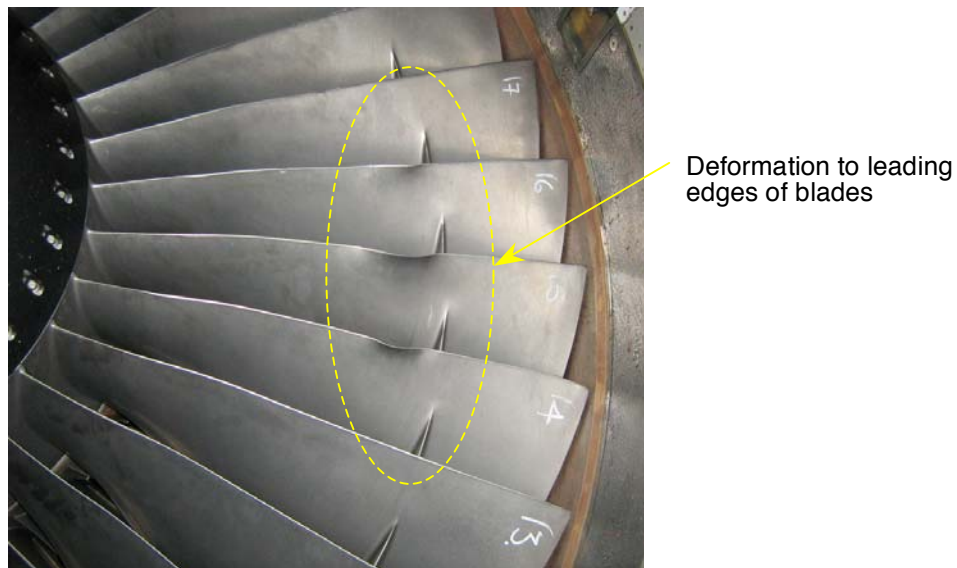
A subsequent examination by the operator's maintenance staff revealed that the birds had struck the nose of the fuselage, the nose and right main landing gear, the wing leading edges, the engine pylons and both left and right engines. The damage to the aircraft was determined by maintenance staff to be minor, except for damage to the leading edges of 4 to 5 blades on both engines (Figure 1) and blockage of the pre-cooler on the left engine.

**Figure 1: Damage to right engine fan blades**

Note: damage to blades on both engines was similar in appearance.

As the damage occurred to the left engine before the aircraft had departed the Melbourne area, the crew were assuming that the right engine would be operational for the entire flight. As it turned out, the right engine had also sustained some damage due to the birdstrike and was thus at an increased risk of failure during the flight.

The aircraft was inspected, cleaned, repaired and returned to service in accordance with the applicable sections of the aircraft maintenance documentation. No further issues relating to this birdstrike incident were reported by the operator.
