ATSB TRANSPORT SAFETY INVESTIGATION REPORT  
Rail Occurrence Investigation 2006006  
Final

Level crossing collision between  
**XPT Passenger Train ST24  
and Passenger Car**

Thurgoona Road, Albury, NSW

5 June 2006

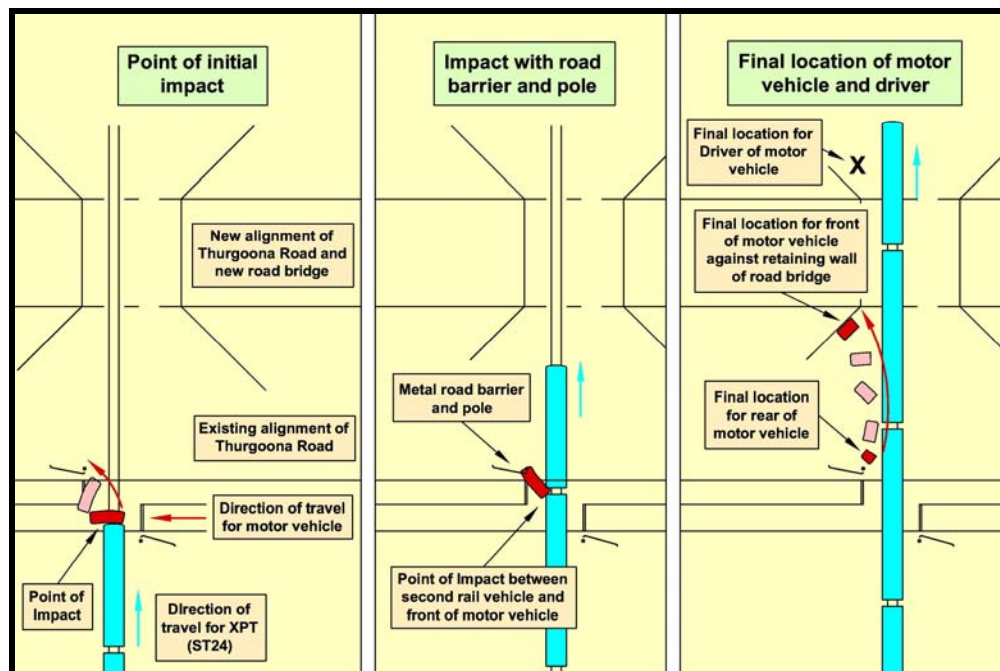
**Figure 4: Collision Sequence**

During the collision, the passenger car was broken into two main sections. The rear of the car remained adjacent the road barrier and mast, with the front section pushed approximately 20 m into the retaining wall of the adjacent road bridge. Both sections of the car ignited with the subsequent fire destroying the entire vehicle. The only occupant (driver) of the passenger car was thrown from the vehicle during the collision, coming to rest approximately 50 m from the initial impact. The driver was fatally injured.

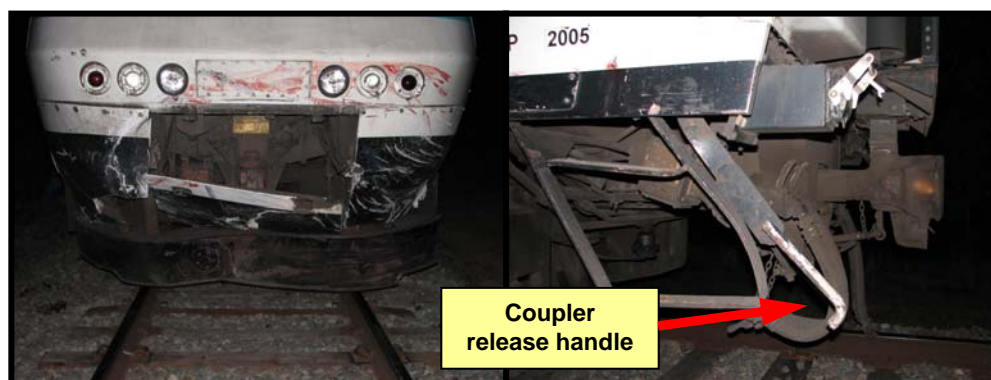
**Figure 5: Front and rear of lead power car**

When all of the rail vehicles had come to a stop, the lead power car had uncoupled and was approximately 300 m in front of the remaining train, a total distance of 864 metres past the level crossing. Examination of the coupler and associated equipment indicated that the passenger car had impacted with the ladder and the support bar for the coupler release handle at the rear of the lead power car. The release handle was pushed to an angle which allowed the coupler to open, which in turn resulted in the lead power car separating from the rest of the train.

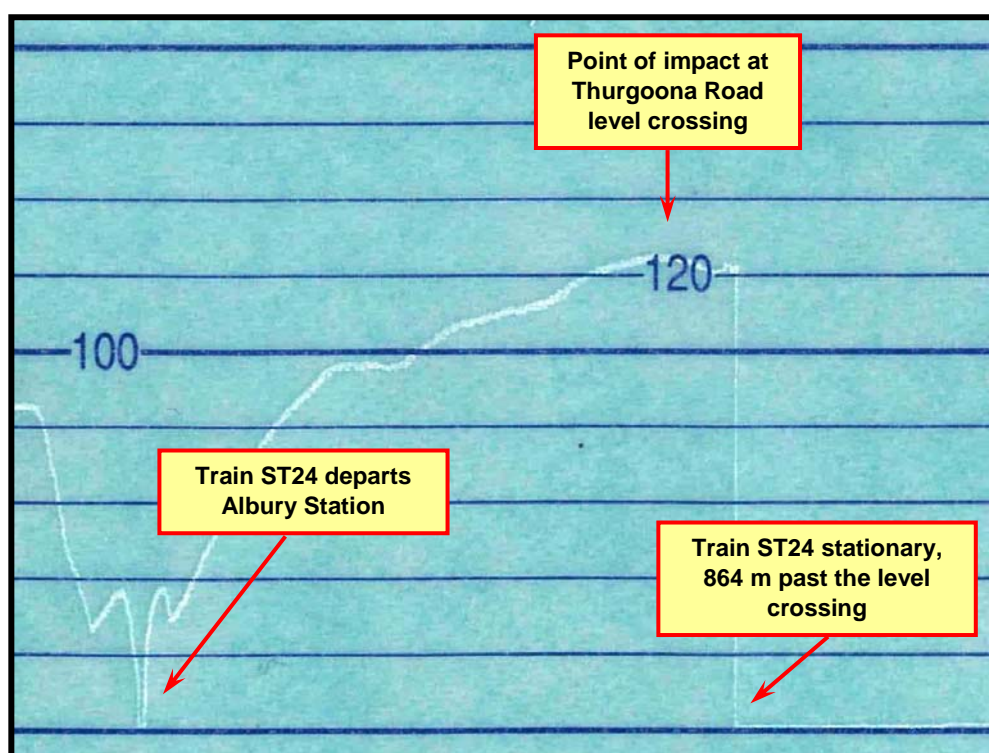
**Figure 6: Train speed for lead power car of train ST24**

The data log showed that train ST24 had departed Albury station approximately five minutes before the collision at Thurgoona Road. Train ST24 had gradually accelerated and was running at between 120 km/h and 130 km/h as it approached Thurgoona Road level crossing. The posted track speed was 160 km/h.

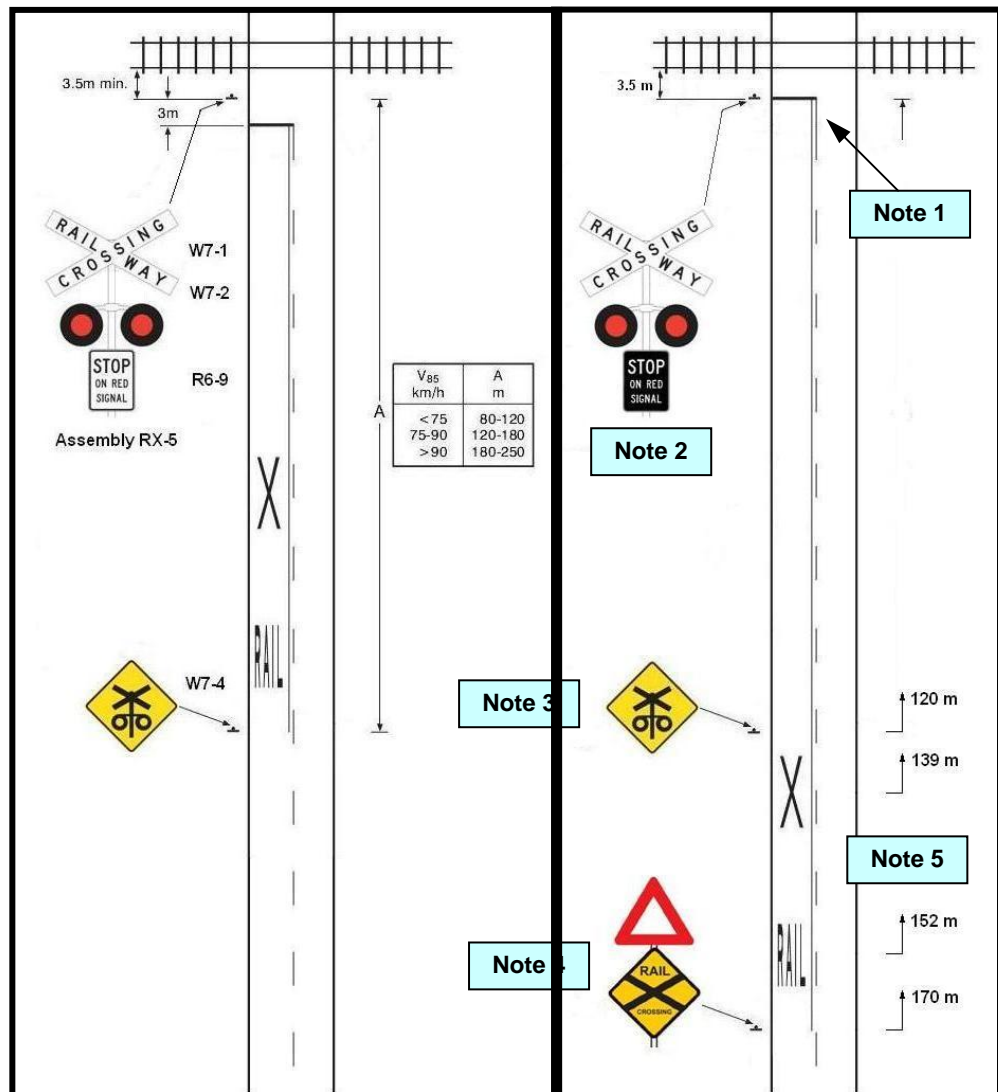
**Figure 8: Signage as required by AS1742.7-1993 (left)  
Signage as installed at Thurgoona Road on 5 June 2006 (right)**

- Note 1: The position of the 'Stop Line' did not conform to the current standard which specifies the 'Stop Line' to be marked 3 m before the flashing light assembly RX-5.

- Note 2: The flashing light assembly conformed to the current standard except for the 'Stop on Red Signal' sign (R6-9). AS1742.7 – 1993 specifies white background with black lettering for the 'Stop on Red Signal' sign (R6-9); however, the sign at Thurgoona road conformed to an earlier standard using black background with white lettering.

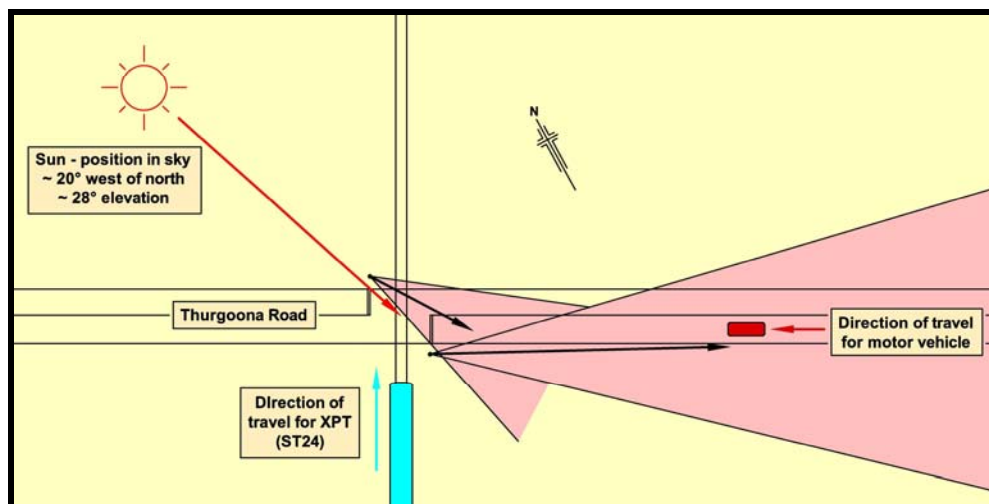
**Figure 9: Sun position and alignment of flashing lights (Eastern approach only)**

At 1322, when the accident occurred, the sun was approximately 20° west of north and at an elevation of approximately 28°. Reflection and ghosting on the flashing light lens surfaces was unlikely to have been problematic for the driver approaching from the east. Similarly, the elevation and angle are unlikely to have contributed to any significant level of glare. The level crossing was observed on the following

day, at the same time of day. The environmental conditions were considered similar to the day of the accident and verified that the effects of the sun were unlikely to have contributed to a reduction in sighting at the Thurgoona Road level crossing.
