ATSB TRANSPORT SAFETY REPORT  
Rail Occurrence Investigation – RO-2007-005  
Final

# Level crossing collision Two Wells, South Australia

6 August 2007

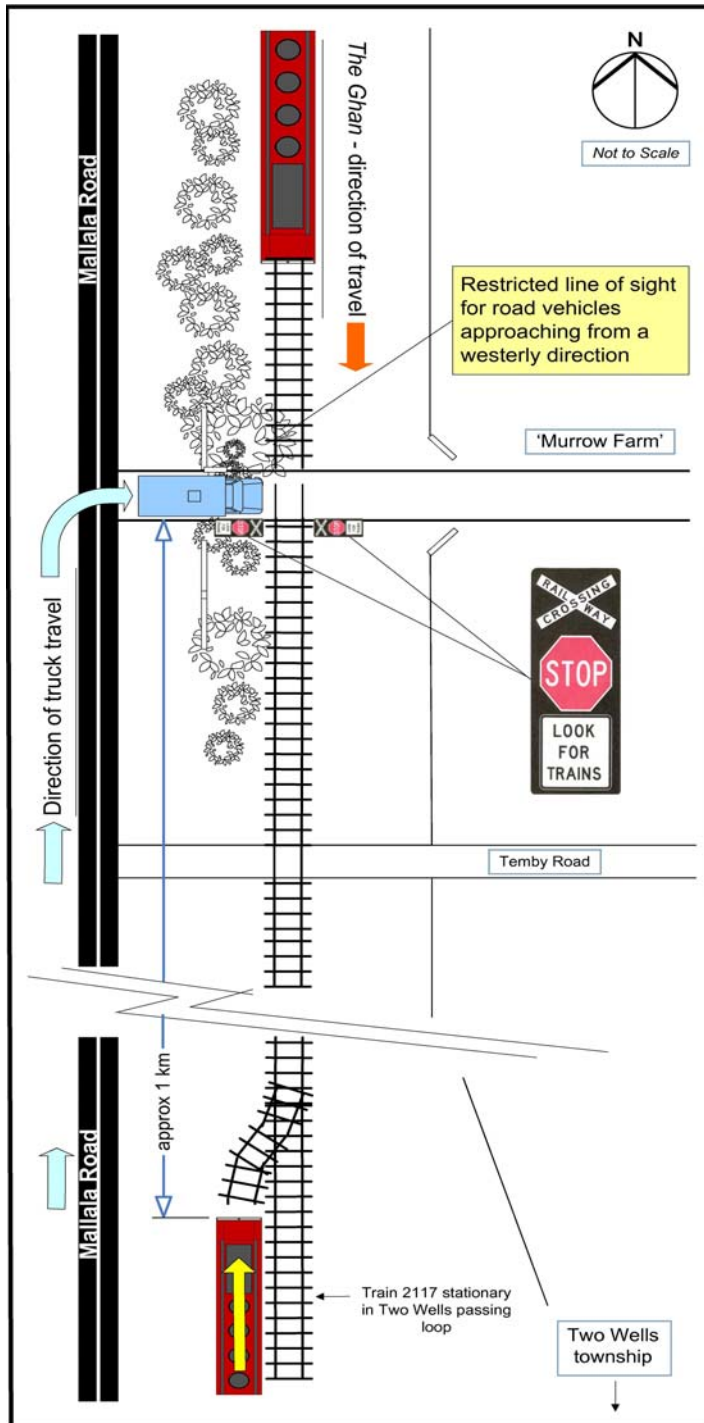
Figure 2: Road-Rail Layout at Murrow Farm

At the time of the collision, there was a 120 m long row of trees and shrubs beside the railway line. This vegetation effectively obscured the view that a driver of a train travelling south had of a road vehicle travelling along Mallala Road and about to turn into the Murrow Farm road to use the level crossing. Similarly, the view of an approaching train for the driver of the motor vehicle approaching the crossing,

was obscured by the same vegetation. Passive traffic control devices<sup>6</sup> were installed to regulate the behaviour of motorists using the level crossing.

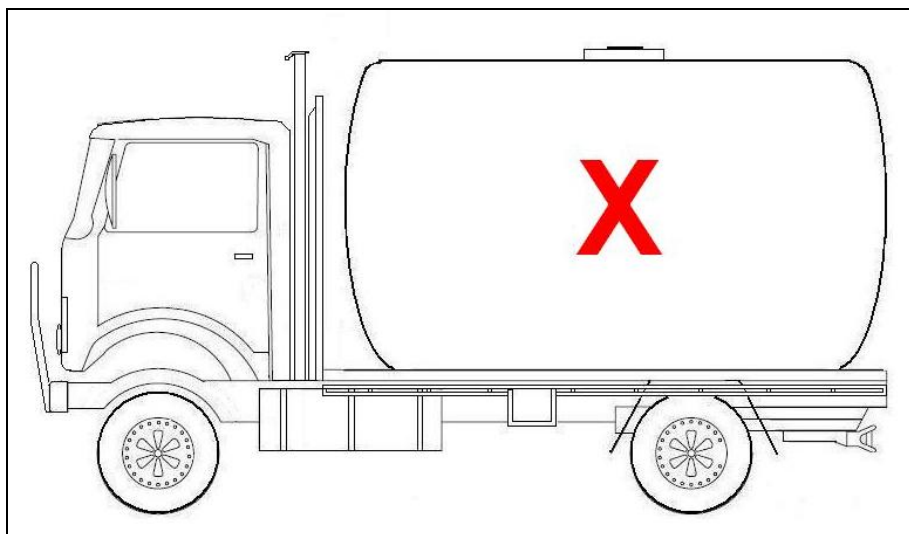
**Figure 3: Location of impact on truck**

The sewage truck was destroyed in the collision with the cabin, chassis and septic tank separating. On impact with the truck, both locomotives were sprayed with sewage and lead locomotive NR74 suffered extensive damage to its upper and lower structural and non-structural components. The train's passenger carriages and other wagons were not damaged.

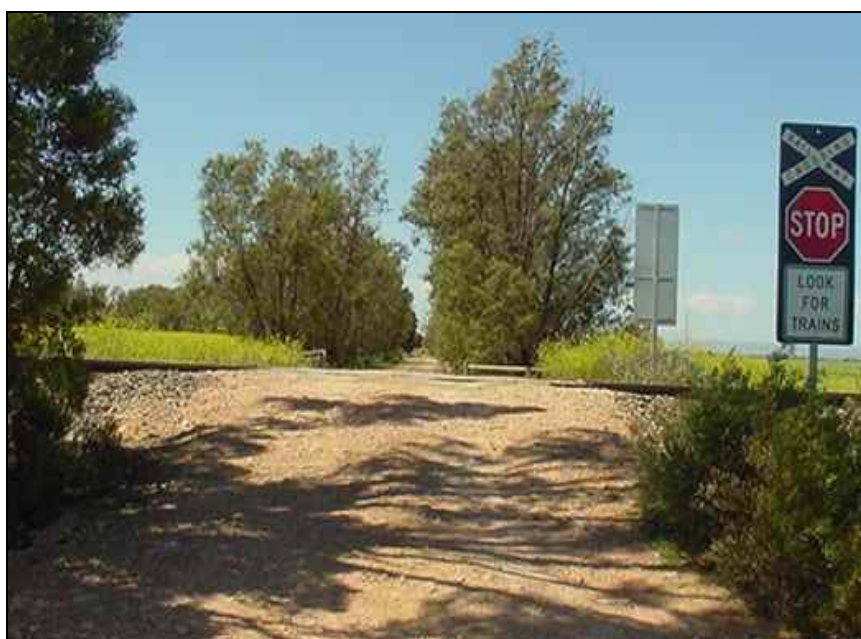
**Figure 4: Murrow Farm road entrance looking east**

The road traffic control devices installed at the Murrow Farm level crossing consisted of 'Stop' signs. At the time of the accident, the signs on both sides of the crossing were in a clean and serviceable condition (Figure 4).

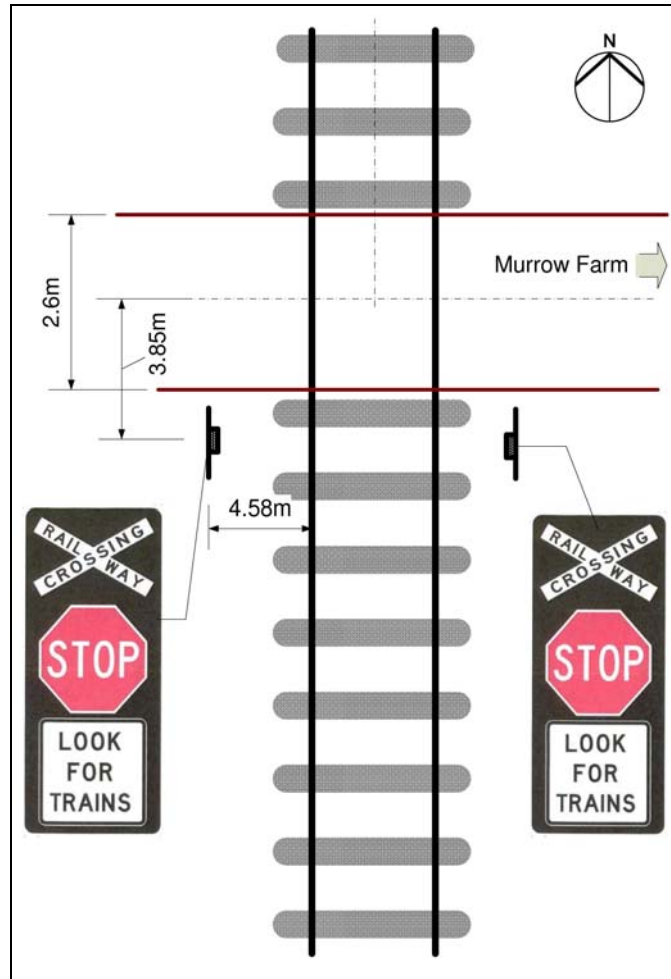
**Figure 5: Signs at Murrow Farm level crossing on 6 August 2007**

The signs used at Murrow Farm were consistent with the intent of AS 1742.7-2007, but all sign elements are printed on a single metal plate. The LOOK FOR TRAINS (G9-48A) and the STOP (R1-1A) elements both conform to the dimensions of the standard. The RAILWAY CROSSING element (R6-24A) has been modified to fit the width of the plate and is 53.5% of the standard specified size. The sign is reflectorized and has a black background with a white border.

The single plate sign assembly for drivers entering the farm was placed on the right-hand side of the roadway and about 4.6 m from the nearest rail. Although it is unlikely to have contributed to the accident as the sign was clearly visible to a road vehicle driver, it is standard practice to position 'Stop' sign assemblies on the left side of the road not closer than 3.5 m from the nearest rail.

The railway 'Stop' sign assembly (RX-2 modified) positioned approximately 4.6 m from the nearest rail instead of nearer to 3.5 m as recommended in Australian Standard AS 1742.7, made it more difficult for the driver to gain a clear view of approaching trains.

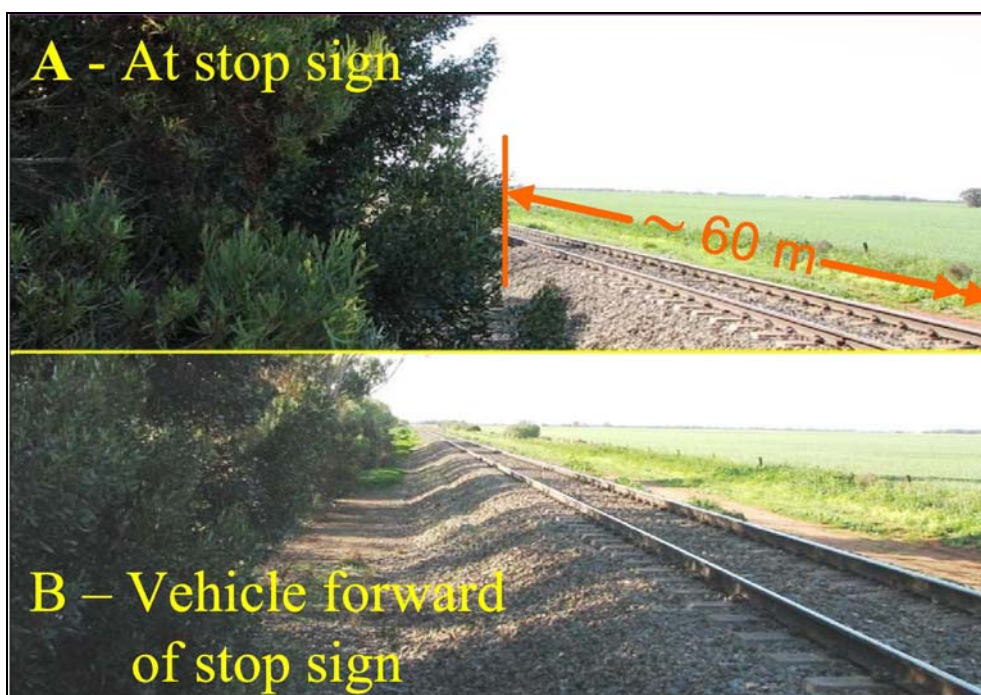
**Figure 6: Sighting distance looking north at the Murrow Farm level crossing**

However, at the time of the collision, the growth of the vegetation adjacent to the crossing meant the actual sighting distance for a train approaching Murrow Farm level crossing from the north was approximately 60 m (Figure 6A). For a vehicle moving forward from the 'Stop' sign, clear visibility of the approaching train could probably be only achieved when the front of the vehicle was in a position that obstructed the rail line and would result in a collision (Figure 6B).

was inadequate for a road vehicle driver travelling in an easterly direction to see an approaching train and allow their safe passage over the crossing.

The sighting distance of approaching trains had deteriorated to the point where the problem was readily identifiable which should have prompted swift maintenance action to prune the vegetation at the crossing. In addition, once the problem had been identified, other interim measures should have been put in place in accordance with the relevant ARTC CoP for private crossings until the maintenance was performed, for example, clearance to use the crossing from train control.
