Bureau of Air Safety Investigation

# Wire strikes

A technical analysis

June 1991

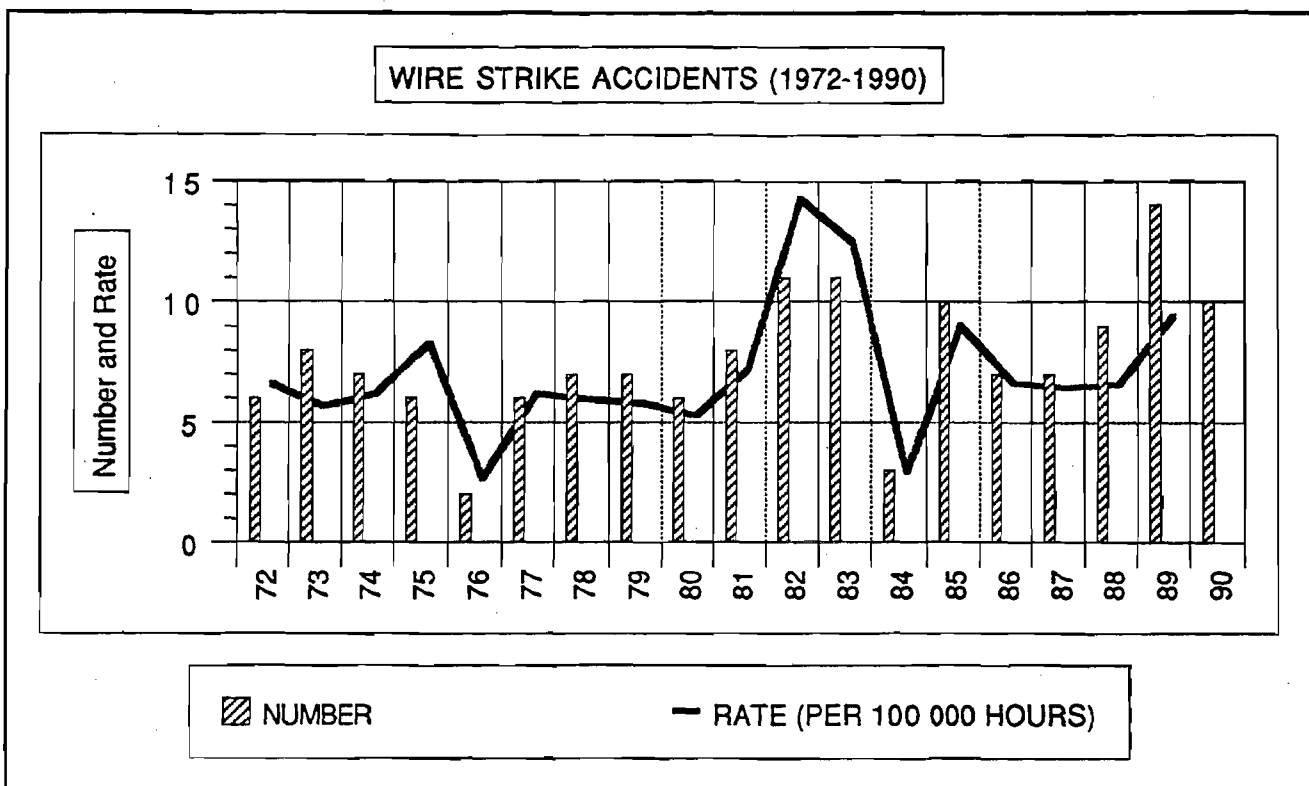
FIGURE 1

Figure 1 displays the number of accidents per year along with the rate of accidents per 100 000 hours flown. The activity data was obtained from the Domestic Aviation Information Section, Department of Transport and Communications. It is interesting to note that although the number of accidents per year increased to a statistically significant extent over the time period under consideration, the accident rate remained stable, despite the years 1982 and 1983 when the accident rate peaked.

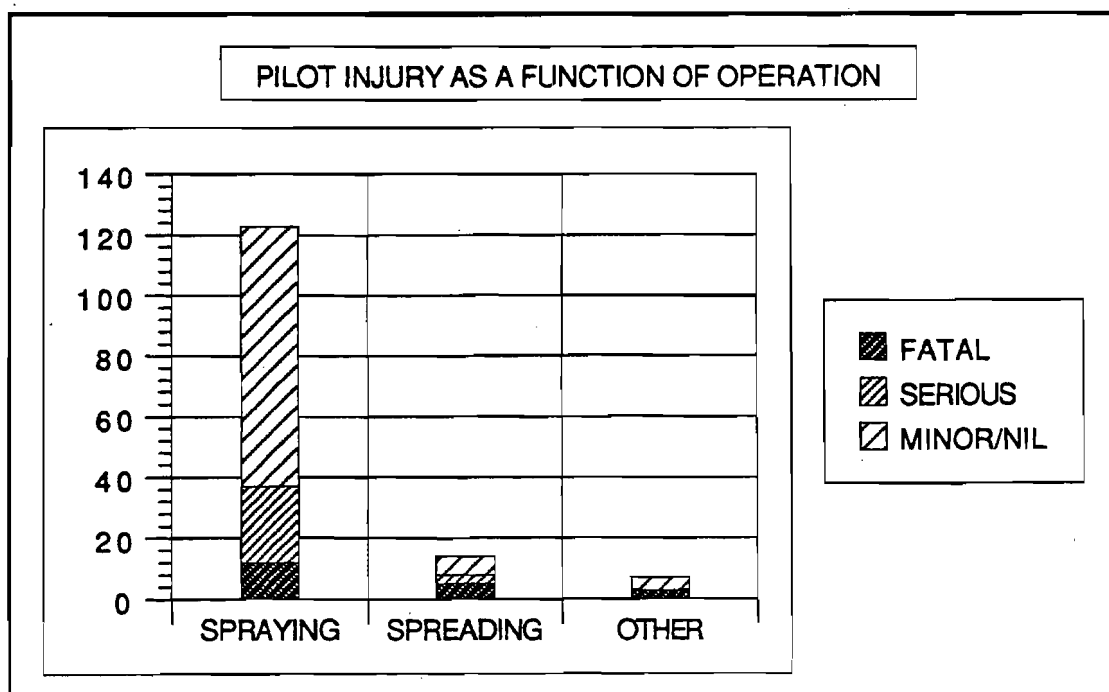
FIGURE 2

Figure 2 presents information once accidents are broken down according to operation and level of injury, and indicates that the majority of pilots escaped with minor or no injuries following spraying accidents

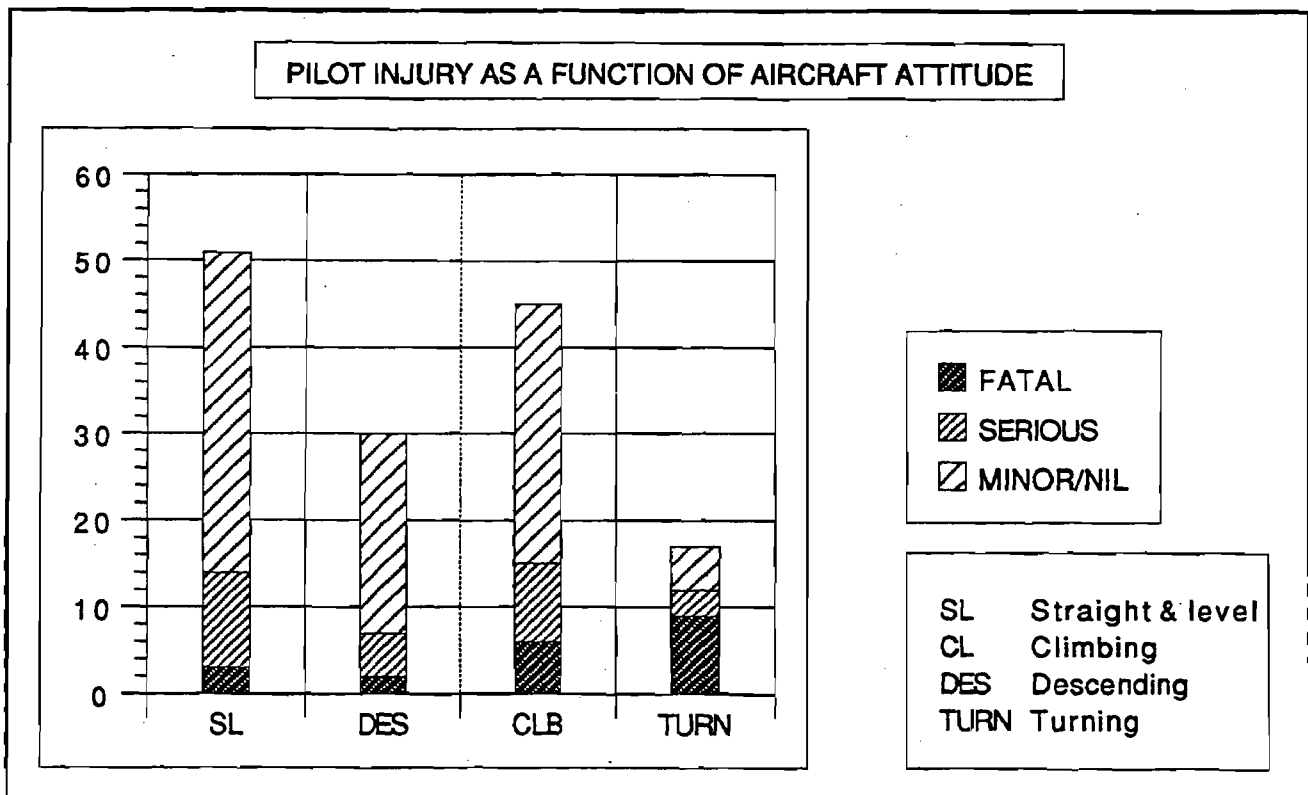
FIGURE 3

Figure 3 indicates the number of accidents according to aircraft attitude and injury classifications within each attitude category. The results indicated that an approximately equal number of accidents occurred when the aircraft was in climb or straight and level flight, and that approximately two-thirds of all the accidents resulted in minor or no injuries.

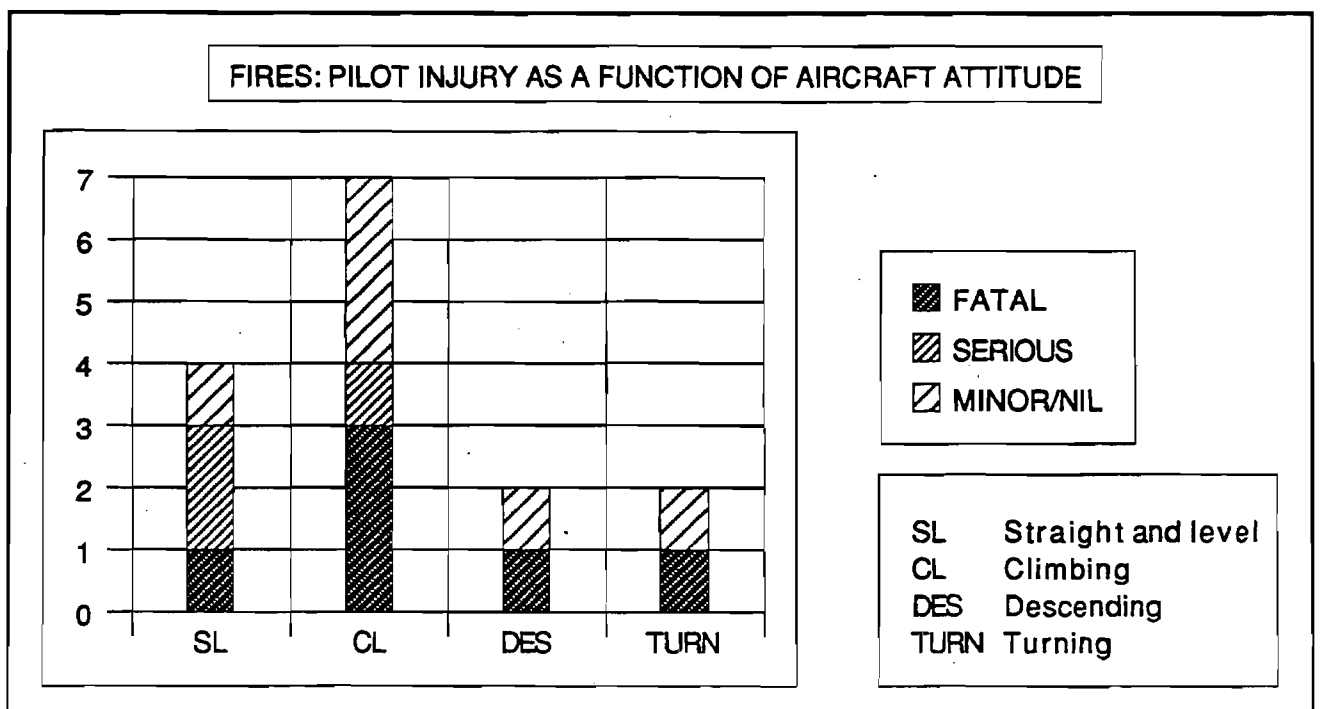
FIGURE 5

Of the 45 accidents where the primary contact was the landing gear, 15 involved post-impact fire (six of which were fatal), three pilots were seriously injured and six escaped relatively uninjured. It is interesting to note that accidents which occurred following landing-gear wire strikes whilst the aircraft was climbing had a high incidence of post-crash fire (see Figure 5).

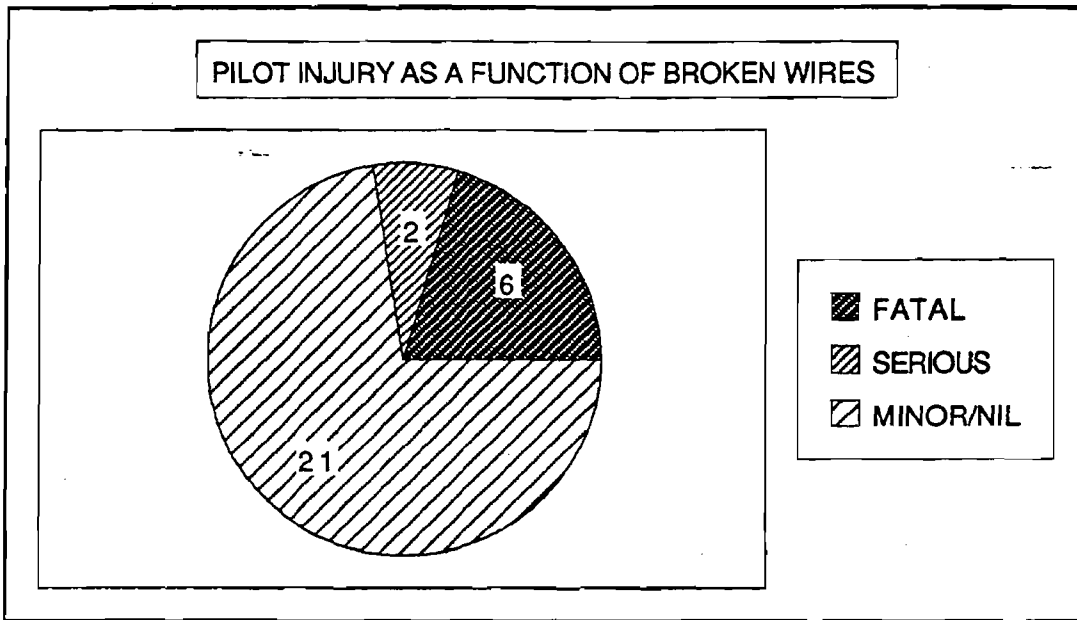
FIGURE 6

Figure 6 indicates that in 29 landing-gear strikes the wire was severed and in the majority of these cases the pilot escaped relatively uninjured. However, when the wire remained intact the injury to the pilot was on average more severe (see Figure 7).

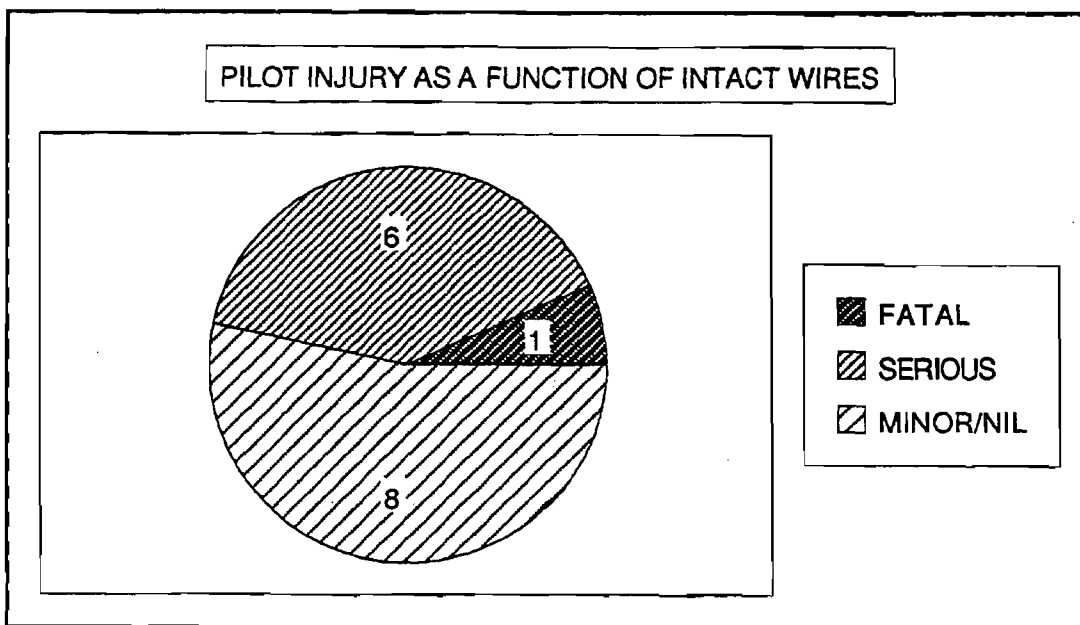
FIGURE 7

There were 15 landing-gear cases in which the wire remained intact. These resulted in one fatality, six seriously injured pilots, and eight with minor or no injuries.

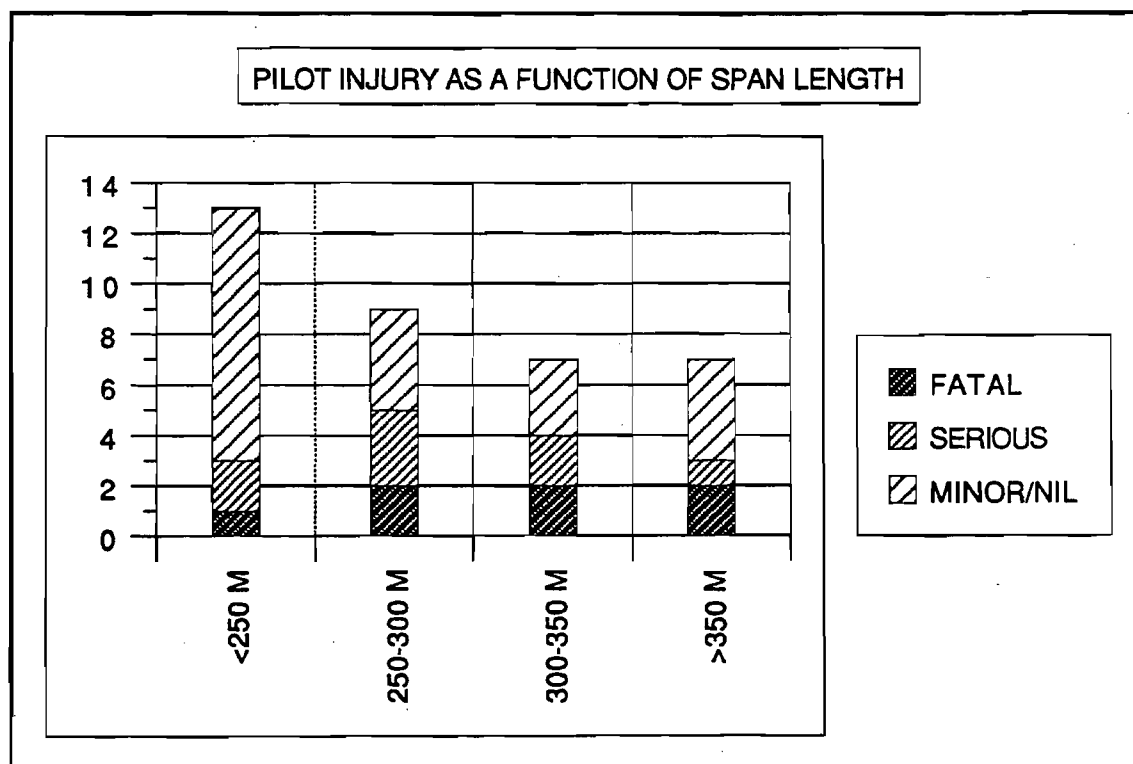
FIGURE 8

Other aspects that should be considered when analysing the dynamics of wire strikes include the type of conductor, span length and striking speed. To obtain a general understanding of the mechanics associated with colliding with wires, it was assumed that the speed of the aircraft during agricultural operations remained fairly constant and within the normal operating range of each aircraft type. A similar approach was made concerning the type of wires, due to a high degree of homogeneity within the database; consequently, span length of the wire was the only variable to be measured against severity of injury (see Figure 8).

The results indicated that the smaller span lengths tend to be more forgiving when the aircraft contacts the wire with the landing gear.

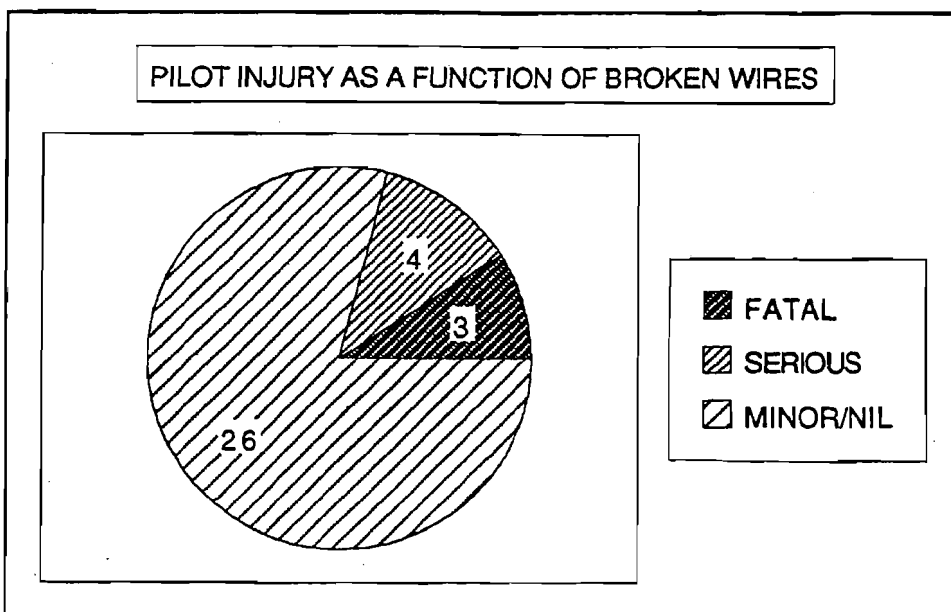
FIGURE 14

Overall, in 33 accidents the impact with the wire actually broke it, resulting in three fatalities, four pilots seriously injured, and the remaining 26 without significant injuries (see Figure 14). In the remaining 27 cases in which the wires were not broken, seven were fatal accidents, seven culminated in serious injuries and 13 escaped without significant injuries (see Figure 15).

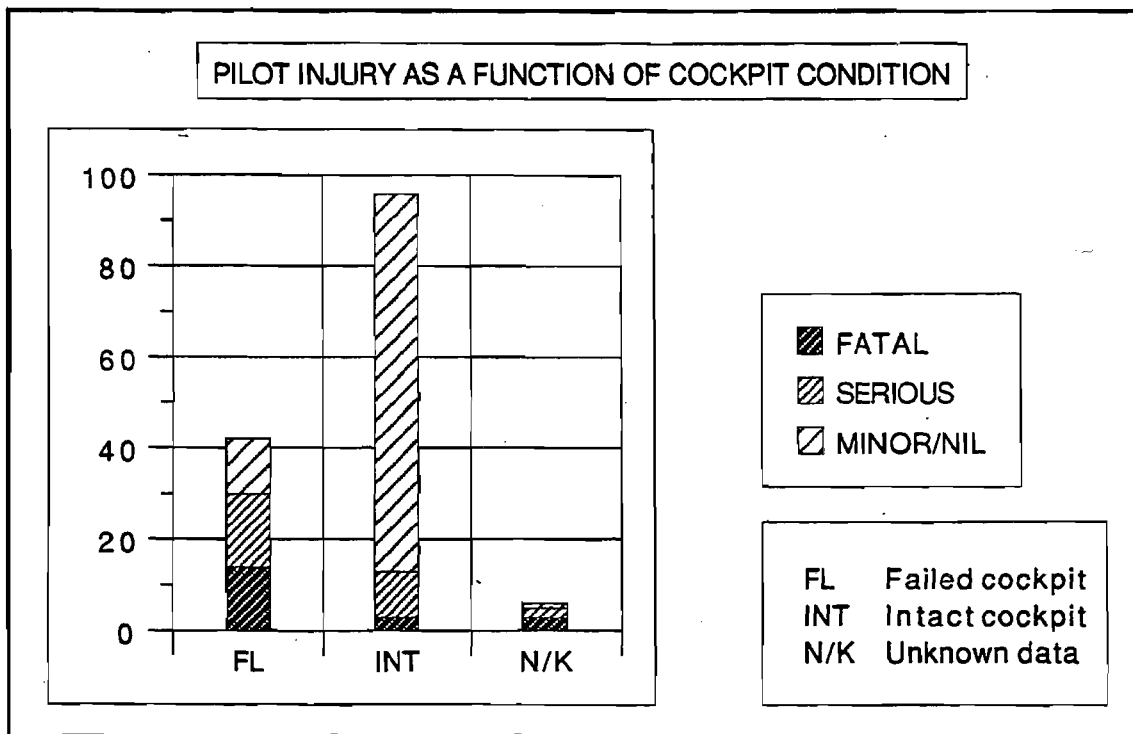
FIGURE 17

The analysis revealed that there was a large proportion of fatal accidents (70%) in which the cockpit environment was known to have failed. The majority of them (71%) were associated with fire. In contrast, a correlation between cockpit failure and fire was present in only 31% of the serious-injury group.

Breakdown by aircraft type revealed that both types suffered structural deformation in 15 cases, causing more fatal accidents with the Piper PA-25 series. Most of the fatal accidents experienced a post-crash fire.

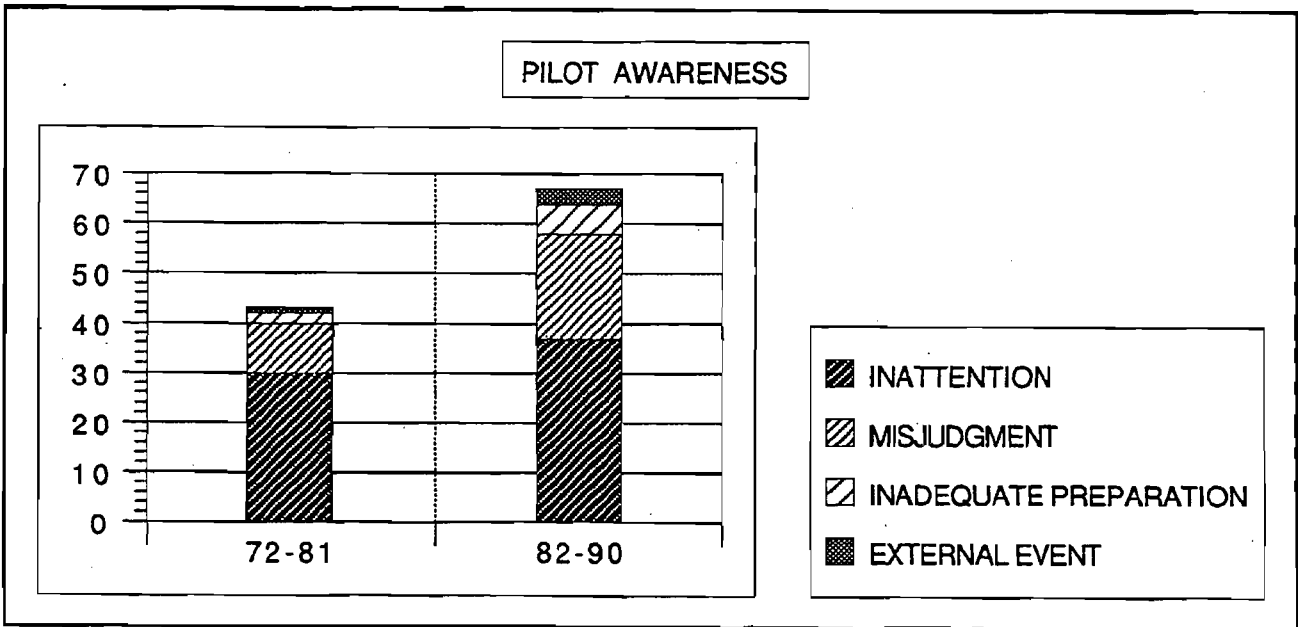
FIGURE 20

Pilots in 79% of the total number of accidents under review were aware of the wires. The reasons attributed to the wire strikes were classified in four groups: inattention, misjudgment, inadequate preparation, and external event. Figure 20 displays the proportion per decade for each group.

The results indicate an increase in each group, except for 'inattention' where percentages decreased from 70% to 55%. Misjudging and inadequate preparation appeared to have contributed significantly to the increase of accidents in the last decade. However, inattention represented and remains the majority of the causes, even though a reduction of cases was recorded in the most recent period.
