ATSB TRANSPORT SAFETY REPORT  
Rail Occurrence Investigation RO-2008-001  
Final

# Level Crossing Collision Birkenhead, South Australia 5 March 2008

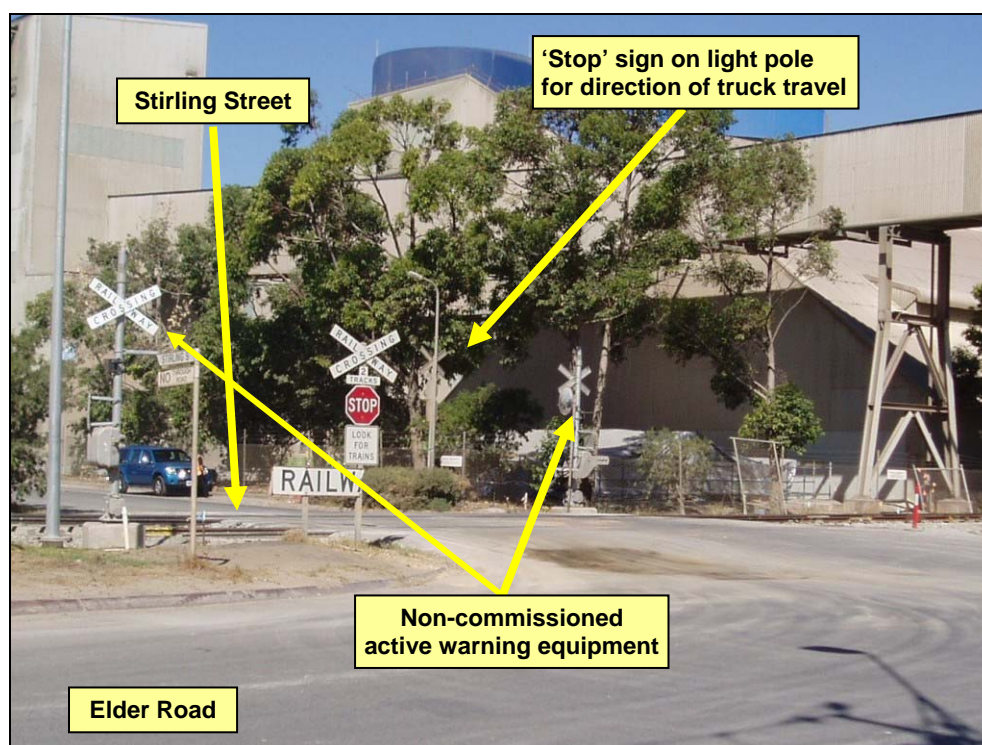
**Figure 2: Partial erection of active warning equipment as at 5 March 2008**

conjunction with the Port River Expressway Project. As at 5 March 2008, these works were still on-going. The works had included the removal of a (disused) parallel rail line that was to the west of the main rail line, the re-surfacing of Stirling Street in the vicinity of the level crossing and the partial erection of active level crossing equipment for the pending conversion from passive to active control. At the time of the collision this equipment consisted of posts and cross-bucks only, the lights and boom barriers were yet to be fitted (Figure 2).

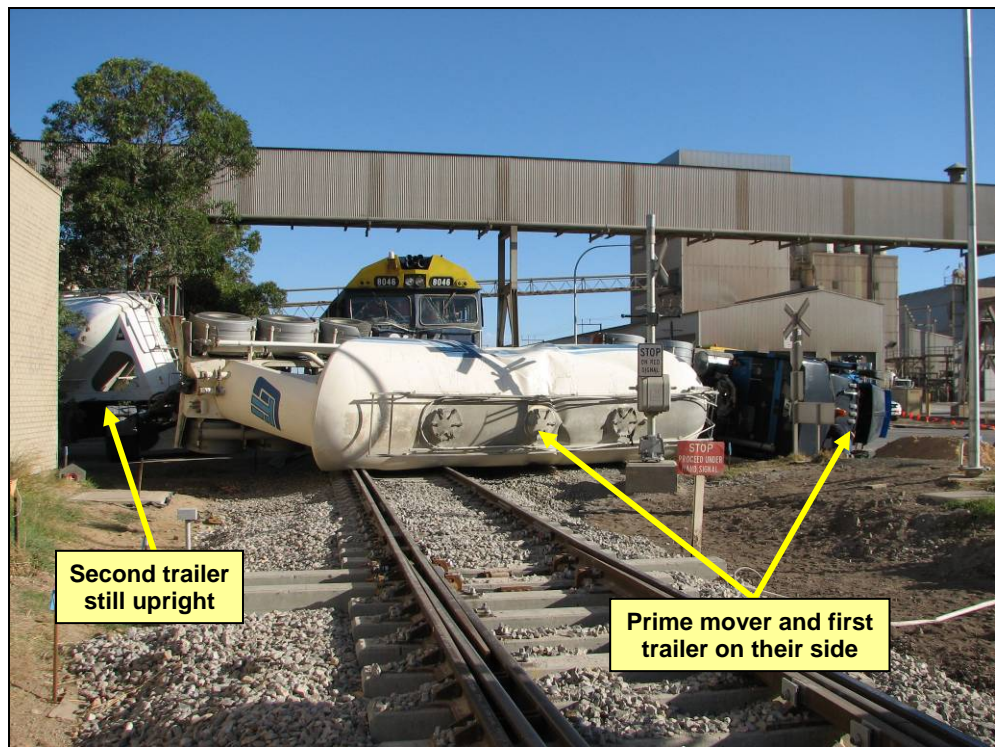
**Figure 3: Collision consequence**

The locomotive collided at about the middle of the pneumatic cement tank of the first trailer, which rolled onto its right side. The first trailer remained secured to the prime mover turntable thereby rolling the prime mover in the same direction. However, the rear trailer remained upright on all wheels because the 'A' frame converter dolly<sup>9</sup> coupler between the first and second trailer twisted. Consequently, this action steered the dolly bogie that was under the leading end of the second trailer in the same direction that the train was travelling (Figure 3). During this sequence, the forward (east to west) movement of the road-train exerted sufficient lateral force on the locomotive to derail all wheels of the leading bogie to the western side of the track.

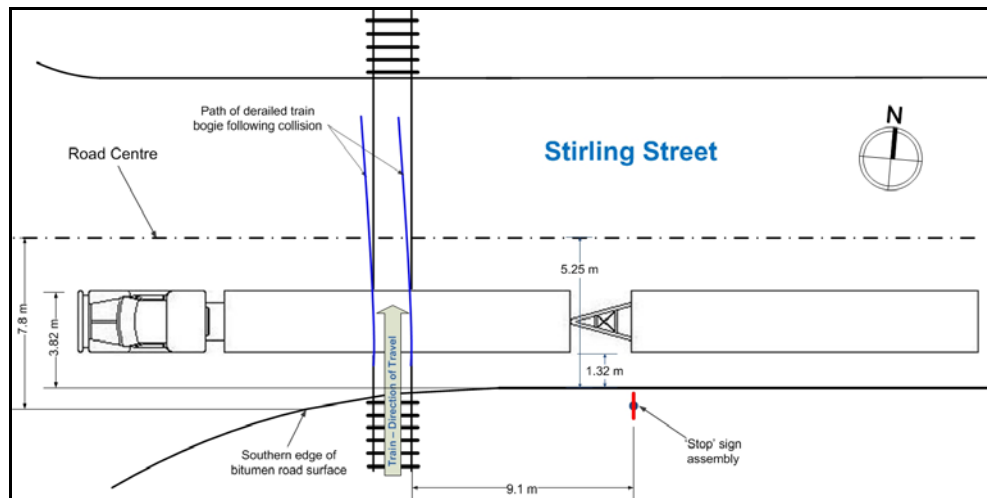
**Figure 4: Diagram of road-train position at time of collision**

Figure 4 illustrates the location of the truck at the point of collision. Site observations and measurements indicate that the road train was essentially in the centre of the westbound lane at the point of impact. The locomotive impacted the first trailer of the road-train almost 'dead centre', about 11.7 m from the prime mover (front) bull-bar.

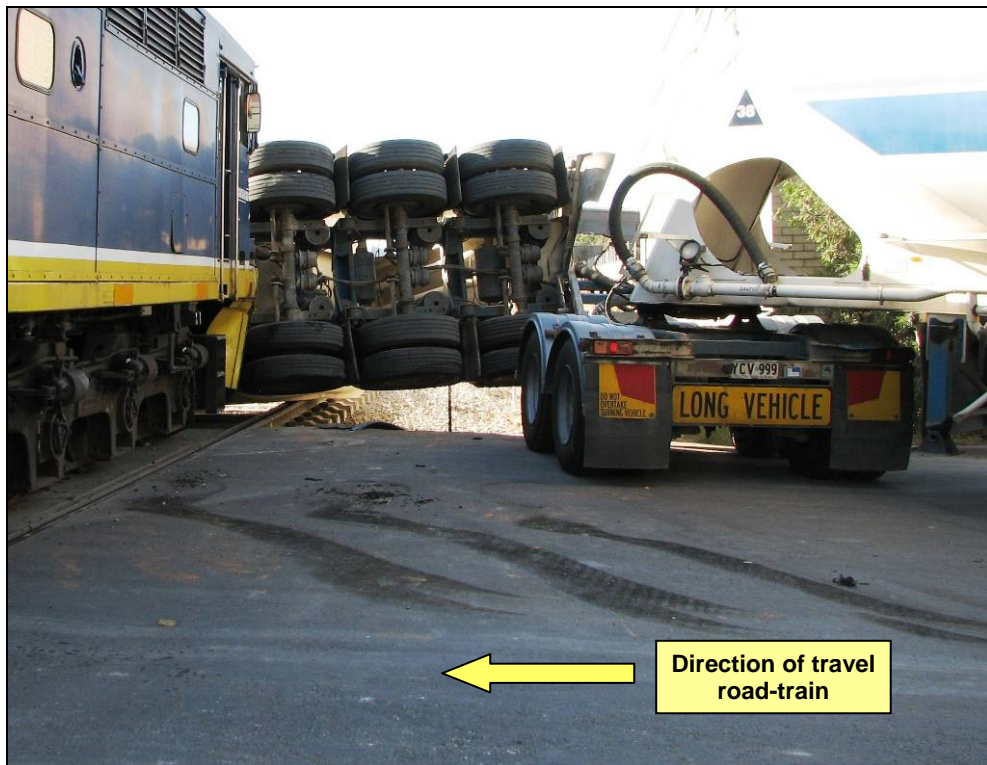
**Figure 5: Tyre marks of rear bogie leading trailer**

There were no tyre skid marks from the road-train at the site that were attributable to braking before impact. The only tyre marks found were the result of the road-train being struck by the train and moved laterally with respect to its direction of travel (Figure 5). The three sets of tyre marks seen are scuff marks from the tri-axle bogie of the lead trailer. These marks indicate that the leading trailer was forced sideways for just over 2 m before it rotated and that the wheels were still turning as this was happening. This indicates that the brakes of the leading trailer were not on at impact. However, behind the 'A' frame converter dolly bogie there were skid marks, indicating that the brakes of the dolly bogie were applied. The length of these skid marks indicated that the dolly bogie brakes applied at or within moments of impact. This was almost certainly due to the air line between the lead trailer and the 'A' frame converter dolly being vented to atmosphere during the collision sequence.

The tyre marks on the bitumen surface support the evidence of the road-train driver who said he did not apply the brakes before or at impact.

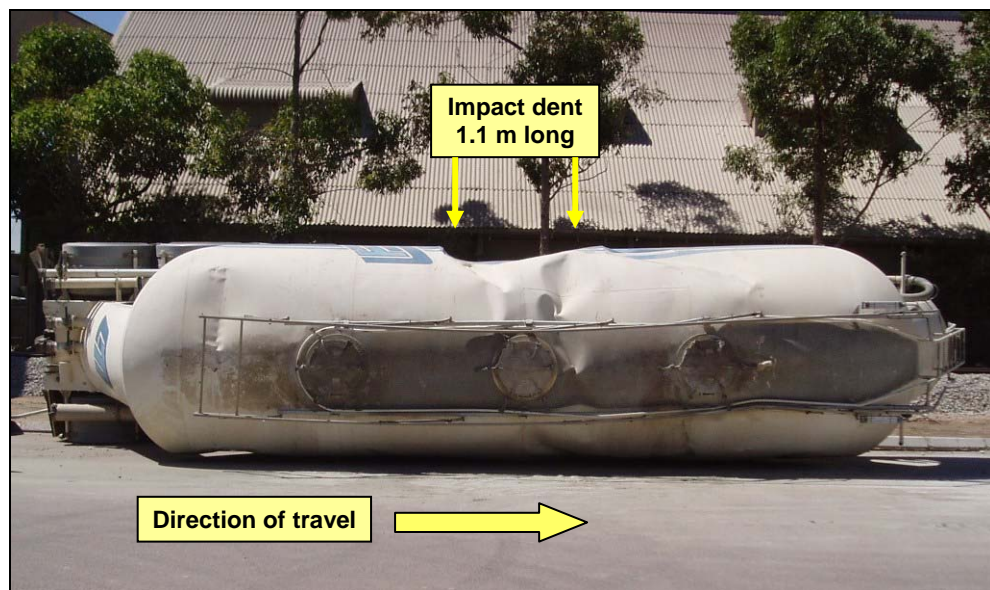
**Figure 6: Leading trailer after removal from site**

- A number of witnesses estimated that the truck was travelling at about 20 km/h as it passed over the Stirling Street level crossing.
- The locomotive impacted the first trailer of the road-train almost 'dead centre' of the pneumatic cement tank (Figure 6), about 11.7 m from the prime mover (front) bull-bar. Therefore, the road-train had to travel 21.4 m from the 'Stop' sign assembly for the locomotive to have impacted the leading trailer at this point.

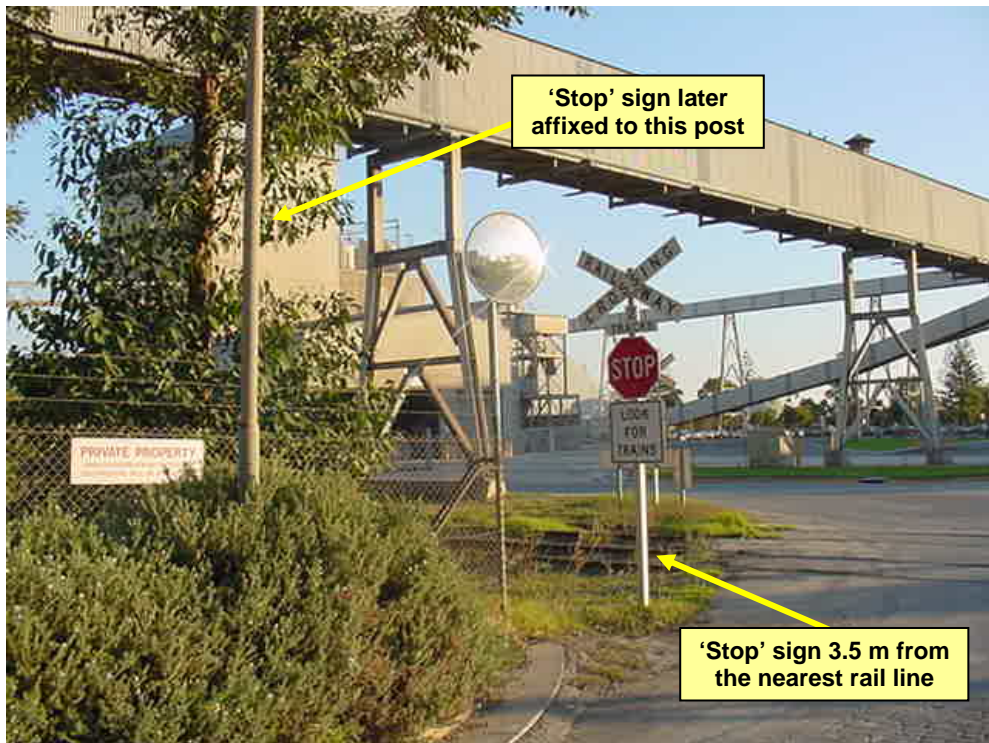
Figure 7: Original position of 'Stop' sign assembly (photographed 2003)

The assessment identified that a Stop line was located about 4.0 m from the rail, but the pavement markings were faded and difficult to see. It was noted that an attempt had been made to resolve inadequate sight distance to the north by installing a mirror for westbound road traffic and by requiring rail traffic to stop and proceed under hand signal. However, the assessment found that sighting to the south was also inadequate, but no measures had been implemented to resolve the issue. The assessment concluded that the crossing did not conform to the requirements of AS 1742.7 due to inadequate sight distance and recommended a similar restriction be placed on rail traffic approaching from the south and for pavement markings to be reinstated. It could not be confirmed if these recommendations had been implemented before the upgrade works started.

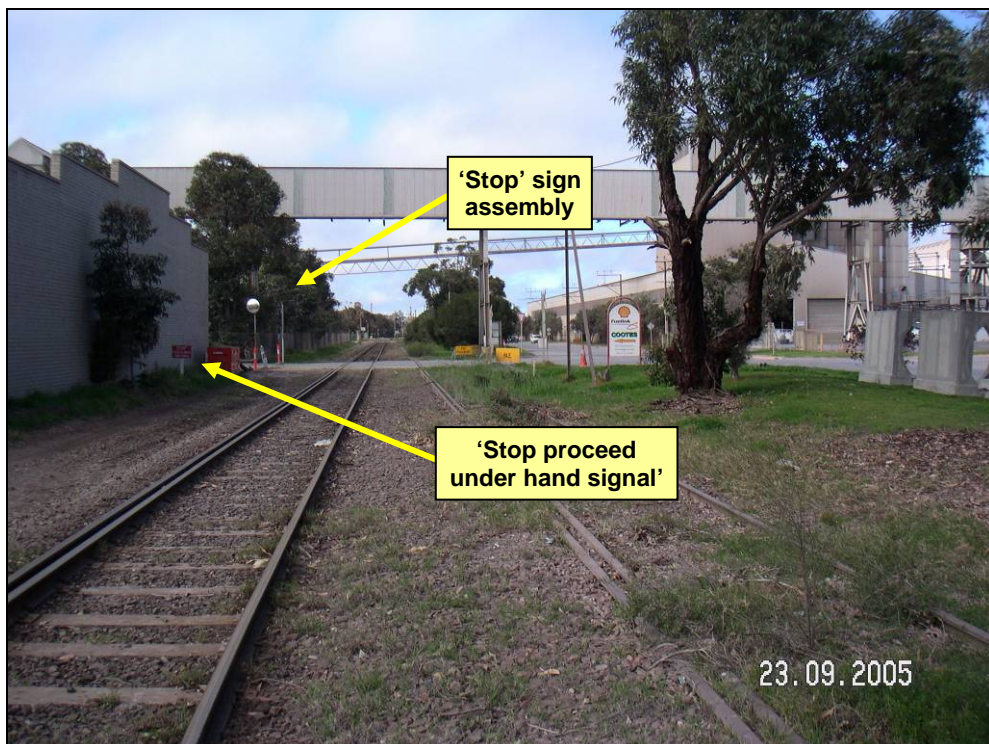
Figure 8: Original position of 'Stop' sign assembly (photographed 2005)

It was evident that the primary track used for rail traffic was the eastern track over Stirling Street (left track in Figure 8). Rail traffic approaching on this track provided the most restrictive view to road traffic stopped on the eastern side of the crossing. Consequently, it is likely that both the obstructions and the track geometry contributed to the inadequate sight distance assessment identified in 2003.

Considering that the agreements and contracts for the upgrade works were signed on 8 July 2005, it is evident that the Stop sign was positioned 3.5 m from the nearest rail line as work was about to commence on the project. However, it is also likely that the crossing did not conform to the requirements of AS 1742.7 at this time, due to inadequate sight distance.

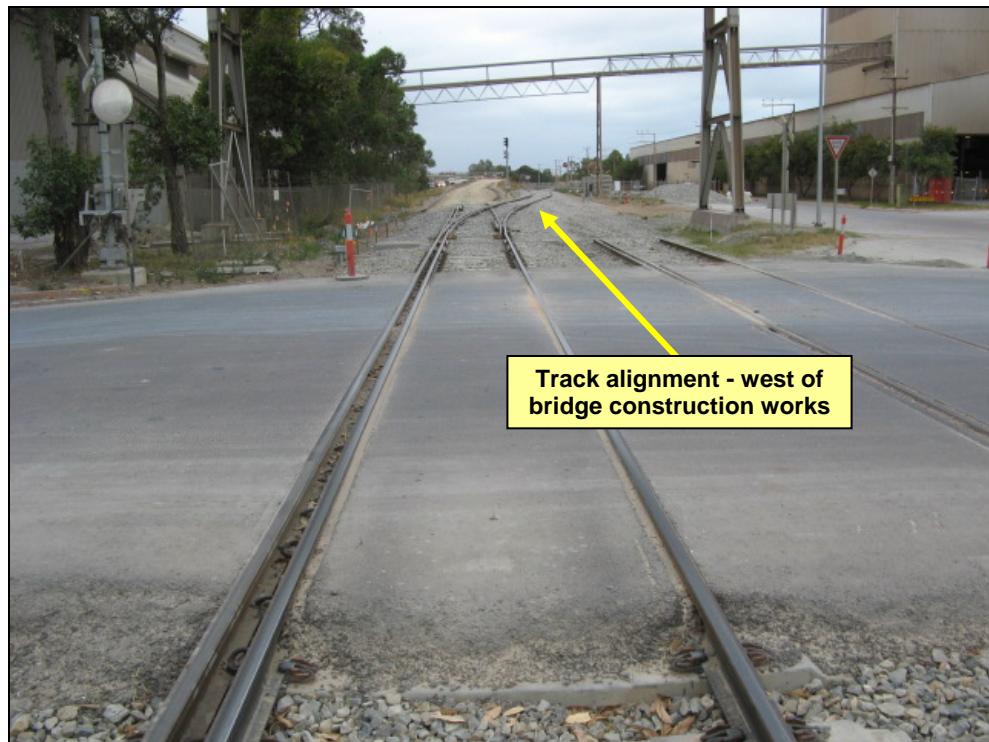
**Figure 9: Track configuration on 5 March 2008**

Part of the Port River Expressway Project involved the construction of a rail bridge over the Port River. The alignment of the bridge was such that the eastern track, south of Stirling Street, would require removal during construction. Consequently, rail traffic was transferred to the western track which was also realigned further west to avoid conflict with construction works. At a later date, the western track was realigned a second time to join the original alignment of the eastern track immediately south of Stirling Street and remained in this configuration until the collision on 5 March 2008 (Figure 9). The track to the north was similar in that it deviated from the eastern track to the western track immediately north of the level crossing. A consequence of the track realignment, with respect to road traffic on Stirling Street, was to improve sight distance to both the north and south.

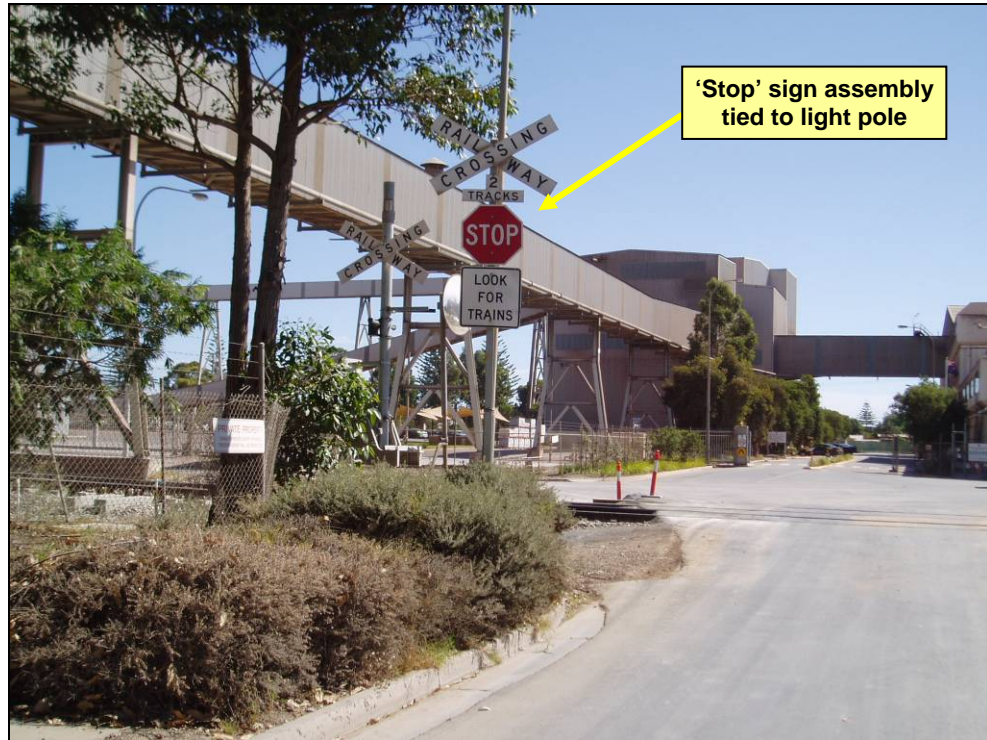
**Figure 10: Stop sign assembly on the day of the collision**

Evidence suggests that the RX-2 Stop sign assembly was originally located about 3.5 m and a Stop line about 4.0 m from the nearest rail line, consistent with minimum distance specified in the standard. However, it is likely that the Stop sign's relocation and the lack of a Stop line were due to the upgrade works being undertaken to install active traffic control. While AS 1742.7 does not stipulate a maximum distance at which a Stop sign assembly or pavement marking can be located from the nearest rail line, the requirement for adequate sight distance still applies.

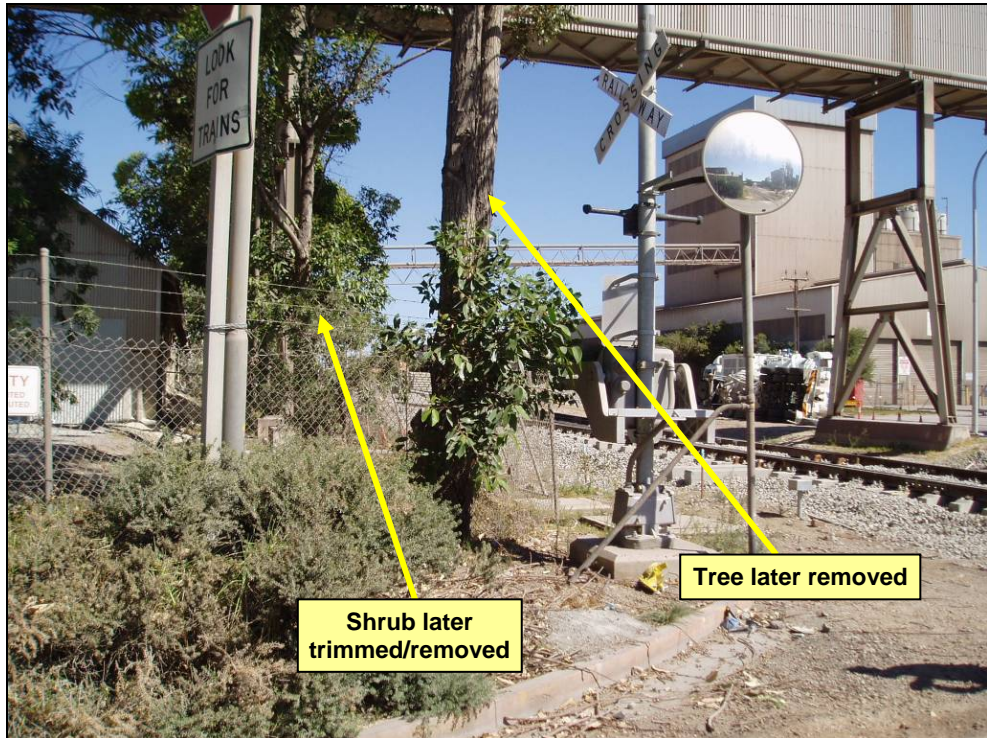
**Figure 11: Visibility along rail line from ground level at Stop sign assembly, on the day of the collision**

Figure 11 illustrates the view from the Stop sign on the day of the collision. The photo was taken from a standing position at the approximate location that a vehicle driver would be when stopped at the Stop sign. It is evident that sighting along the rail line was limited and intermittent at best.

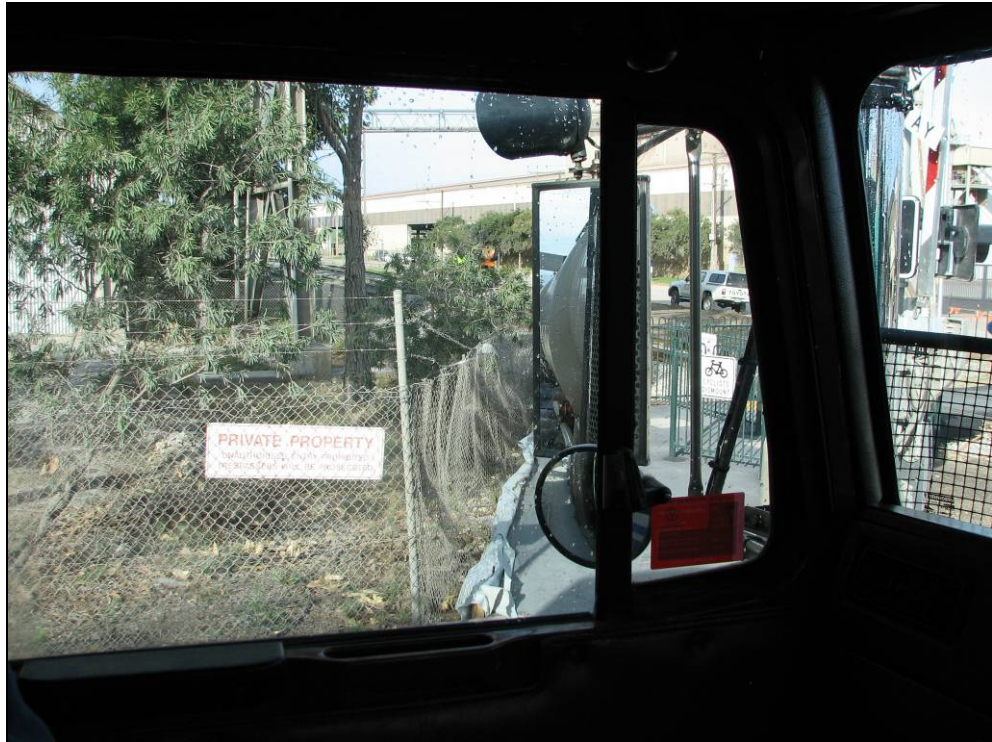
**Figure 12: Visibility from prime-mover, nose 9.1 m from the nearest rail**

The nose of the prime-mover was positioned at the location where the Stop sign assembly was on the day of the accident, 9.1 m from the nearest railway line. The photograph in Figure 12 was taken at this point from the driver's seat. From this

elevated position and without the tree and shrub<sup>17</sup> that had been removed by this time (Figure 11), sight distance for trains approaching from the south was about 40 m, including the intermittent view through the vegetation. This is significantly less than the 160 m required by the standard for a double road-train or for any other configuration of articulated heavy vehicle. It should also be noted that the sight distance for trains approaching from the north was almost negligible due to an adjacent building

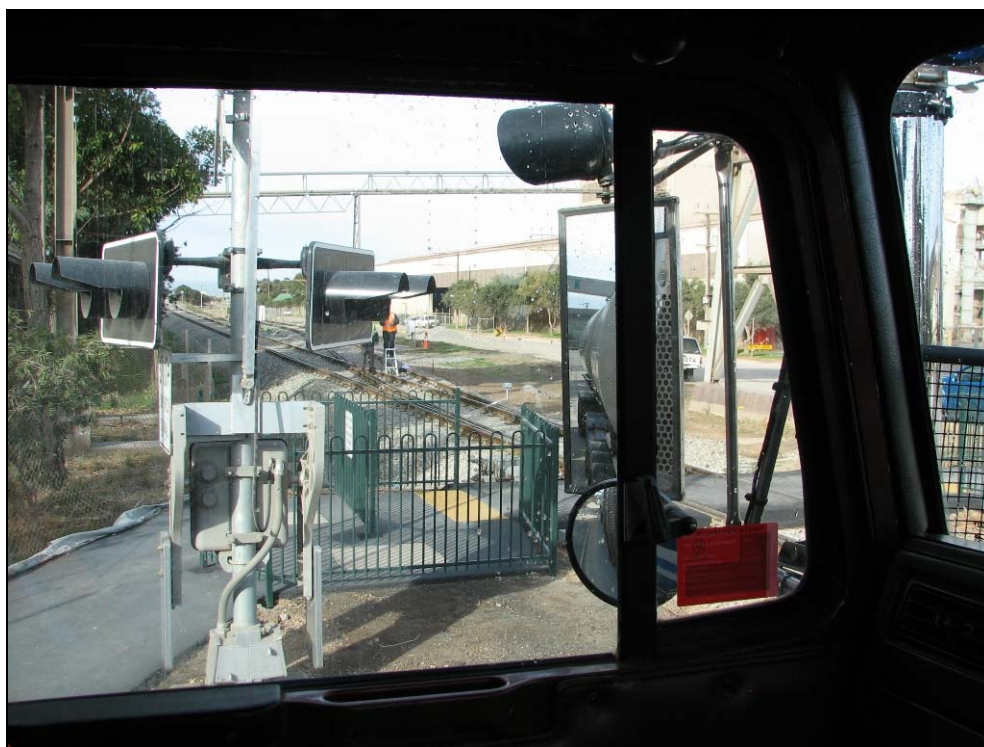
**Figure 13: Sighting distance, original position of the Stop sign assembly**

Figure 13 illustrates the view from the driver's seat when the truck was positioned with its nose about where a Stop line would normally be located. It is evident that the view is greatly improved from this location, particularly when noting that the active level crossing warning equipment (post, lights, boom barrier arm) depicted in Figure 13 were not in place at the time of the collision. From this location, sight distance far exceeded the 147.5 m required by the standard for a double road-train.

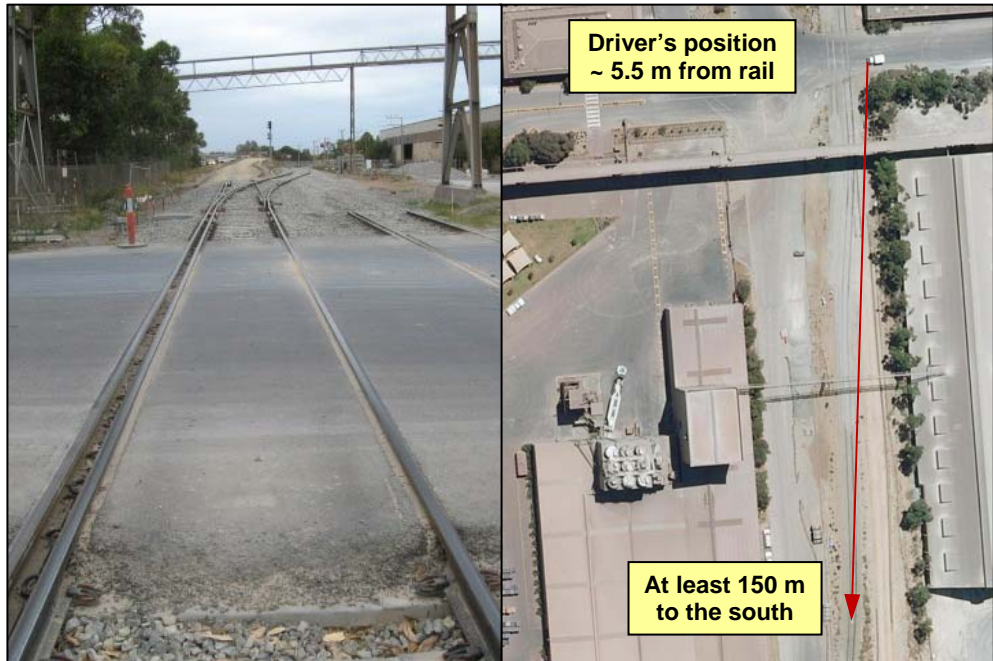
**Figure 14: Sighting to the south of Stirling Street level crossing**

Figure 14 illustrates the track geometry and sighting to the south of Stirling Street level crossing when the ALCAM assessment was conducted in February 2008. Analysis verified that, if a Stop line was visible about 4 m from the rail, sight distance to the south would have exceeded the requirements of AS 1742.7 (refer to section 2.3.3, Table 3 Sight distance requirements as per AS 1742.7).

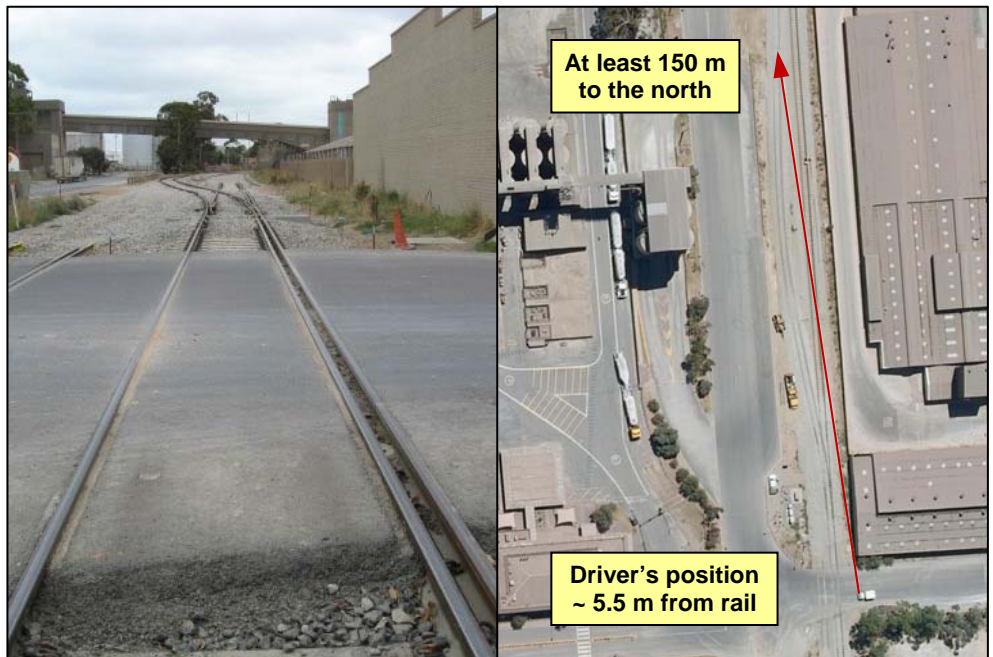
**Figure 15: Sighting to the north of Stirling Street level crossing**

Similarly, Figure 15 illustrates the track geometry and sighting to the north of Stirling Street level crossing when the ALCAM assessment was conducted in February 2008. Analysis verified that, if a Stop line was visible about 4.0 m from the rail, sight distance to the north is likely to have exceeded the requirements of AS 1742.7. In addition, the mirror and the restriction for trains to stop and proceed under hand signal had remained in effect for rail traffic approaching from the north.
