Introduction

The Australian Transport Safety Bureau has commenced the publication of a safety bulletin for the helicopter industry. This follows an external review of the Bureau undertaken in 1999. The review contained a number of recommendations, from which the production of this bulletin has emerged.

Helicopter Operations Safety Bulletin

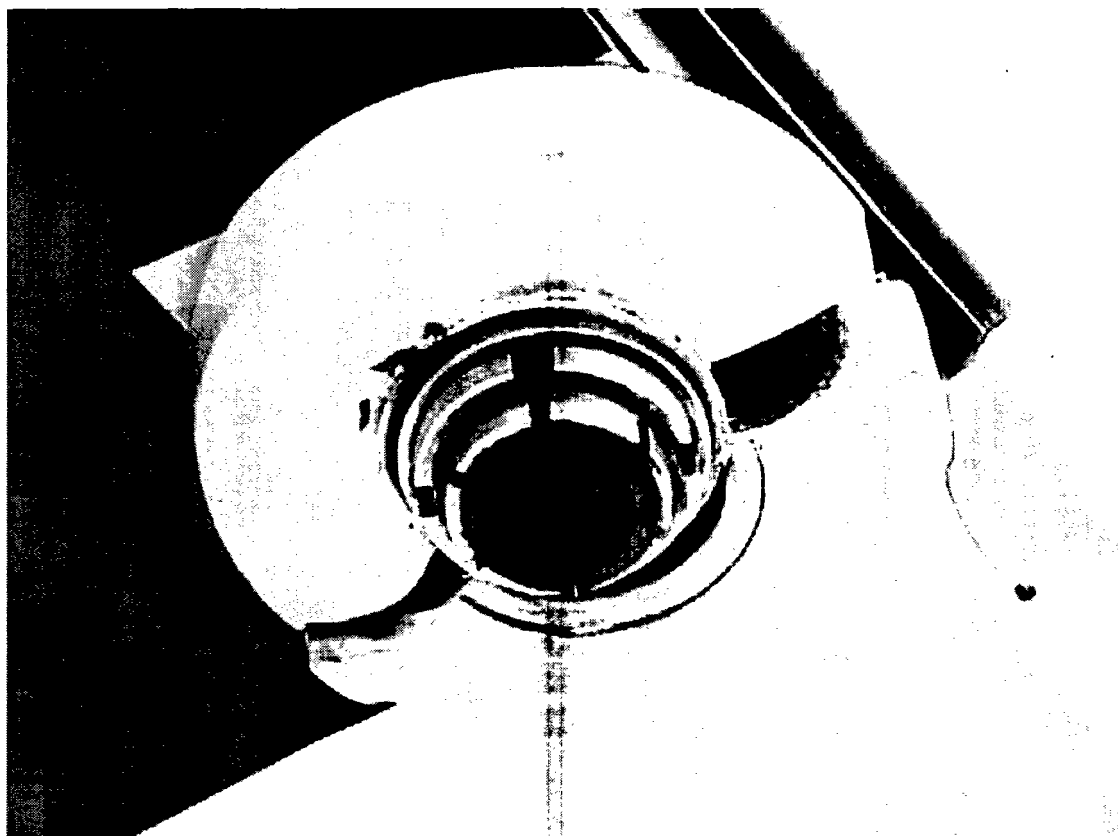
On the 9th of May 2000 a Bell 212 carried out an emergency landing following severe in-flight vibration. There were no injuries to crew or passengers. On further investigation one of the main rotor head grips Part Number 204-011-121-121 was found with the lower tang cracked chord-wise from under the blade bolt bush outwards to the leading and trailing edges of the grip. When the blade bolt was removed the broken piece of the tang fell off.

Figure 1 - The blade grip as found insitu.

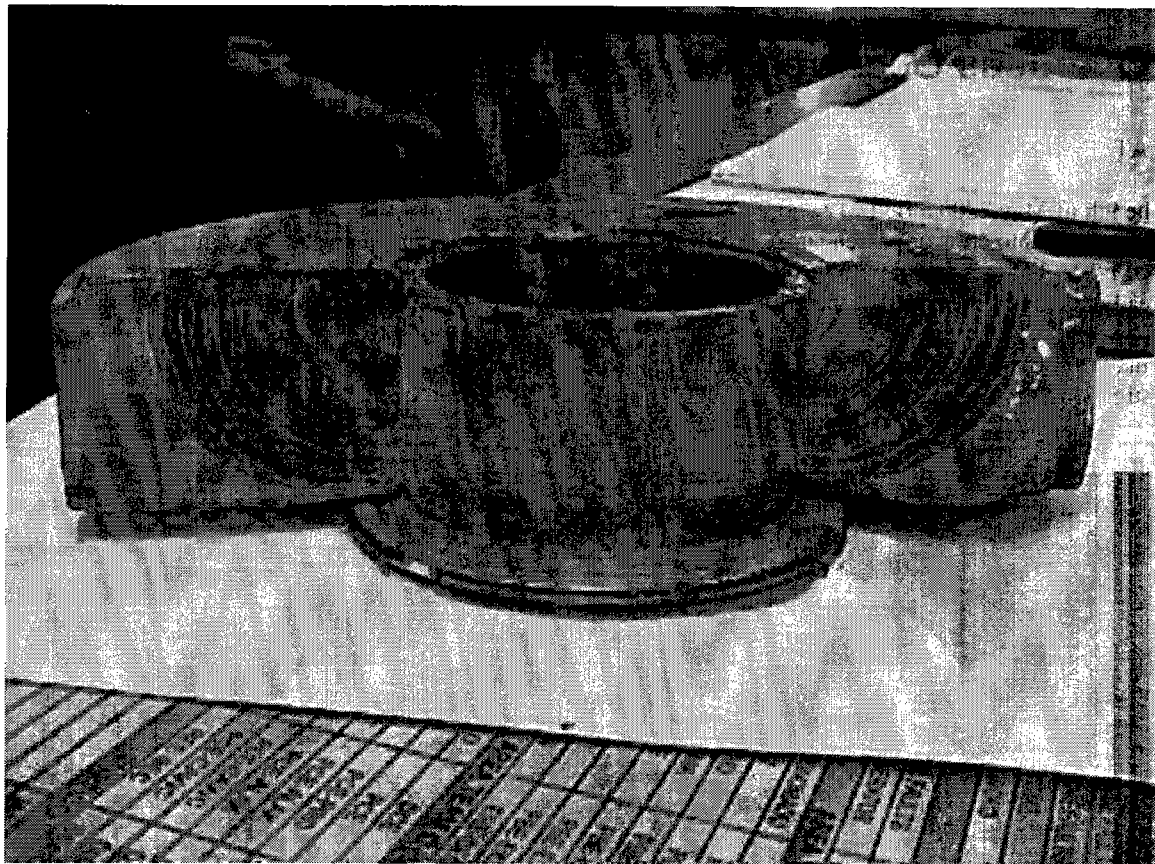
Figure 2 - Cross section of the failed area showing the characteristic "beach marks" of a fatigue failure.

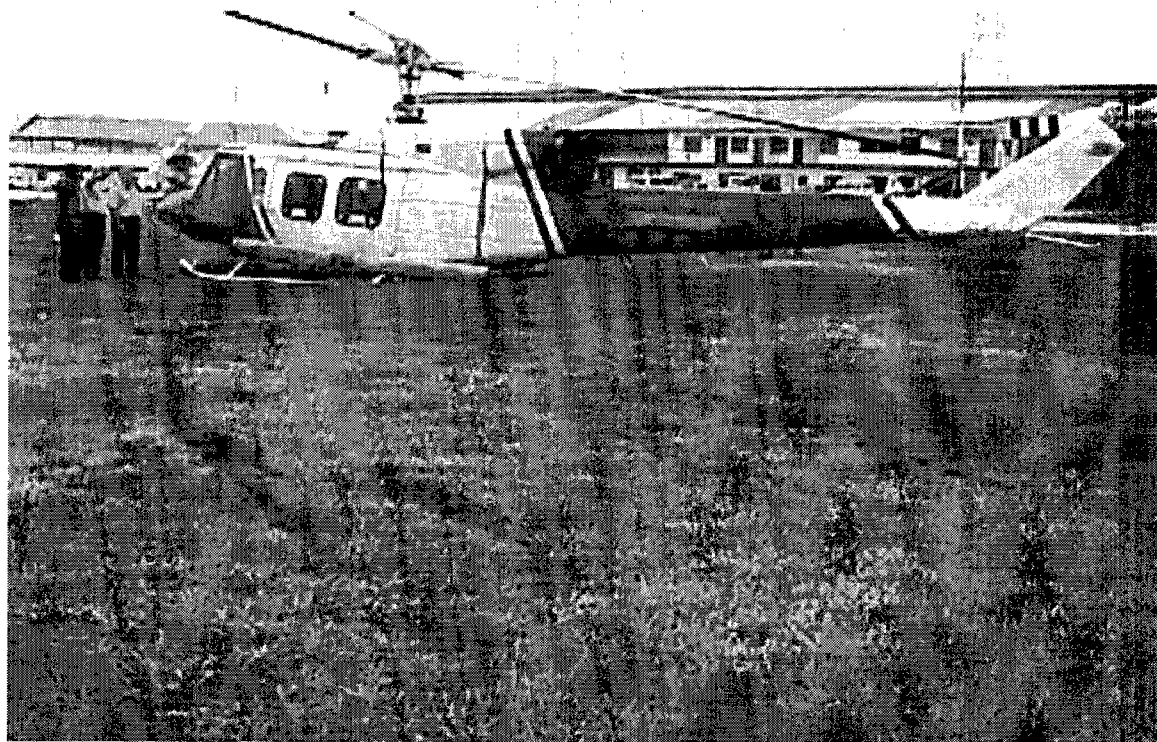
Figure 3 - The Bell 212 following the landing.
