**ATSB TRANSPORT SAFETY REPORT**  
Occurrence Investigation Report AO-2009-002  
Final

**Main rotor blade skin debonding**  
**29 December 2008**  
**135 km NE Alice Springs, NT**  
**VH-HZB**  
**Robinson Helicopter Company**  
**R22 Beta**

**ATSB TRANSPORT SAFETY REPORT**  
Aviation Occurrence Investigation  
AO-2009-002  
Final

**Main rotor blade skin debonding**  
**29 December 2008**  
**135 km NE Alice Springs, NT**  
**VH-HZB**  
**Robinson Helicopter Company R22 Beta**

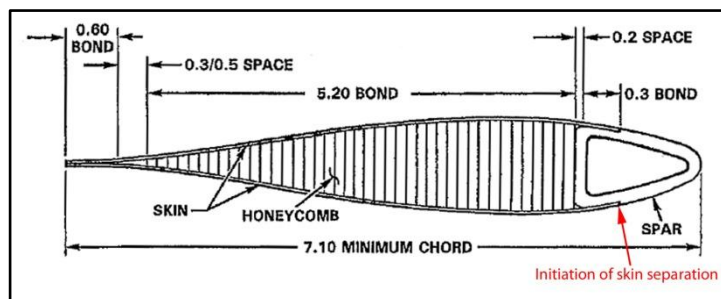
**Figure 1: Schematic diagram showing the construction of the current R22 main rotor blade design (P/N A016-4) and the location of debonding**

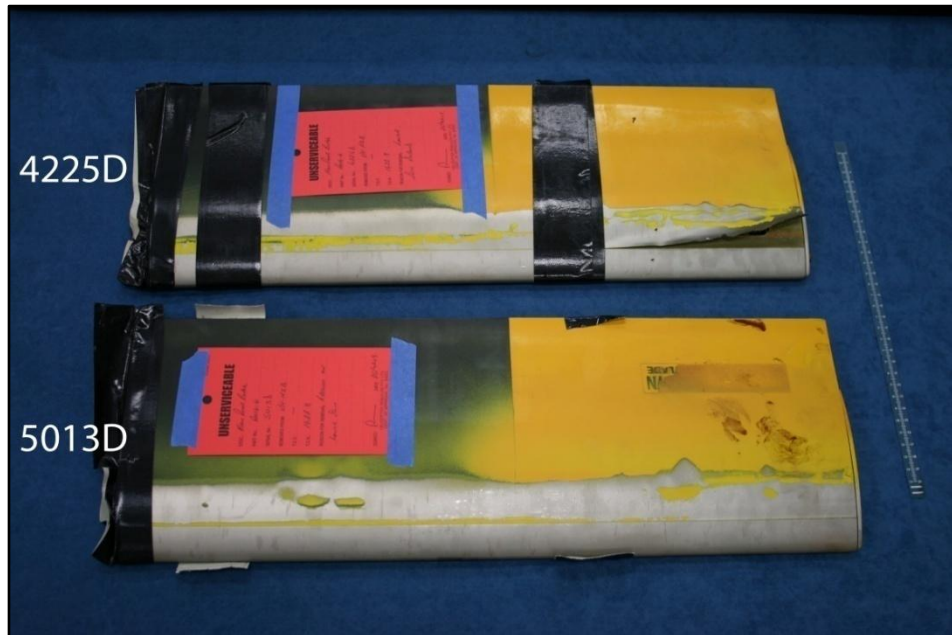
**Figure 3: General view of the main rotor blade outer sections as received (underside)**

The aerofoil skin of rotor blade 4225D (Figure 3) had separated from the blade on the underside, along the skin-to-spar bond line. The blade had debonded for approximately 160 mm along the length of the blade from the tip cap, and 45 mm towards the trailing edge (measured from the skin-to-spar bond line). The separated section of skin had curled backwards towards the trailing edge, and exhibited notable thinning along the forward-most edges. The flap of material formed by the separation along the bond line extended approximately 25-30 mm from the normal aerofoil surface (Figures 4 and 5). Thickness measurements of the skin in the region adjacent to the bond line revealed values of between 0.002 and 0.004 in (0.051 to 0.102 mm); considerably lower than the 0.008 in (0.203 mm) specified in the maintenance manual. Transverse tearing also extended from the forward skin edge into the bulk material.

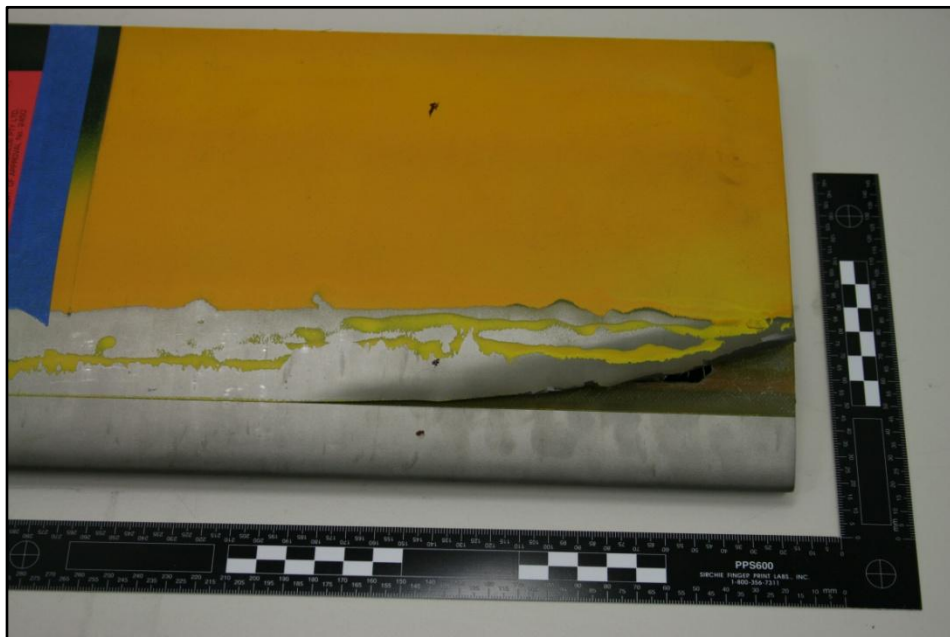
**Figure 4: Main rotor blade 4225D showing the extent of skin separation on the underside of the blade**

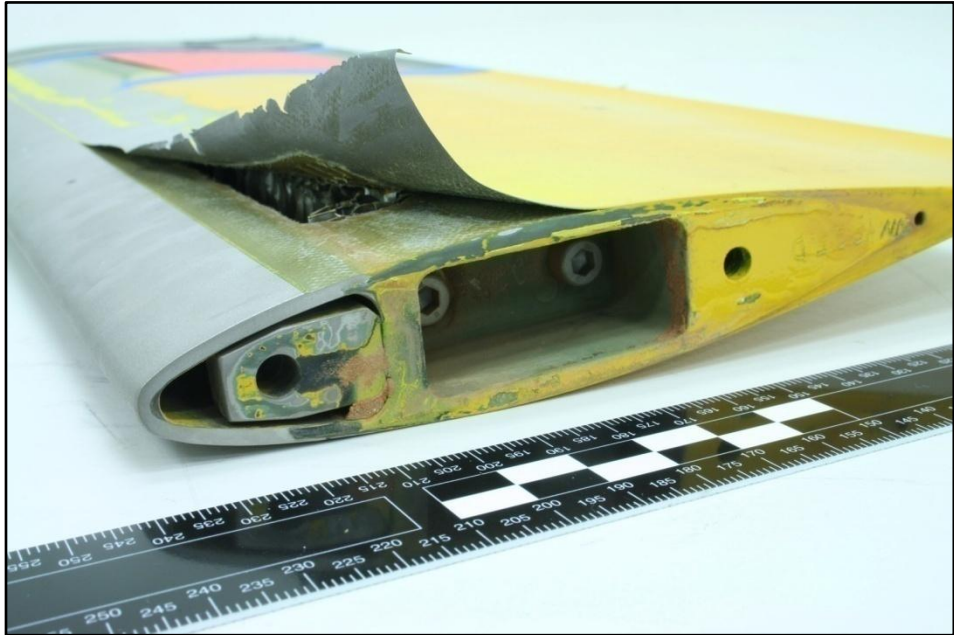
**Figure 5: End view of main rotor blade 4225D following removal of the tip cover**

The leading edge on both the upper and lower blade surfaces exhibited prominent erosion of the surface paint and primer. On the underside, the paint line had been eroded to a distance of greater than 35 mm from the bond line towards the trailing edge. The upper surface also exhibited erosion, with no surface paint remaining on the trailing edge side of the skin-to-spar bond line. The surface of the spar and outer surface of the skin was smooth and dull, with a slightly granular appearance, and was consistent with abrasive wear by fine particulate matter, such as dust and sand.

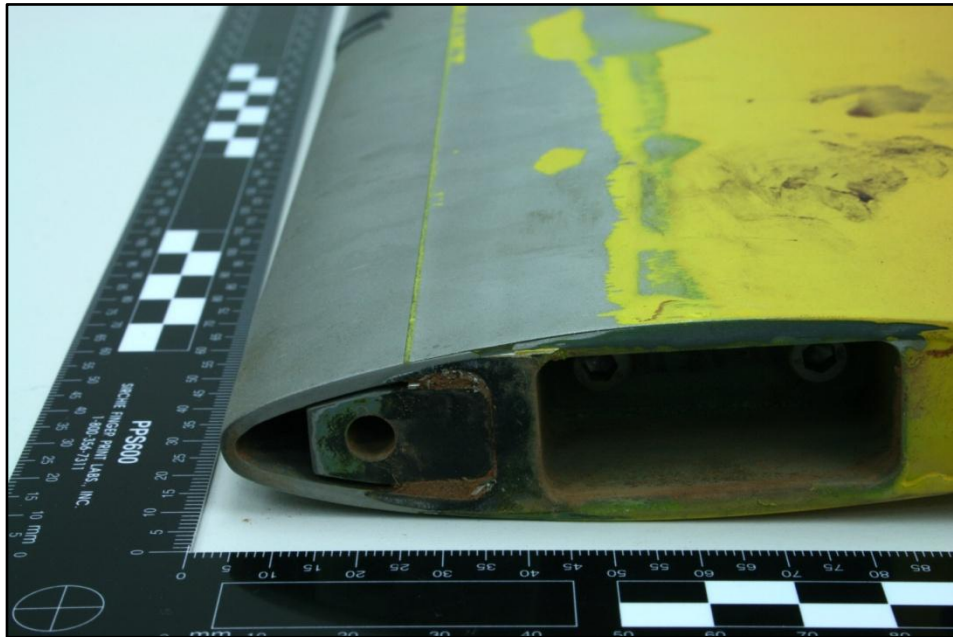
The opposite main rotor blade, serial number 5013D, also showed extensive erosion of the paint and primer on both the upper and lower surfaces. No paint was observed on the underside of the blade to a distance of approximately 25 mm past the bond line; the degree of paint erosion was consistent along the length of the section examined. Additionally, no paint was observed on the spar side of the bond line on the upper surface.

Removal of the tip cover (Figure 6) revealed some thinning of the skin, with a noticeable difference in the height on either side of the skin-to-spar bond line. No evidence of skin separation could be discerned visually and a tap-test, performed in accordance with AD/R22/54 Amdt 3, along the entire length of the submitted section suggested that no debonding had occurred.

**Figure 6: Main rotor blade 5013D after removal of tip cover showing erosion of paint and primer, and thinning of the skin**

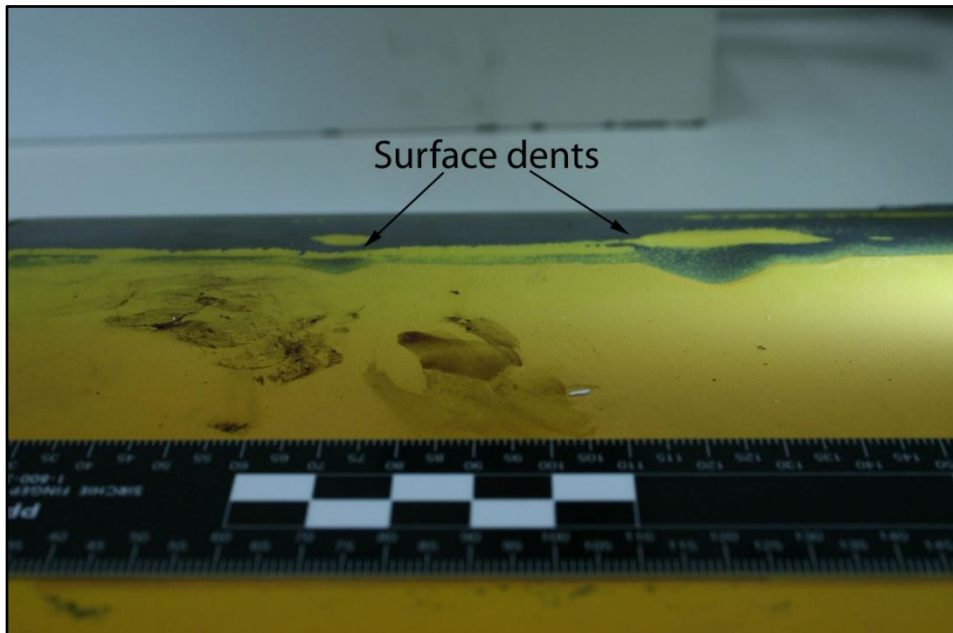
Main rotor blade 5013D exhibited two small dents on the lower surface (Figure 7), which coincided with areas of greater paint erosion. The dents were within the limits specified in the component maintenance manual and a tap test of the surrounding areas revealed no evidence of debonding.

**Figure 7: Bond line of blade 4225D in the area adjacent to the separated skin area**

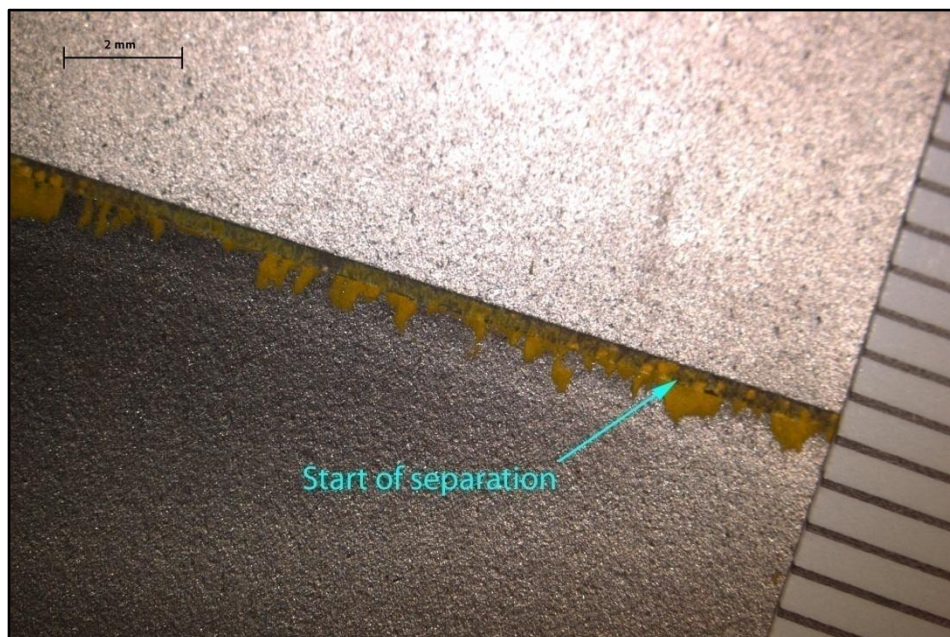
The separated skin-to-spar bond line of blade 4225D and the bond line on the underside of 5013D were examined visually and with the aid of a low-powered stereobinocular microscope. Both blades revealed a gap between the spar recess edge and the overlying skin of approximately 0.5 mm (Figure 8). This was generally consistent with a lap joint configuration; however, it should be noted that in both cases, a slight difference in the height of the skin and spar sections was observed, which suggested some level of erosion of the skin had occurred. The preferential erosion of the surfaces on the trailing edge side of the skin-to-spar bond line was clearly observed when viewed from the end of the blade, with the tip covers removed (refer to Figure 9 & 6)

**Figure 8: Bond line of blade 4225D in the area adjacent to the separated skin area**

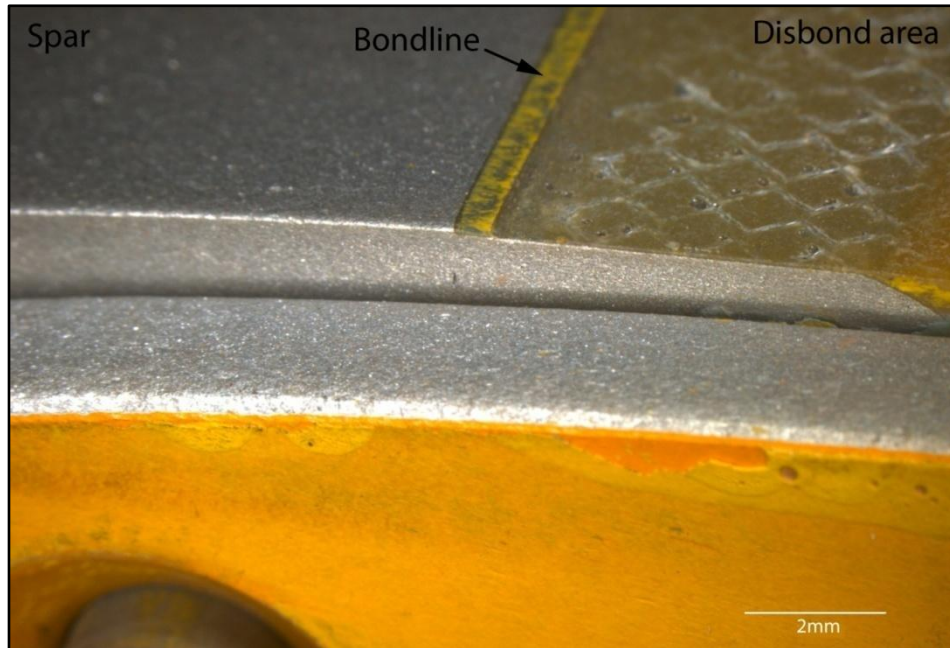
**Figure 9: View of the skin-to-spar debond area of blade 4225D taken from tip, showing erosion of the bond line**

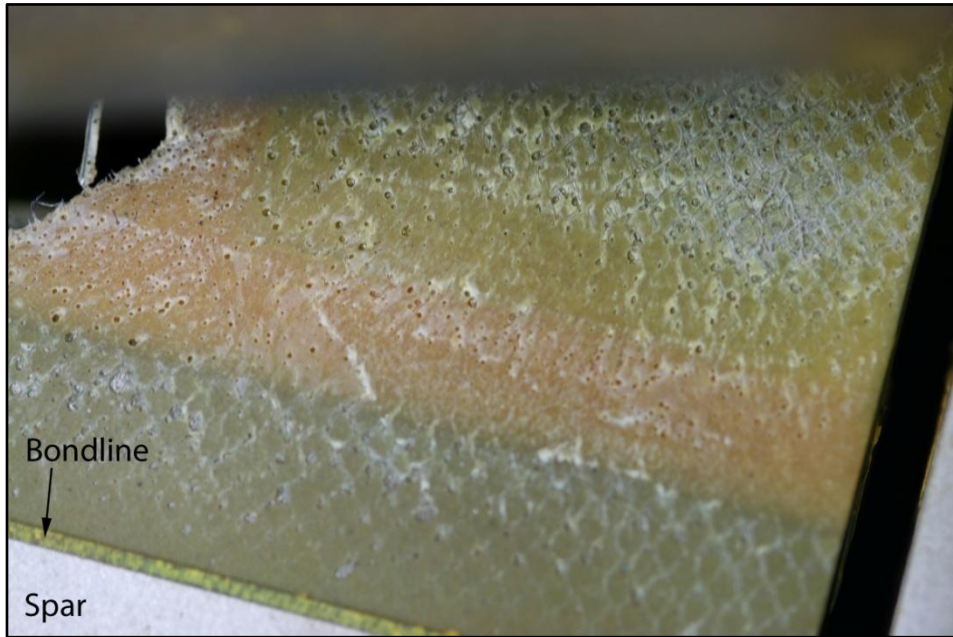
An inspection of the exposed adhesive on blade 4225D indicated that separation had occurred via a mixed mode failure mechanism, that is, a combination of cohesive<sup>3</sup> and adhesive<sup>4</sup> failure (Figures 10 to 12). The area immediately adjacent to the skin-to-spar bond line was primarily an adhesive failure. The exposed surfaces on both sides of the joint, that is, the mating faces, were smooth and clean. The underside of the separated skin did not exhibit any residue of the adhesive in an area approximately 1 to 1.5 mm wide, along the length of the exposed bond line.

**Figure 10: Debonded area on blade 4225D showing the surface of the adhesive**

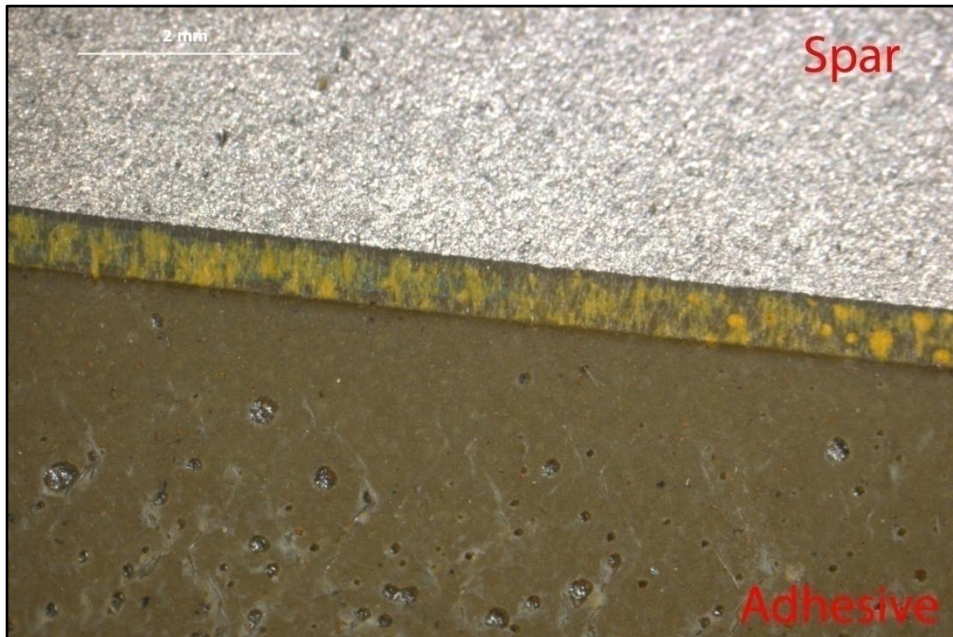
The remaining area of exposed interface exhibited mixed mode failure features, with both smooth areas of adhesive failure, and rough, fibrous areas associated with failure of the adhesive itself, that is, cohesive failure. This mode was also characterised by widespread remnant adhesive remaining on the underside surface of the separated skin. The failure had occurred in close proximity to the interface between the adhesive and the skin, and did not appear to have penetrated the carrier cloth<sup>5</sup>.

**Figure 11: Magnified view of the bond line and adhesive surface immediately adjacent to the skin-to-spar bond line**

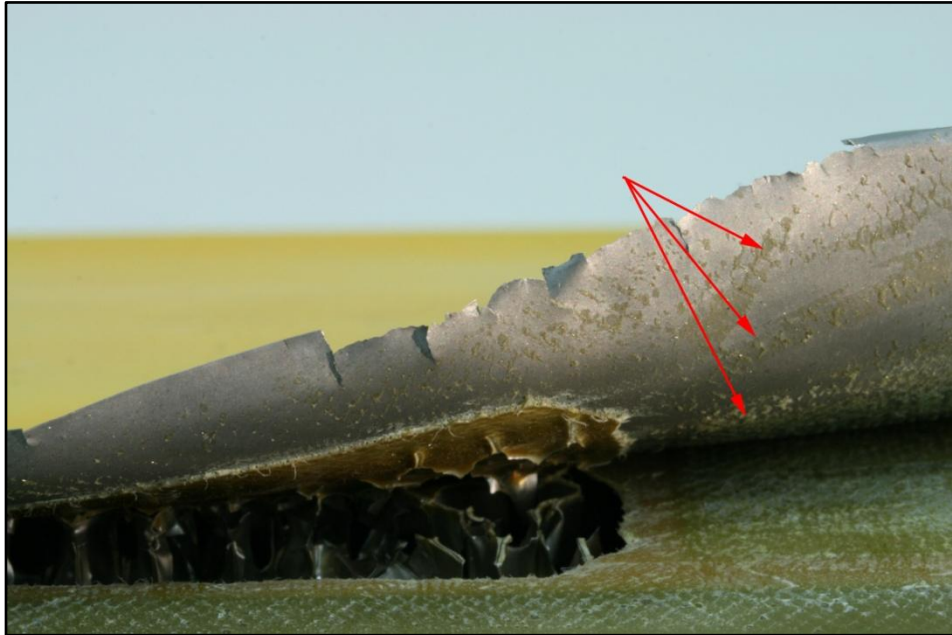
**Figure 12: Underside of separated skin on blade 4225D, showing the presence of adhesive on the skin side of the joint (arrowed)**

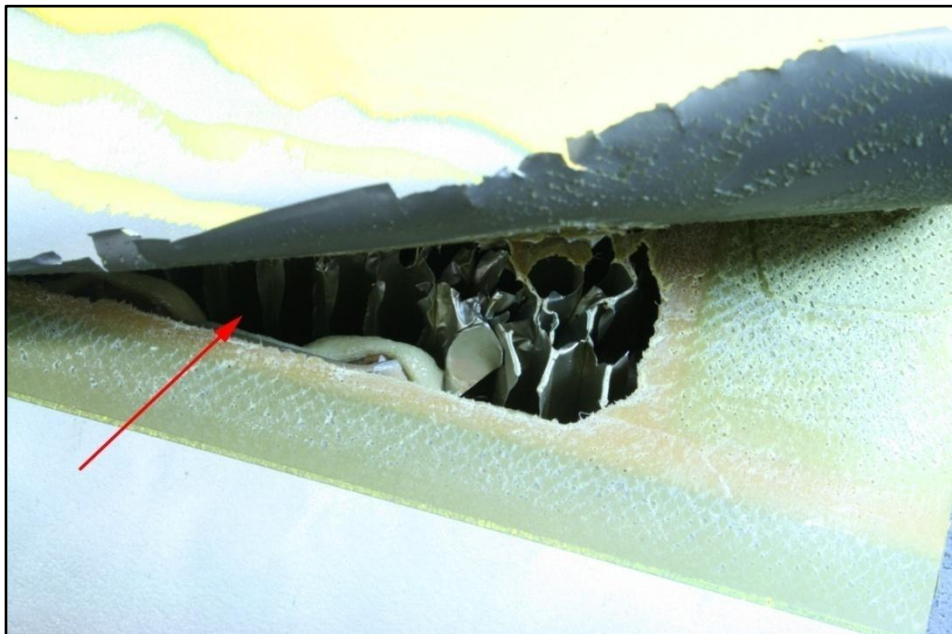
Examination of the core-to-spar bond exposed by the debonded section of skin on blade 4225D, showed evidence of a lack of adhesive in this location (Figure 13). The honeycomb core did not appear to abut with the adhesive on the rear of the spar segment.

**Figure 13: Core-to-spar bond of blade 4225D, showing a gap between the aluminium honeycomb structure and the adhesive on the spar**
