ATSB TRANSPORT SAFETY REPORT
Occurrence Investigation Report AO-2007-008
Final

Engine failure
259 km SSE of Broome, WA
24 May 2007
VH-IWO
Raytheon Beechcraft B200 King Air

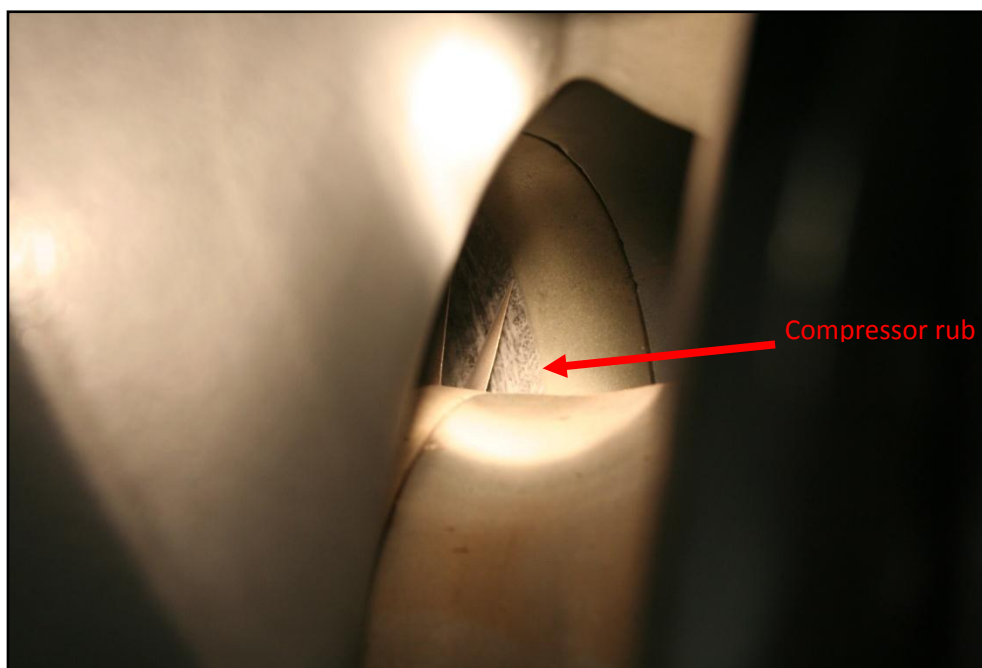
Figure 1: Compressor casing rub (first stage)

Upon removal of the air inlet screen, evidence of first stage compressor rub was observed on the engine's inlet casing (Figure 1). The first stage compressor blade tips were discoloured, indicating prior localised heating. There was no evidence of any foreign object damage in the compressor section of the engine.

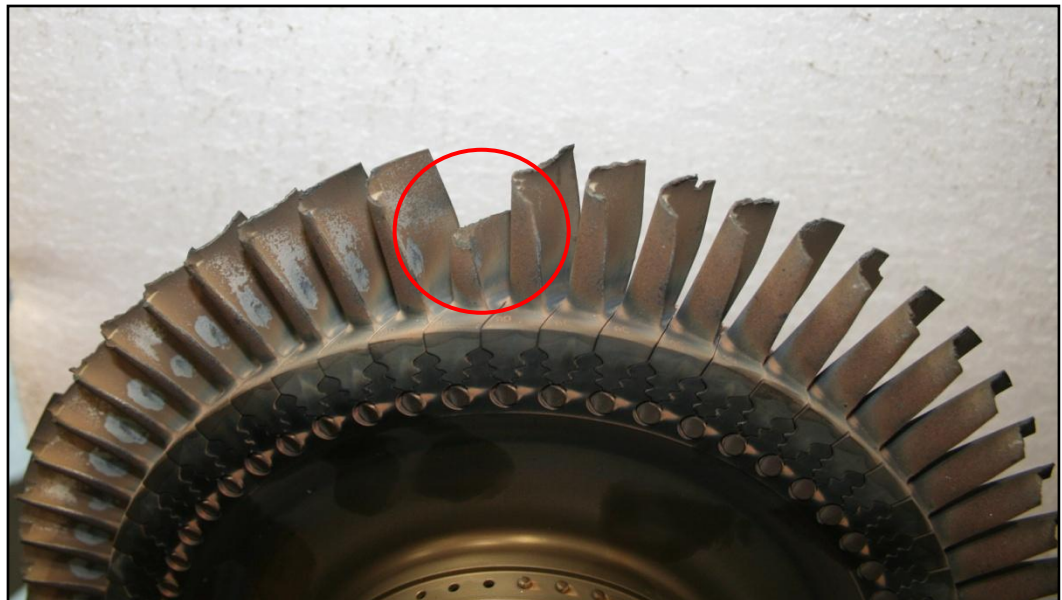
Figure 2: Severe CT blade tip erosion and fractured blade (circled)

- there were small pieces of metal debris in the combustion case liner, the gas generator case and at the bottom of the turbine case
- there was foreign object damage to the trailing edges of two of the vanes of the compressor-turbine guide vane
- the compressor-turbine shroud exhibited light rubbing marks as a result of contact with the compressor-turbine blade tips
- there was a large amount of heat distress-related CT blade tip erosion
- one compressor-turbine blade had fractured at about one third of its span (Figure 2).

Of the 58 disc blades examined, one had fractured transversely through the mid-span section, about 10 to 12 mm above the blade platform transition (Figure 2). There was localised plastic deformation (or necking), and numerous surface fissures were identified at the point of blade fracture. Plastic deformation and surface fissures at the point of blade fracture are often observed in the case of stress-rupture failures of high-temperature componentry (Figure 3). Stress-rupture occurs as a product of excessive loss in material strength, and is typically a late-stage result of microstructural creep¹².

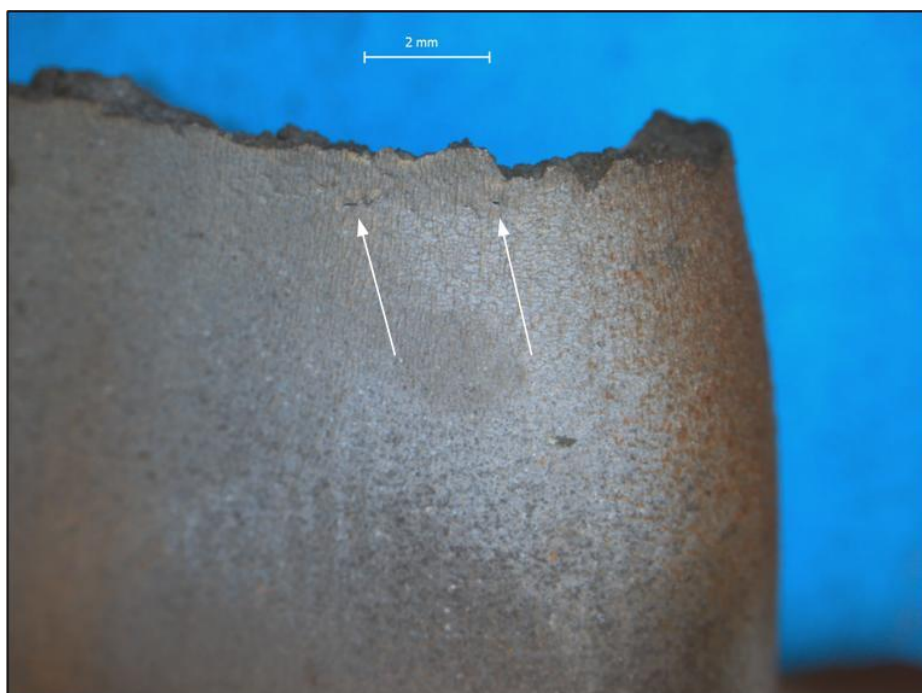
Figure 3: Profile view of blade fracture – note reduction in section and fissuring (arrowed)

Creep and eventual stress-rupture is a time/temperature dependent failure mechanism, and the onset of a premature stress-rupture failure is often precipitated by a period (or multiple periods) of exposure to temperatures above the design limits identified for the component alloy type. In the context of a turbine aircraft engine, fuel scheduling and engine handling during start and acceleration have the potential to produce overheat events, which can have a cumulative damaging effect on the high temperature components of the engine.

The compressor-turbine blade failed due to stress-rupture. That rupture was a product of excessive loss in material strength, which was typical of late-stage microstructural creep of the blade from exposure to over-temperature events. The loss of section from the blade would have produced a substantial reduction in turbine efficiency, with a corresponding drop in the compressor-turbine speed and discharge pressure (CDP). Increased fuel scheduling, in response to the decreasing CDP, would likely have produced the escalating inter-turbine temperatures, surging and exhaust smoke reported by the pilot and flight nurse.

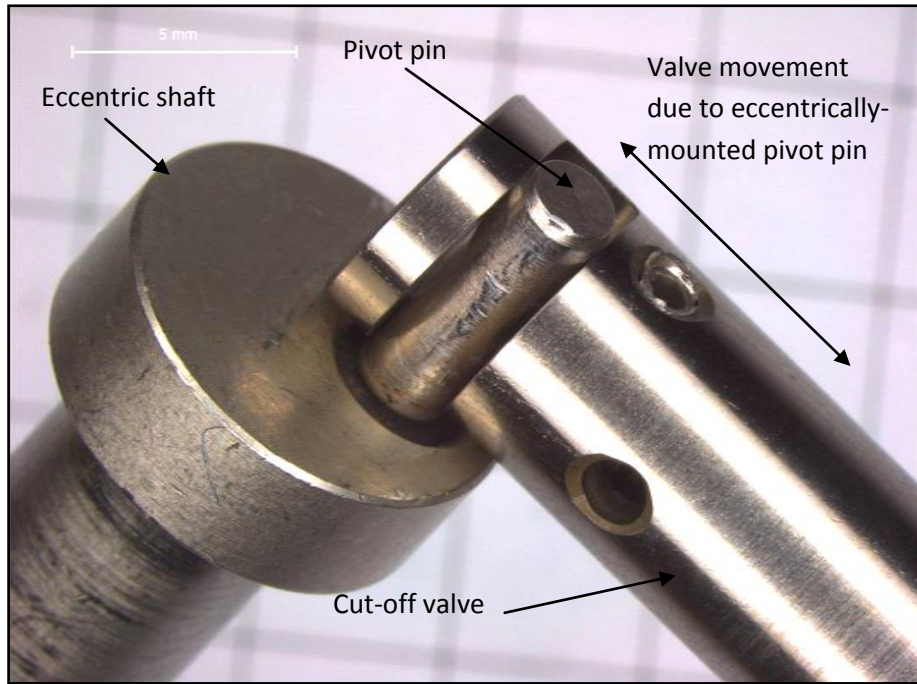
Figure 4: Cut-off valve eccentric shaft and pivot pin

The condition of the fuel cut-off valve seat was considered by the examining technician to be appropriate for the TSO. However, after removing the cut-off sleeve, it was identified that the cut-off valve could slide in and out through the sleeve, but was unable to rotate on its eccentrically-mounted pivot pin (Figure 4) due to binding between the two components. Damage in the form of tool marks was evident to the pivot pin and cut-off valve slot (Figures 5 and Figure 6).

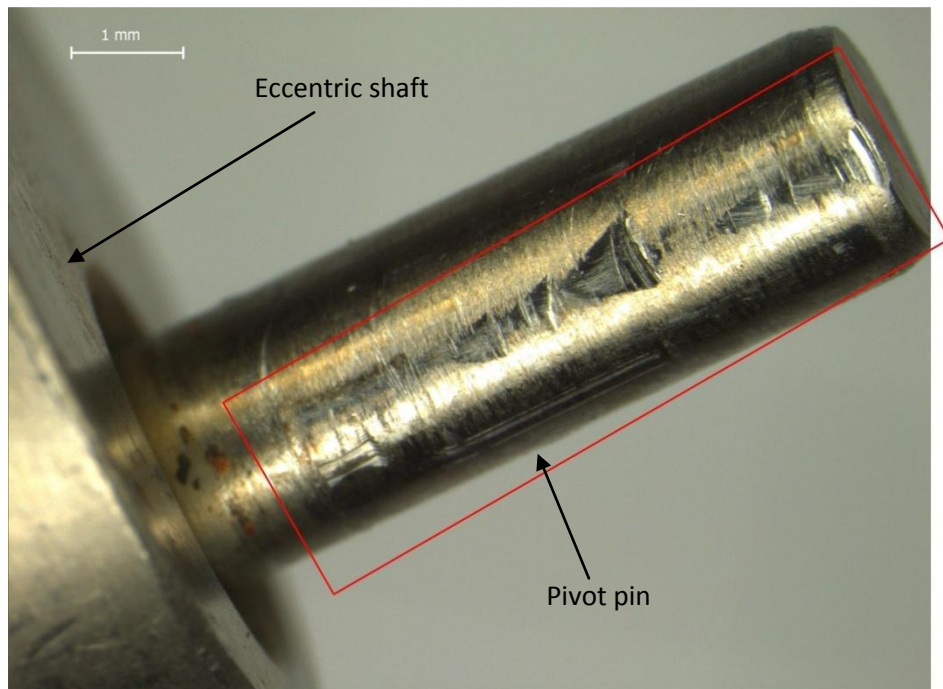
Figure 5: Pivot pin showing tool marks (boxed in red)

It was not possible to determine when the pivot pin seizure occurred in the life of the FCU. However, after freeing the observed pivot pin binding, the assembly was refitted to the FCU. The FCU was again tested, and the cut-off modulation function performed to specification.
