ATSB TRANSPORT SAFETY REPORT  
Aviation Occurrence Investigation A0-2009-013  
Final

## Avionics system event

### Sydney Airport, NSW

### VH-VYL, Boeing 737-800

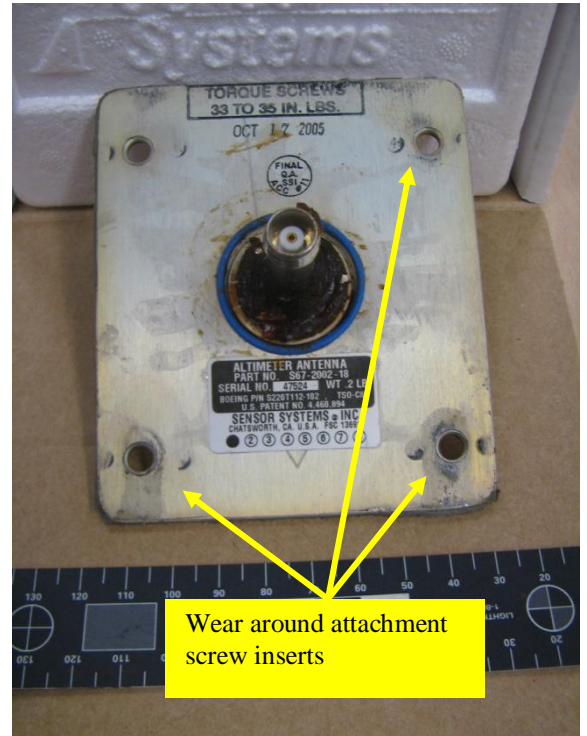
Figure 1: Left receive antenna

An examination found that the left RA receive antenna displayed rubbing wear adjacent to the attachment screw inserts. A bonding check of the antenna indicated that the antenna's resistance was outside the aircraft manufacturer's limits. The antenna was replaced and the aircraft was returned to service.

A bonding check<sup>3</sup> was carried out on the left RA system, which revealed that the receiver antenna's resistance was 1.1665 ohms. That value was above the aircraft manufacturer's maximum allowable limit of 0.001 ohms. No other RA defects were found.

The aircraft's left and right RA receive and transmit antennas were examined by the Australian Transport Safety Bureau. Wear was found on both antenna contact surfaces, adjacent to the attachment screw inserts. The left receive antenna showed the highest level of wear (Figure 1).

The surface wear adjacent to the attachment screw inserts on the left receive and transmit antennas was consistent with surface rubbing resulting from movement between the antenna and the aircraft's skin. The effect of the wear on the operation of the RA systems could not be determined. However, the possibility for the wear to have contributed to the antenna's increased resistance could not be discounted.

The aircraft operator replaced the left RA receive and transmit antennas and, following subsequent system testing, the aircraft was returned to service.

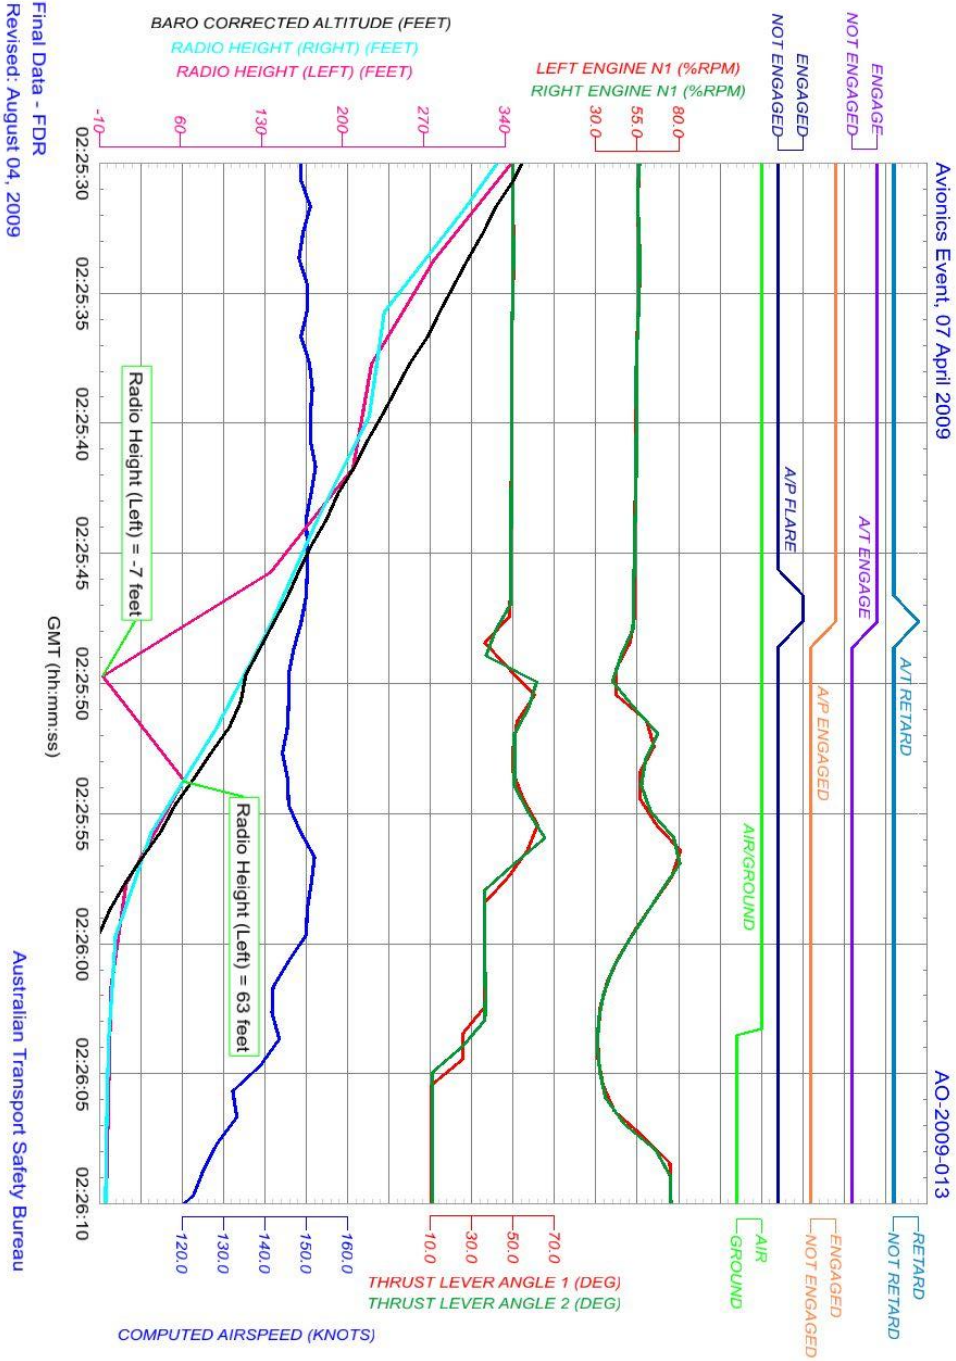
# APPENDIX A: GRAPHICAL REPRESENTATION OF DFDR DATA

A subsequent engineering examination of the aircraft's autopilot system built-in test equipment (BITE) identified spurious left RA inputs. A review of the aircraft's digital flight data recorder (DFDR) information confirmed a coincident, momentary reduction in the left RA altitude reading from about 130 ft to minus 7 ft, followed by an increase to 63 ft within 4 seconds. The autopilot disconnected and the autothrottle commenced moving the thrust levers towards idle.

The DFDR data indicated that control of the aircraft and the descent profile were not affected (Appendix A).
